Conditions and Needs Assessment

Dillingham Airport Master Plan Update

Project No. CFAPT00353/ AIP 3-02-0078-017-2018

December 2021

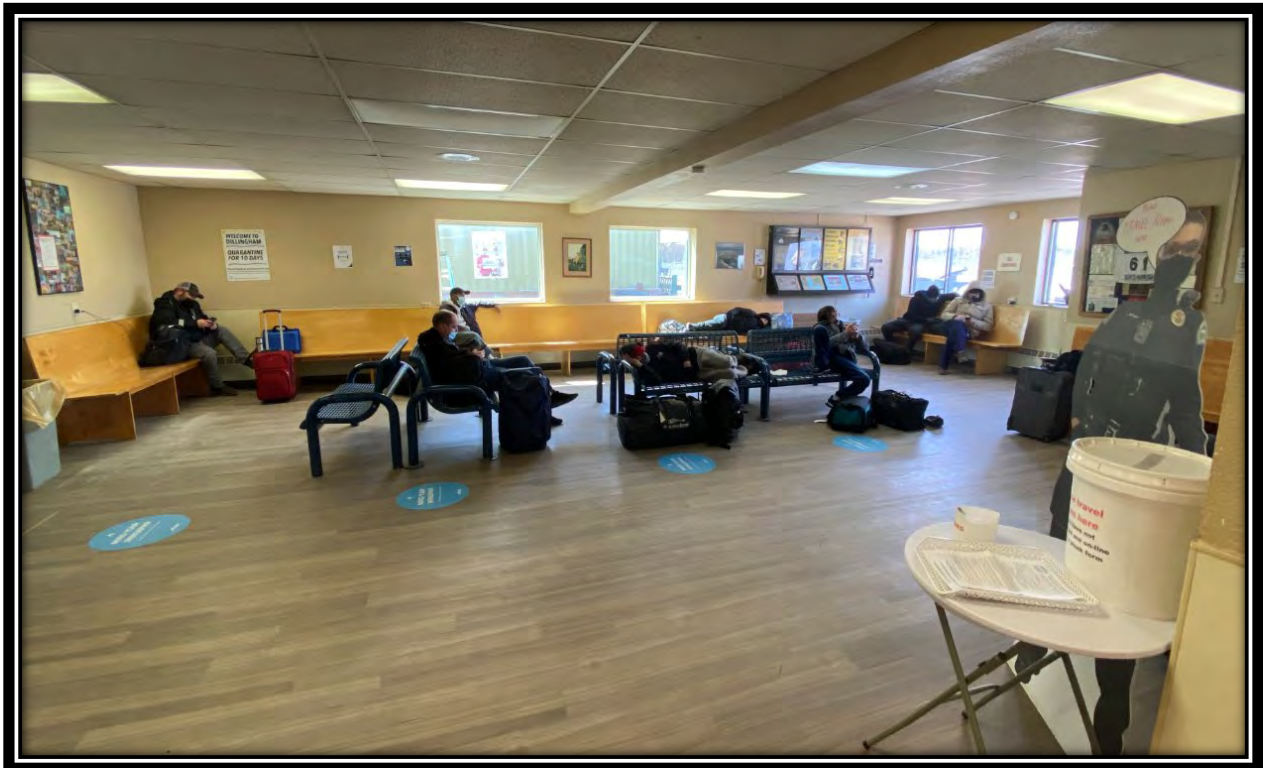
There is a single gate and baggage claim area at the Alaska Airlines/Ravn Alaska terminal building. The ticketing area has five kiosks. The waiting area is not physically separated from the gate for security purposes, although TSA personnel are present. There are no restaurants, concession areas, or vending machines at the airport. Restroom facilities are unreliable and inadequately sized to meet needs during the busier summer months.

Figure 9: Waiting Area, Alaska Airlines/Ravn Air Terminal Building

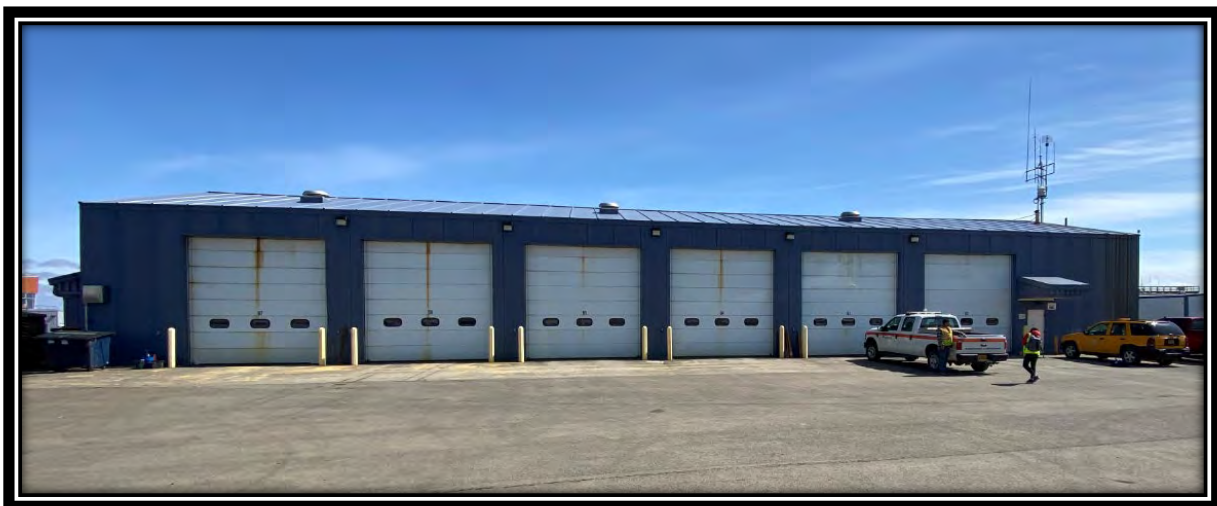
Figure 12: ARFF/SERB

The ARFF/SRE building's roof is in poor condition.	CIMP Inspection	Roofing materials are in poor condition; there are visible signs of leaks.

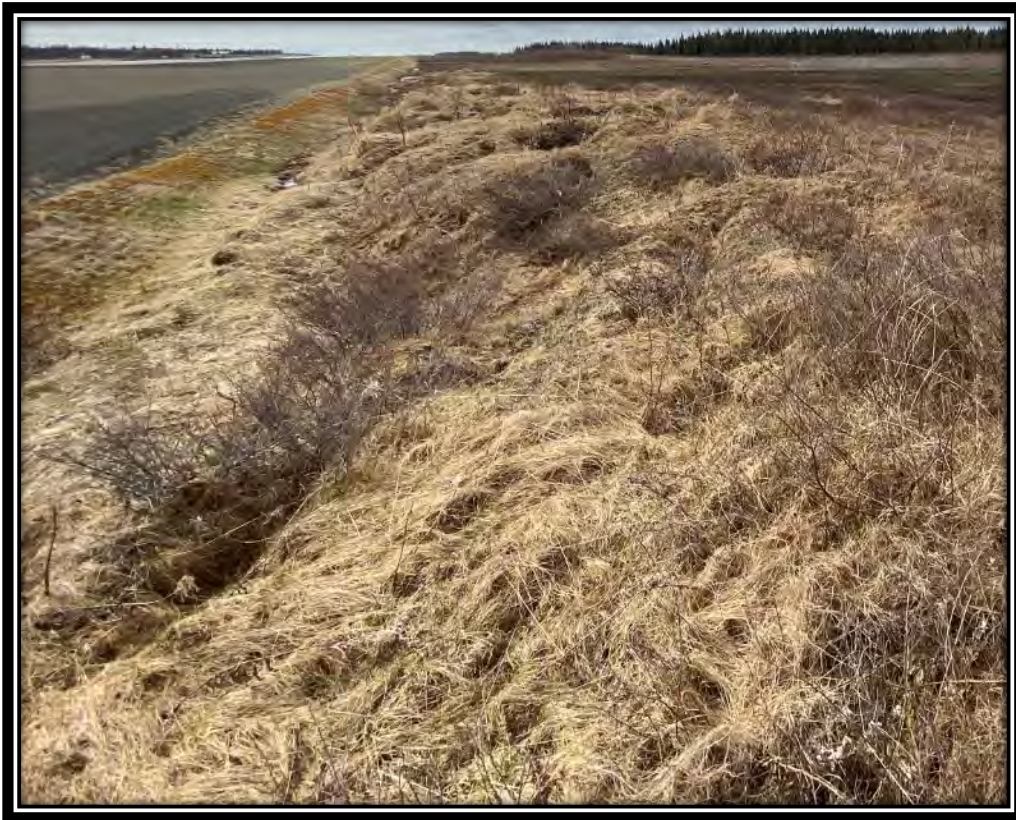
Figure 14: Surface Irregularities in the Tundra Surrounding the Airport Embankment

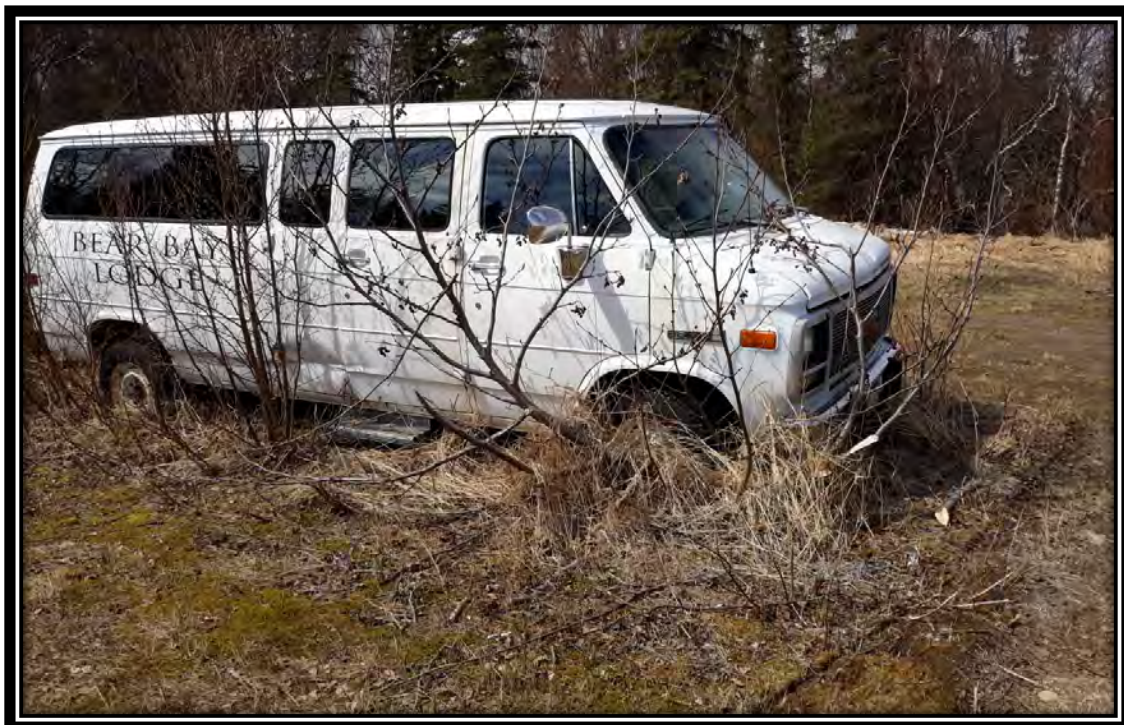
Separate vehicle parking for general aviation is not available. Pilots park personal vehicles in the airplane’s tie-down spot while flying. The long-term parking area is approximately 0.3 miles southwest from the Alaska Airlines/Ravn Air terminal building. Two overhead lights have been added since the previous Airport Master Plan update, but the area is otherwise unsecured. Several junk vehicles have been abandoned in the long-term parking lot. While DOT&PF requires vehicle owners to move their vehicles from the long-term parking after 30 days, enforcement remains a challenge. Removing the abandoned vehicles would improve the security and operability of the parking lot.

Figure 15: Abandoned Vehicle in Long-Term Parking Lot

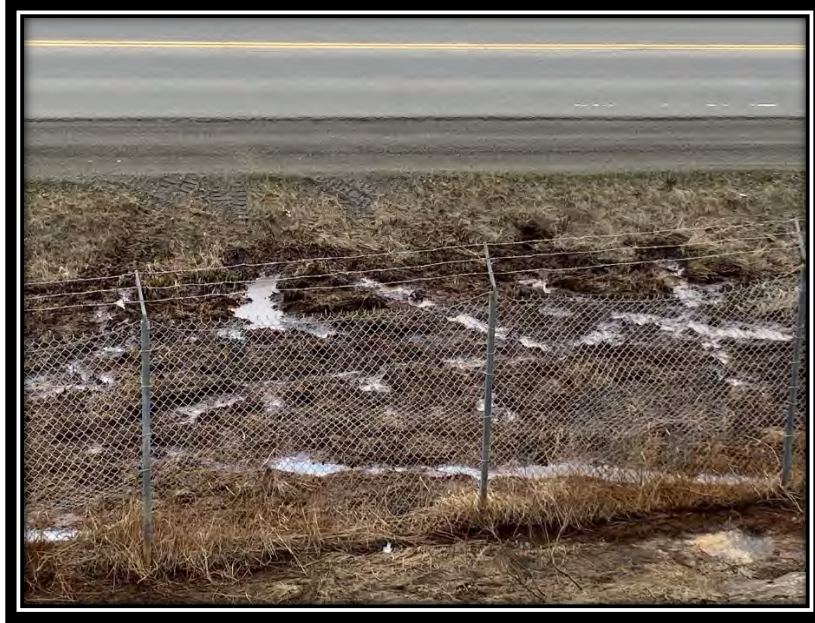
Category	Issue	Source	Notes
	All lighting has degraded (bad connections, insulation, wiring and transformers). Testing 12.2.2019, Runway ohm resistance reading is 14 ohms and 6.6 megaohms. Taxiway ohm resistance reading is 12 ohms and 0.028 megaohms. According to Item L-108, paragraph 108-3.10 c., “the insulation resistance to ground of all non-grounded series circuits is not less than 2,000 megaohms”. The insulation is indicating it is degrading.	CIMP Inspection	Runway lighting is approximately 18 years old.
	Fencing surrounding several areas of RW 1-19 is difficult to access for repairs. Much of the land is wet and not suitable for vehicles, and there is a steep slope at the southeast area beyond the runway. The fence is sloping in several areas.	Site visit, CIMP Inspection	Possibility for a combination of relocating certain fence areas and constructing an interior perimeter access road. See Figures 16 and 17.

Figure 16: Saturated Land, RW 1 End Looking Southeast

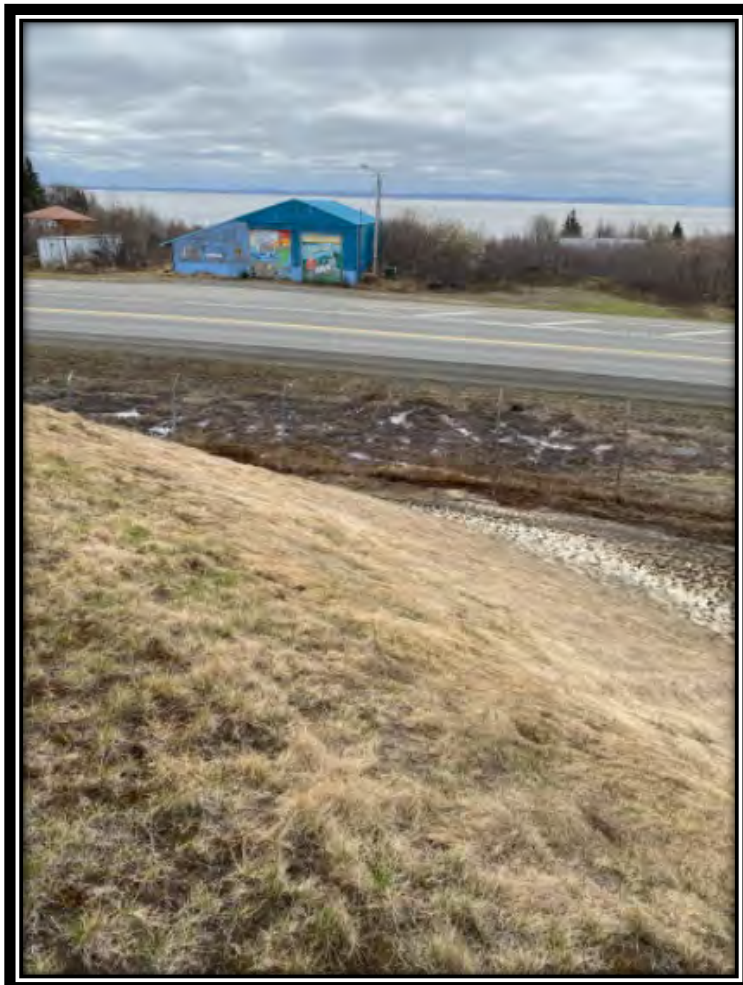
Figure 17: RSA Embankment Slope, RW 1 End Looking Southeast

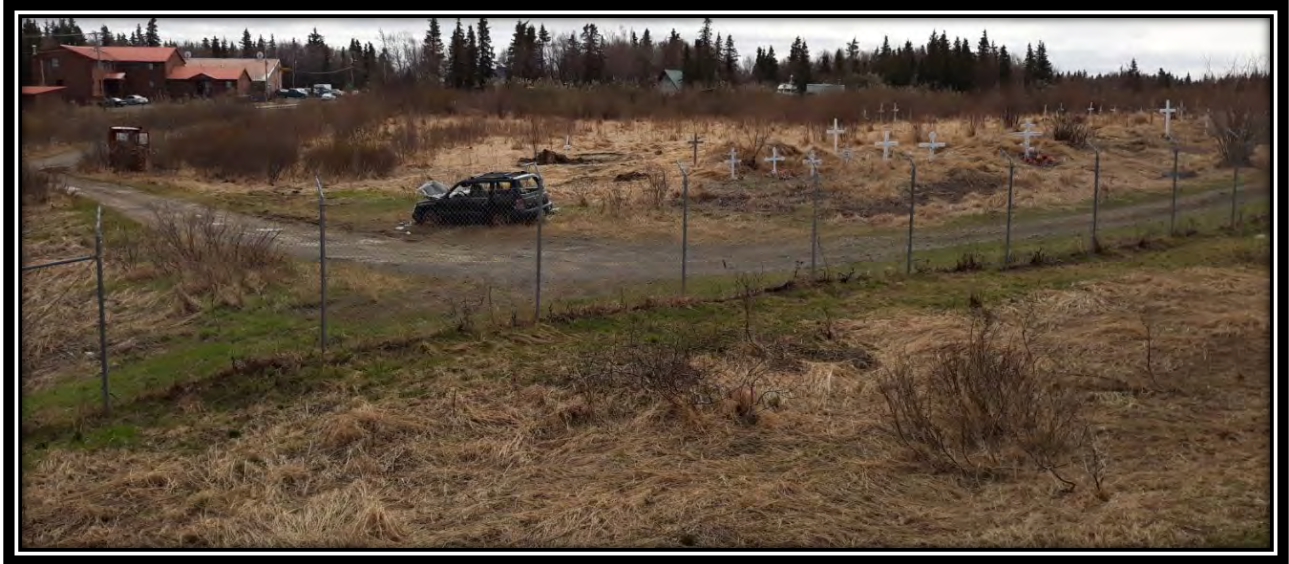
Figure 18: Evergreen Cemetery

The Evergreen Cemetery is located east of the runway on a knoll above the runway elevation, fully within airport property boundaries. The cemetery is still in use. It encroaches on the east side of the RSA which, according to FAA standards, should be cleared around the airfield. Both the adjacent residential uses and the culturally sensitive Evergreen Cemetery may affect the safe operation of the airport or limit its expansion.

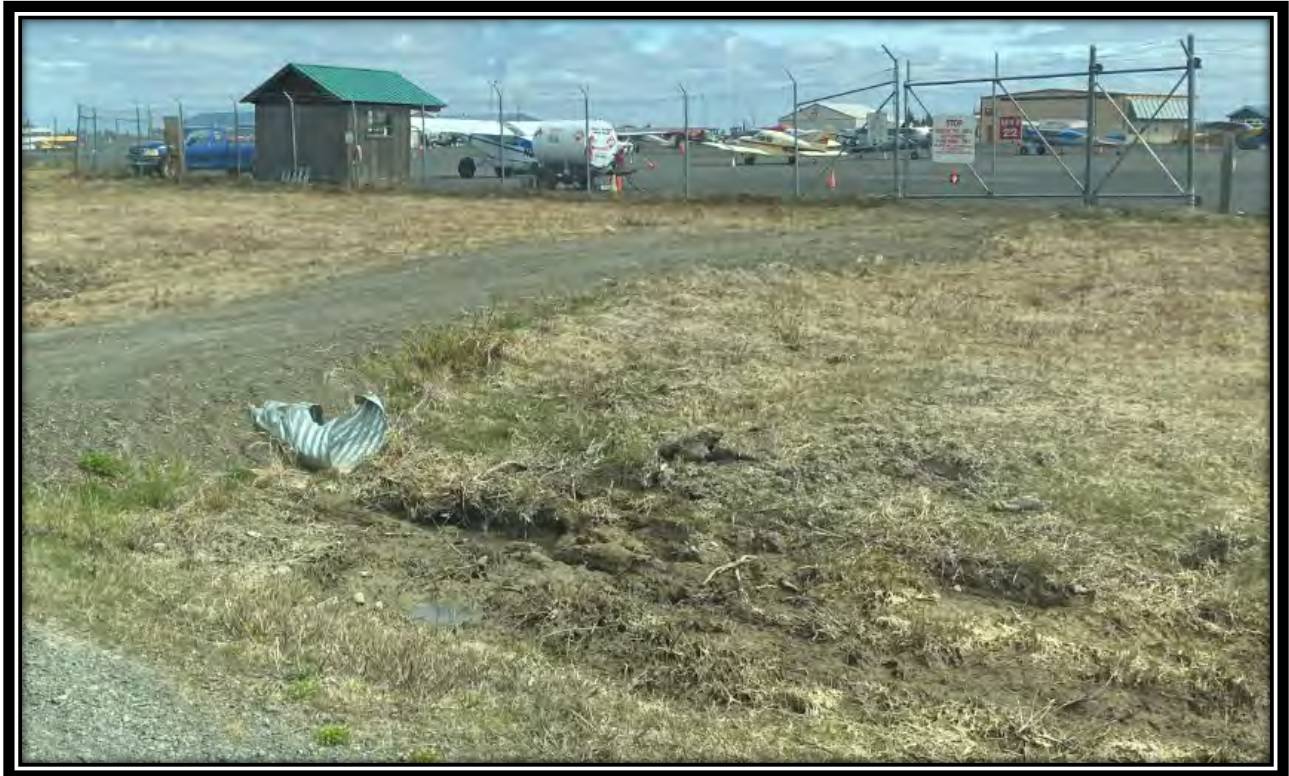
Several of the smaller culverts at airport access points are in a state of significant disrepair.	Site visit	See Figure 19.
Facilities: Capacity	A Parallel taxiway to RW 1-19 is needed to improve operational efficiency. Pilots currently taxi on the runway before taking off.	Previous AMP, public comments, site visit, stakeholder interviews	
	Commercial and GA operations use the same runway, which can cause delays during busy periods; several GA pilots have stated a preference for a gravel runway. Some pilots with tundra tires on their aircraft use the gravel surface in the RSA adjacent to RW 1-19 to land.	Public comments, stakeholder interviews, site visit	During the site visit, there was a small aircraft that used the gravel surface instead of RW 1-19 to land.

Figure 19: Culvert by GA Apron Access Point
