Appendix C-Phase 1 Environmental Site Assessment

Nightmute Airport Improvements

Project #: 51809

PHASE 1 ENVIRONMENTAL SITE ASSESSMENT

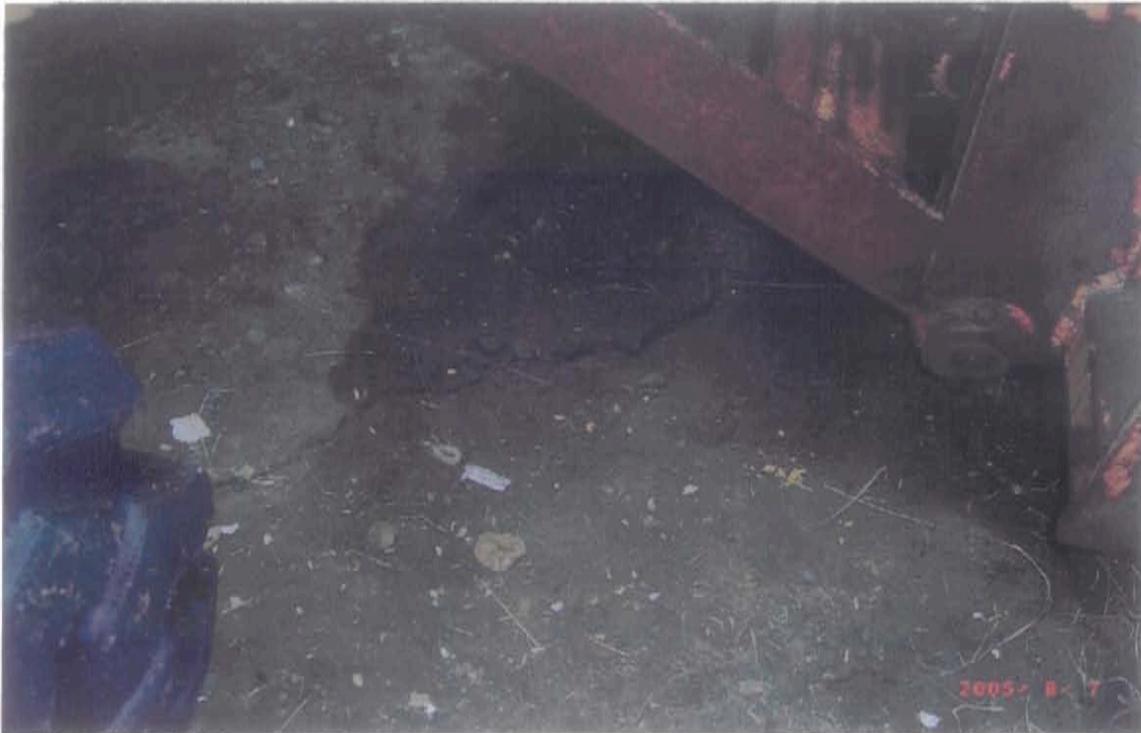
The interior of the SREB was untidy and somewhat disorderly (Appendix B, photo sheet). Several petroleum products were stored in the building. There were a few drums with torn labels indicating Universal Fleet plus motor oil. The actual contents of the drums are unknown. The SREB appears to be the storage place for an old grader, a portable power generator, motor oil, hydraulic oil and other equipment and supplies. The cemented floor underneath the grader was cracked and stained with what appears to be petroleum products. It is possible that the petroleum products have sipped through the cracks to the ground

Interior of the snow removal equipment building. The photograph was taken on 8/8/05. The camera had a wrong date setting.

Since the project will involve demolition of the SREB, it is recommended that construction contract includes provision for appropriate excavation and remediation of contaminated soils. The contractor must comply with the ADEC Contaminated Site Regulations for cleanup of contaminated soils.

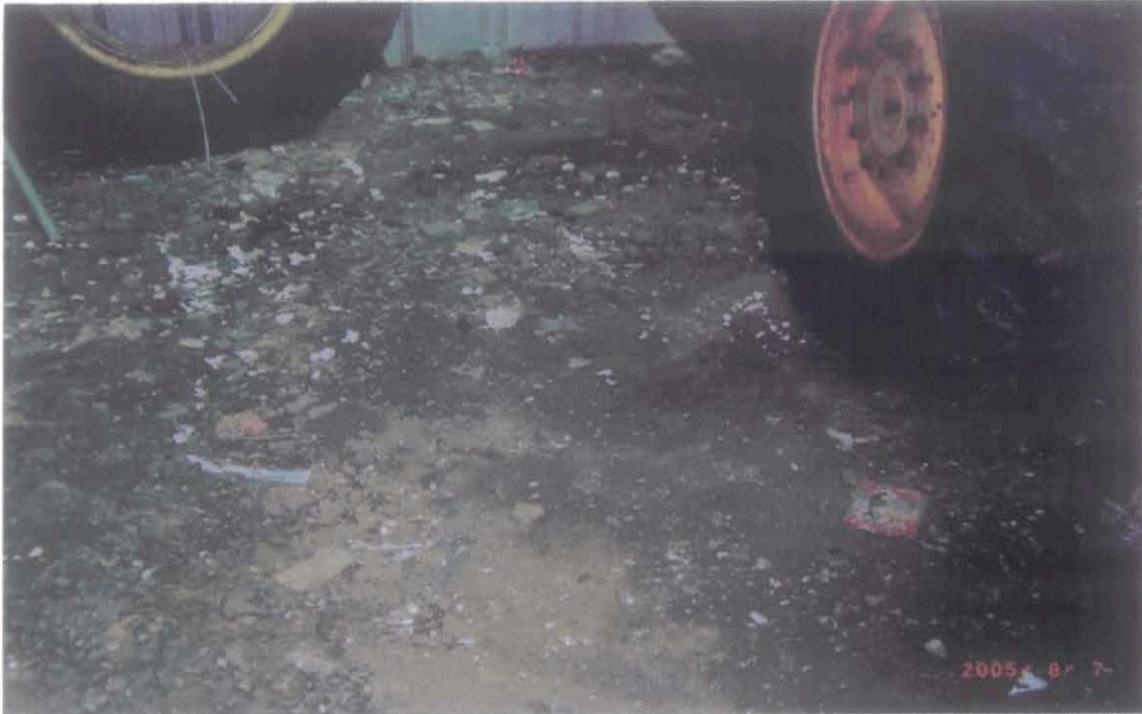
Stains & trash on the floor of the snow removal equipment building. The photograph was taken on 8/8/05. The camera had a wrong date setting.

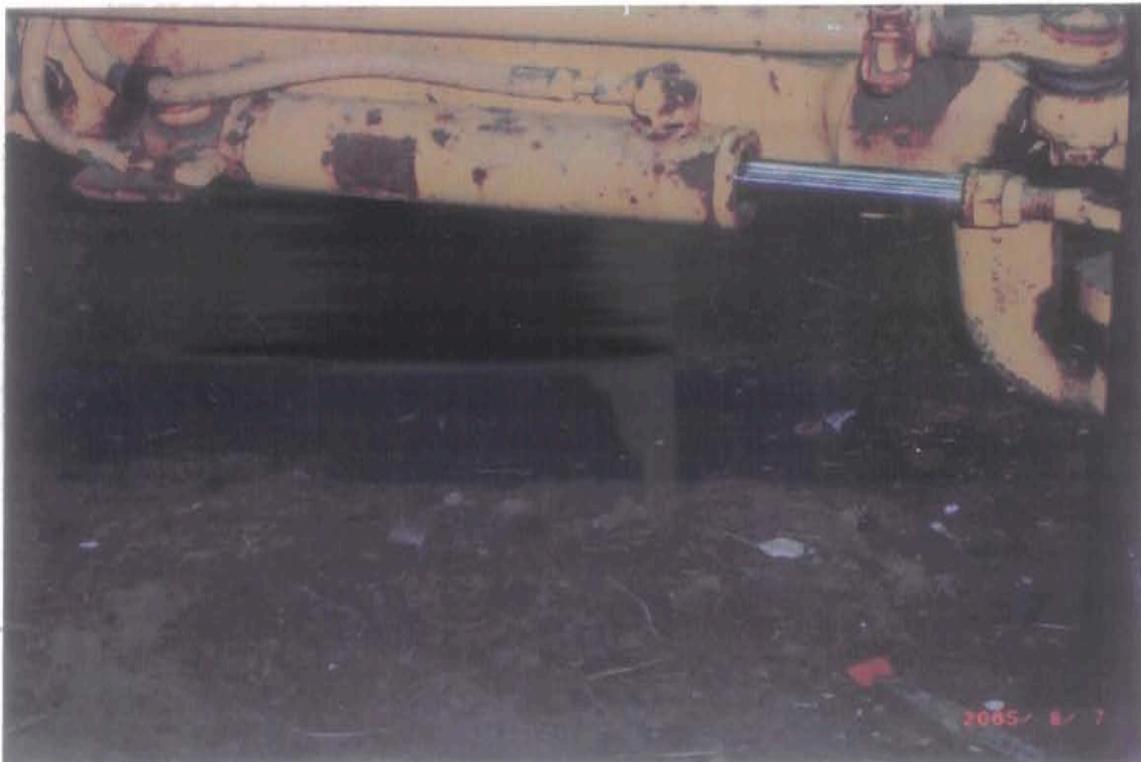
Stains on the floor of the snow removal equipment building. The photograph was taken on 8/8/05. The camera had a wrong date setting.

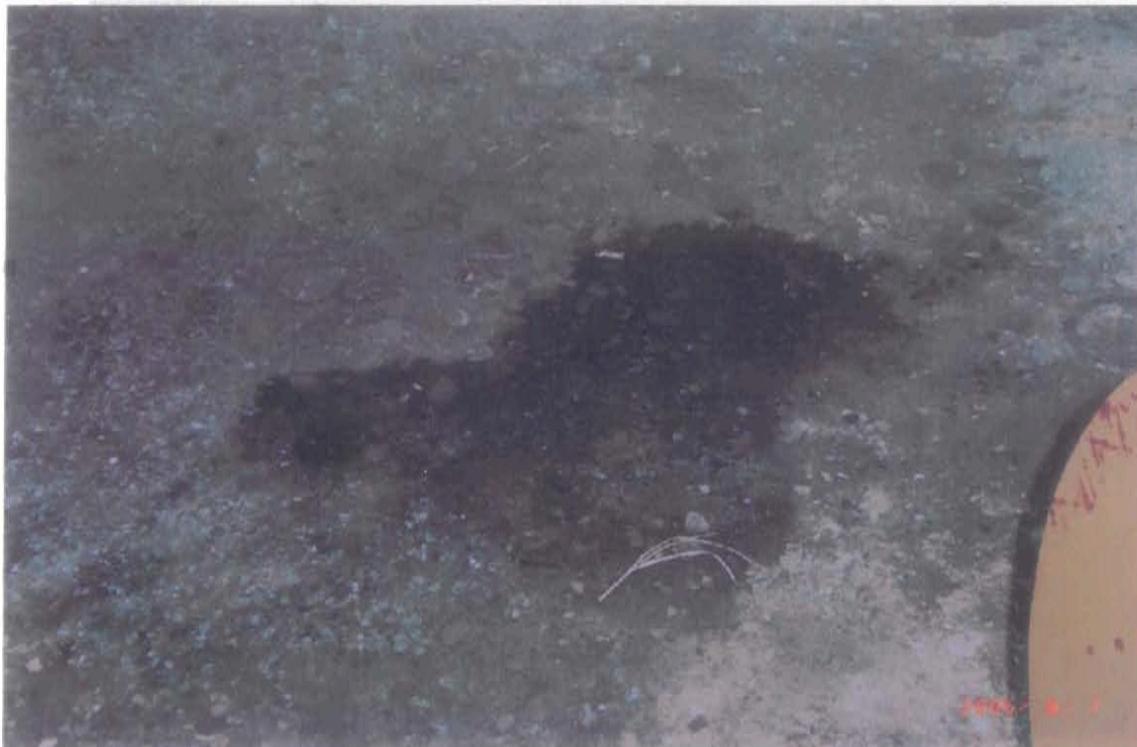
Stains on the floor of the snow removal equipment building. The photograph was taken on 8/8/05. The camera had a wrong date setting.

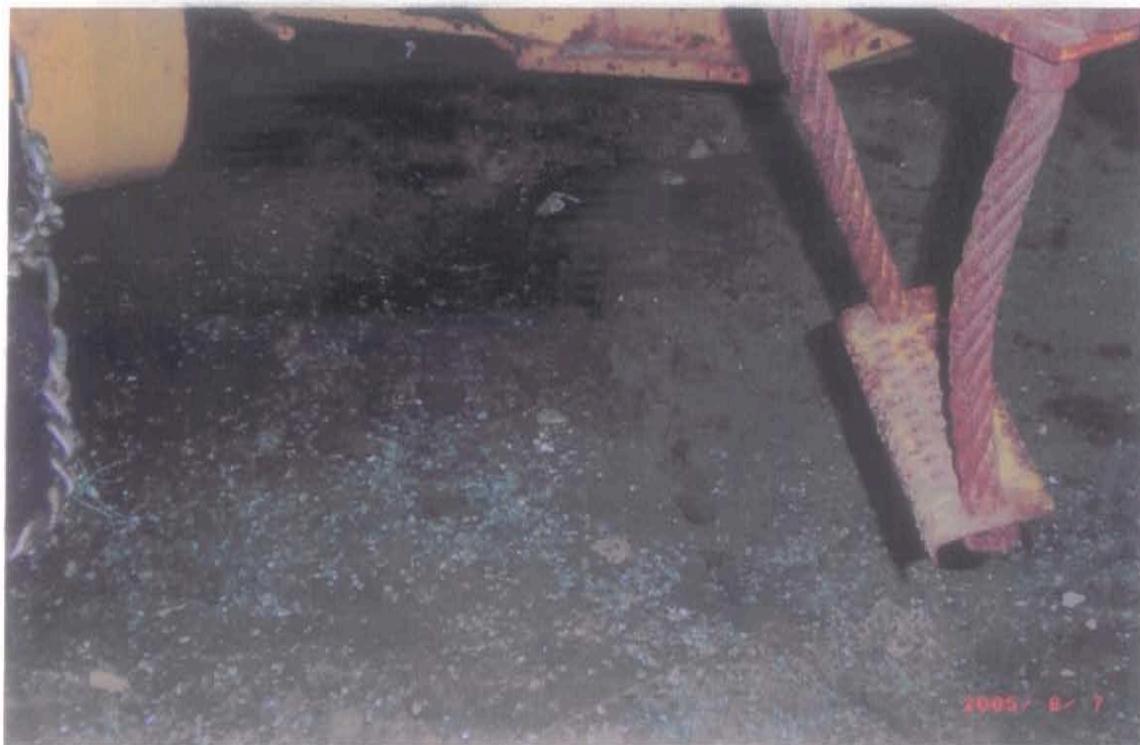
Stains and broken glass on the floor of the snow removal equipment building. The photograph was taken on 8/8/05. The camera had a wrong date setting.

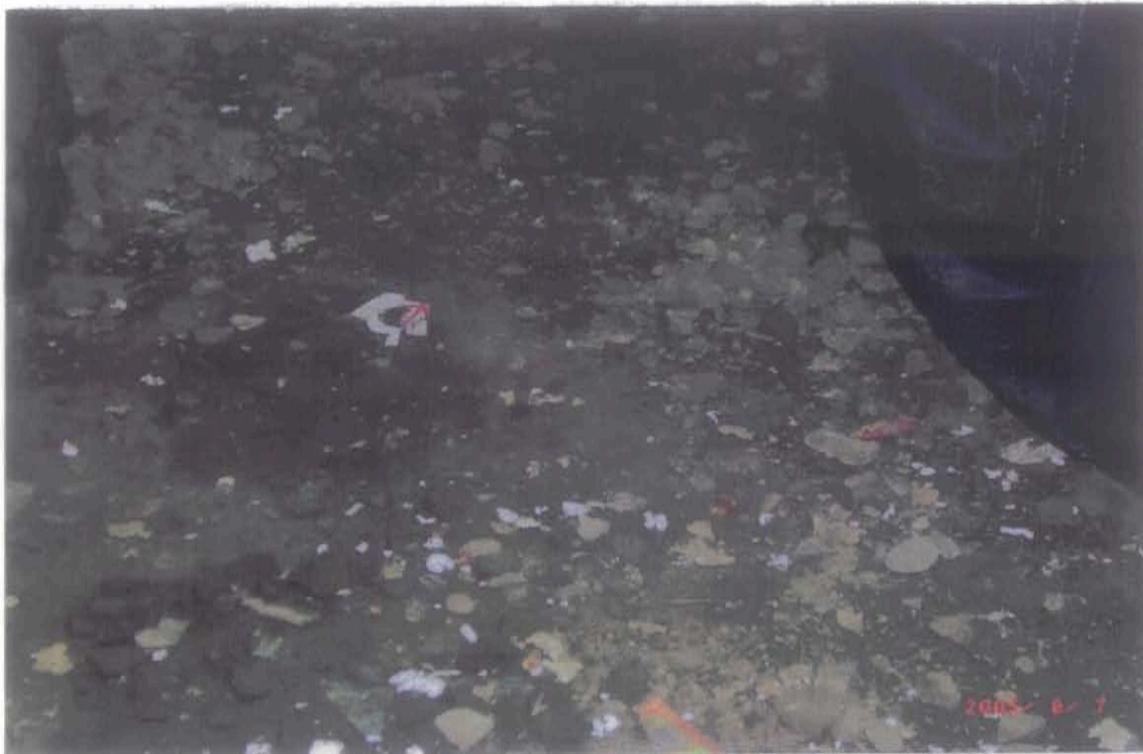
Stains & trash on the floor of the snow removal equipment building. The photograph was taken on 8/8/05. The camera had a wrong date setting.

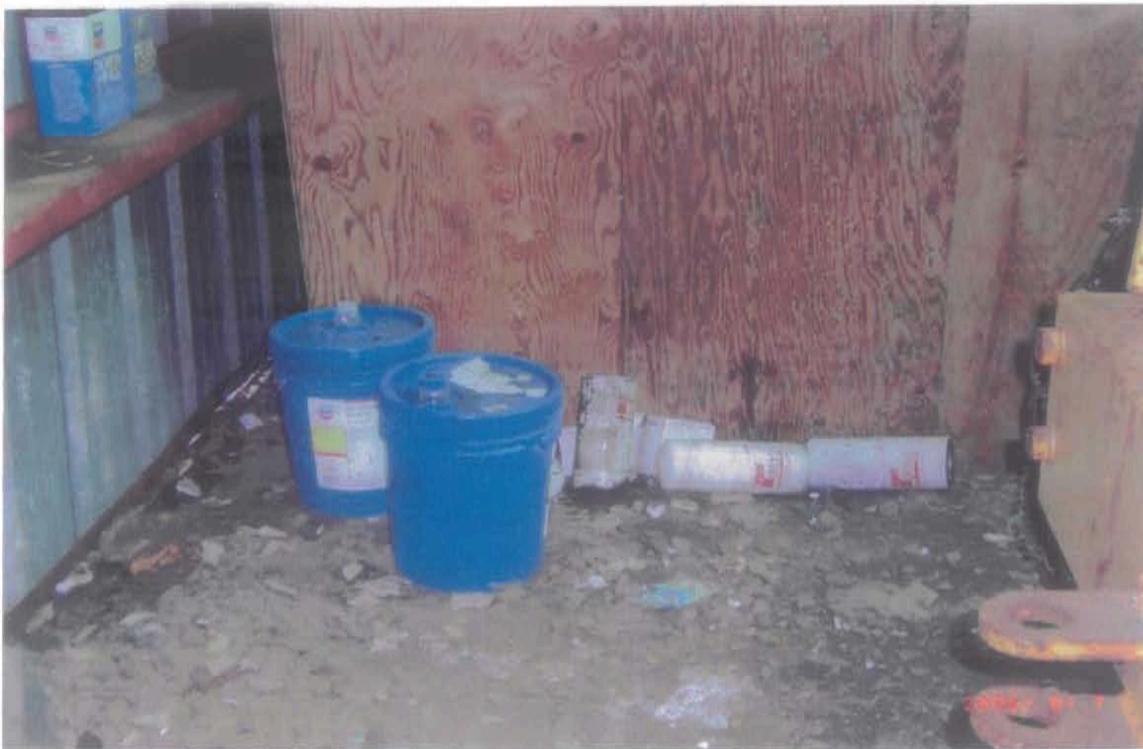
Chemicals & other products stored in the snow removal equipment building. The photograph was taken on 8/8/05. The camera had a wrong date setting.

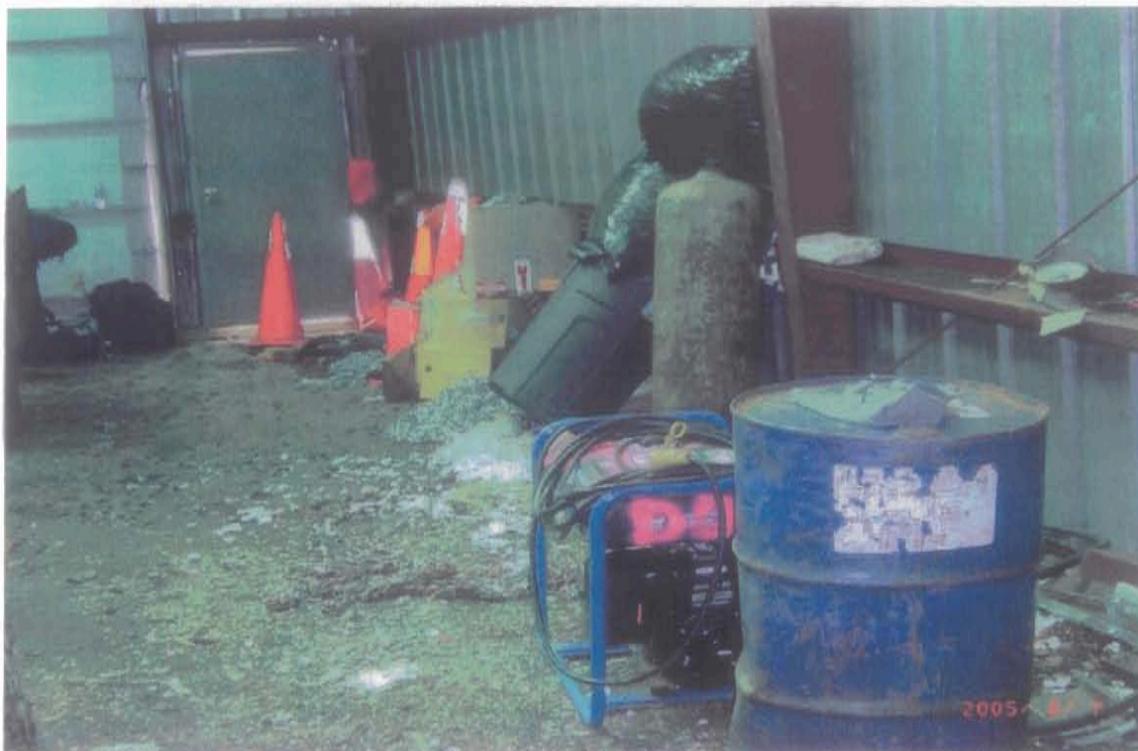
Chemicals, trash & other products stored in the snow removal equipment building. The photograph was taken on 8/8/05. The camera had a wrong date setting.

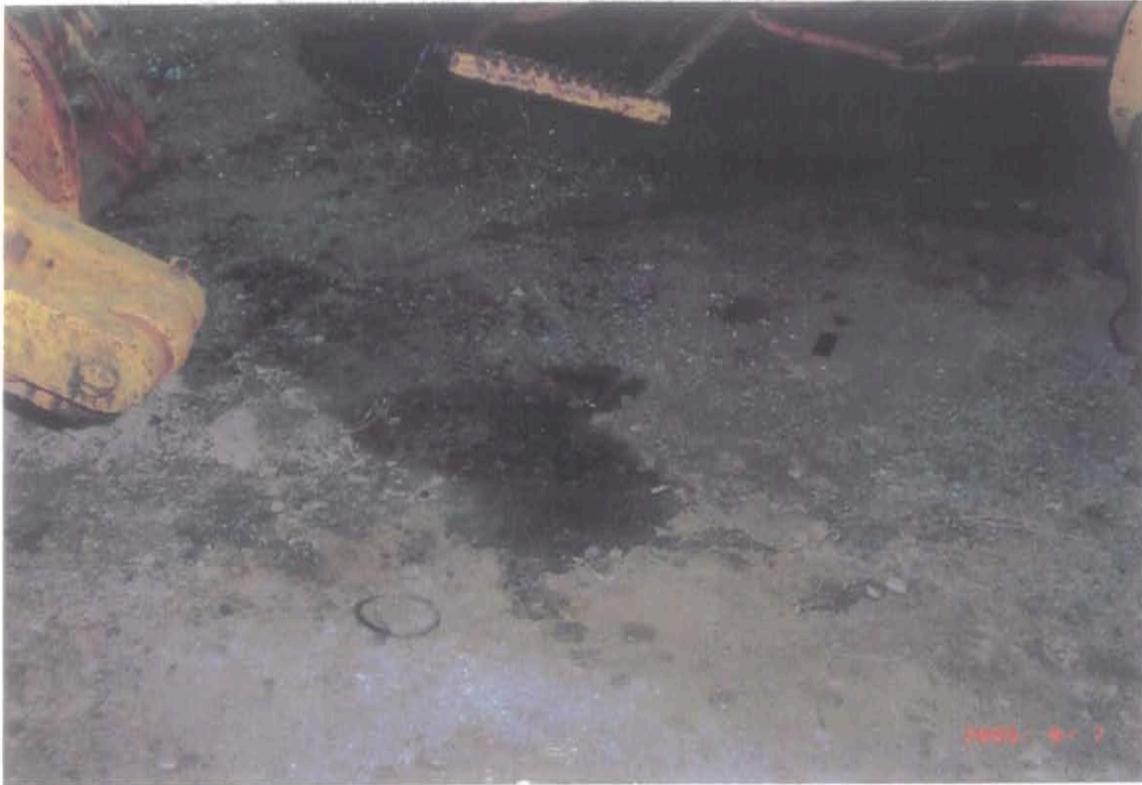
Stains on the floor of the snow removal equipment building. The photograph was taken on 8/8/05. The camera had a wrong date setting.

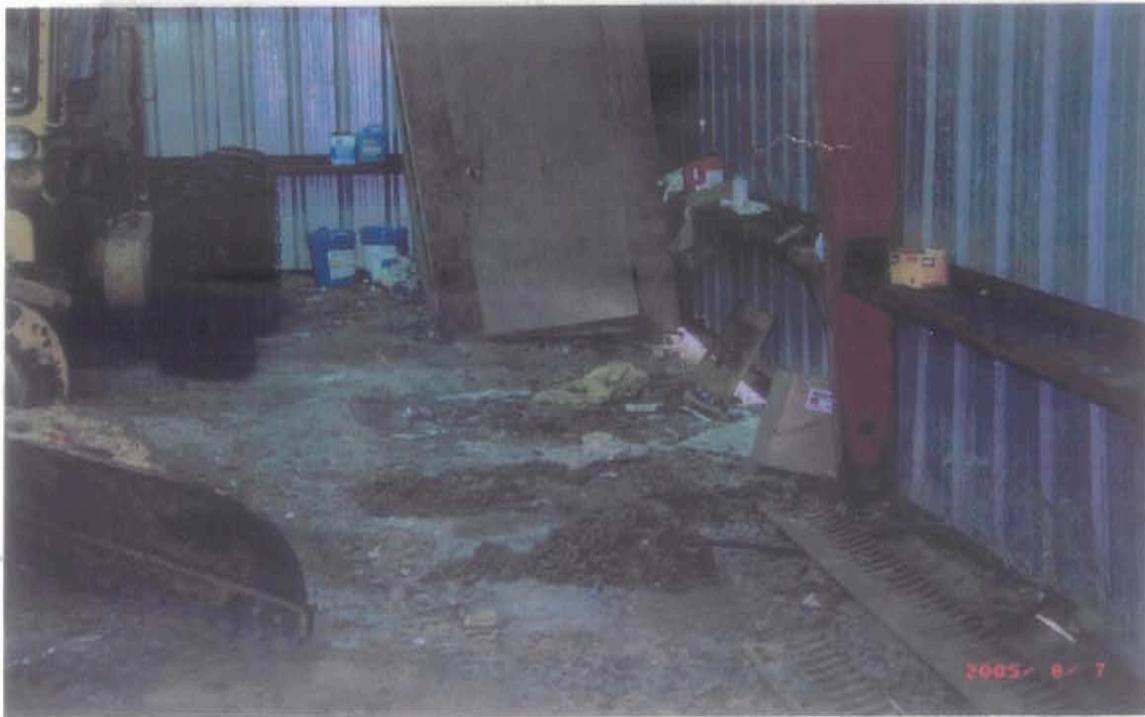
Grader and other things stored in the snow removal equipment building. The photograph was taken on 8/8/05. The camera had a wrong date setting.

R. Grader not loader. The grader is very old and mechanics go out there to work on the machine. There have been several leaks for the past 30 years.

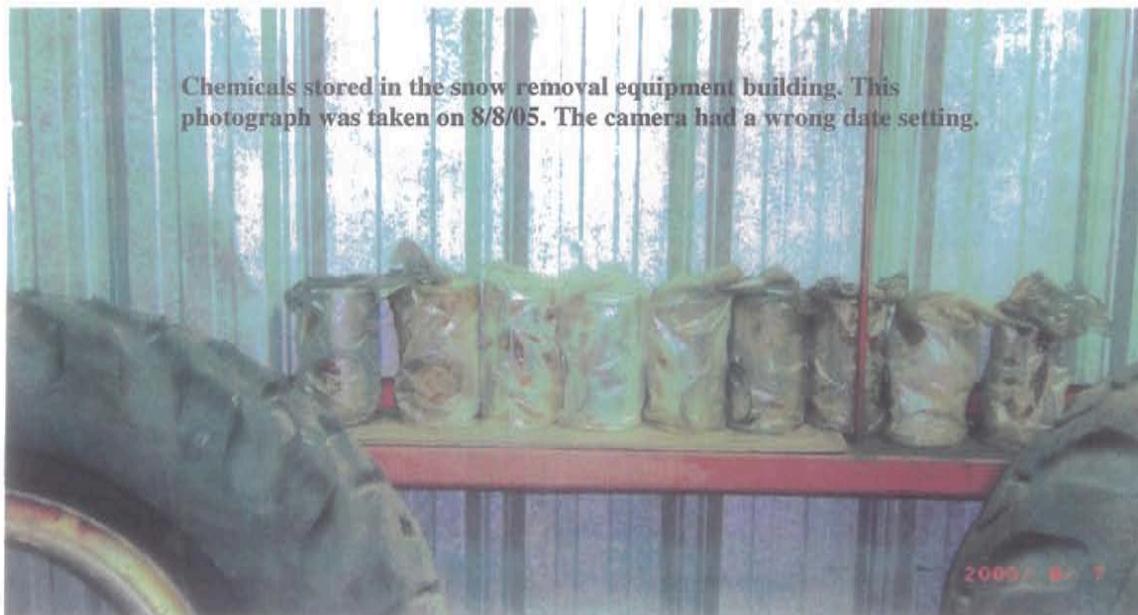
Chemicals stored in the snow removal equipment building. This photograph was taken on 8/8/05. The camera had a wrong date setting.

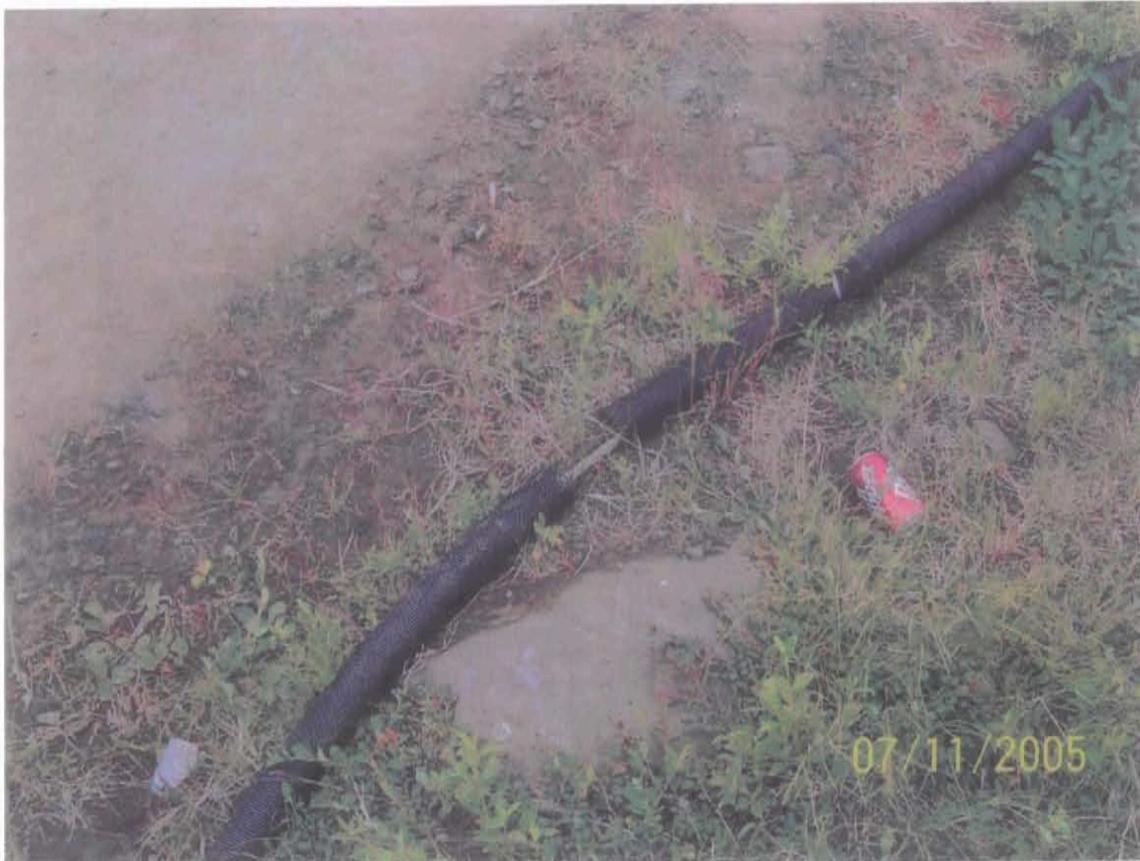
Photo taken on 7/11/05. Picture of a conduit that crosses the airport access road. It extends from an old store to a house across the street. See photo below.

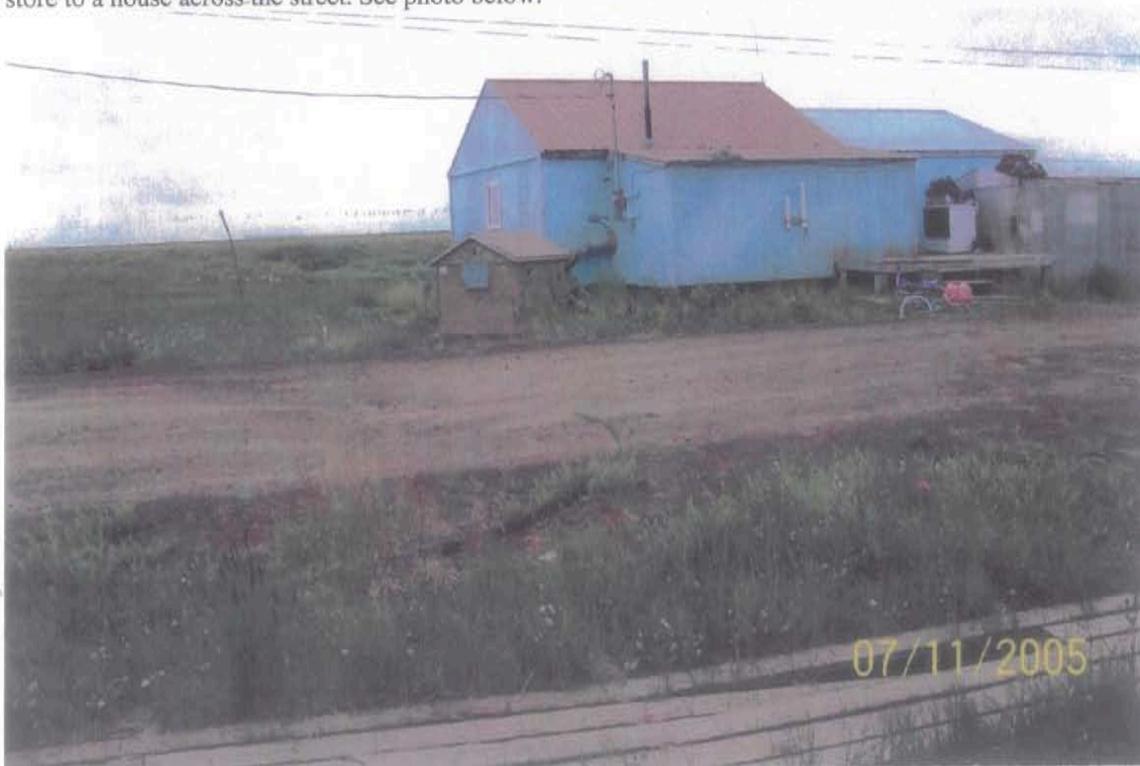
Conduit crossing the road to the house. The use of the conduit is unknown. It had an aluminum conductor inside. This blue house adjacent to the airport access road has an outhouse building located slightly within the ROW.

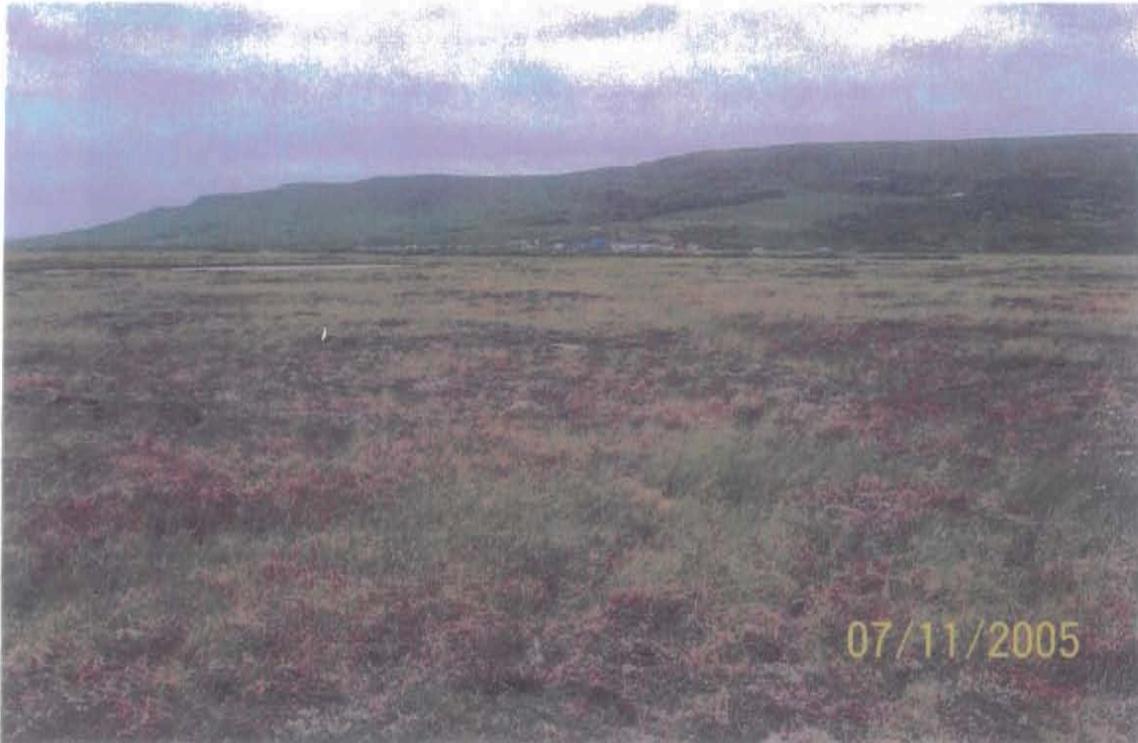
A view from the end of the proposed runway looking towards town. The yellow markers indicate a winter trail that will be relocated as a result of the project.
