# STATE OF ALASKA

Department of Transportation and Public Facilities

Subject: Nightmute Reconstruction  
Project No. 51809

Date of trip: November 15, 2004

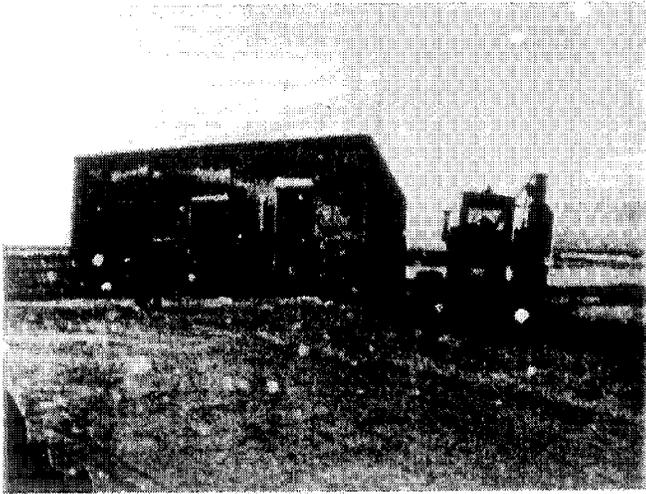
68

Nightmute Trip Photo Log	
Gary Lincoln, Ralph Klehl and Crane Johnson	
11/15/2004	
1010067	Existing waiting shelter and old DOT grader. The new grader is located inside of the SREB building.
1010068	A view of the access road. Its has experienced severe differential settlement. Parts of the road have settled back to the original grade, a majority of the road is approx 1' above original grade.
1010070	Another view of the access road with the Toksook river to the left. Photo taken approx. 200 yds from existing apron along the road.
1010071	Another view of the access road with the Toosok river to the left. This photo is taken in the vicinity of the mounds looking towards the village.
1010072	Another look at the access road with the Toosok river to the left.
1010073	Looking towards the end of the access road. The blue building to the right is a store. The old ROW ends just before the road building in the center. This red building is the village corporation store.

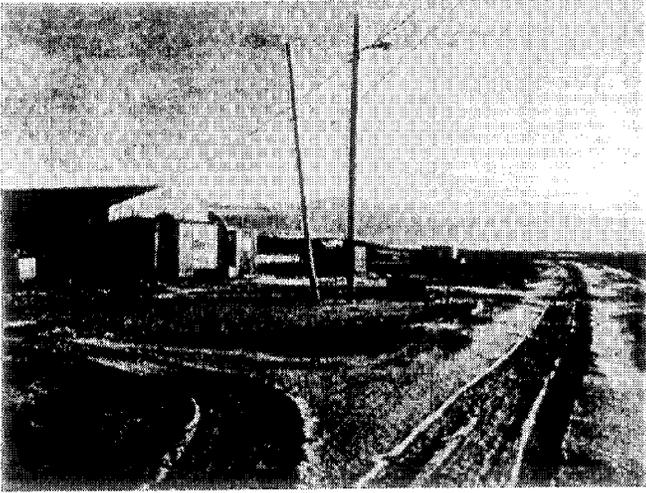
74

1010074	This a a view along the access road back towards the Toksook river and airport. The building to the left is a store.
1010075	An old historical building in Nightmute.
1010076	This is view looking from town towards the start of the old ROW. The old airport access ROW starts just past the red building on the left. It is 50' wide. Gary and Ralph are in the foreground.
1010077	This is a view looking back into town. Gary and Ralph are in the same location as in picture 1010076. Its shows the opposite view.
1010078	This shows the one culvert that was found along the airport access road.
1010079	Same culvert in picture 10170078, upstream end.
1010080	View from the access road looking back into town. The large lake on the right was altered to bring its southern edge closer to the road. At this point the edge of the lake is adjacent to the airport.
1010081	This is a view along the access road looking towards the airport. The toksook river is to the right. The projection into the river in the foreground is the old turnout that was constructed during the original construction project.

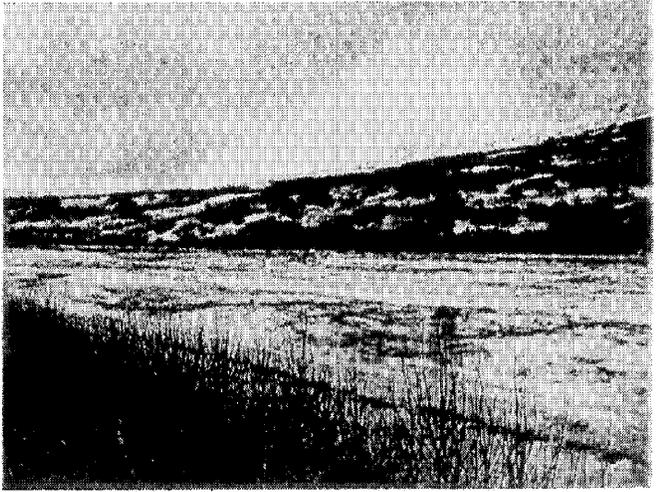
83

1010082	From the access road looking back into town.
1010083	This is a view of the low lying area that is adjacent to the access road. The possible location of the haul road would be along the bench above the lowlying areas. View to the NW.
1010084	Picture from the same location as 1010083 looking more to the north.
1010085	Same location as picture 1010083, looking to the NE. The potential material site is just over the bluff near the end of the bench. One route discussed for the haul route would be down the natural ramp in the left side of the picture and then across the lowlying area over to the access road.
1010086	A closer look at the bluff. The natural ramp is to the left out of the picture.
1010087	This is a view from below the bluff in picture 1010086 looking to the west upststream in the lowlying area. The possible archeological sites are the mounds to the left in the picture.
1010088	View from the same location as picture 1010087 looking towards the SE. The access road is adjacent to the willows in the background. The mounds are in the right hand side of the photo. Prior to our field visit this was one of the potential haul routes over to the access road. The edge of the lake can be seen in the left hand side of the picture. Active fish traps were located in this area and one elder snowmachined by and let us know that the drainage between the mounds and the bluff in picture 1010086 contains black fish and is used for subsistence fishing.

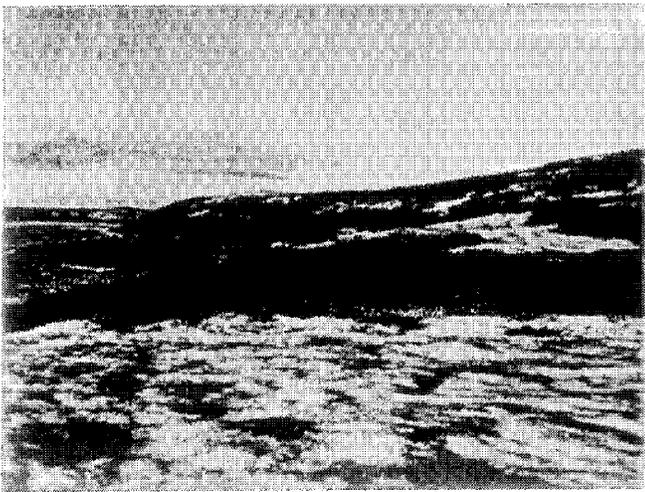
96

1010096	This is a view from the bluff along the bench towards town. A potential haul route was along this bench, tying into a ramp in the existing material site behind town.
1010097	A closer view of the vegetation that is growing in the low lying area between the bench and access road.
1010098	A view from the edge of the existing apron looking towards town. The new apron would be located in this area, between the photographer's location and the river.
1010099	The existing SREB.
1010100	The existing shelter with a view towards the looksok river.
1010101	A view from the same location as 1010100 looking towards the existing unlighted windcone.
1010102	A view from the existing runway/taxiway intersection looking down the runway to the SW.
1010103	A view from the existing runway/taxiway intersection looking towards the existing apron.
1010104	A view from approximately midway down the existing runway towards the SW.

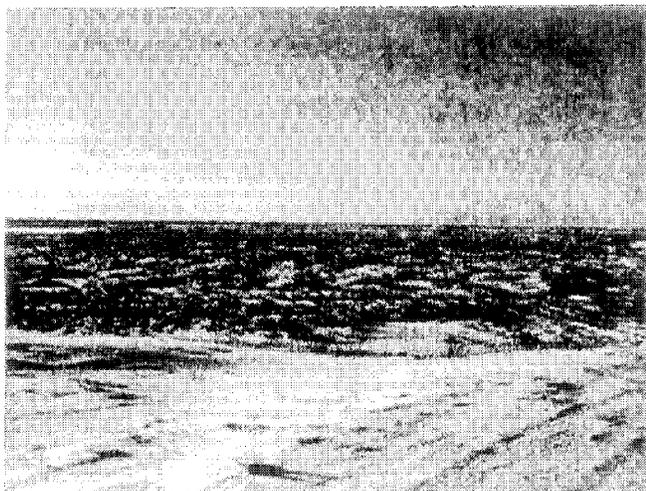
105

1010105	A view from the existing runway looking down the centering of the proposed runway extension.
1010106	Looking from the SW end of the runway towards the NE end.
1010107	A view from the taxiway looking to the SW. The depression adjacent to the runway is typical for both sides. Estimated to be approx. 2' in depth.
