Copper River Highway Bridge 339, Cordova Alaska

AKSAS Project # 60555
July 17, 2012

Project Scope & Existing Conditions

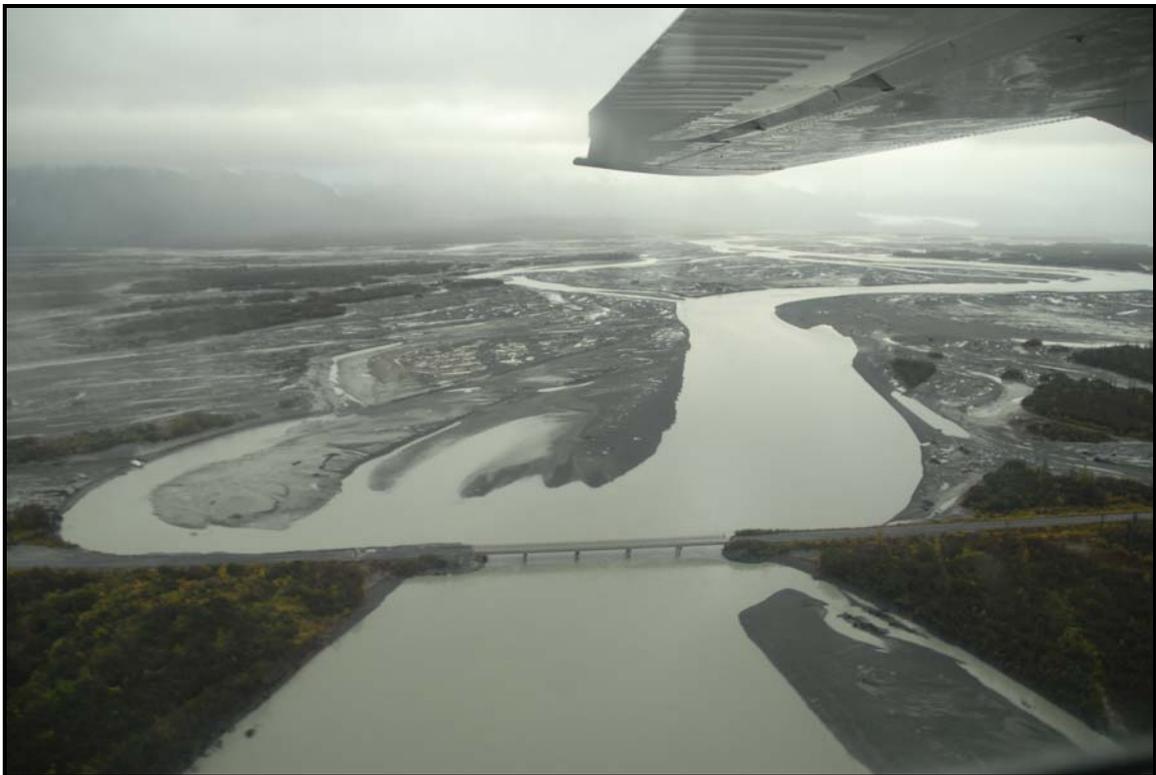
Because the bridge has a fixed opening (400' long) water velocities increase as water flows under the bridge. This velocity increase has scoured the streambed down 67 feet under the bridge and the river has breached the road creating a 100-foot gap on the east end. Bridge scour has removed and/or nearly removed all the soil around the pier and abutment piles. (see figures 2 and 3)

Figure 2 - Bridge 339 looking north October 6, 2011

- During the summer of 2011 the river channel migrated east and began scouring the far east bridge piers and abutment.
 - By August 2011 the scour was so severe it was determined the bridge had lost its structural capacity and was closed for safety.

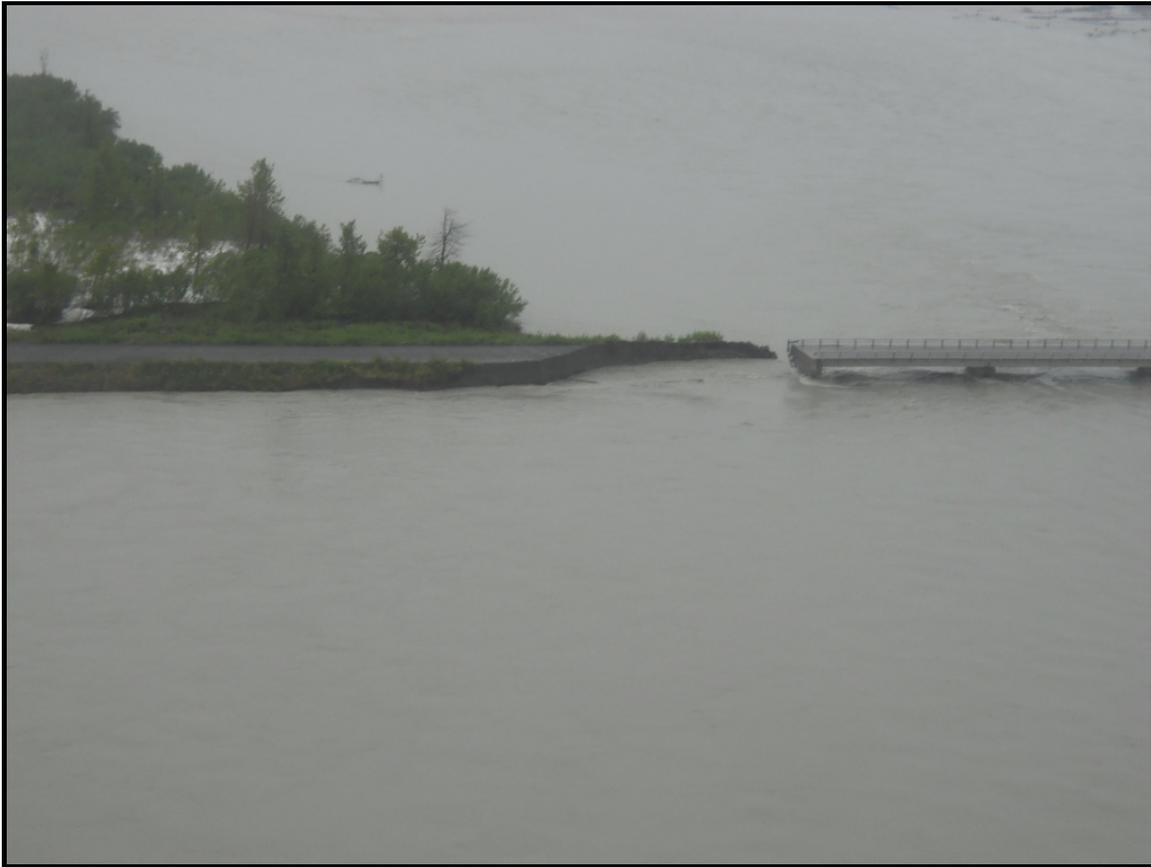
Figure 3 – Bridge 339 looking south at the east abutment June 26, 2012

- Summer 2012 the river channel is still migrating east and the river has breached the road creating a 100-foot gap on the east end. (see figure 3)

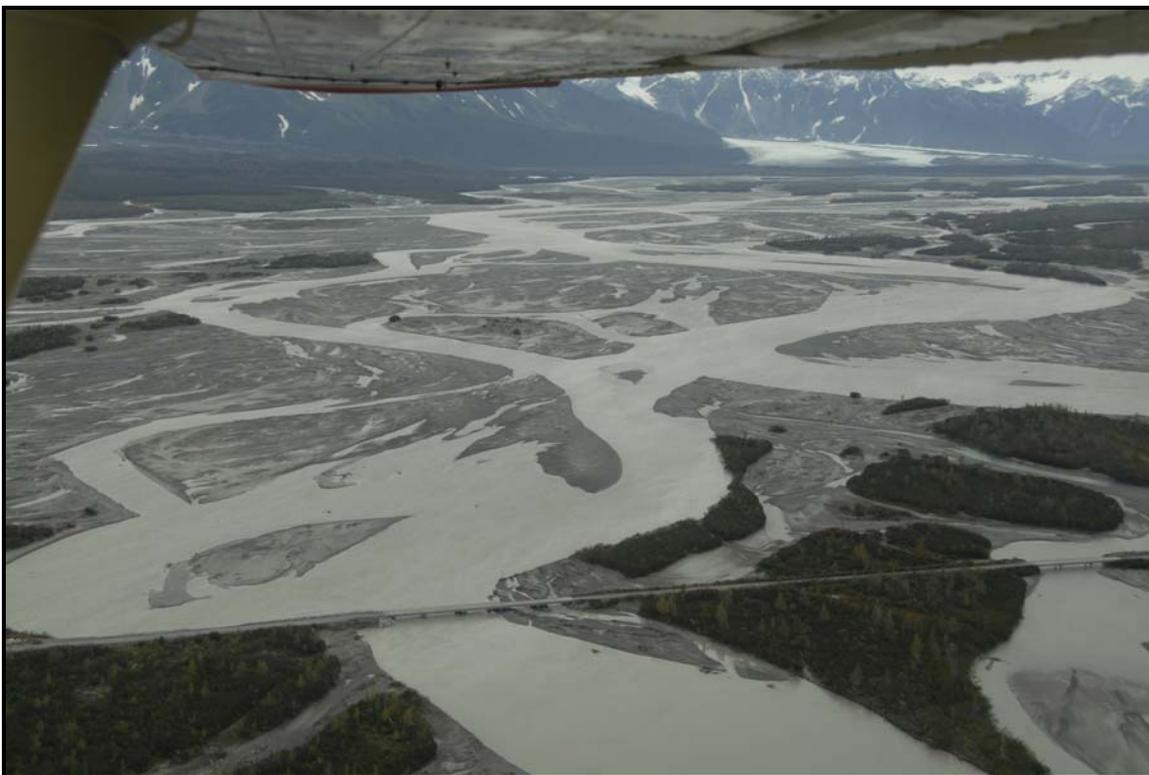
- During 2009 it was noticed things were changing again and more flow was being directed towards bridge 339 and the west approach road. (See figure 4)
- In 2010 AK DOT&PF along with the U.S. Geological Survey began a comprehensive monitoring program at Bridge 339.

Figure 4 – Bridge 339 looking north September 29, 2008
