***NOATAK RIVER BANK EROSION STUDY
AT NOATAK, ALASKA***

ANTHC Project No. AN01-Q55

February, 2003

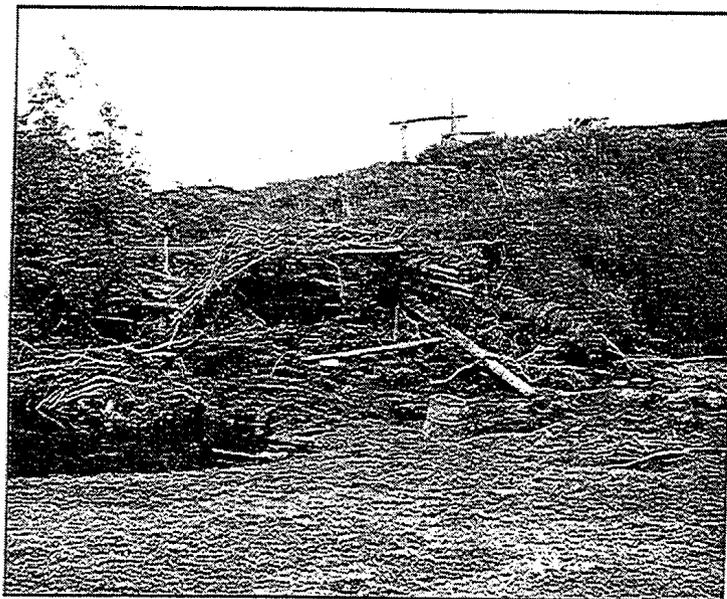
FIGURE 2

Remaining section of a ruined wall at the north end of the Village - August, 2002.

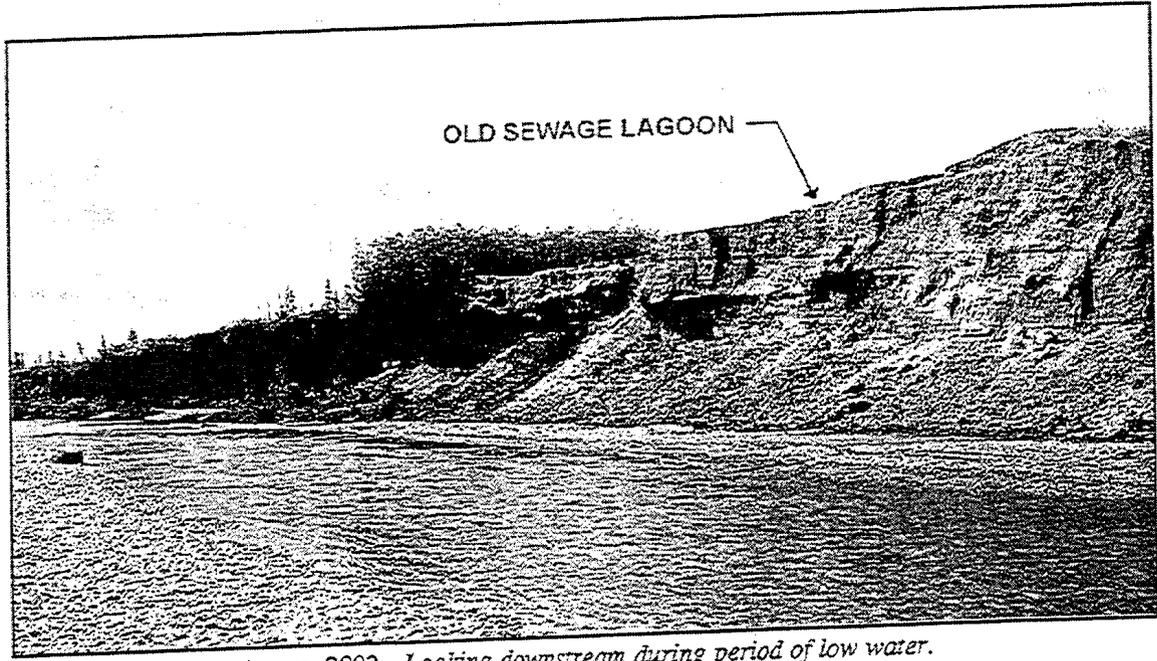
FIGURE 5

August, 2002 - Looking downstream during period of low water.

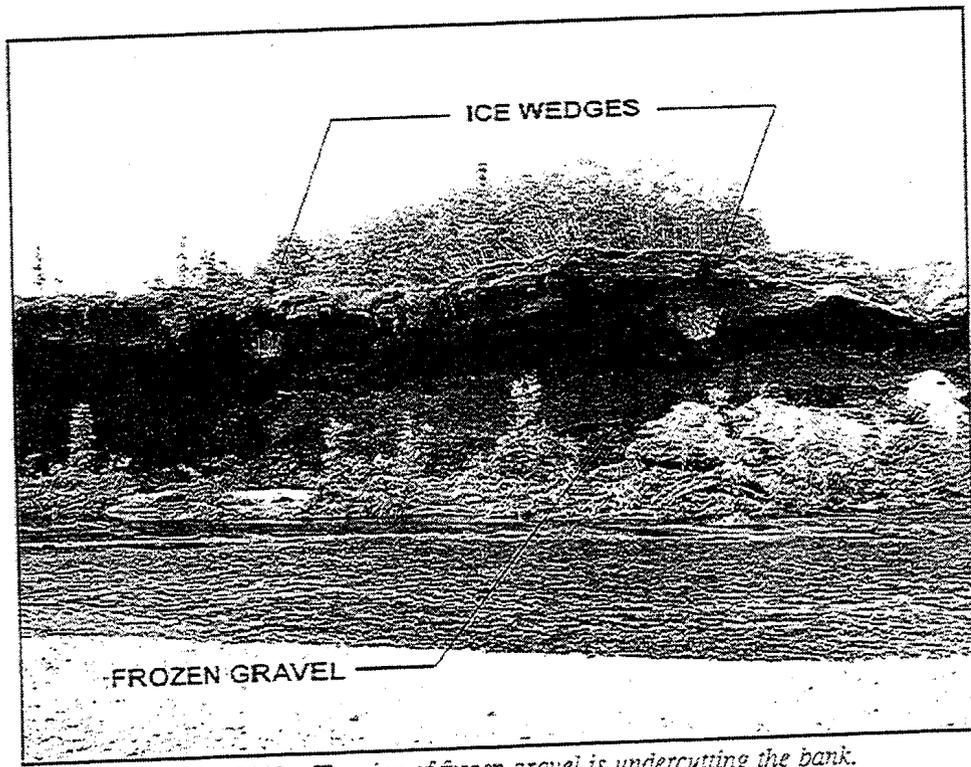
August, 2002 - Thawing of frozen gravel is undercutting the bank.
