Chignik Dock

The most recent above water survey was completed on September 6, 2012. The underwater inspection occurred on July 30, 2009.

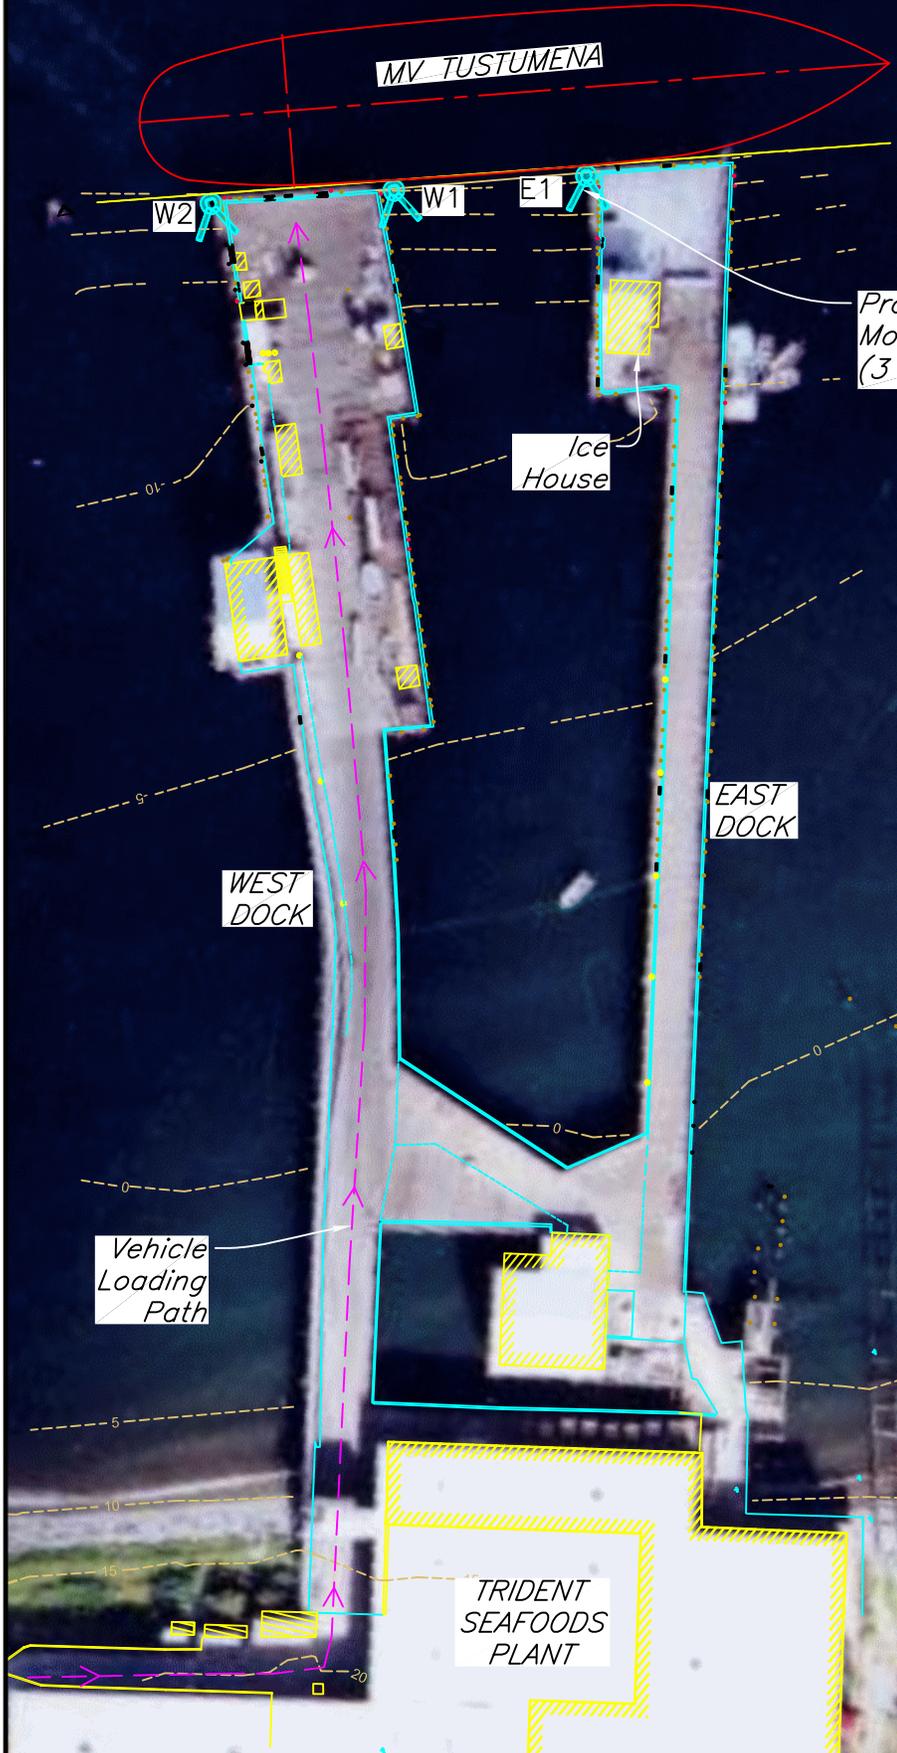
GENERAL LAYOUT CHIGNIK

Proposed New Steel Mooring Dolphins, typ. (3 each)
