Boney Courthouse Mechanical
Upgrades and Earthquake Repairs
Design Services
RFP No. 25202076

GEORGE F. BONEY MEMORIAL COURTHOUSE
DEFERRED MAINTAINANCE PROGRAM
PRELIMINARY PROJECT PLANNING DOCUMENT

Department of Transportation & Public Facilities, State of Alaska

October 8, 2008

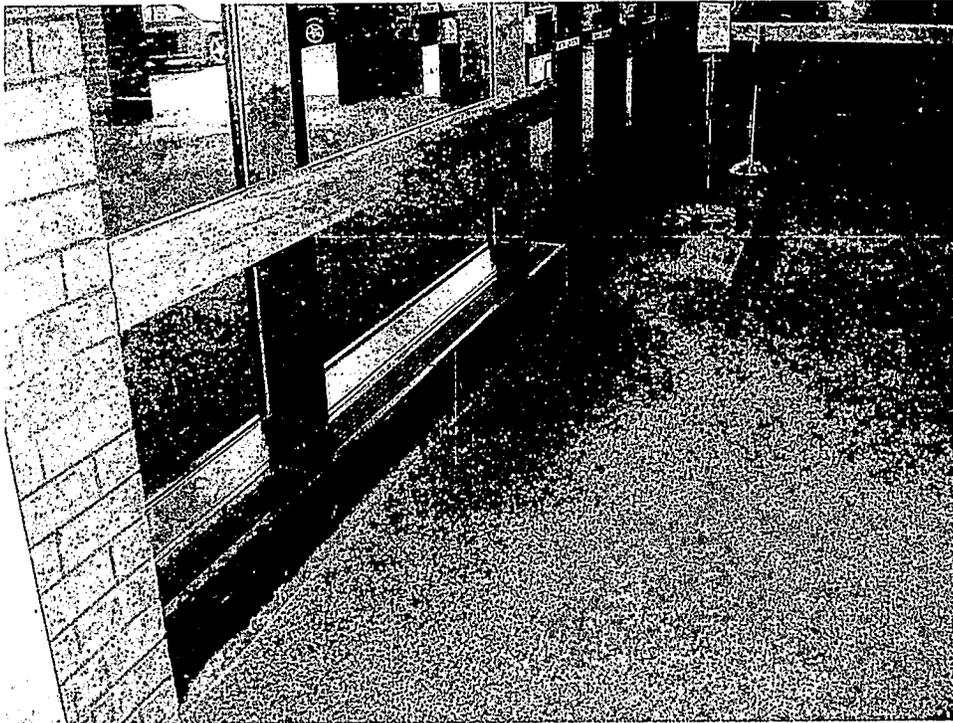
3. Issue: Public Lobby Heating 100 East and West heating systems were deactivated.
 - The lobby is extremely cold in the winter which is affecting other room HVAC requirements on this floor.

Photo 1. View of public lobby East Entrance. HVAC systems for the East and West Entrances need to be put into operation to help fix cold area affecting the 1st floor.

- Reactivate the heating systems in this area as a temporary measure.
- Redesign of the system connection with the building heating system. To include a new heat exchanger and piping to the units.
- Install new DDC controls to replace the out dated pneumatics controls for better control of the system.
- Repair or replacement of damaged grills and covers in the lobby.
- Review of the coil sizes and replacements of damaged coils to address previous leaks in the system. This is possibly why it was turned off 10-12 years ago.
- Balancing of both air and water system will be required.
- Cleaning of the duct work.

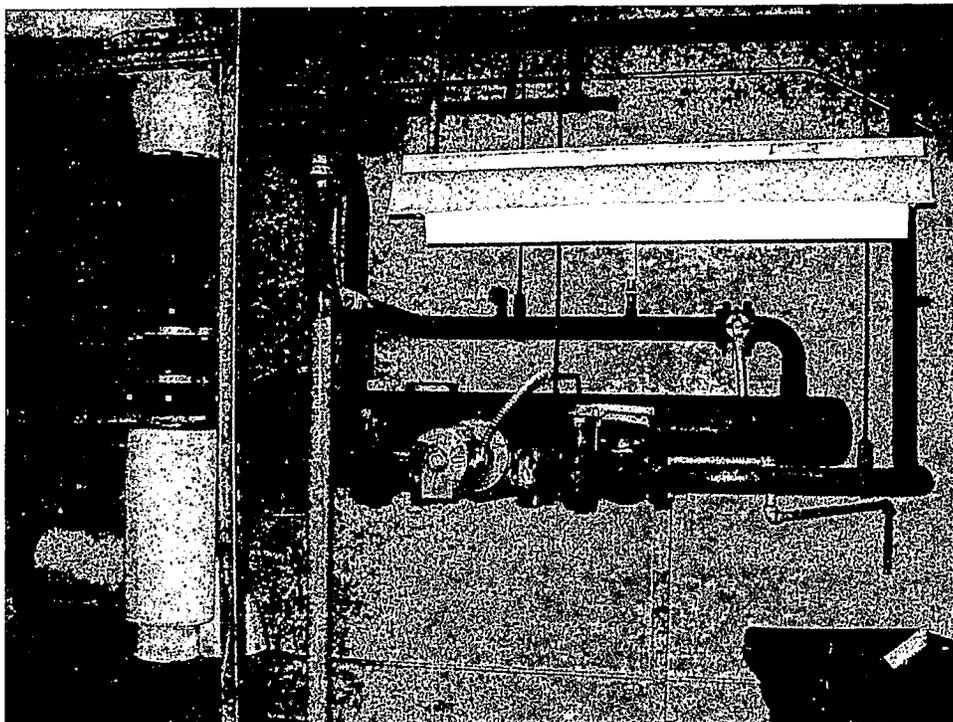
Photo 2. Public lobby heating system in boiler room needs to be redesigned and new DDC controls installed.

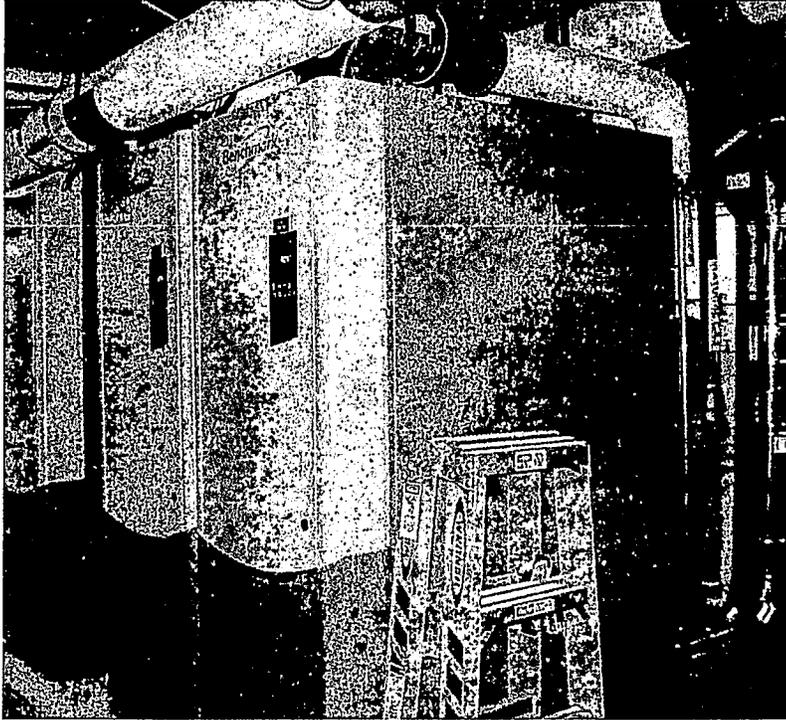
Photo 3. View of new high efficiency condensing boilers installed this year. Redesign of the building heating systems needs to be done to realize the real savings available.

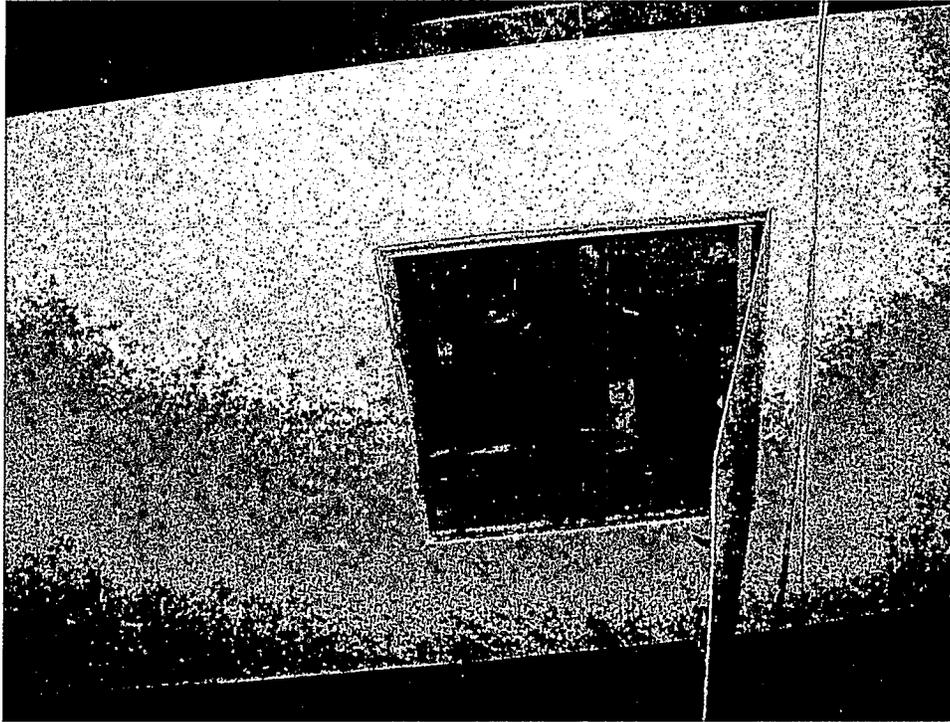
Photo 5. View inside the second floor access panel. Notice the lack of insulation on the exterior curtain wall. Heating is in adequate and improperly controlled.

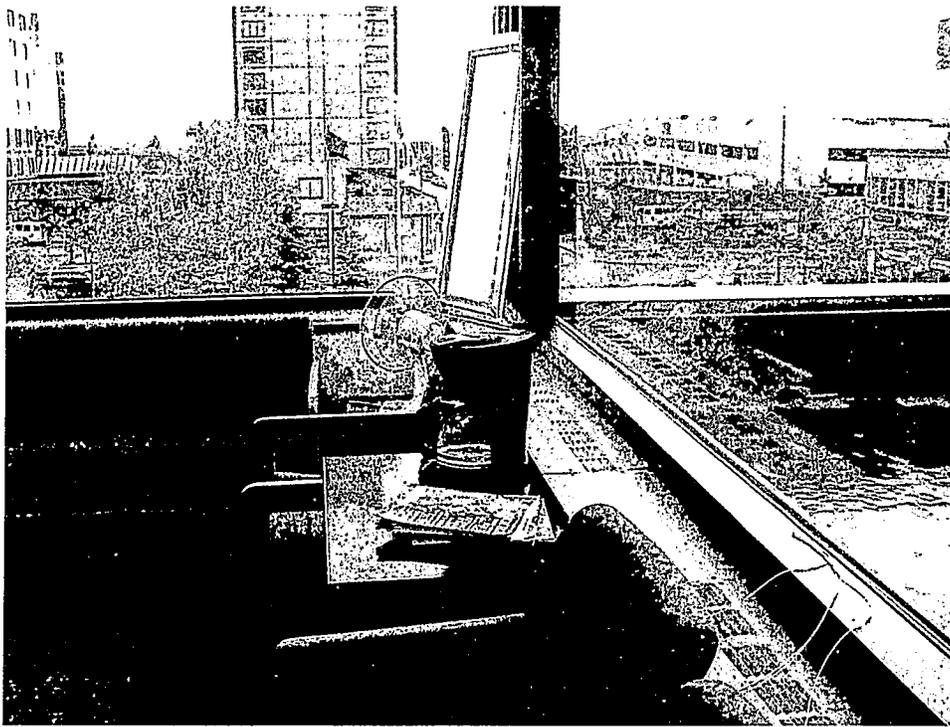
Photo 6. View of typical perimeter building heating system.

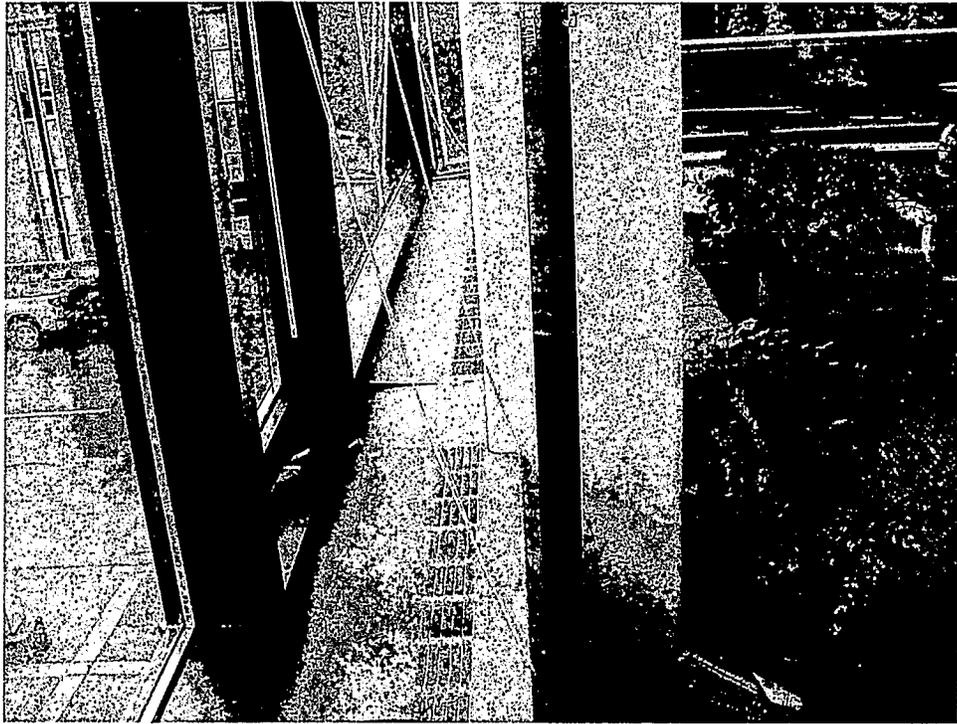
Photo 7. View of typical perimeter building heating system. Some cover deterioration is noted.

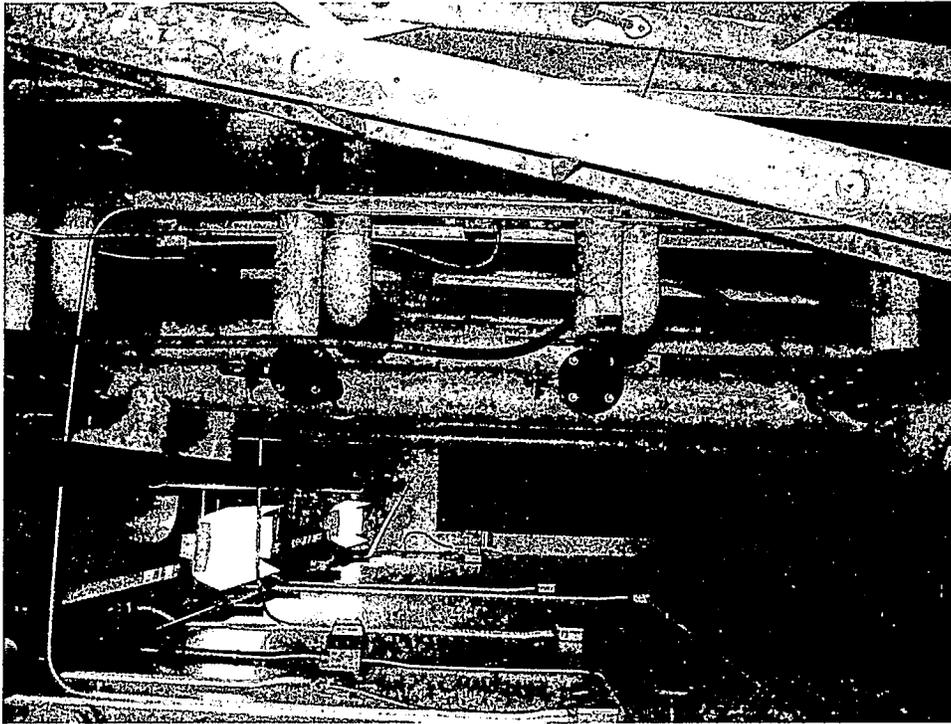
Photo 9. View of typical air handler piping. System is supplied with straight water and has potential freezing condition that will damage the equipment and building.

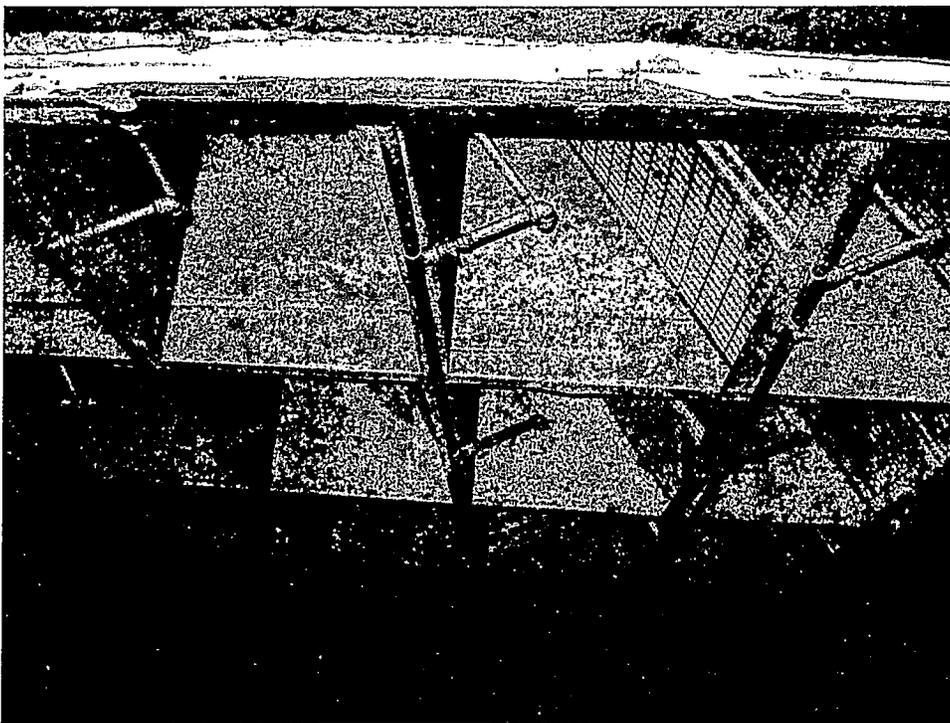
Photo 10. View of abandon humidification system.

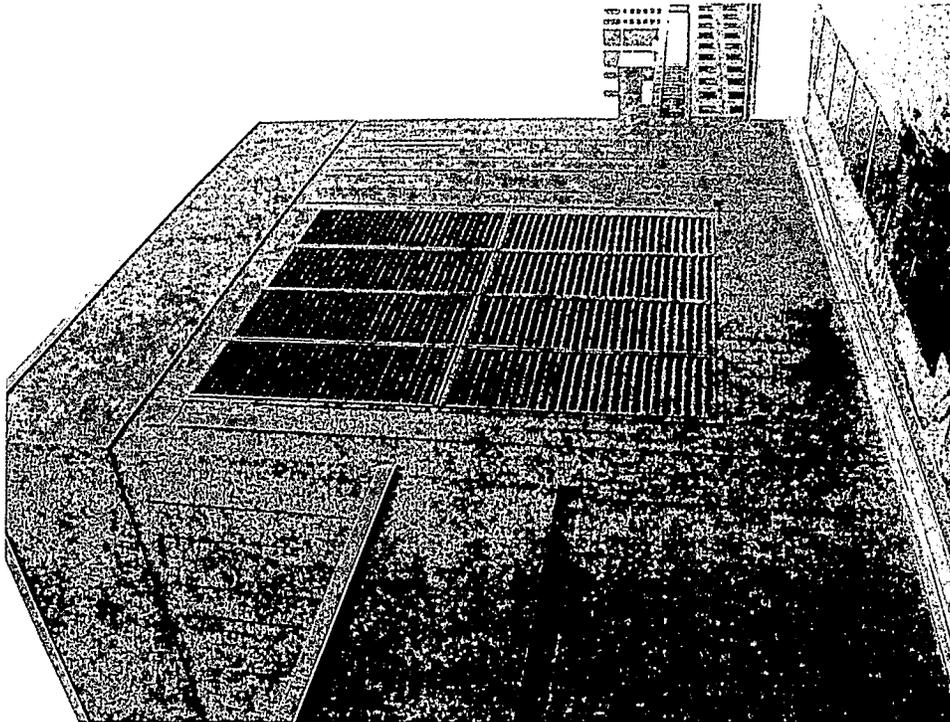
Photo 12. View of end wall of penthouse at fan #2. End wall at fan #1 was damaged and shows some signs of distortion a review of the end walls should be completed.

- Cut open the damaged end walls.
- Remove old existing Air Handling Units.
- Install new modular units that can be bolted together in place. The coils in the new units should be sized for design day of -18 degree F to 60 degrees F with a supply water temperature of 160 degree F.
- Install new DDC controls on the entire HVAC Systems in the Penthouse.
- Install new heat exchanger and glycol makeup system for AHU's.
- Replace end wall with new structural upgraded walls sections.
