# HAINES HIGHWAY

MILEPOST 3.5-25.3

ENVIRONMENTAL SITE ASSESSMENT

DOT&PF PROJECT NO. 68606  
HAINES, ALASKA

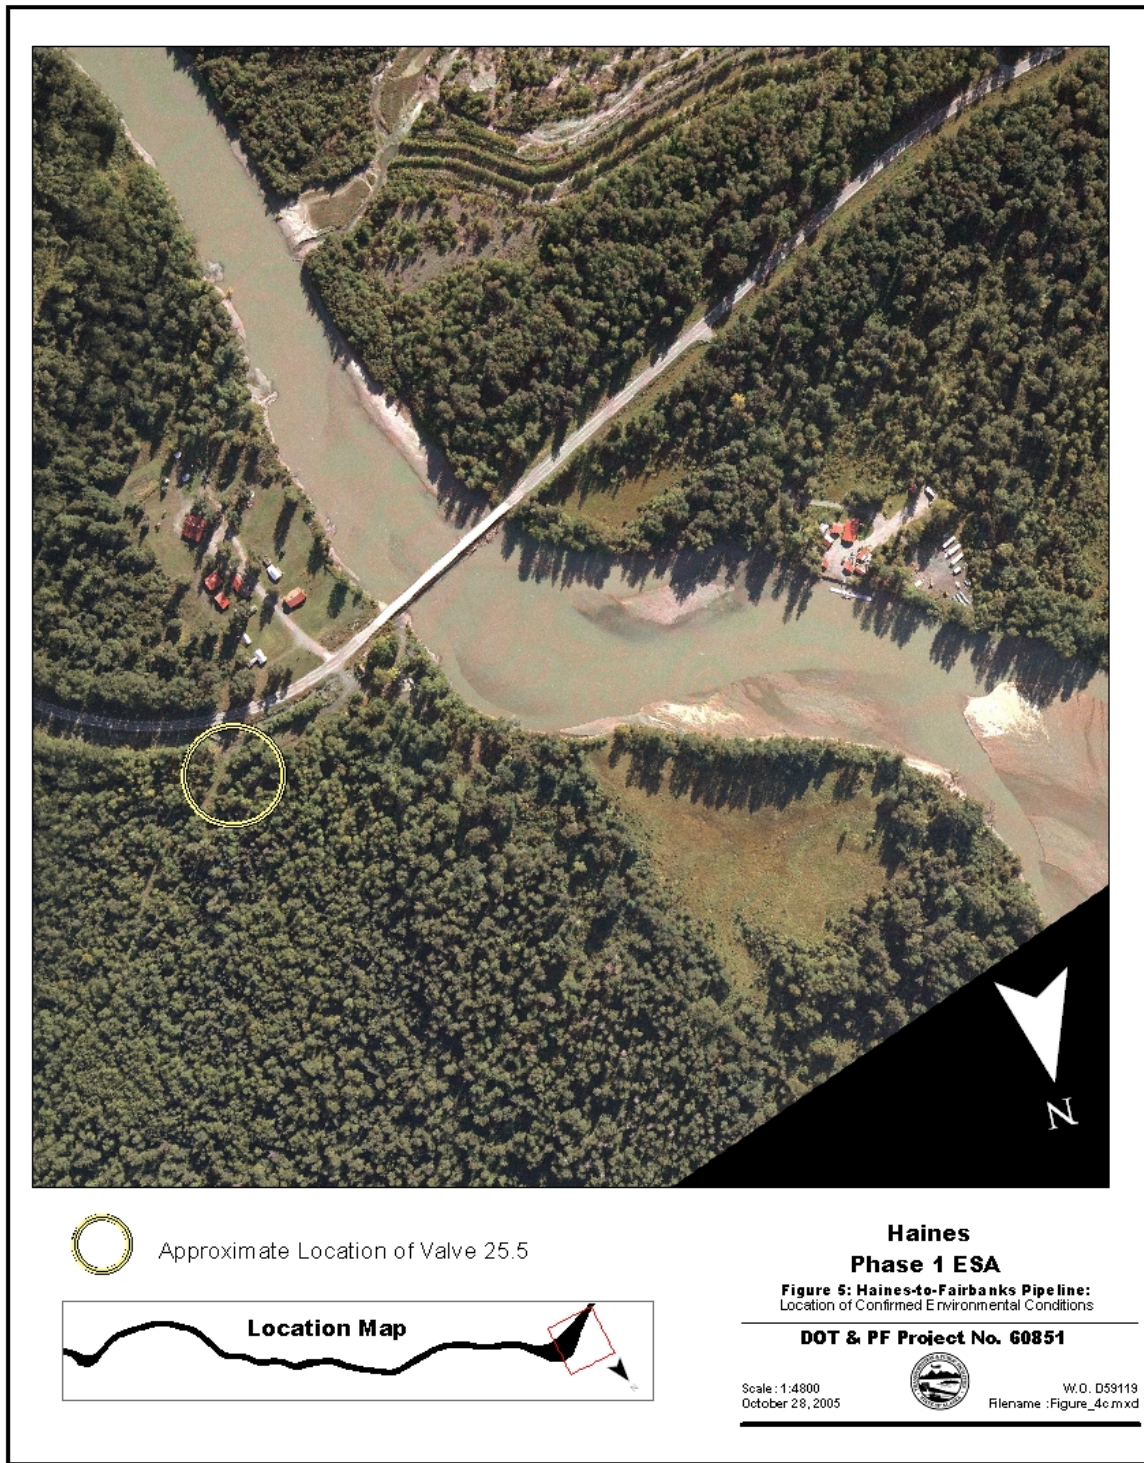
**Figure 5: Haines-to-Fairbanks Pipeline: Location of Confirmed Environmental Conditions**

The U.S. Army Corps of Engineers (USACE) administers the investigation and performed hydrocarbon sampling in November 2005, which will resume in May or June of 2006 (see Table 2). The November sampling included two locations within the vicinity of the study area, referred to as Release 19.5 and Valve 25.5. During the investigation, hydrocarbon contamination was found at Valve 25.5, near the Wells Bridge (see Figure 5). The second site is located around MP 17.5 and hydrocarbon product was detected, but not at ADEC action levels.

Although the Property contains 14 areas of debris, junked cars, illegal camping areas and other various structures, none of these areas warrant further investigation. However, based on the information obtained during this Phase I ESA, it is DOWL's judgment that past activities on and adjacent to the Property have posed no significant potential for environmental impairment of the Property, with the exception of contaminated soil detected Vault Valve 25.5 described in Section 8.0 and shown in Figure 5. It is recommended that the client continue to monitor the status of the Haines-to-Fairbanks pipeline investigation and coordinate with ADEC, regarding the results of upcoming sampling.

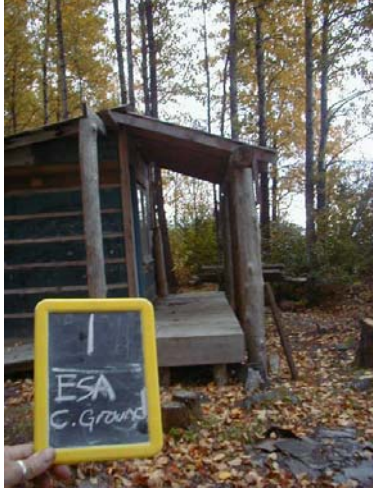
- Site 1: A cabin has been constructed just off the shoulder in a parking area.
- Site 2: Six 55-gallon drums were found between the road and the developed area of the Southeast Roadbuilders property. Five barrels appeared to be old, empty, and were rusted thoroughly without any apparent labeling. One barrel had a fading label and was empty.
- Site 3: A cabin (a potential squatters cabin) has been constructed in a heavily wooded area between the road and the river. Associated debris includes appliances, car parts, and a footpath made of wood.
- Site 4: An illegal dumping area that contained batteries, firepit, filled soap buckets, and other debris.
- Site 5: Between the road and the mountainside, a small shed has been built that is a hydroelectric generator. Associated material includes metal piping, a drum, and other mechanical equipment.

<p><b>Photograph No. 1</b></p> <p>Location: Site 1</p> <p>Direction: Facing southwest</p> <p>Comments: Cabin on Shoulder</p>
