FINAL REPORT

**LYNN CANAL HIGHWAY
PHASE I
ZONE 4 GEOTECHNICAL INVESTIGATION**

STATE PROJECT NUMBER: 71100

*Golder Associates Inc.
1750 Abbott Road, Suite 200
Anchorage, Alaska 99507*

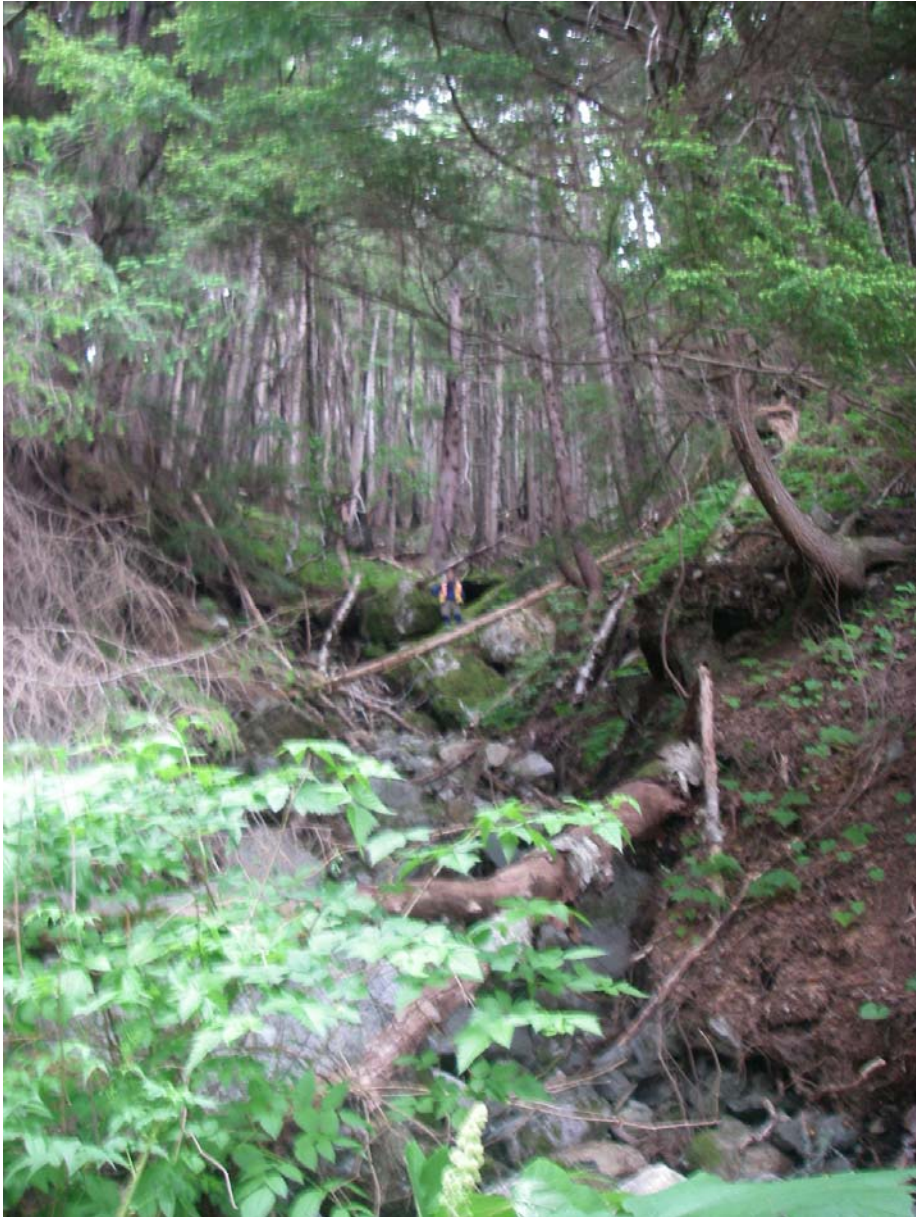
DF02. View east/upslope up debris flow channel incised into overburden. Photo taken 50 ft right of IRP 2006 1515+00.

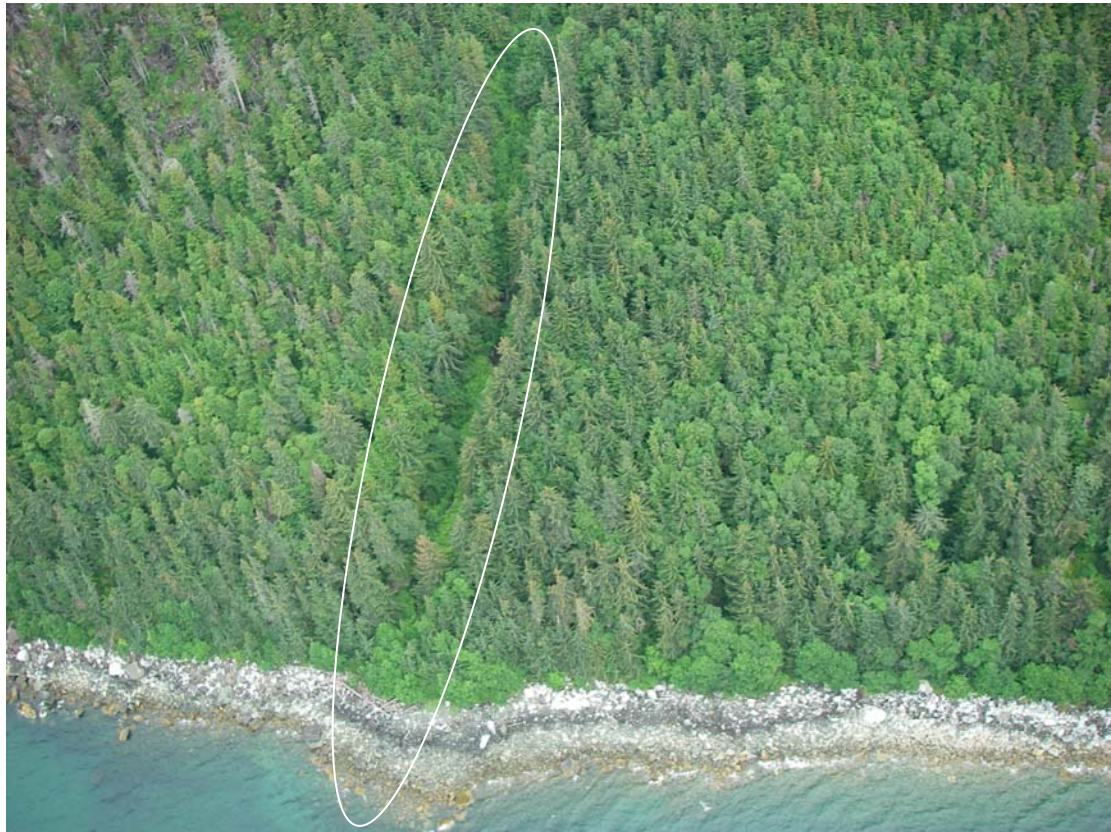
DF03. View east/upslope at debris flow channel, deposition zone, and fan near IRP 2006 1518+00.

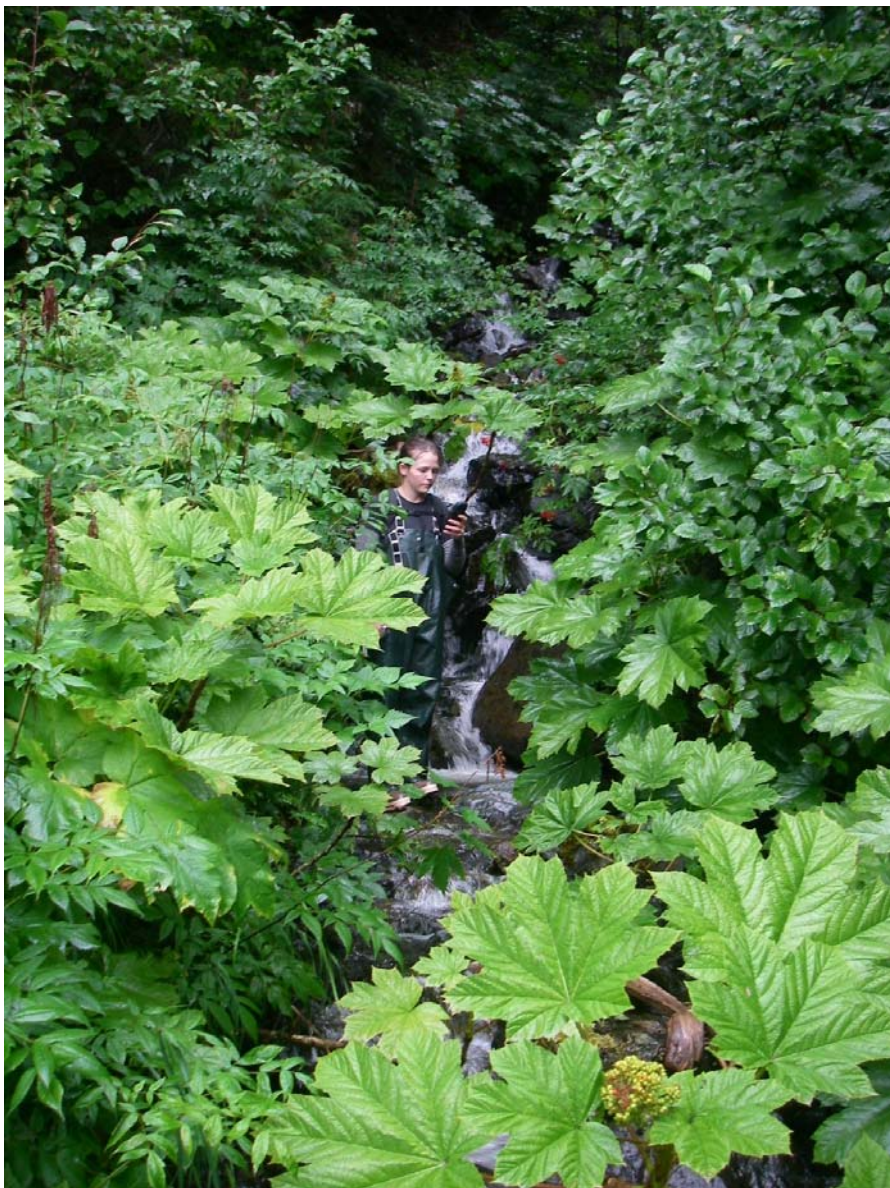
DF03. View east/upslope up debris flow channel. Photo taken 10 ft right of IRP 2006 1517+50.

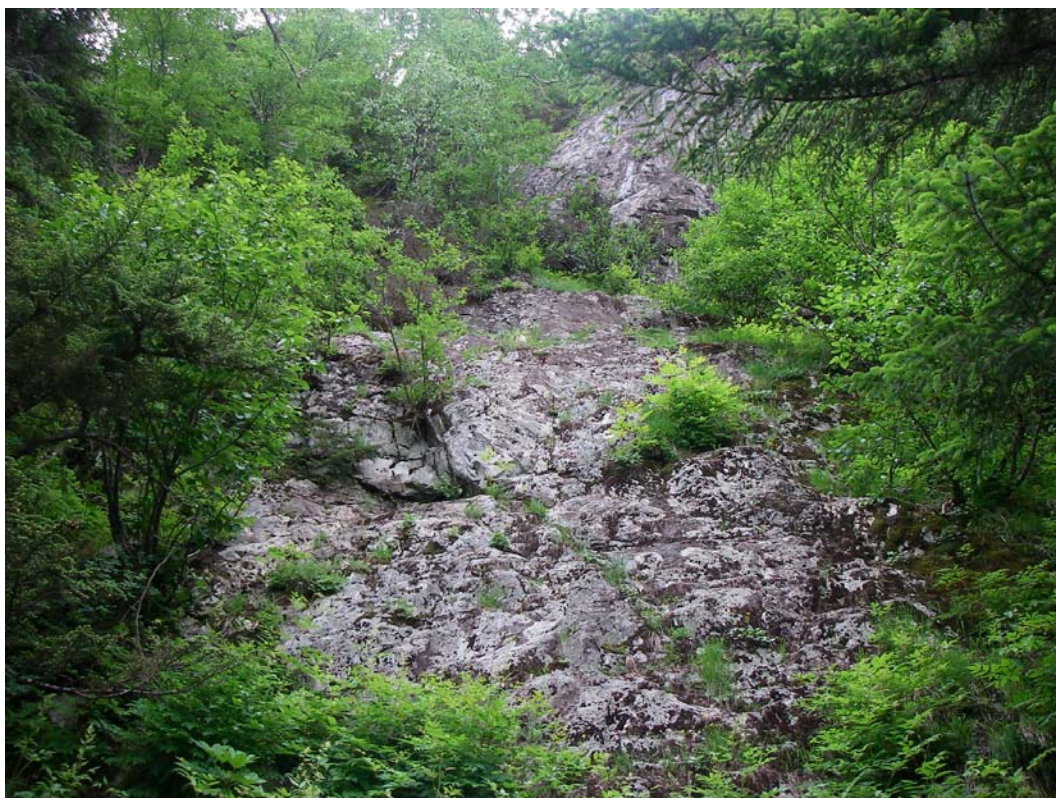
RF01. Basalt cliff that is the origin of rockfall hazard. Photo taken 350 ft right of IRP 2006 1551+00.

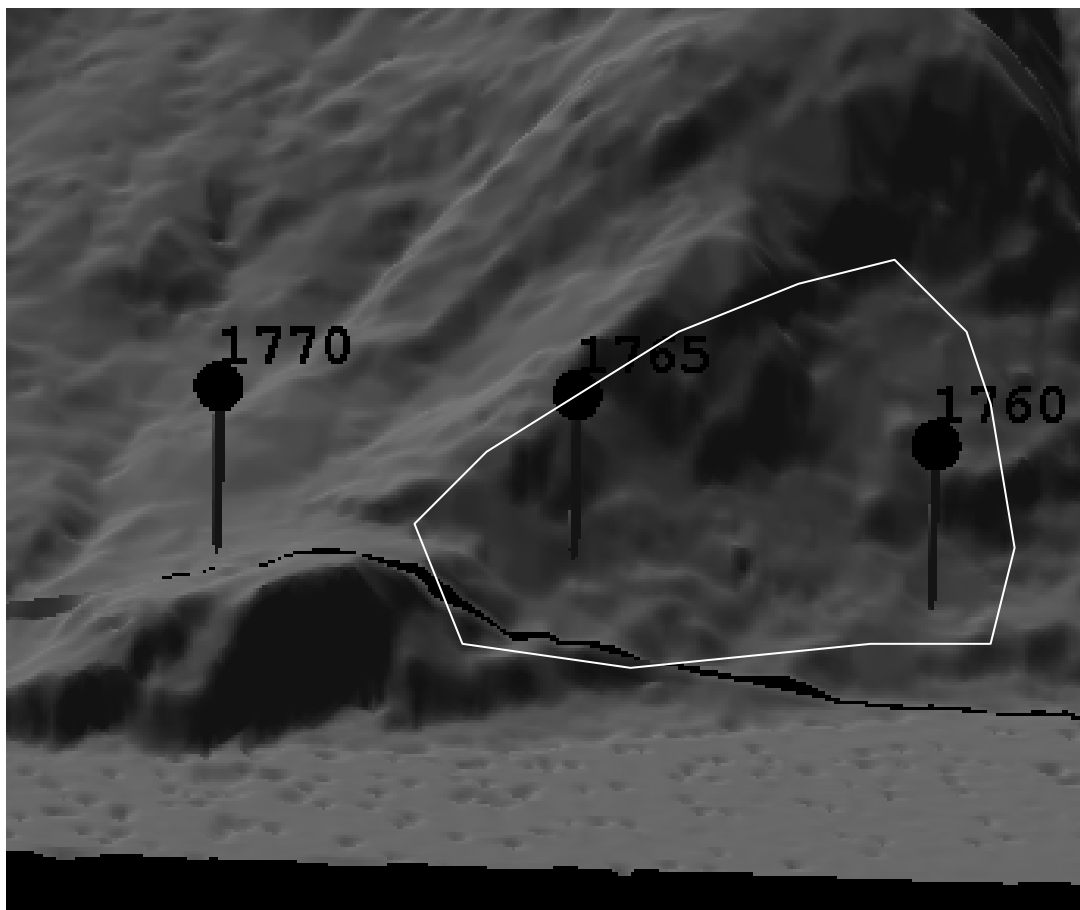
RF09. LIDAR image of rockfall hazard.

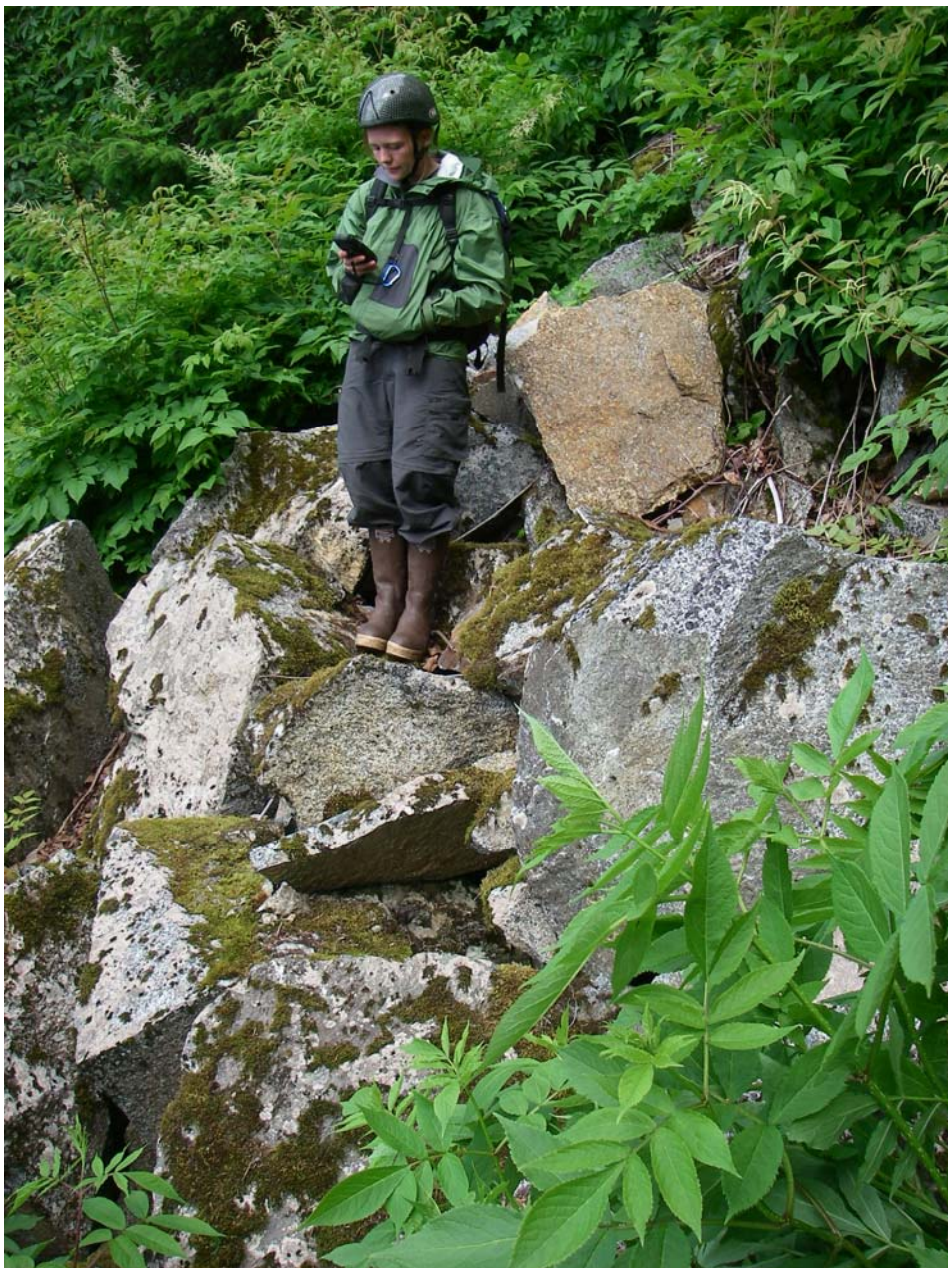
RF15. View north/up alignment across deposit of fresh 2 ft diameter rockfall. Photo taken 240 ft east of IRP 2006 1948+00.

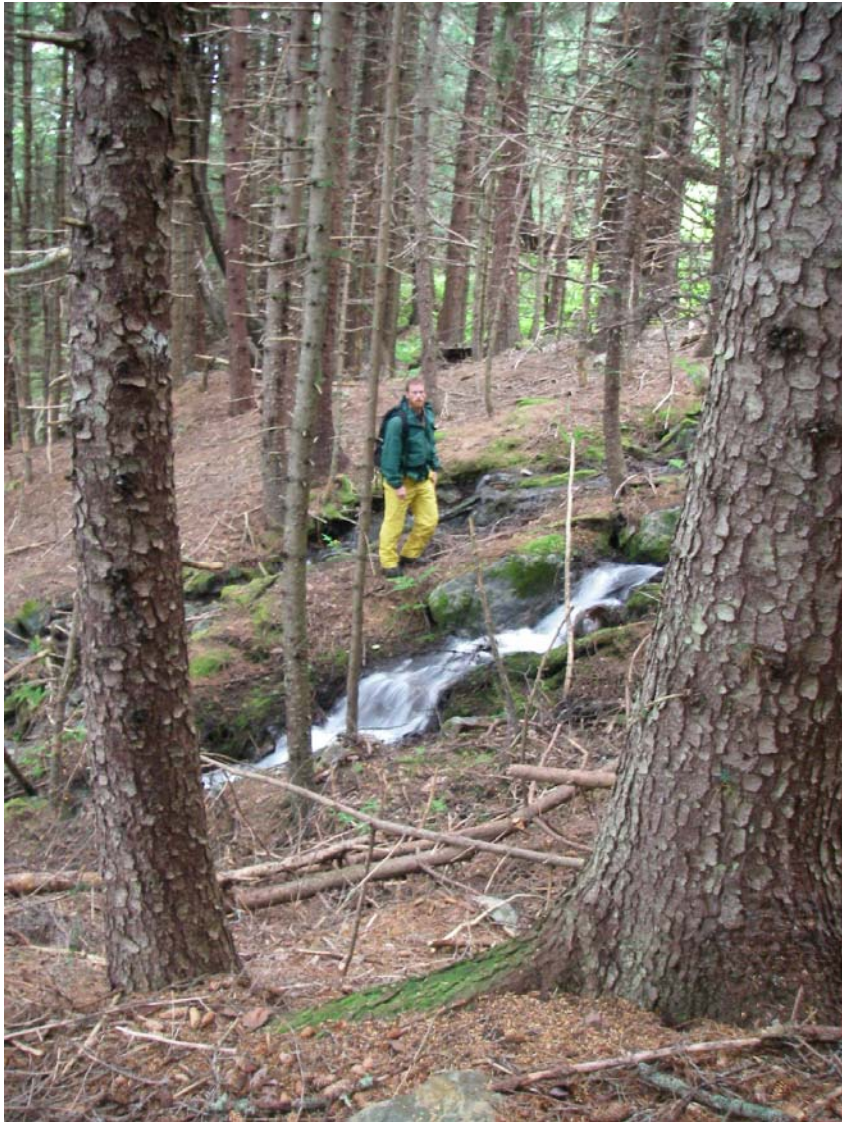
DF24. View north/up alignment across debris flow fan at centerline at IRP 2006 2055+00.

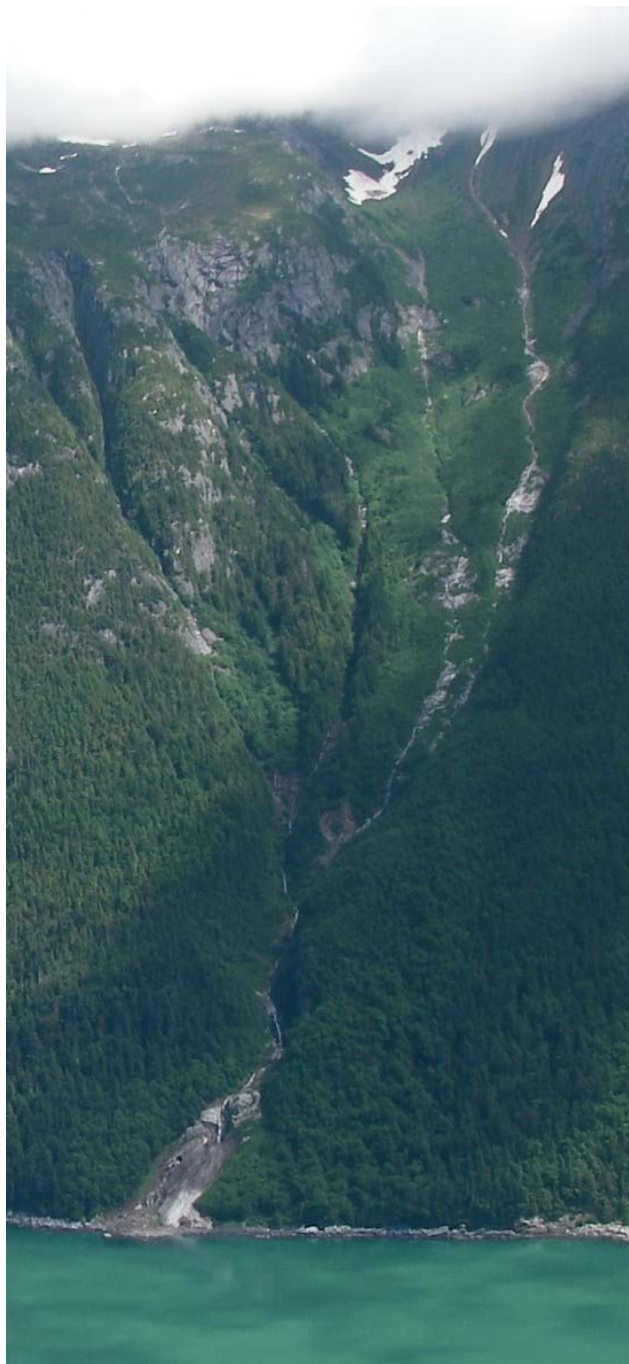
Hazard ID #:	DF29
Hazard Type:	debris_flow
HIN:	153
Rating:	A
IRP 2006 Location:	2114
Frequency (yrs):	1-5
Predictability:	moderate
Material Volume (CY):	10-100
Clast Size (ft):	1-2
Source Elev. (ft):	3000+
Centerline Slope:	fan
Alignment Location:	deposition_zone
Impact Alignment:	yes
Alignment Exposure (ft):	200-500
Vegetation:	denuded
Deciduous Trees:	yes
IRP 2006 South Margin:	2115+00
IRP 2006 North Margin:	2117+40
Photo #:	5125, 5926, 6248

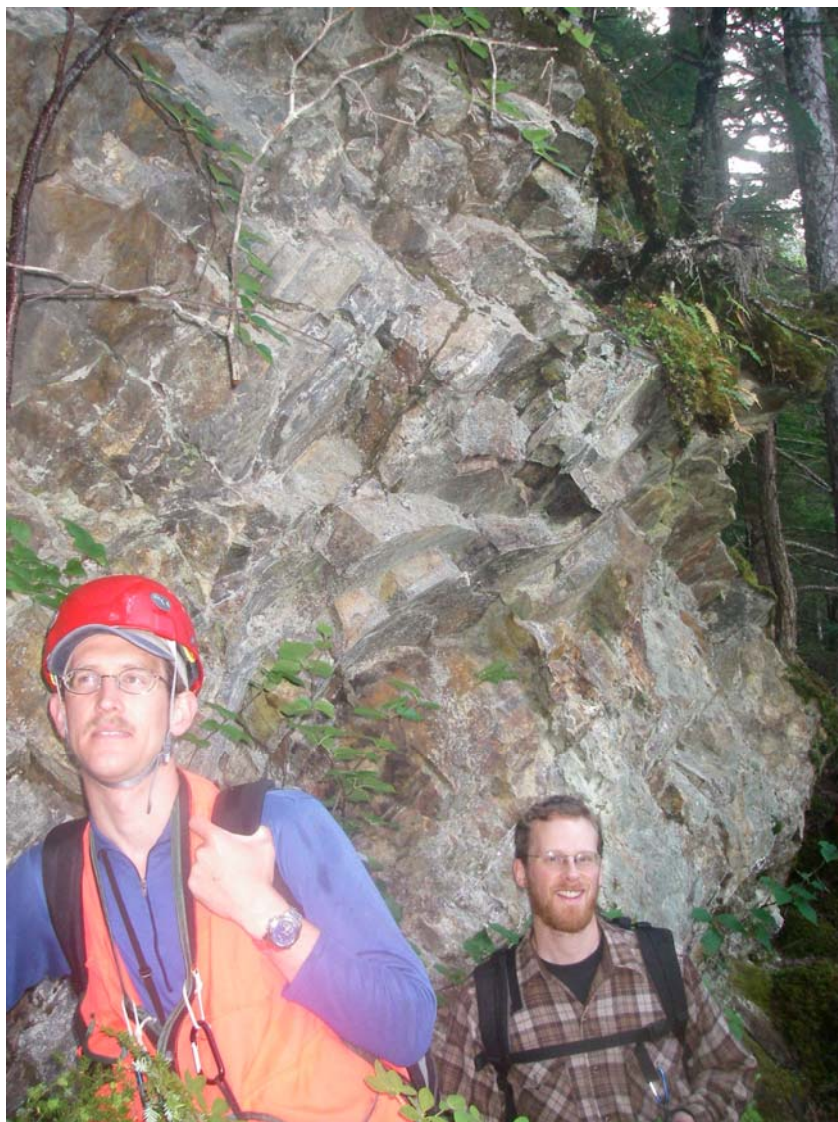
RF24. View east of rockfall hazard with fresh scarring.
Photo taken 215 ft right of IRP 2006 2258+00.

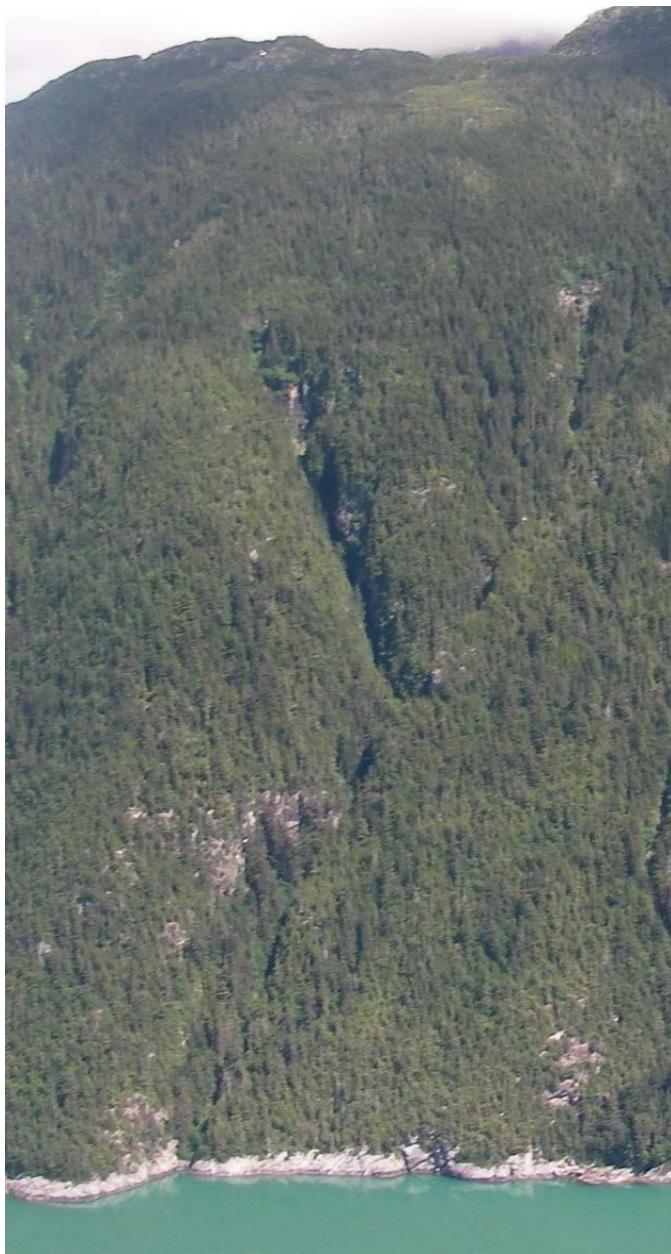
DF37. View east/upslope at debris flow channel and avalanche path ELC028.

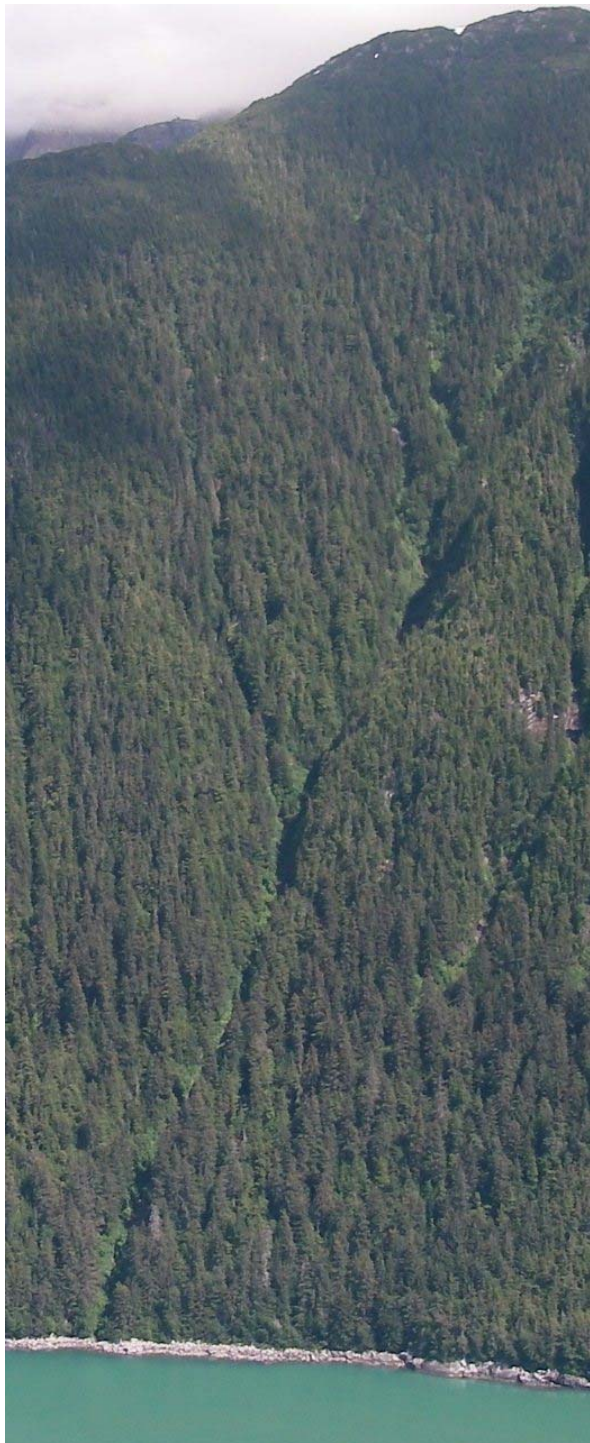
DF38. View east/upslope at debris flow channel and avalanche path ELC029.

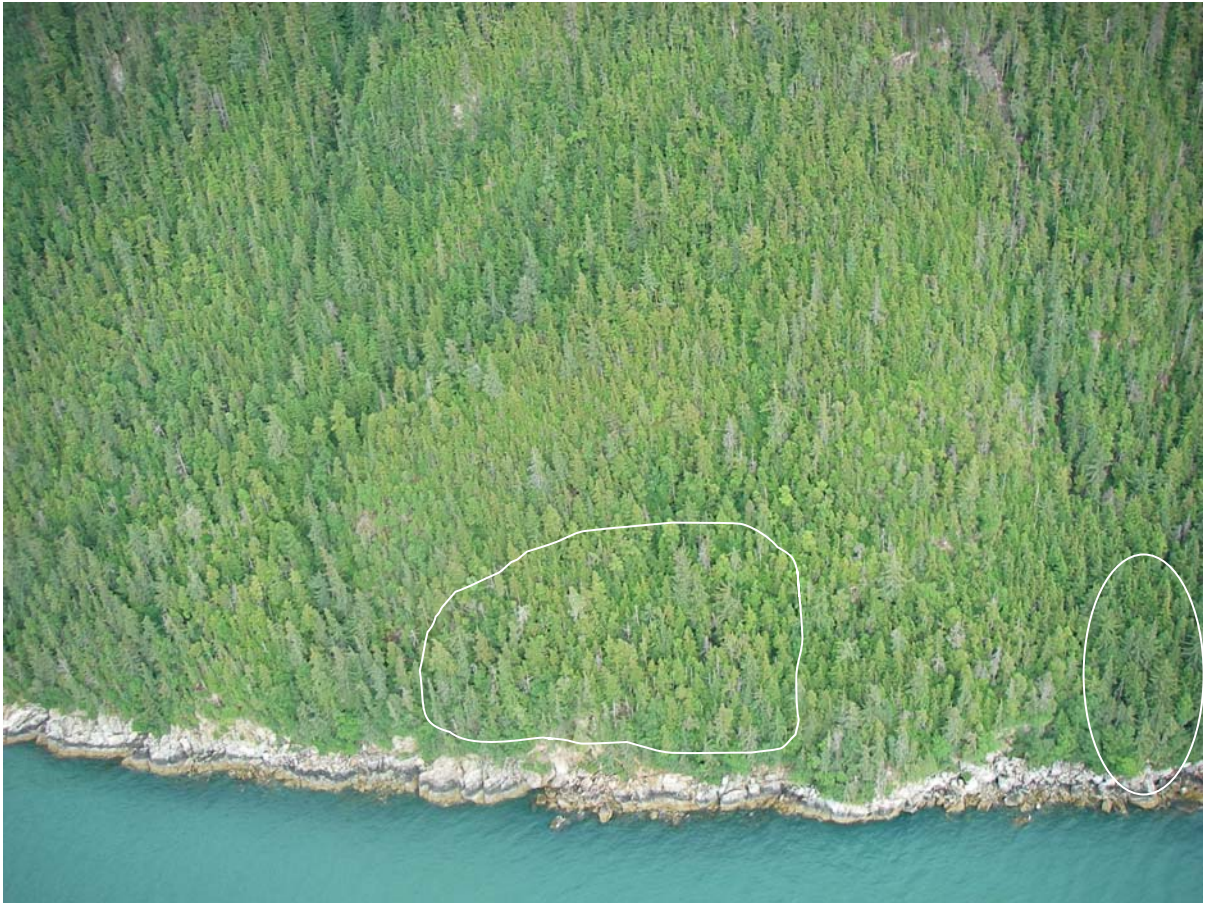
RF39 & RF40. View east/upslope at rockfall hazards RF39 (right) and RF40 (left).

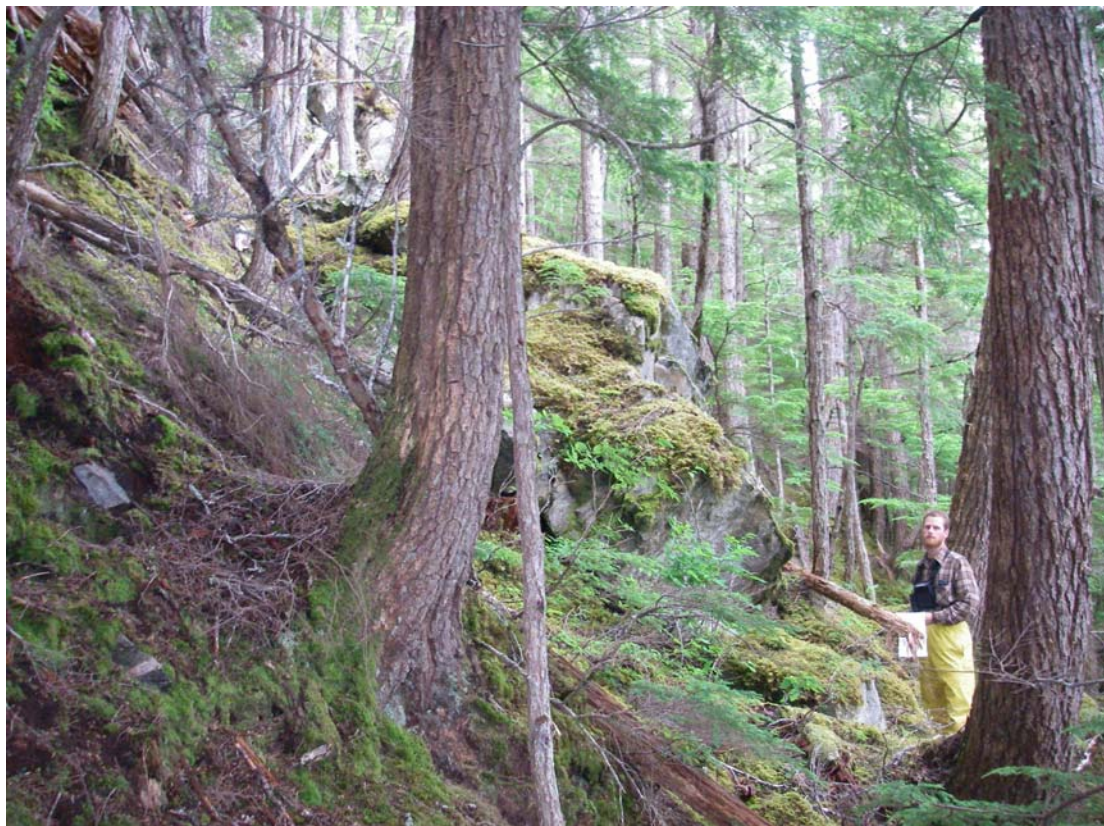
RF40. View south/down alignment at rockfall hazard. Photo taken 80 ft right of IRP 2006 2484+20.

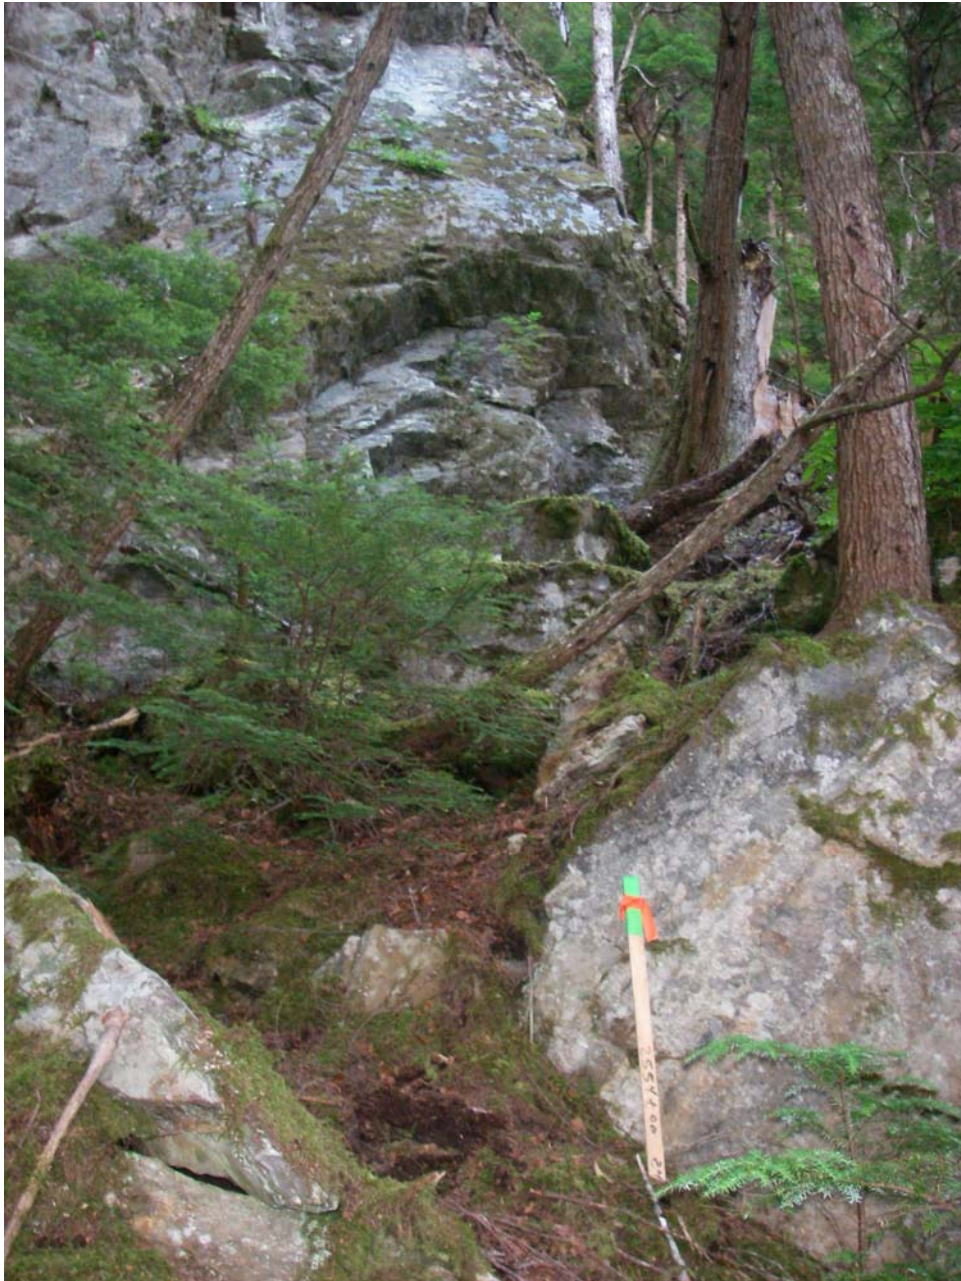
HR05. View east/upslope at hazard rock. IRP 2006 alignment location 2554+00 at stake.

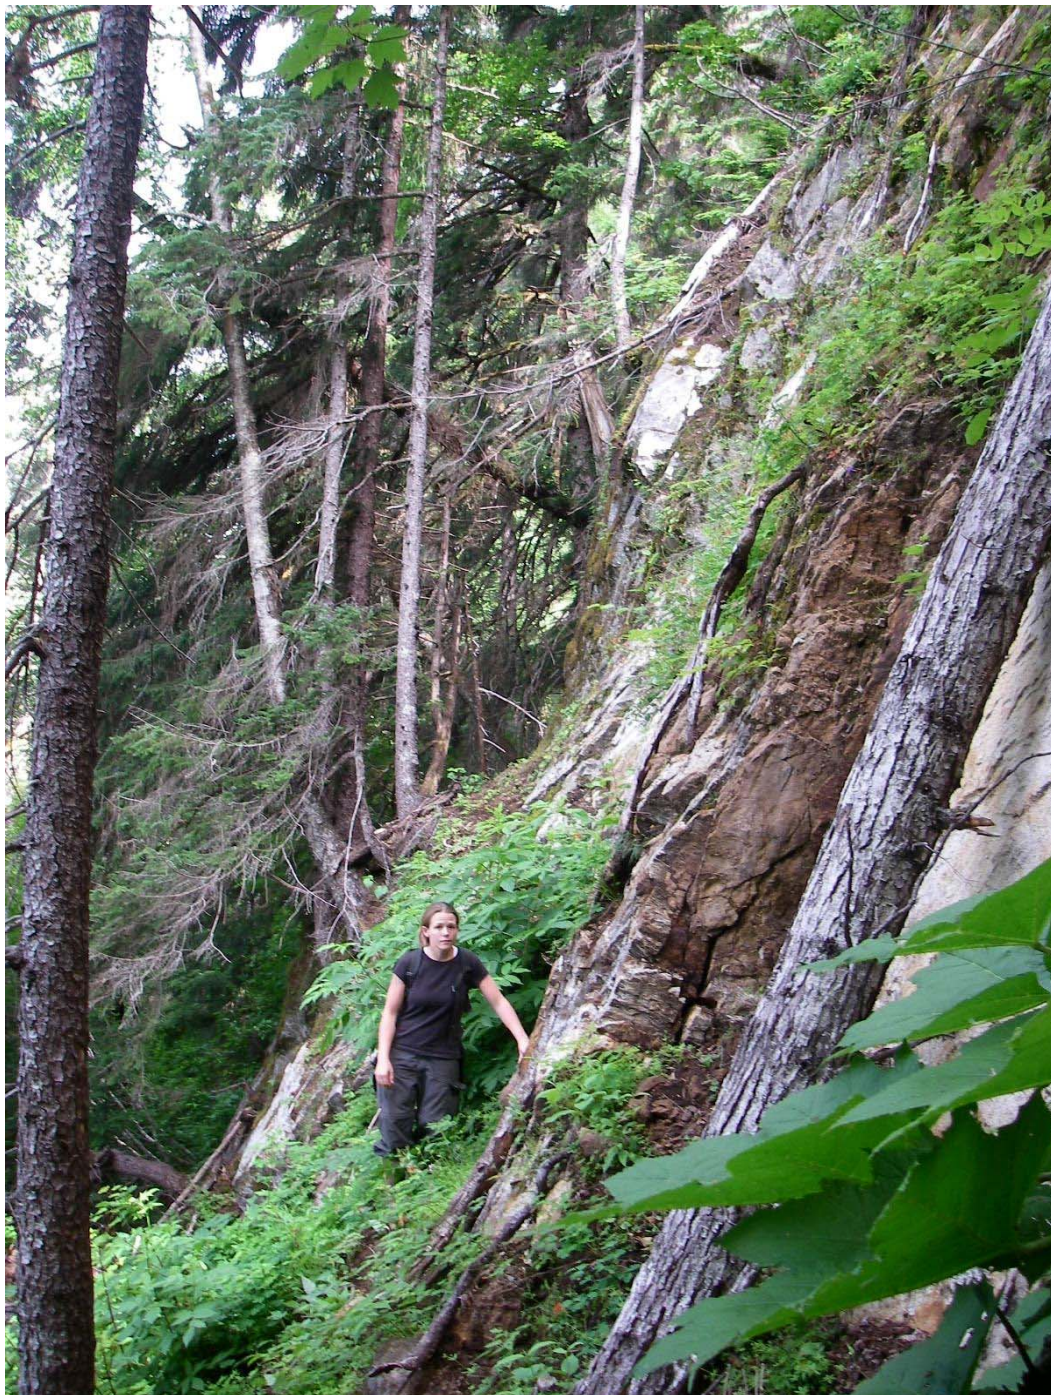
RF51. View north/up alignment across steep face of rockfall hazard.
Photo taken 160 ft right of IRP 2006 2560+50.

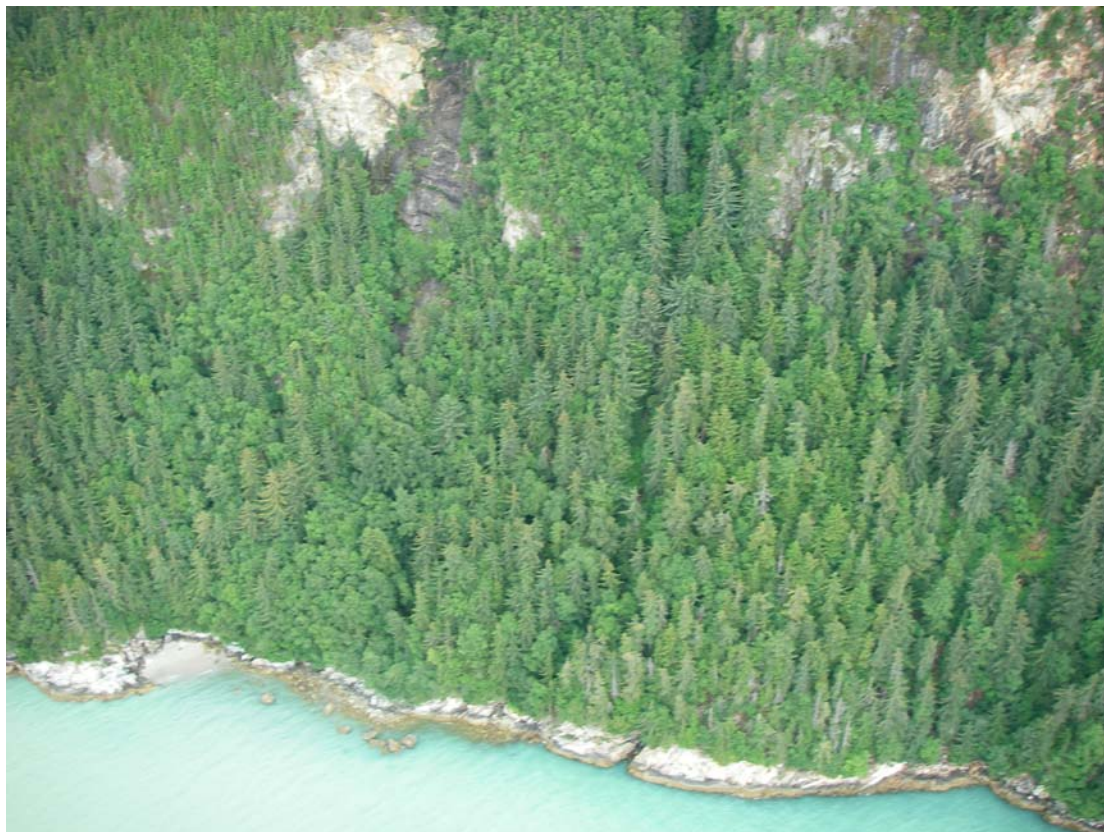
RF52. View east/upslope at rockfall hazard.

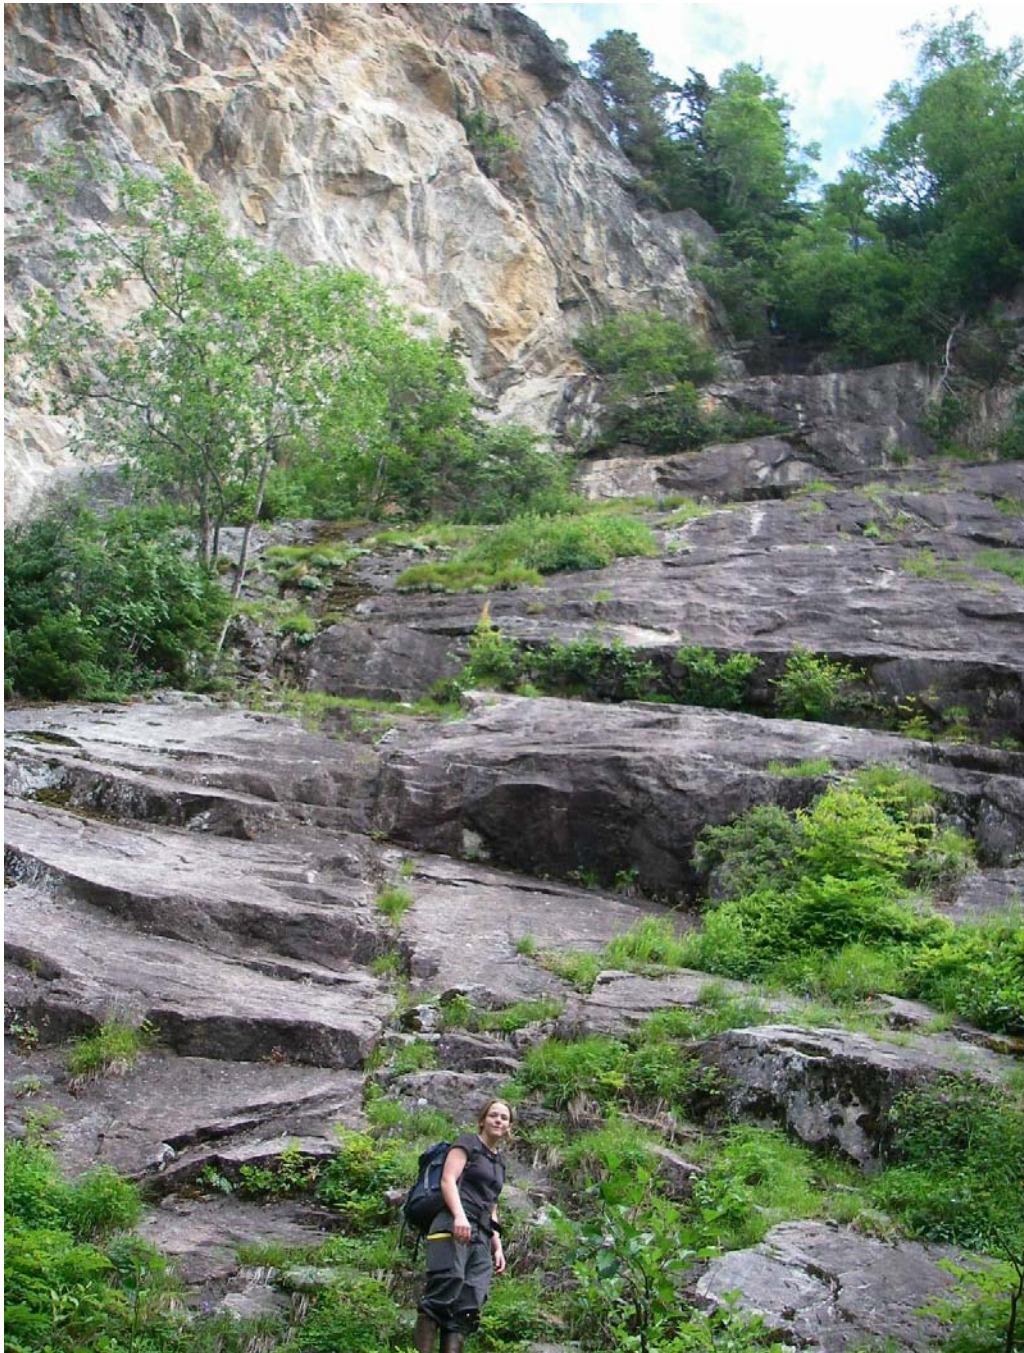
RF52. View east/upslope at source for rockfall hazard. Slope-parallel joints promote planar failure. Photo taken 200 ft right of IRP 2006 2565+20.

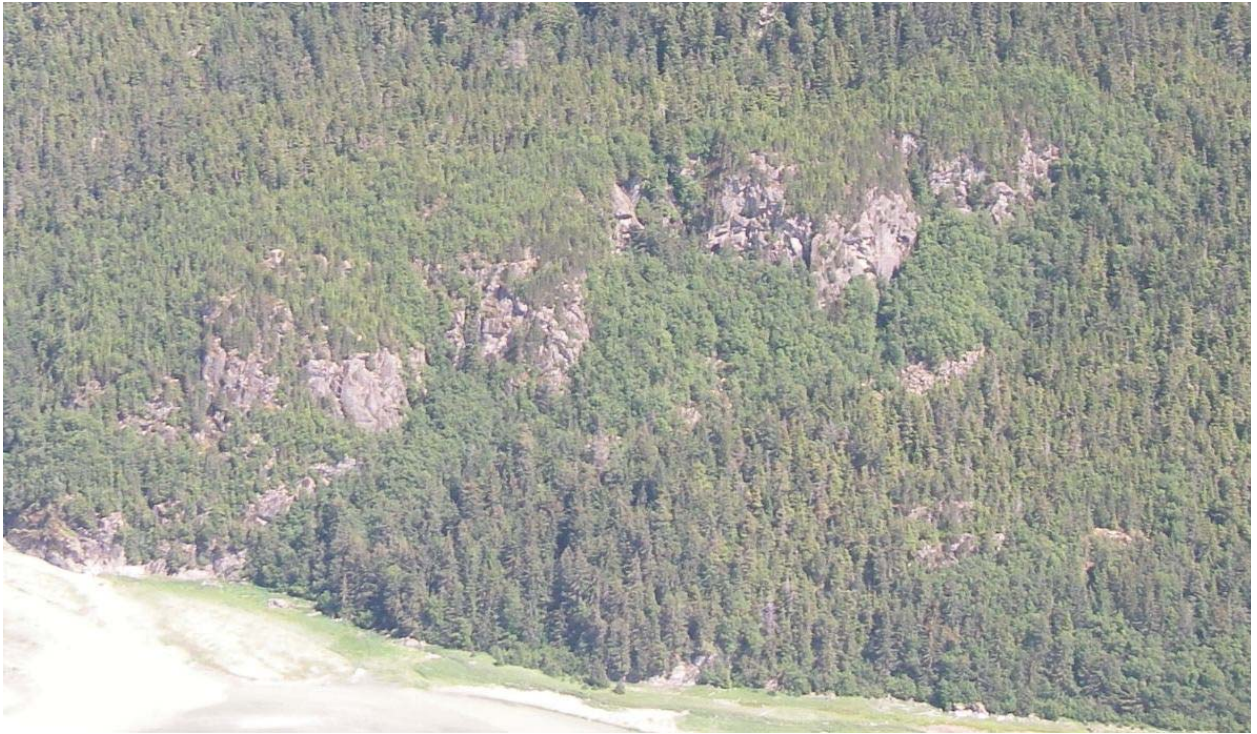
RF53. View east/upslope at rockfall hazard.
