Subject: **Geotechnical Memorandum GM06-03: Geotechnical Site  
Reconnaissance of Shelter Cove Road System  
[Addendum to Geotechnical Memorandum GM28-99,  
“AK PFH 39, Shelter Cove Road: PIR Preliminary  
Geotechnical Information” (2/18/00)]**

The following memorandum and addendum to the Shelter Cove geotechnical PIR provides reconnaissance geotechnical information for the Tongass National Forest's Shelter Cove road system on Revillagigedo Island, Alaska. The Shelter Cove road system is being considered for inclusion in the Alaska Forest Highway 39 Ward Lake Extension (aka Shelter Cove Road) project, which was discussed in Geotechnical Memorandum No. GM28-99. The geotechnical reconnaissance was performed on May 14<sup>th</sup>, 2003 in the company of Dale Lewis (WFLHD Forest Highway Programming Coordinator), Betty Wilt (Tongass National Forest Engineer) and Bob Emley (Tongass National Forest Civil Engineering Technician). The purpose of the reconnaissance was to determine if geotechnical problems exist on the route that could significantly increase the cost of roadway improvements required to upgrade the road for recreational use by the public.

**ATTACHMENT 1**

**Site Photograp

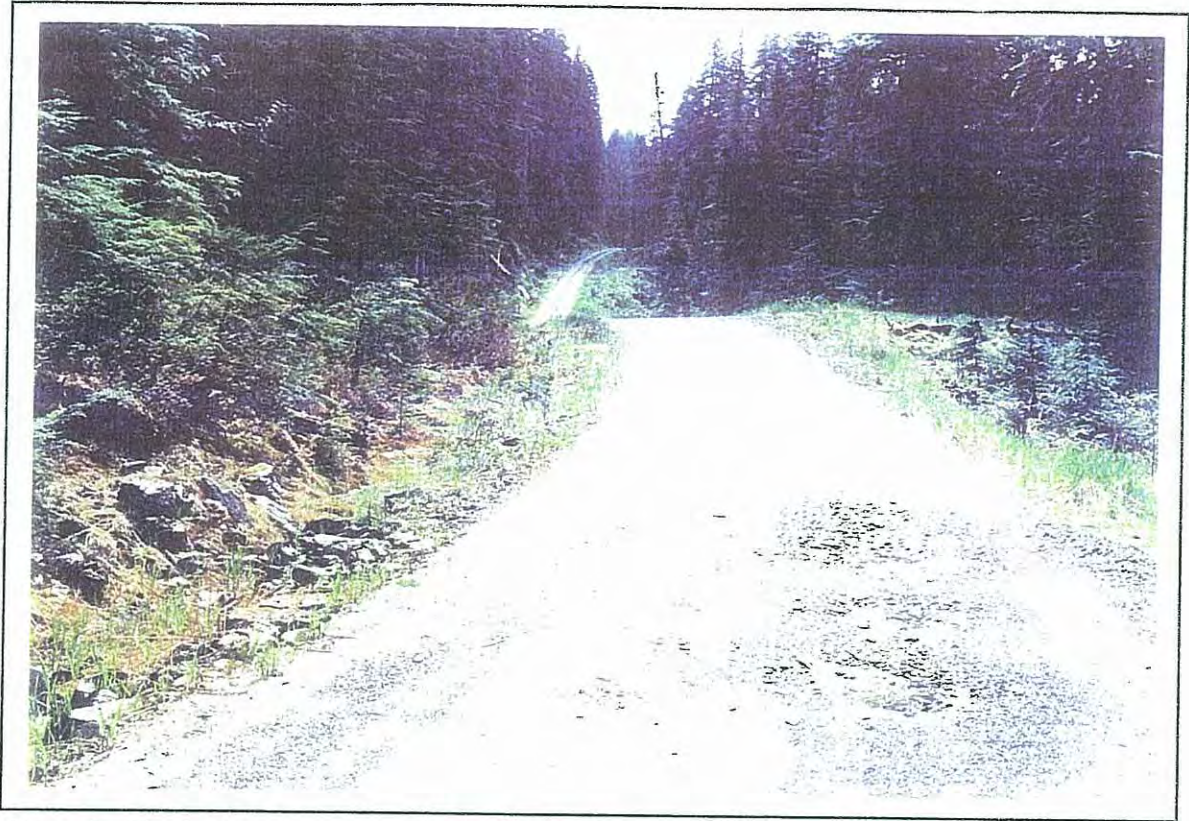
The Shelter Cove road is a single lane Forest Service timber sale road about nine miles in length and an average of 5.5 m to 6.7 m (18 to 22 ft.) in width. The road has good alignment and width for timber sale purposes but the vertical and horizontal alignment are deficient from the standpoint of AASHTO standards.

Photo 1 : Typical roadway section to Shelter Cove road system. Note poor vertical roadway alignment.

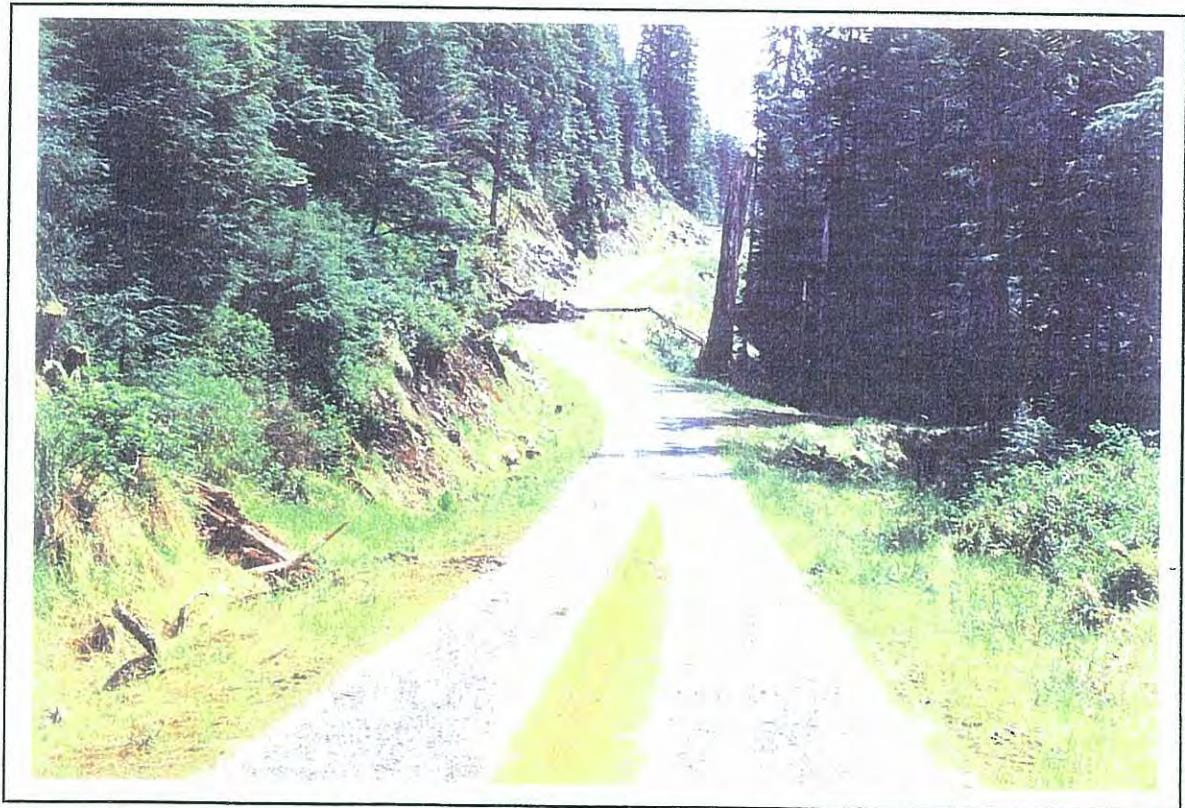
Photo 2 : Typical roadway section showing steep cut slopes in mixed soil and rock common material. Note irregular roadway alignment.

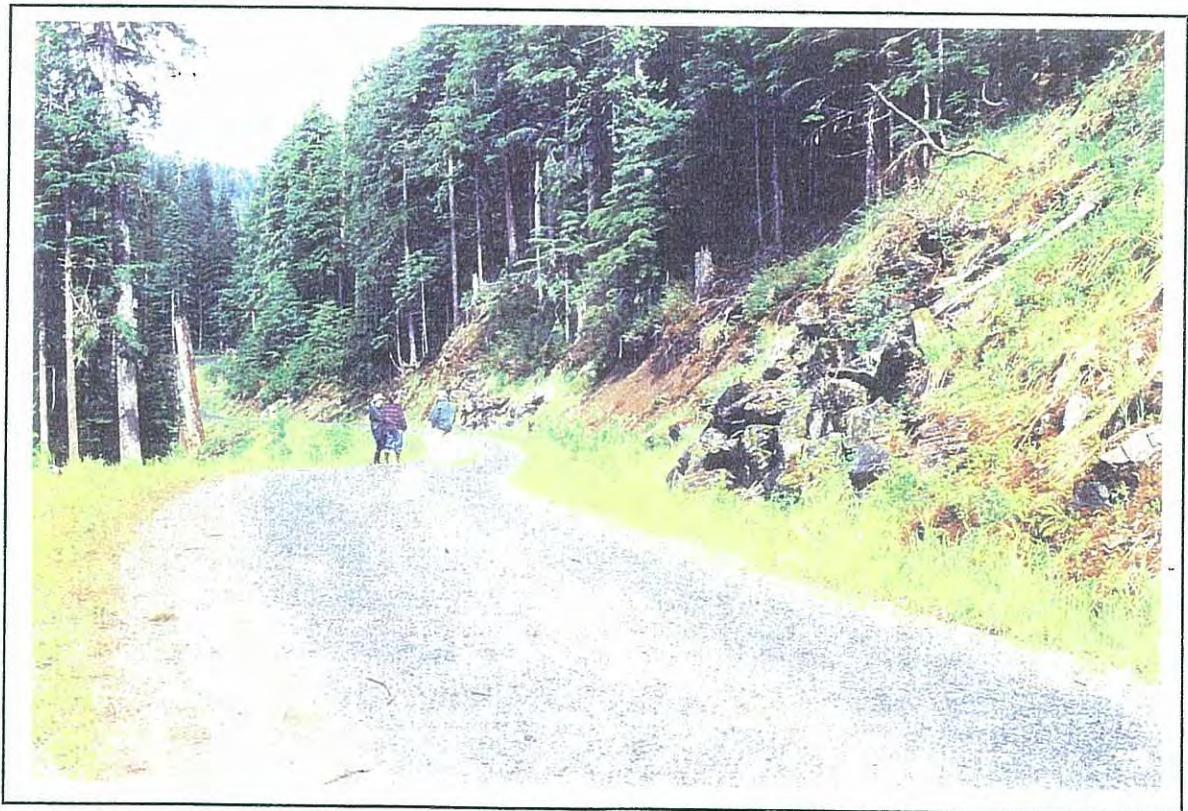
Contractors do not get paid for excavation flatter than 1:1 but they excavate flatter cuts when they need additional material elsewhere on the job. It appeared that common materials on the Shelter Cove road had been excavated in the range of 1:1 to 1V:1.25H.) The common cuts appeared to be generally stable, but I did see a section of 4 to 5 m (13.1 to 16.4 ft.) high cuts in moist silty soil in which several failures had occurred. The failures had been stabilized with Class 4 or Class 5 riprap stacked steeply against the slope like a shallow inlay, which seemed to be working pretty well.

Photo 4 : Large riprap stacked against shallow cutslope failure.

Some back slope failures in the wet silty soils may occur. The Forest Service practice of placing large riprap inlays against failures appeared to work well in those materials.

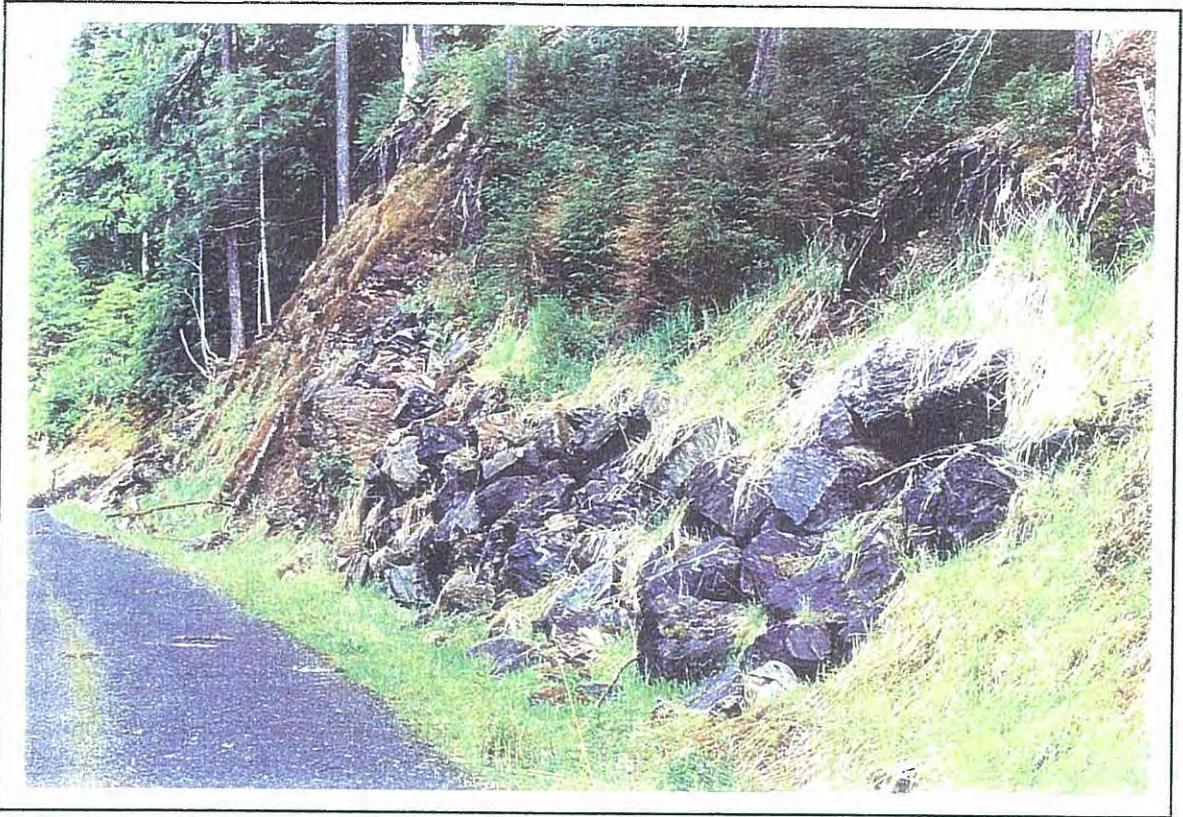
Photo 5 : Another cut failure stabilized with steeply stacked riprap.

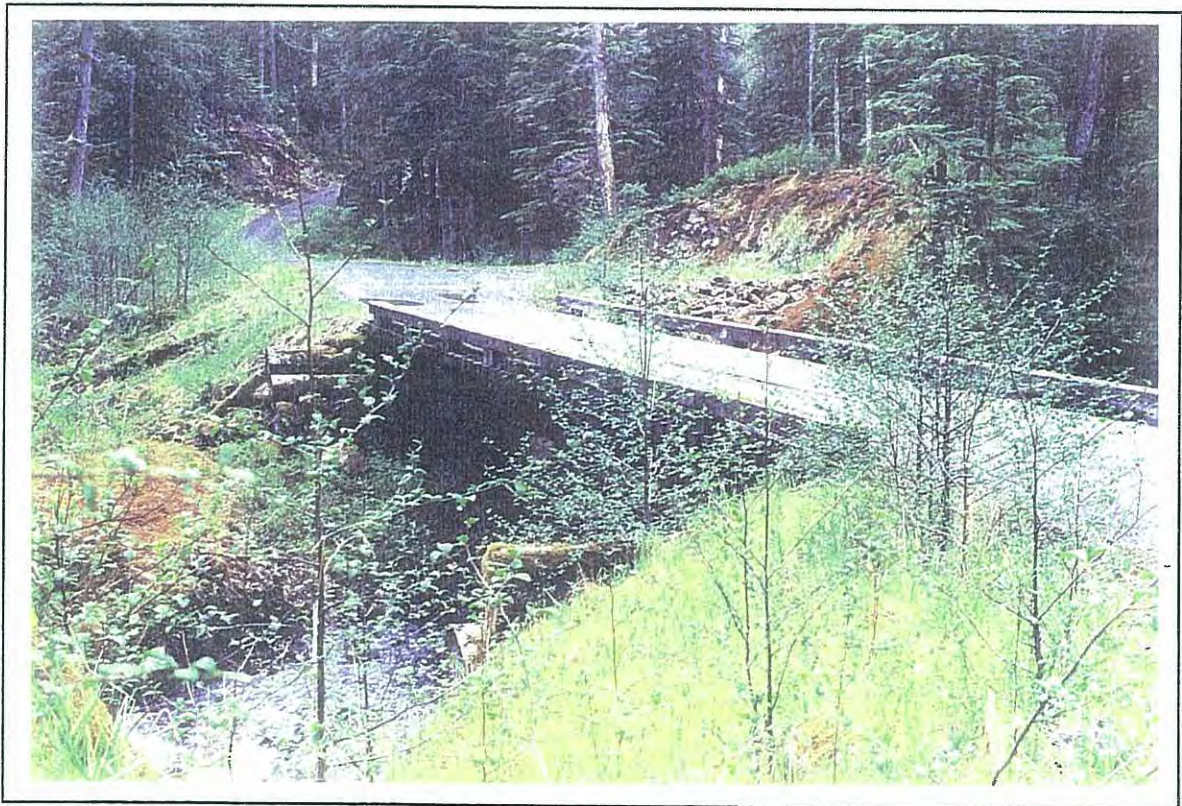
Photo 6 : Bridge at about MP 7.5.

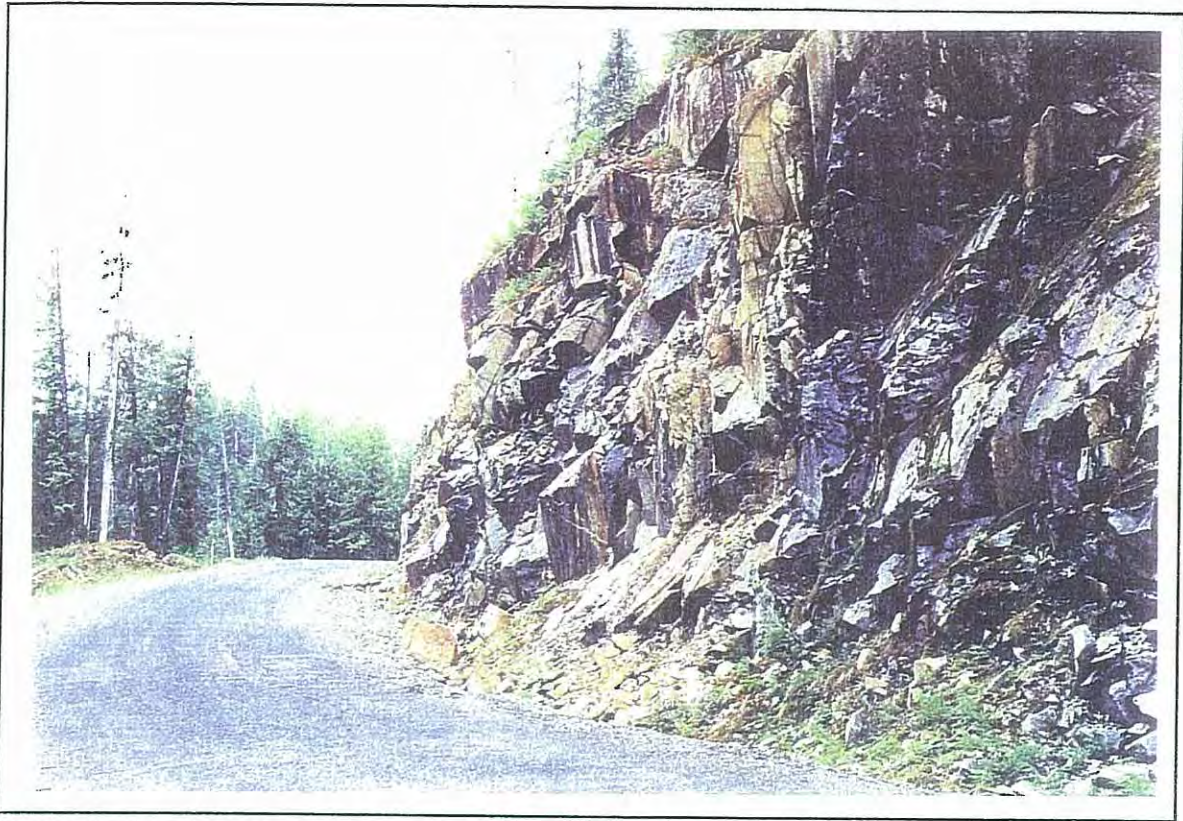
Photo 9 : Another outcrop of extremely fractured phyllite with planar joints inclined toward roadway (right side of photo).

The phyllite bedrock on this project is foliated, fractured, and moderately to highly jointed. Well-developed planar joints were observed at some locations. It is possible that rock stabilization measures such as rock bolting or doweling would be required in some places to stabilize adversely oriented blocks or masses of rock exposed by new cuts.

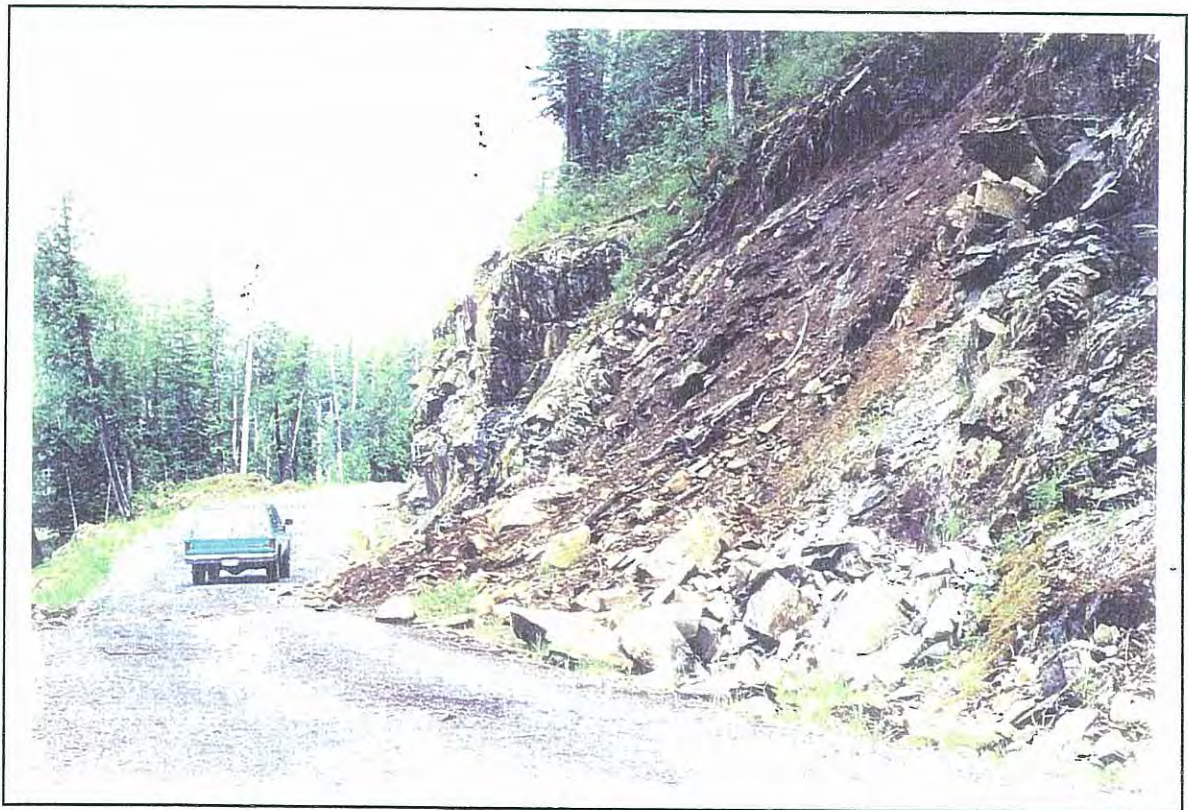
One rock cut in which a significant rock slide had occurred was observed; otherwise, the existing rock cuts on the Shelter Cove Road appeared to be generally stable. If roadway widening is required for the proposed project, new cuts in rock will be necessary. The rock cut slope ratios used by the Forest Service (approximately 1V:2H to 1V:1H) appeared to be reasonably stable and similar cut ratios should be anticipated for new cuts on a WFLHD project.

Photo 10 : View back from Photo 2 showing rock slope failure on steeply inclined joint system. Overburden is about one meter thick.

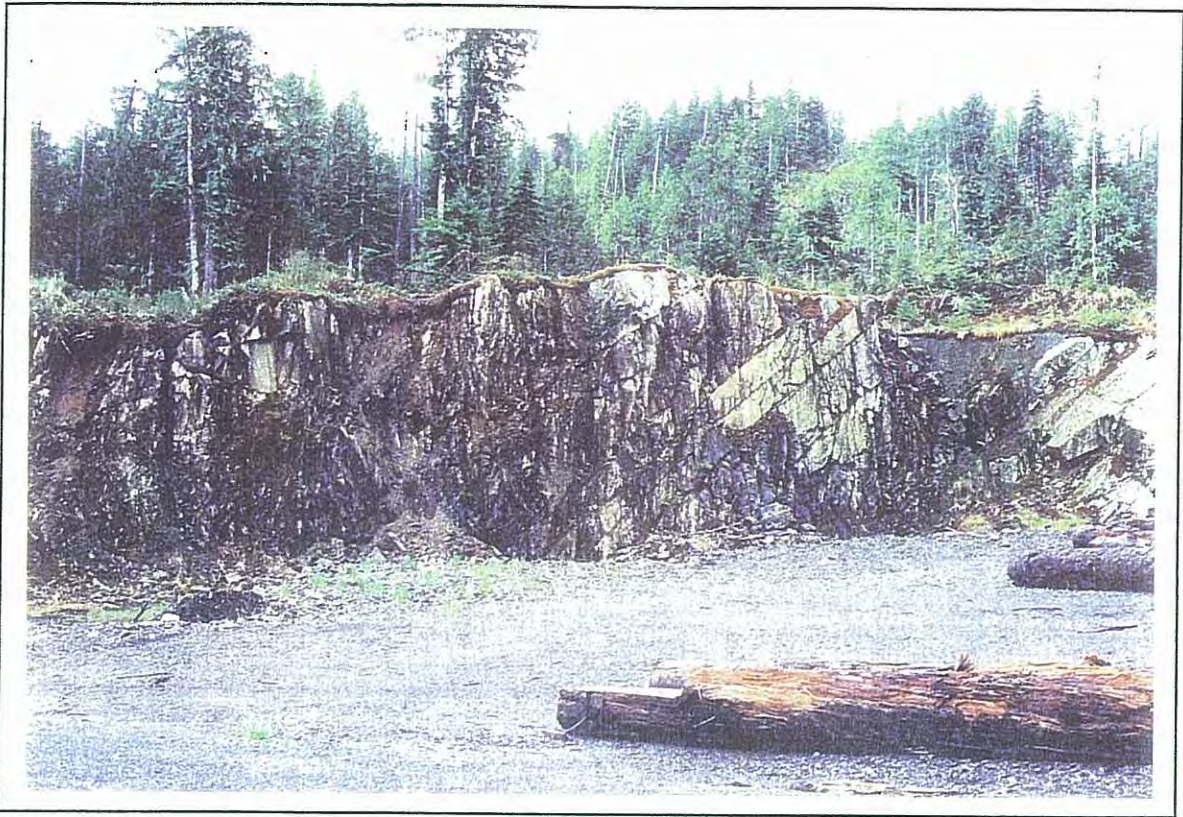
Photo 11 : Quarry on Shelter Cover Road.

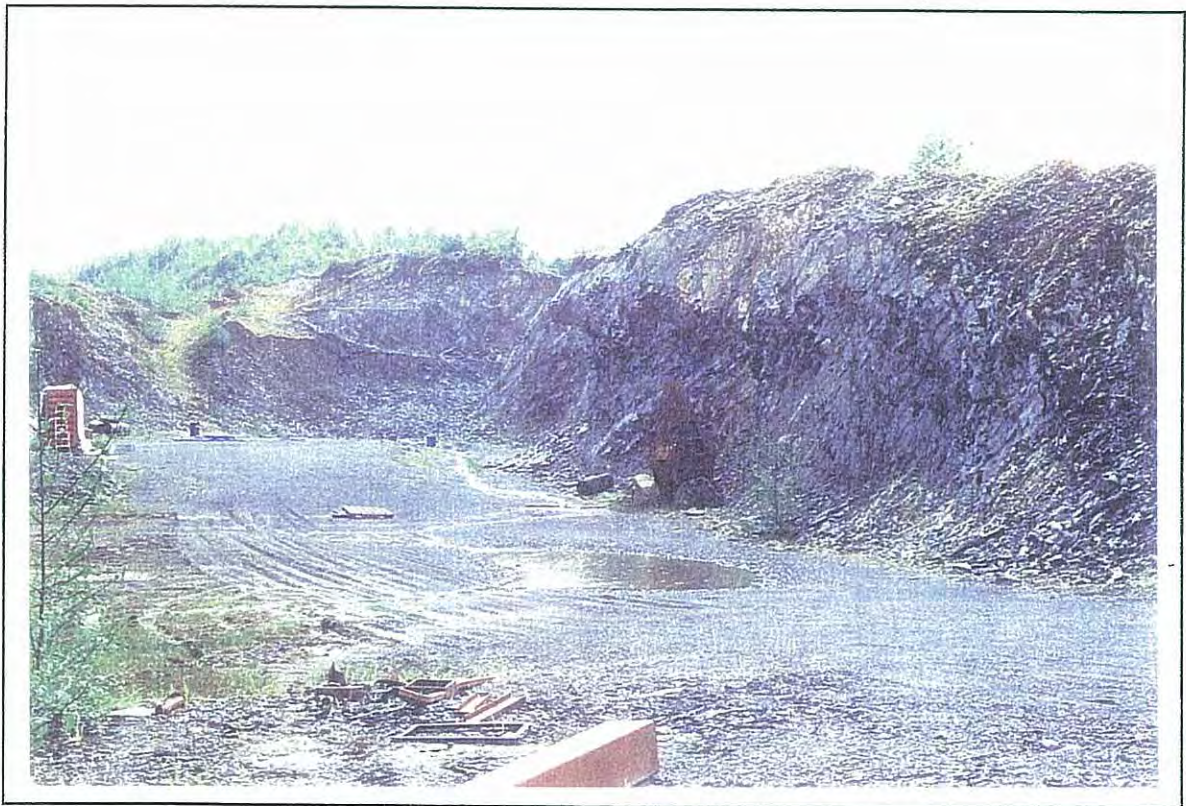
There are several existing sources of construction aggregate along the Shelter Cove Road. The rock appeared to be of marginal quality with respect to standard WFLHD requirements, but, because of the remoteness of the location, it is assumed that the rock for new road construction would come from an existing material source or from the rock cut excavation.

Photo 12 : Largest existing quarry on Shelter Cove road system. Rock is highly fractured phyllite.
