Routine Inspection Report

Date: 7/14/2017

Br No 574

GULKANA RIVER

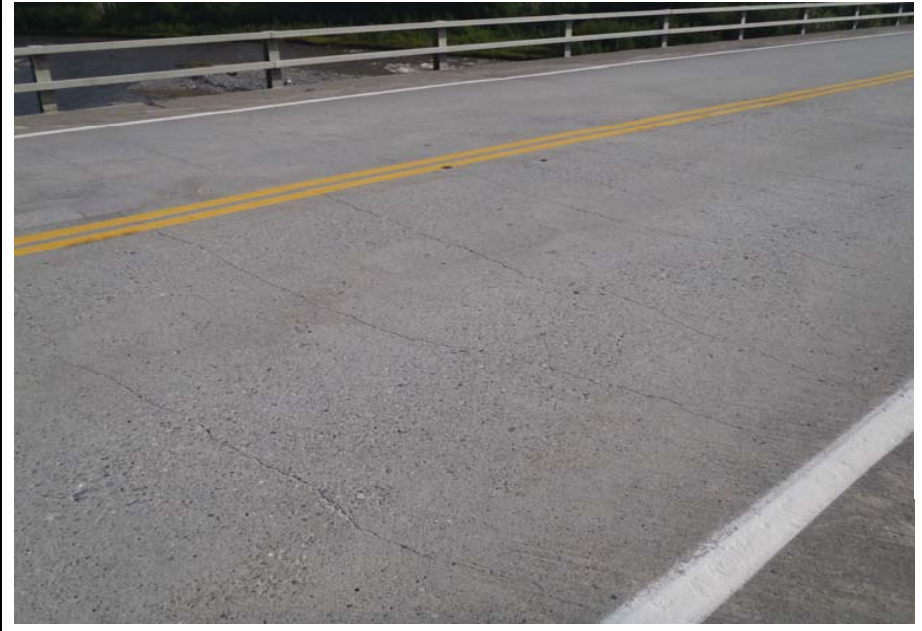
<i>Element</i>	<i>Description</i>	<i>Observations</i>
12	Reinforced Concrete Deck	Most delaminations are near highway centerline and around previously patched areas especially at the FE of the bridge. About 25% delams in the SB and minimal delams in the NB lane. Deck cracking is prevalent and many patches are cracked. About 15 spalls have been filled with asphalt. Minor amount of transverse cracking with efflorescence in soffit overhangs.
> 1120	<i>Efflorescence/Rust Staining</i>	
> 1130	<i>Cracking (RC and Other)</i>	
107	Steel Open Girder/Beam	Minor rust freckles on girders, cross frames, and lateral bracing with combined area less than 1% of total painted area. Second and sixth transverse stiffeners from the NE on the US girder are bent. Swallows nests on the lateral bracing connection plates.
> 515	<i>Steel Protective Coating</i>	
210	Reinforced Concrete Pier Wall	Vertical cracks on both faces of both piers. Crack width of about 1/16 inch for the full height of the pier at about centerline. Some locations behind steel nosing armor sound hollow as if it is not in direct contact with concrete. Pier 3 has a tight horizontal crack about 6 feet above the waterline.

Bridge No. **0574** Br. Name **Gulkana River** Date **07/14/17**
 Inspector **Murray / Knapp** Frame **10**
Deck cracks, typ.

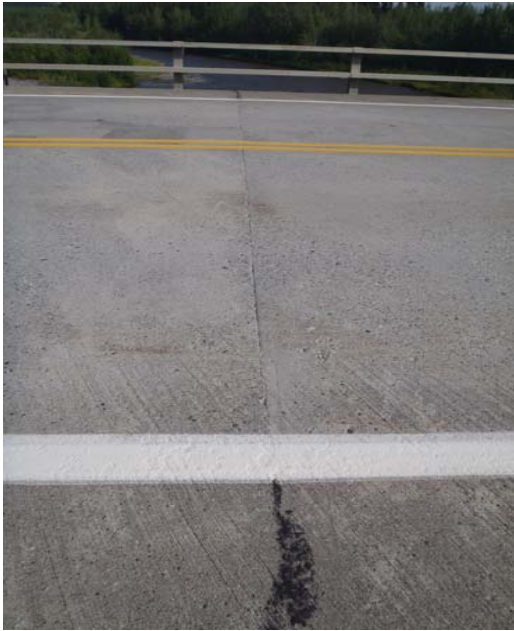
Bridge No. **0574** Br. Name **Gulkana River** Date **07/14/17**
 Inspector **Murray / Knapp** Frame **13**
Deck cold joint

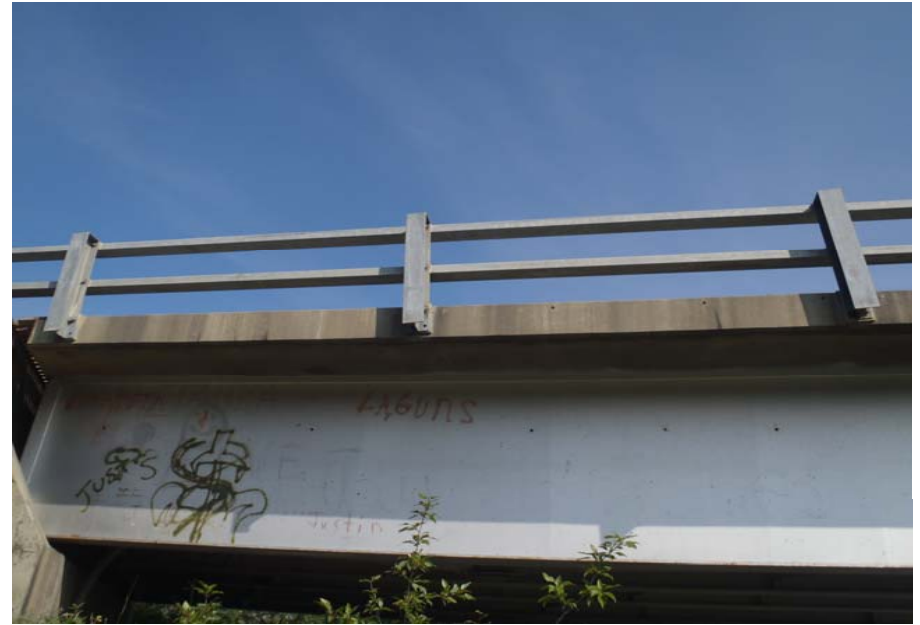
330	Metal Bridge Railing	Loose lower rail to post bolt FE DS Post #11 NE DS Post #2 missing both lower compression bolts post to deck. Post #1 missing 1. First 3 posts on NE DS are leaning towards NE. Broken post to PL welds and damaged rail (NE at about 213 feet to 236 feet)
> 515	<i>Steel Protective Coating</i>	
600	Signs Smart Flag	NE name place sign is missing.
602	Approach Rail Smart Flag	The bolts connecting the vertical angle to the Thrie beam in the FE US transition are missing. Three nuts are missing on the FE DS transition rail posts. FE DS thrie-beam transition is damaged. All approach rails have minor damage.

Bridge No. **0574** Br. Name **Gulkana River** Date **07/14/17**
 Inspector **Murray / Knapp** Frame **14**
NE DS rail posts tilted

<i>Priority</i>	<i>Description</i>	<i>Quantity</i>	<i>Work Needed</i>
High	Approach Railing-Repair	1355	Replace missing bolts on FE US and FE DS transitions.
High	Bridge Rail-Repair (LF)	7	Install missing nuts on rail post connections to deck - approximately 10 places.
Medium	Channel-Remove Debris (EA)	1	Periodically remove drift and debris from piers to prevent scour.
Low	Substructure-Patch spalls (LF)	3	Chip to sound concrete, clean and coat exposed reinforcing steel and patch spalled area in hider wall FE DS side. Place fill under abutment FE.
Low	Misc-Install Sign (EA)	1	Install name place sign NE DS side.

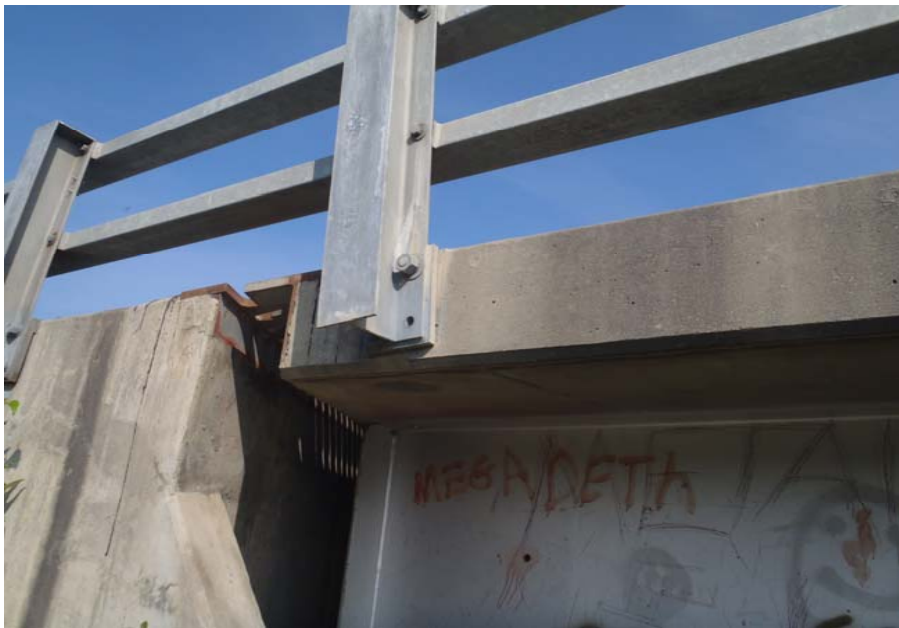
Bridge No. **0574** Br. Name **Gulkana River** Date **07/14/17**
 Inspector **Murray / Knapp** Frame **15**
NE DS railing missing bolts

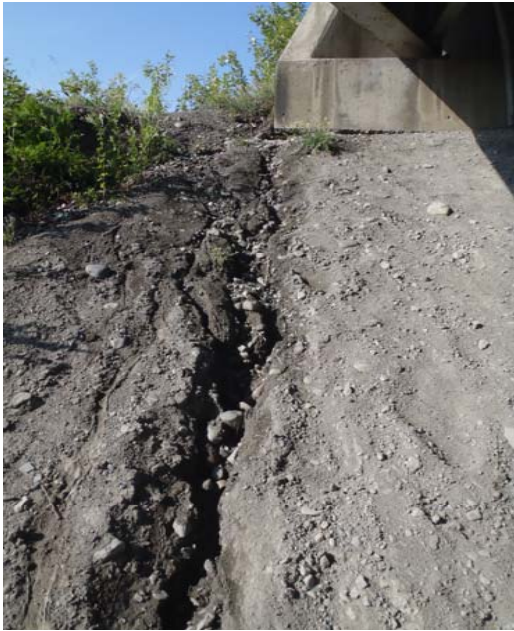
Bridge No.	0574	Br. Name	Gulkana River	Date	07/14/17
Inspector	Murray / Knapp		Frame	17	
NE Surface drainage causing rill

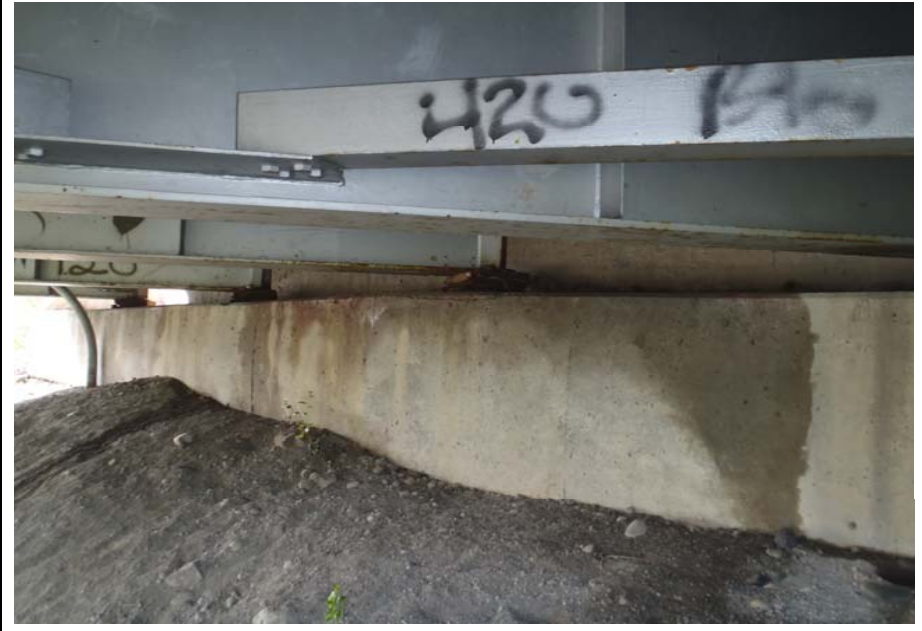
215	Reinforced Concrete Abutment	Some honeycombed section in NE backwall but concrete is sound. FE backwall has 1/16 inch vertical cracks at four locations. Two piles are exposed under the FE abutment. Near the centerline of the bridge, the edge of the pile is within about 1 inch of the front face of the concrete pile cap beam. Backwalls have vertical cracks FE DS hider wall has 8 inch x 3 inch spall with exposed reinforcing that is rusting. Dirt on caps
304	Open Expansion Joint	At both abutments, one side of the finger joints is about 1/4 inch higher than the other. No apparent problems appear to have resulted in this height differential. Spall in the FE DS end of the expansion joint concrete.
311	Movable Bearing	Expansion bearings at abutments are damaged but functional. Paint system has failed and the PTFE laminations are delaminated and damaged. Bearings appear to be functional and are in a fully expanded position at this and other recent inspections.

Bridge No.	0574	Br. Name	Gulkana River	Date	07/14/17
Inspector	Murray / Knapp		Frame	18	
NE abutment

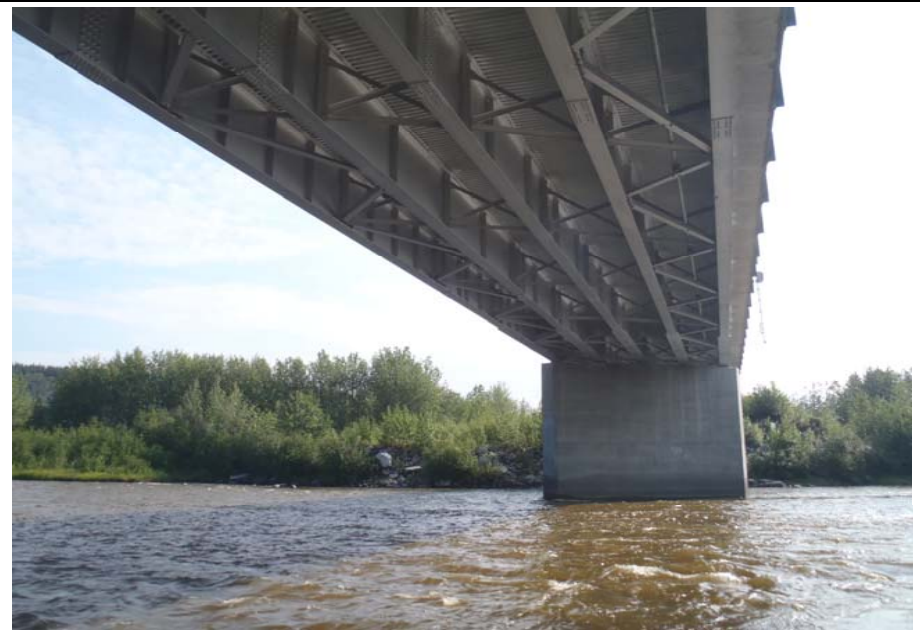
Bridge No. **0574** Br. Name **Gulkana River** Date **07/14/17**
 Inspector **Murray / Knapp** Frame **24**
Pier 3

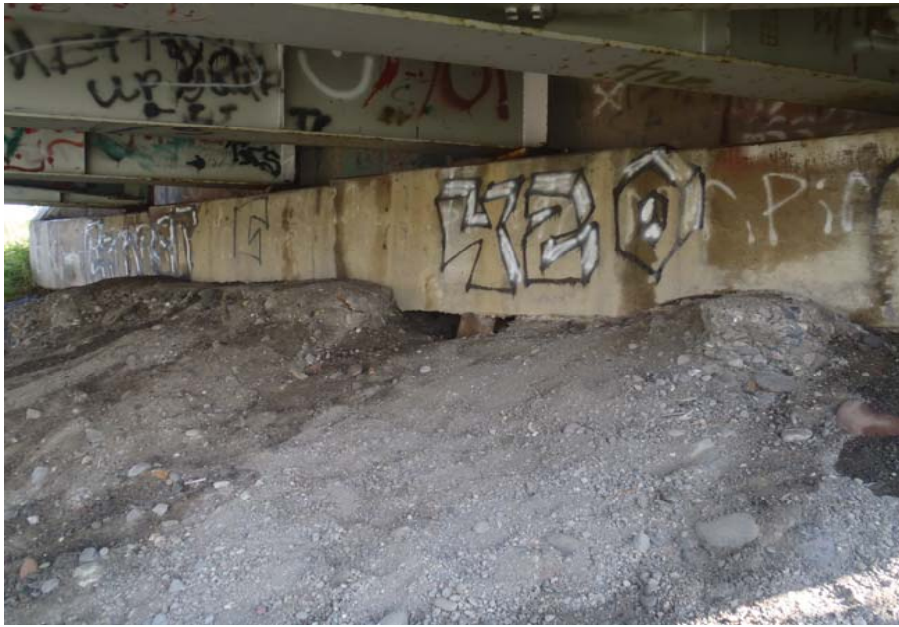
Bridge No.	0574	Br. Name	Gulkana River	Date	07/14/17
Inspector	Murray / Knapp		Frame	25	
FE abutment with exposed piles

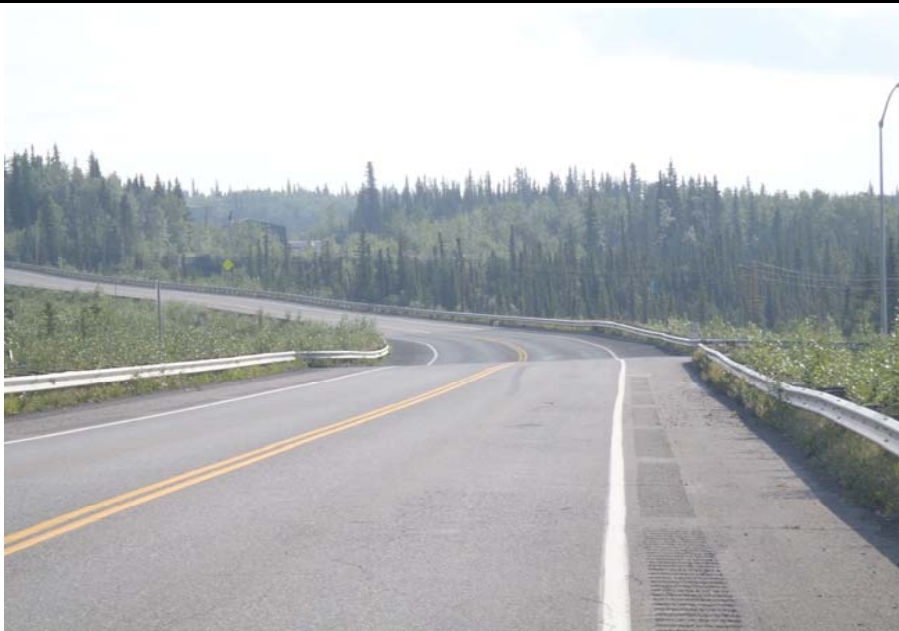
Bridge No.	0574	Br. Name	Gulkana River	Date	07/14/17
Inspector	Murray / Knapp		Frame	27	
FE rail extends far from bridge
