Routine Inspection Report

Date: 7/14/2017

Br No 684 ROCK CREEK

Bridge No. 0684, ROCK CREEK

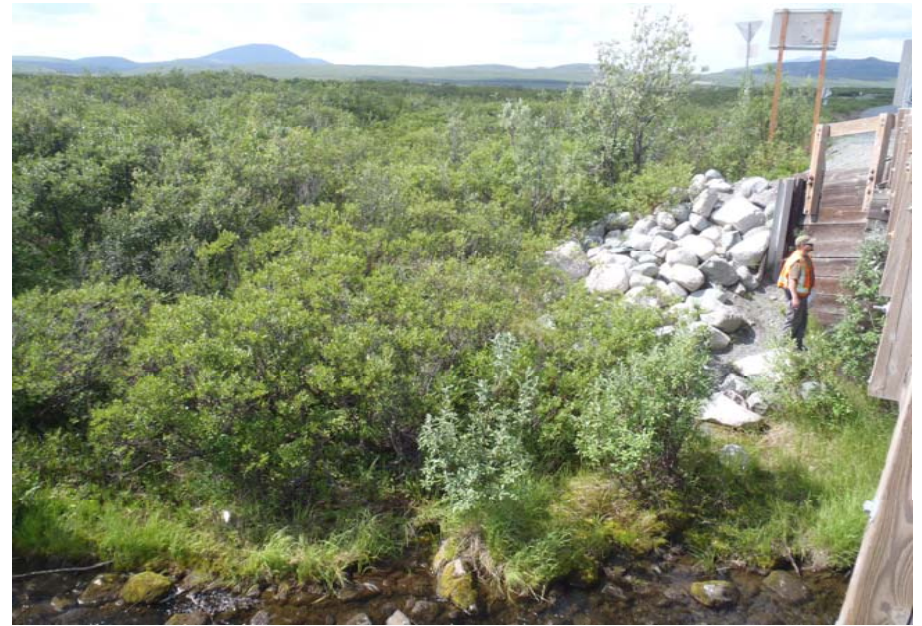
Round boulders placed as riprap at NE DS corner. Appears stable but non angular material tends to be prone to "rolling".

Bridge No. **0684** Br. Name **Rock Creek** Date **07/14/17**
 Inspector **Murray / Knapp** Frame **6**
DS NE Bank

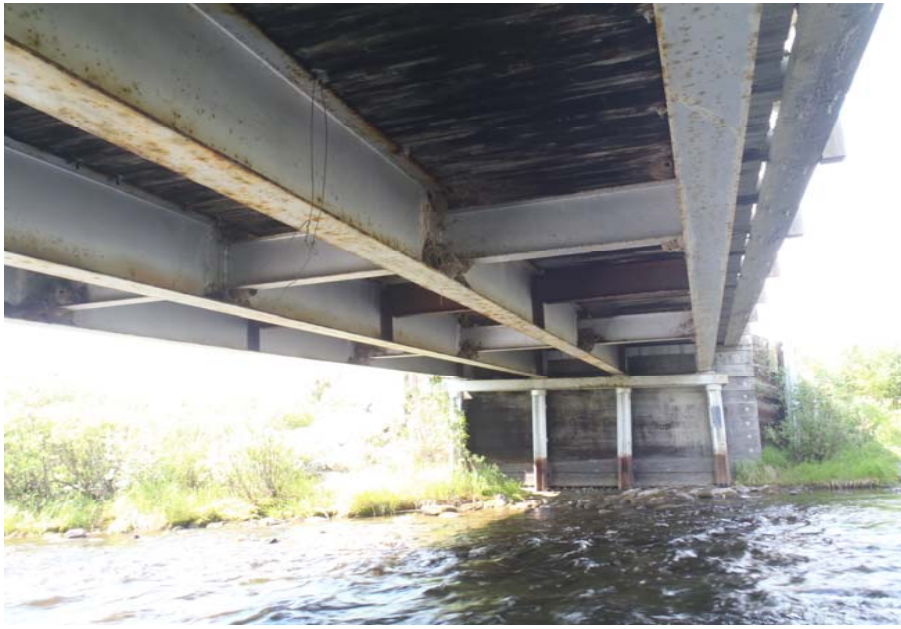
Bridge No.	0684	Br. Name	Rock Creek	Date	07/14/17
Inspector	Murray / Knapp		Frame	9	
Underside from FE, abutment 1

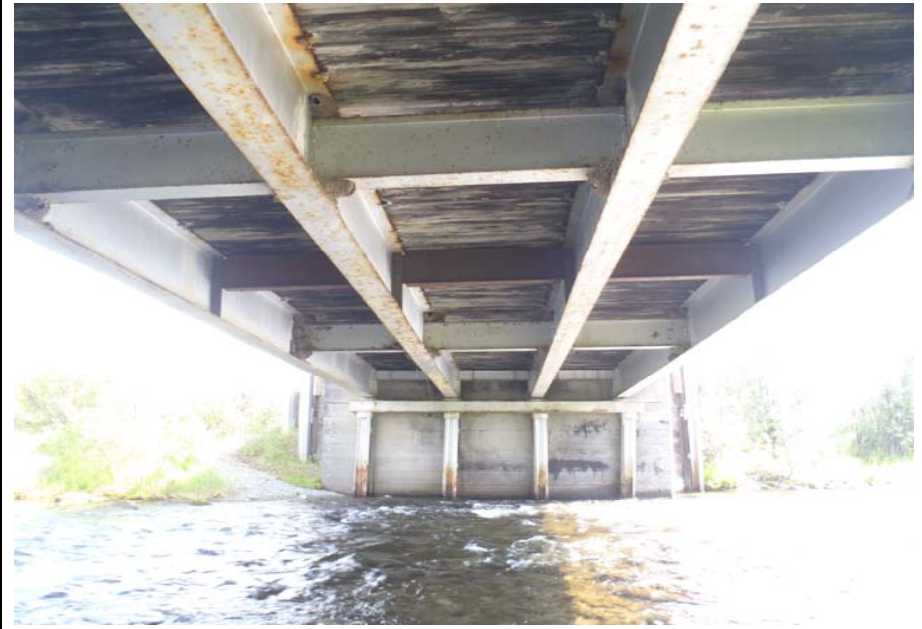
Bridge No.	0684	Br. Name	Rock Creek	Date	07/14/17
Inspector	Murray / Knapp		Frame	10	
Underside view from NE, FE abutment

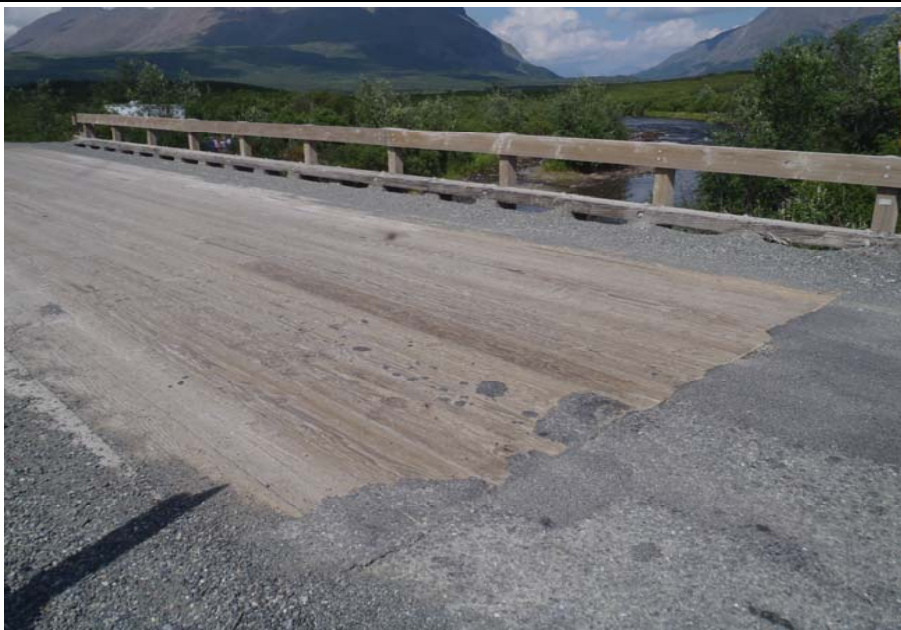
<i>Element</i>	<i>Description</i>	<i>Observations</i>
31	Timber Deck	Timber deck has minor splits and cracks along deck edge.
> 510	<i>Wearing Surfaces</i>	Running planks have 0.25 inches of wear in a few locations, but minimal wear in rest of deck.
107	Steel Open Girder/Beam	Swallows are nesting at almost all of the diaphragms. Paint system is corroding with heaviest corrosion on top flanges. NE US exterior girder looks a little twisted -- Could be associated with NE abutment problems. Total of three intermediate diaphragms per bay - two at third points and one at midspan.
> 515	<i>Steel Protective Coating</i>	
218	Other Abutments	NE backwall is pushed back into the approach fill at the DS end. DS girder overhangs the pile cap 2.25 ft. Backwall and wingwall are out of plumb 6.5 inches in 7.5 feet. Fill at NE is about 12 inches below cap and the DS side appears to be higher than the US side. Surface rust on pile extensions from groundline up 3 feet. Pile rust lines appear level. NE US 3-rail pile has cracks in two of the three rail piles. Pile has had splice plates installed across crack. NE DS pile has a crack in a vertical weld. FE US wingwall pile has a crack in a vertical weld. Distance between black marks on G4 bottom flange and G4 bearing: 2013: 1.25" 2015: 1.625" 2107: 2.5" NE DS corner of the bridge appears to be about one foot higher than the other three corners.

Bridge No.	0684	Br. Name	Rock Creek	Date	07/14/17
Inspector	Murray / Knapp		Frame	11	
Running planks

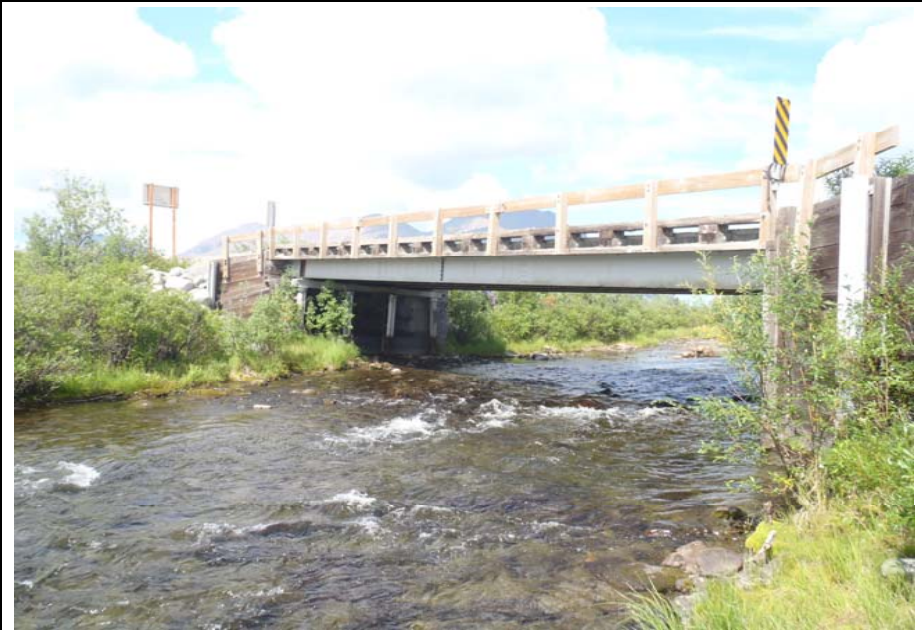
> 6000	<i>Scour</i>	Timber lagging does not extend to stream bed at FE DS with ~1 foot of undermining.
311	Movable Bearing	NE bearings moving toward backwall. Rust on NE bearings.
> 515	<i>Steel Protective Coating</i>	
313	Fixed Bearing	Rust on FE bearings.
> 515	<i>Steel Protective Coating</i>	
332	Timber Bridge Railing	NE US, FE DS and DS midspan bullrail has impact damage.
600	Signs Smart Flag	No object marker at NE US corner. FE Name place sign missing.
602	Approach Rail Smart Flag	No approach rails at either end.

Probing at FE abutment found ~1 ft gap at bottom of lagging to streambed; smaller gap visible at NE abutment;

Bridge No.	0684	Br. Name	Rock Creek	Date	07/14/17
Inspector	Murray / Knapp		Frame	12	
FE DS elevation

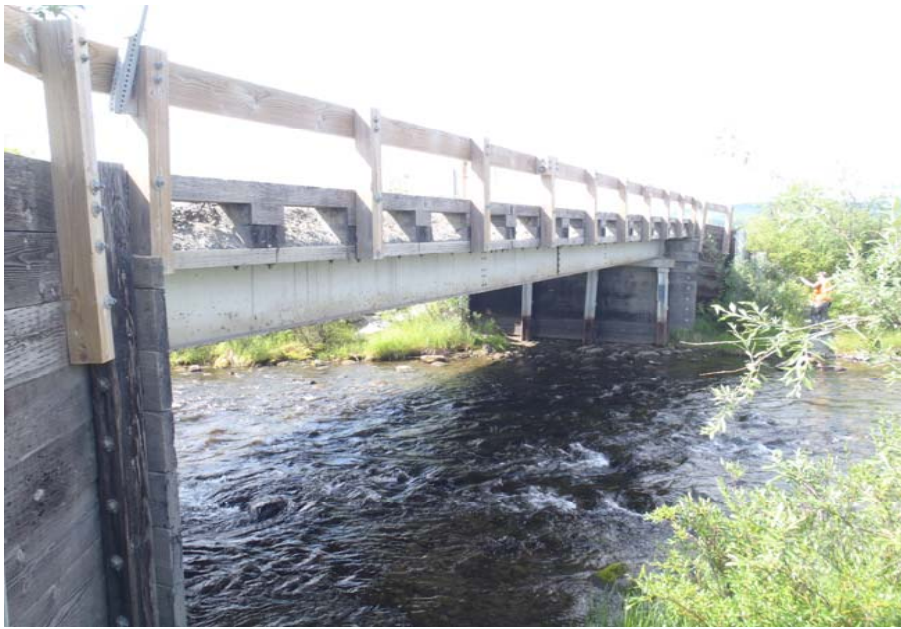
FE US wingwall and end of lagging wall are getting 'punky'.
FE US wingwall pile has a crack in a vertical weld.

Bridge No. **0684** Br. Name **Rock Creek** Date **07/14/17**
 Inspector **Murray / Knapp** Frame **13**
FE US elevation, delete

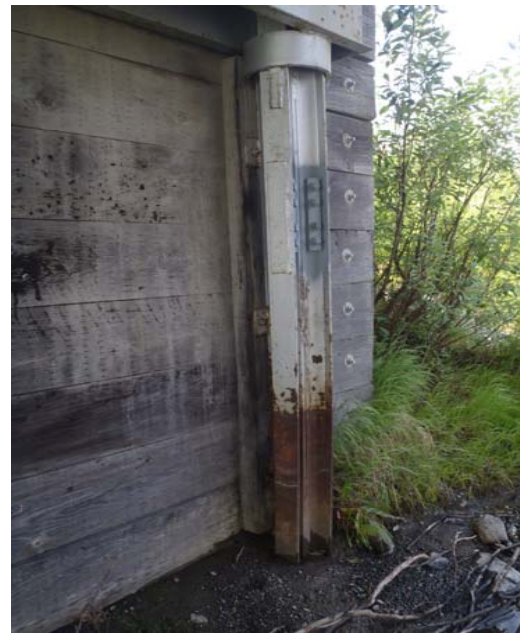
Bridge No. **0684** Br. Name **Rock Creek** Date **07/14/17**
 Inspector **Murray / Knapp** Frame **14**
Abutment 1, repaired pile

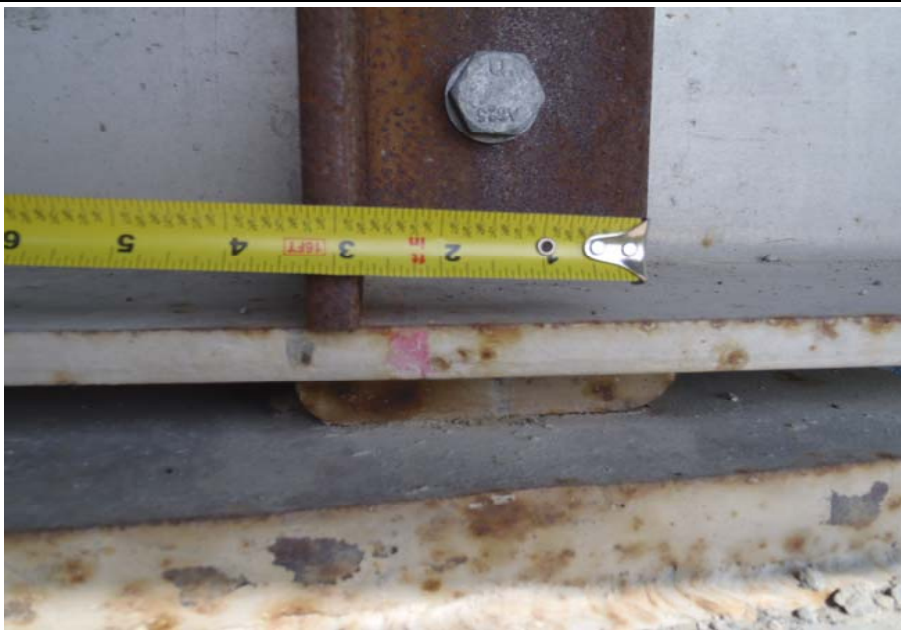
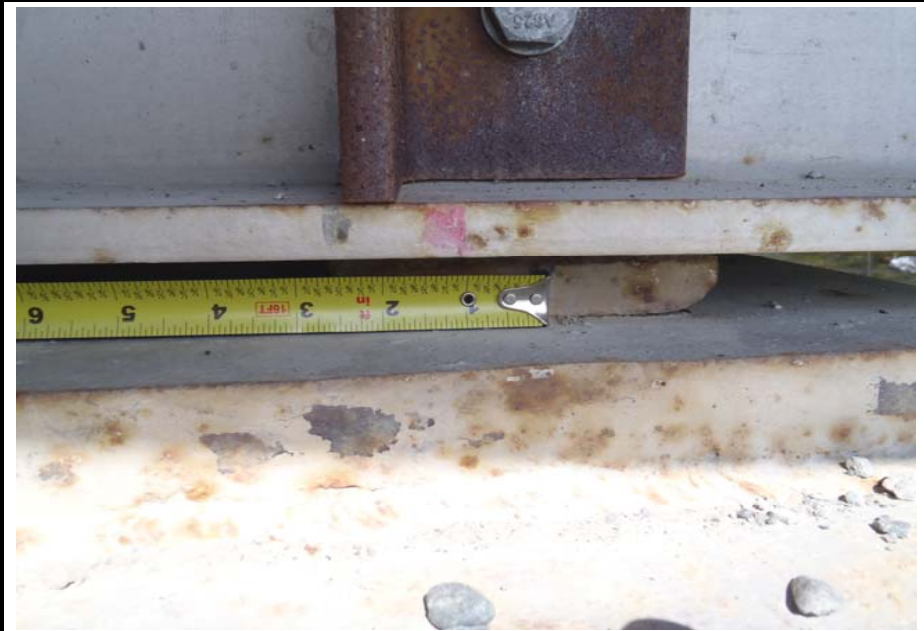
Bridge No. **0684** Br. Name **Rock Creek** Date **07/14/17**
 Inspector **Murray / Knapp** Frame **15**
NE DS bearing movement

Bridge No. **0684** Br. Name **Rock Creek** Date **07/14/17**
 Inspector **Murray / Knapp** Frame **16**
NE DS bearing movement
