Routine Inspection Report

Date: 8/15/2017

Br No 1193 CHOKOSNA RIVER

INSPECTOR: Jared Levings

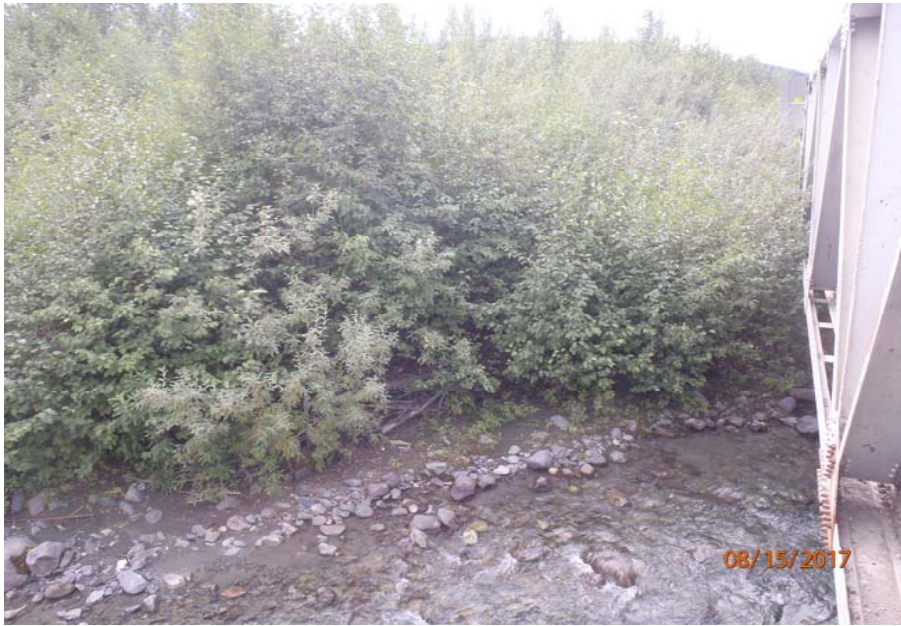
Bridge No.	1193	Br. Name	Chokosna River	Date	08/15/17
Inspector		Levings / Henry		Frame	5
	NE DS bank

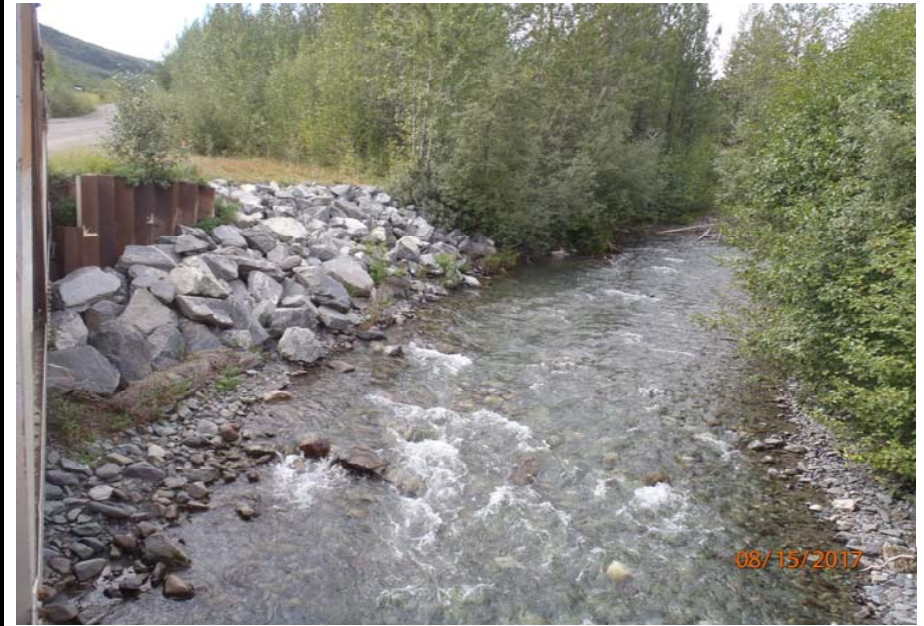
Bridge No.	1193	Br. Name	Chokosna River	Date	08/15/17
Inspector		Levings / Henry		Frame	6
	Looking US at NE US bank

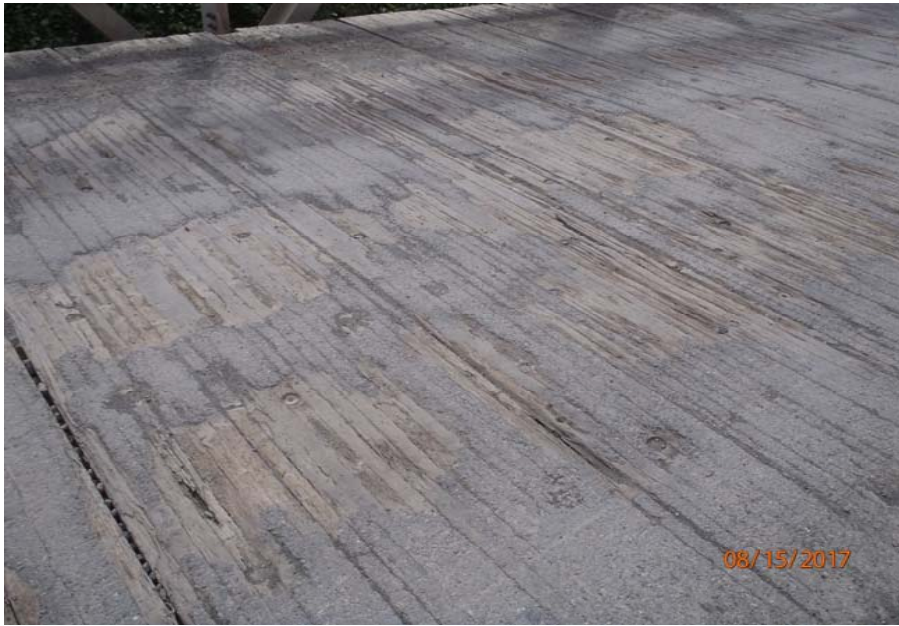
<i>Element</i>	<i>Description</i>	<i>Observations</i>
31	Timber Deck	End panels broken and covered with gravel. Remaining panels have up to 2 inches of wear in wheel lines; FEUS remaining deck section is 4 inches thick. Soffit is wet and punky even tho weather has been sunny for the last few days. Many deck clips are missing. G3 nailer between L3' and L2' has slid out from above the flange and deck now spans two stringer spaces.
113	Steel Stringer	Surface rust and minor laminar rust on lower half of the stringers. No intermediate diaphragms are present. S2-FB2' connection has one loose bolt.
> 515	Steel Protective Coating	
120	Steel Truss	US truss heat-straightened, gouged, bent, and torn many times; the four sliced diagonals have 3 welded cover plates over the damage. US L1-L2 outboard top leg has a minor bend. US FE lower chord is bowed upward for about 3 panel points. Freckle rust or surface rust throughout.

Bridge No.	1193	Br. Name	Chokosna River	Date	08/15/17
Inspector	Levings / Henry		Frame	9	
Deck condition, typical

<i>Priority</i>	<i>Description</i>	<i>Quantity</i>	<i>Work Needed</i>
High	Deck-Replace (SF)	191	Replace bridge deck. Install full-width running planks.
High	Substructure-Replace (EA)	1	Replace abutments. Replace backwalls.
Medium	Deck-Wash (SF)	2060	Clean lower chords prior to Fracture Critical inspection.
Medium	Superstructure-Repair Steel (LF)	63	Replace or tighten the following bolts and replace missing nuts: -U1 US bolt. -L0-FB0 US and DS bolt. -FB1 DS inboard underside bolt. -FB2 four underside bolts at both ends. -FB3 four underside bolts at both ends. -FB3 DS lower chord bolt. -FB2' US underside bolt. -Stringer 2 FB2' connection bolt. -US L2 missing nut. -US U1 missing rivet.
Medium	Bridge-Replacement (EA)	1	Existing bridge has several problems, consider bridge replacement.
Low	Misc-Install Sign (EA)	2	Install name place signs.

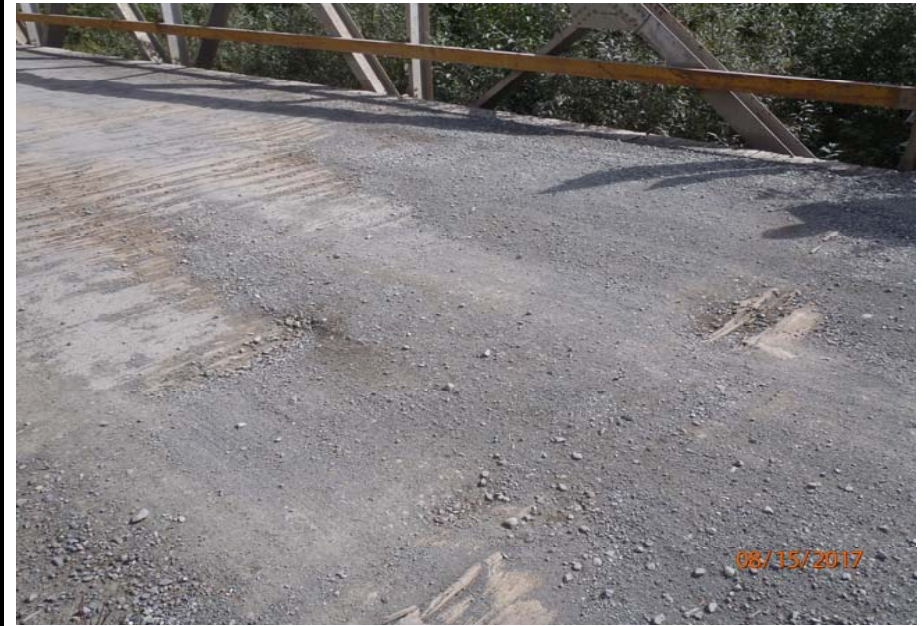
Bridge No.	1193	Br. Name	Chokosna River	Date	08/15/17
Inspector	Levings / Henry		Frame	10	
NE begin deck with gravel and erosion of wood

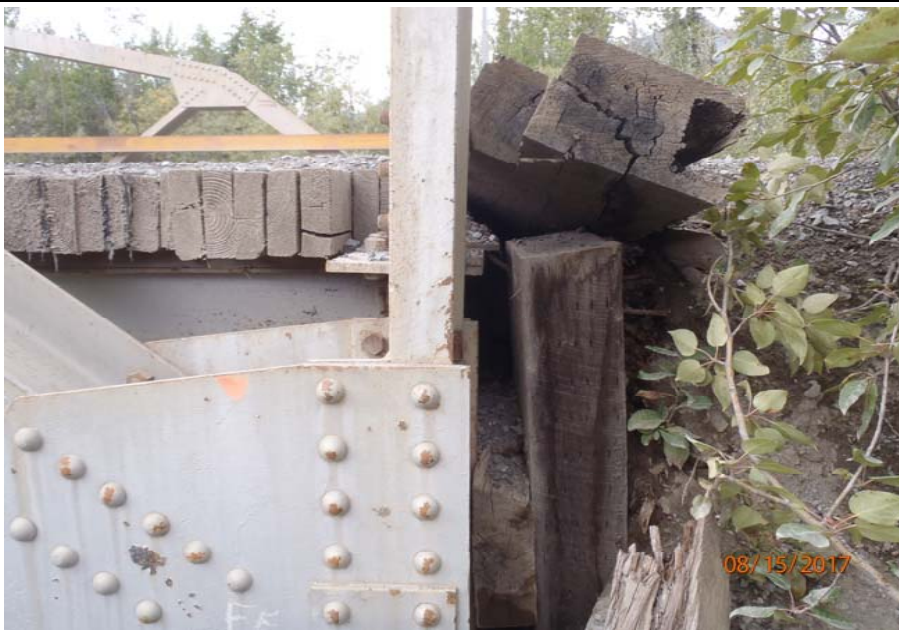
Bridge No.	1193	Br. Name	Chokosna River	Date	08/15/17
Inspector	Levings / Henry		Frame	11	
FE DS corner, broken timber at approach transition

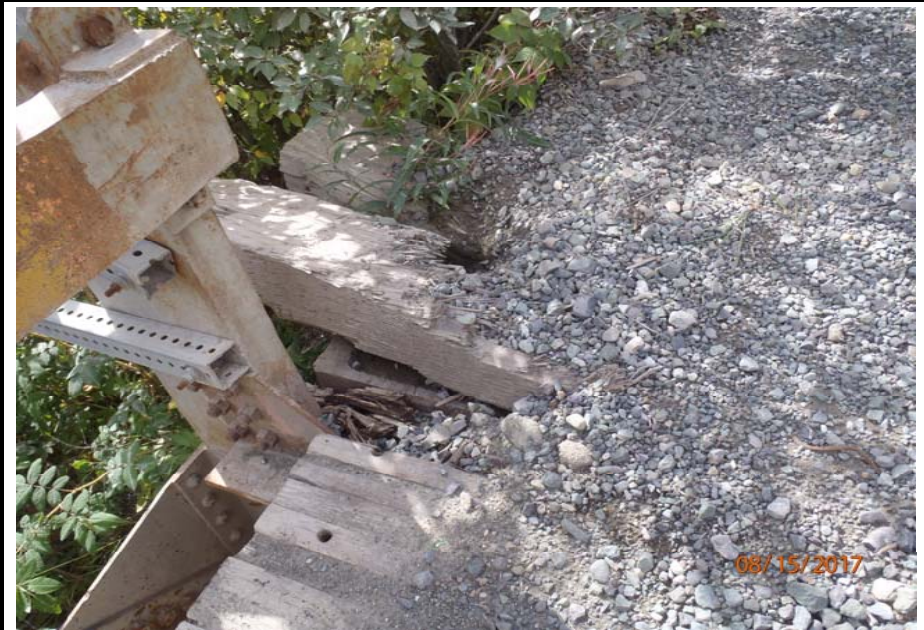
Bridge No.	1193	Br. Name	Chokosna River	Date	08/15/17
Inspector	Levings / Henry		Frame	12	
NE DS transition, broken timber plank

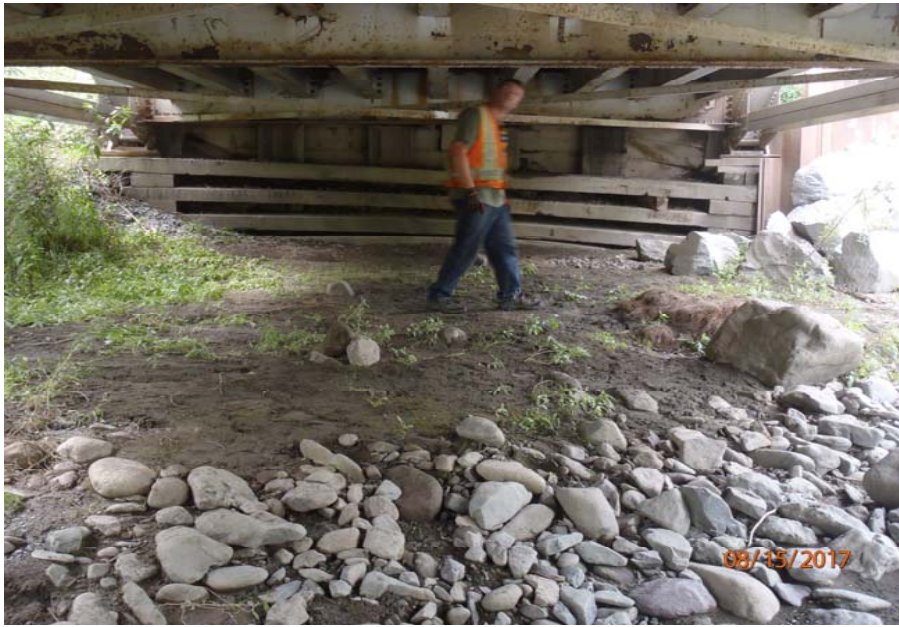
Bridge No.	1193	Br. Name	Chokosna River	Date	08/15/17
Inspector	Levings / Henry		Frame	13	
NE abutment with settlement of US corner

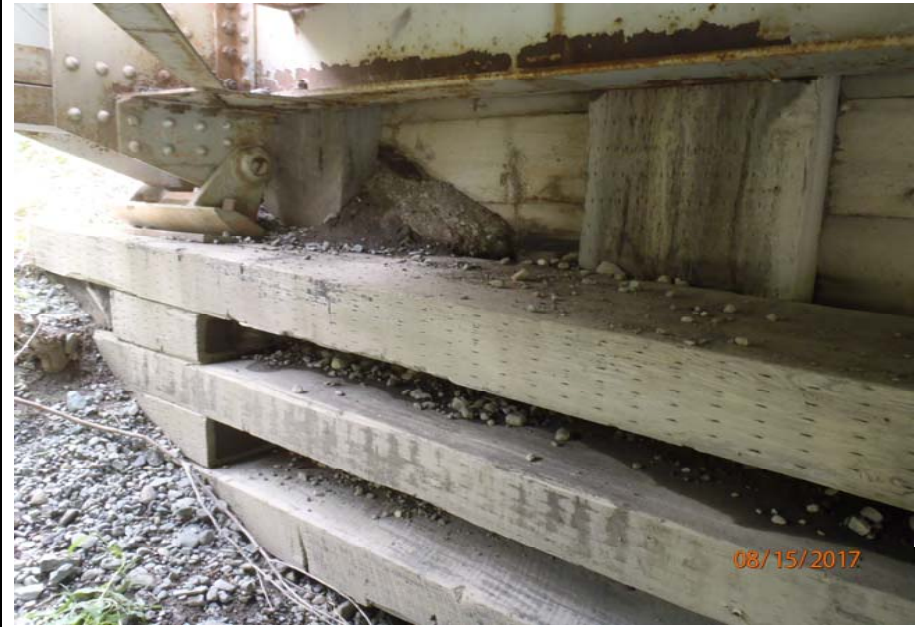
Bridge No.	1193	Br. Name	Chokosna River	Date	08/15/17
Inspector	Levings / Henry		Frame	14	
NE abutment and DS bearing

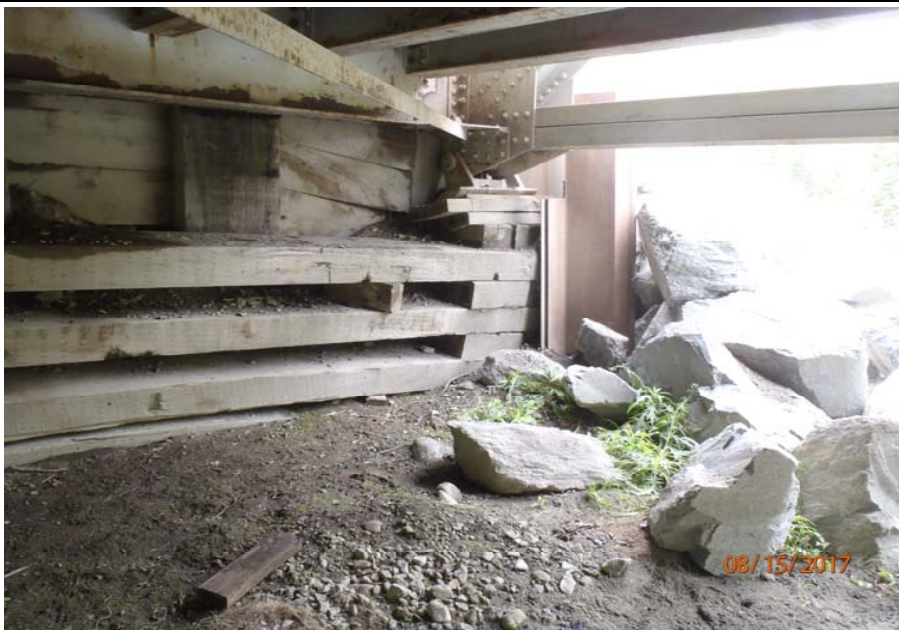
Bridge No.	1193	Br. Name	Chokosna River	Date	08/15/17
Inspector	Levings / Henry		Frame	15	
NE abutment and US bearing

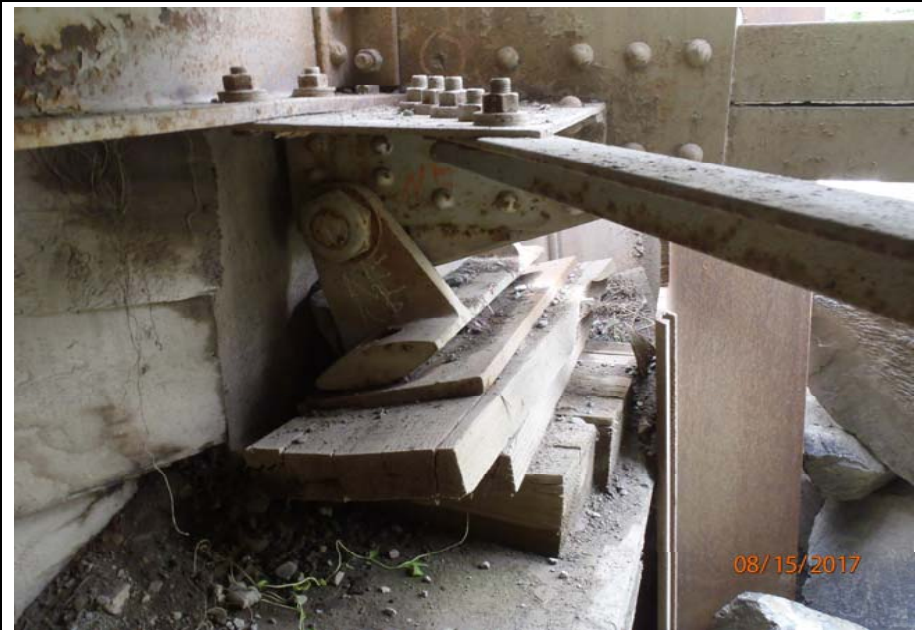
311	Movable Bearing	Bearings expanded well past middle 3rd but now rest against the backwall. DS bearing is bending anchor bolts; US bearing has no anchor bolts. US bearing shimmed up but blocking is crushing. US leans about 5 degrees in the transverse direction and 17 degrees in the longitudinal direction. Surface rust throughout.
> 515	<i>Steel Protective Coating</i>	
313	Fixed Bearing	Surface rust throughout. Bearings are tilted toward abutment; US 1 degree and DS 2 degrees.
> 515	<i>Steel Protective Coating</i>	
330	Metal Bridge Railing	3rd panel point from FEUS, rail steps toward truss 1 inch and sags 1/4 inch. Many lower connection brackets are welded rather than bolted. Freckle or surface rust throughout.
> 515	<i>Steel Protective Coating</i>	
600	Signs Smart Flag	No name place signs.
604	Bank Protection Smart Flag	NEUS sheet pile wall exposed an additional 3ft from original construction. NEUS minor bank erosion away from riprap.

Bridge No.	1193	Br. Name	Chokosna River	Date	08/15/17
Inspector	Levings / Henry		Frame	16	
NE US bearing, rotated approximately 14 degrees

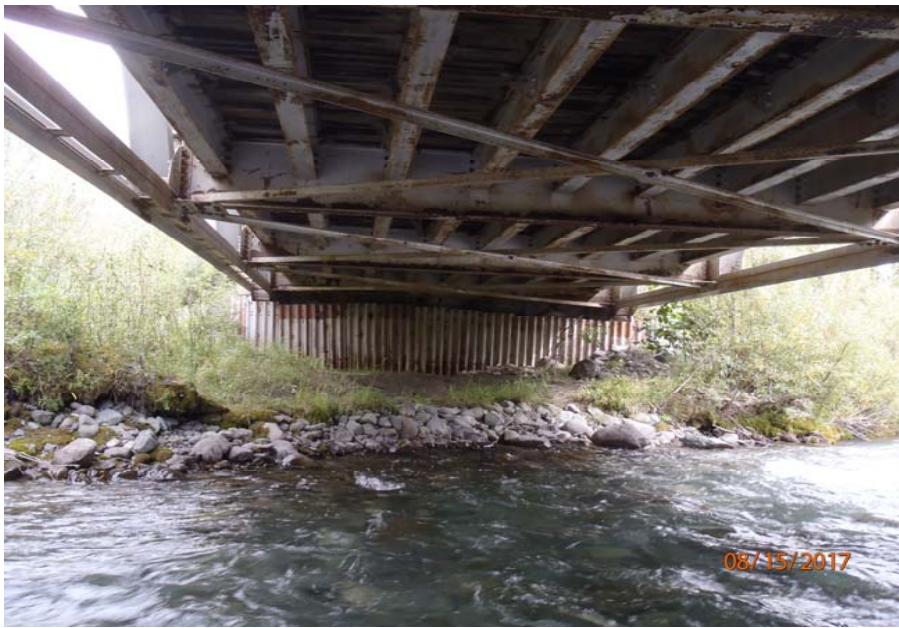
Bridge No.	1193	Br. Name	Chokosna River	Date	08/15/17
Inspector	Levings / Henry		Frame	17	
FE abutment and US low chord with vertical bends

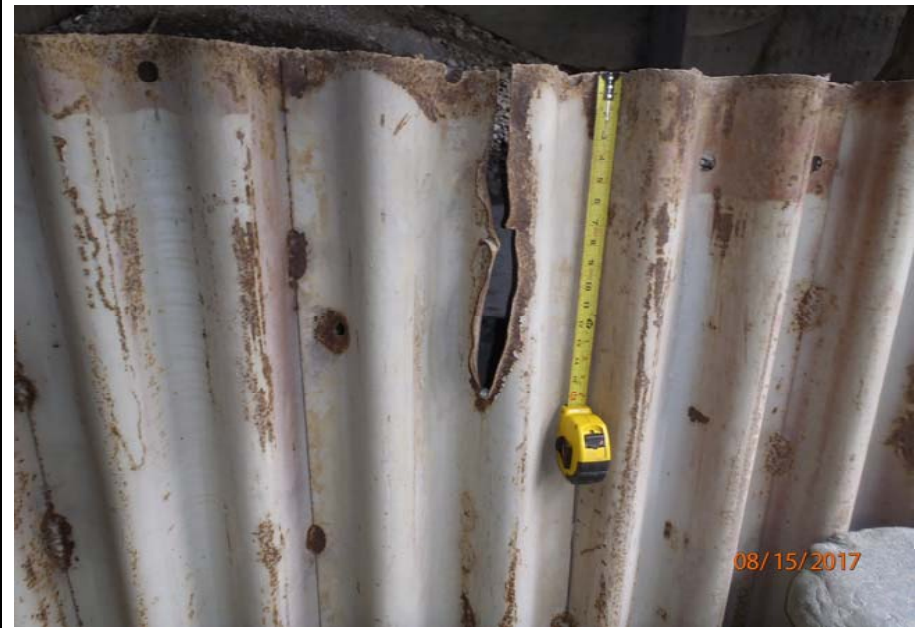
Bridge No.	1193	Br. Name	Chokosna River	Date	08/15/17
Inspector	Levings / Henry		Frame	18	
FE abutment sheet pile wall, torn

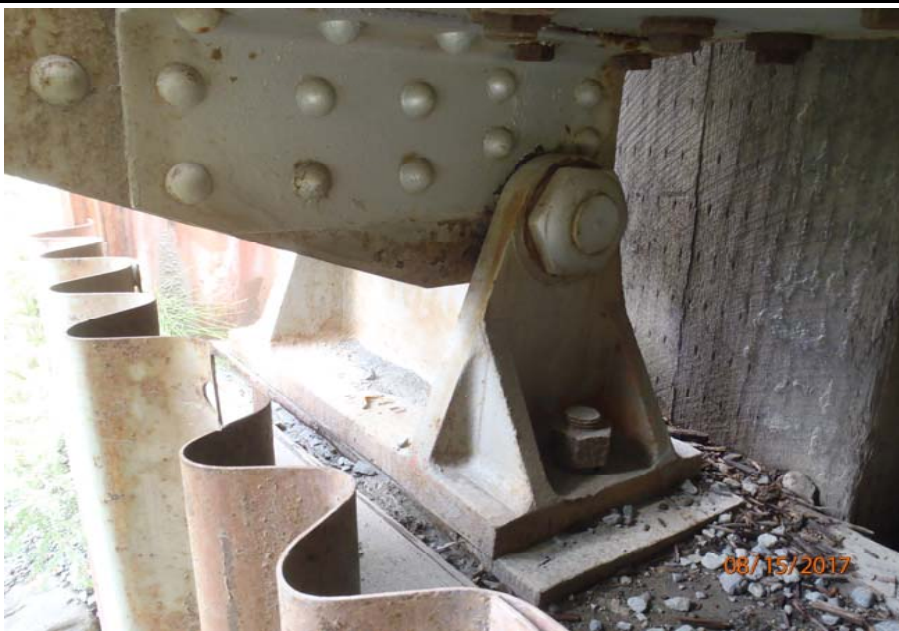
Bridge No.	1193	Br. Name	Chokosna River	Date	08/15/17
Inspector	Levings / Henry		Frame	19	
FE abutment, bearing 1

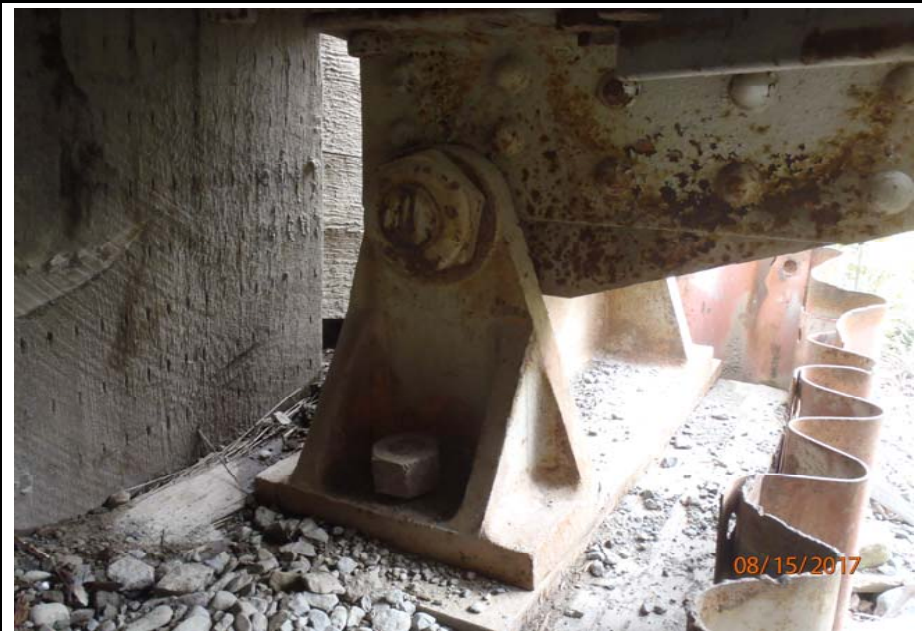
Bridge No.	1193	Br. Name	Chokosna River	Date	08/15/17
Inspector	Levings / Henry		Frame	20	
FE abutment, bearing 2

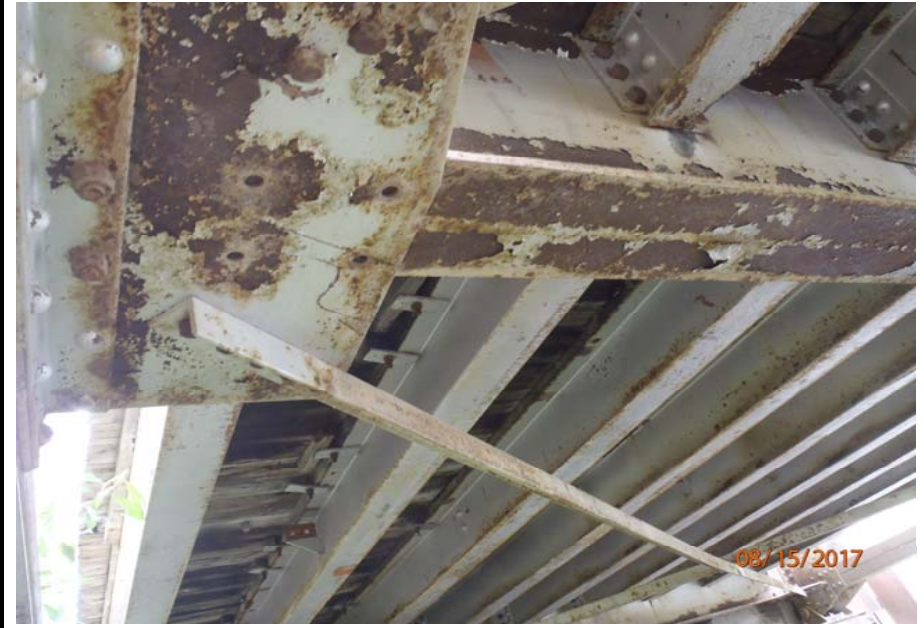
> 515	Steel Protective Coating	
152	Steel Floorbeam	Freckle rust or surface rust throughout. Up to 1/8 inch laminar rust on lower webs and some rust blooms on upper webs. FB0 bowed toward midspan; backwall is resting against FB. FB1 DS inboard bottom bolt not engaged. FB2 and FB3 missing bottom four bolts at both ends. FB2' US bottom has one loose bolt.
> 515	Steel Protective Coating	
162	Steel Gusset Plate	Freckle or surface rust on each plate. U2 and U2' gussets have gouges adjacent to new bolts. U1 US inboard bolt sheared. LO-FB0 connection, one bolt sheared US and DS. FB3 DS to lower chord bottom bolt not engaged.
> 515	Steel Protective Coating	
216	Timber Abutment	Backwall planks are decayed and sloughing. NE deck-backwall interface is separating and a hole has formed behind the planks; planks pushed out 4 inches near centerline. NEUS sheet pile wall leans toward roadway about 15 degrees. NEUS cribbing settled about 15 inches. FEDS sheet pile wall leans out 3 inches over a 3ft height and is torn 15 inches vertically. FEDS deck-backwall interface is separating and a hole has formed behind the planks; soil built up under hole.

Bridge No.	1193	Br. Name	Chokosna River	Date	08/15/17
Inspector	Levings / Henry		Frame	30	
Floorbeam at L1, missing 4 bolts

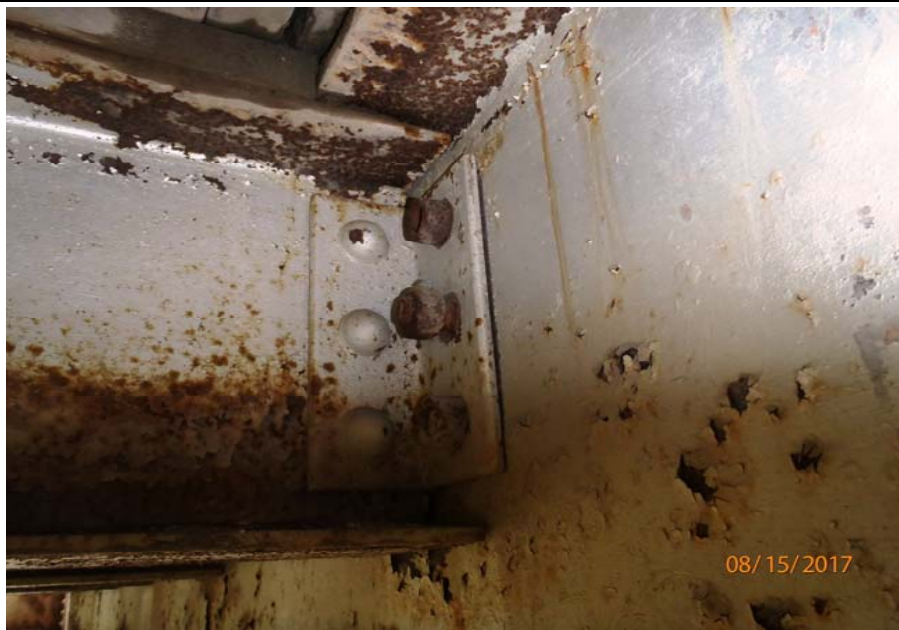
Bridge No.	1193	Br. Name	Chokosna River	Date	08/15/17
Inspector	Levings / Henry		Frame	31	
Loose bolt at floorbeam 2', NE, stringer 3

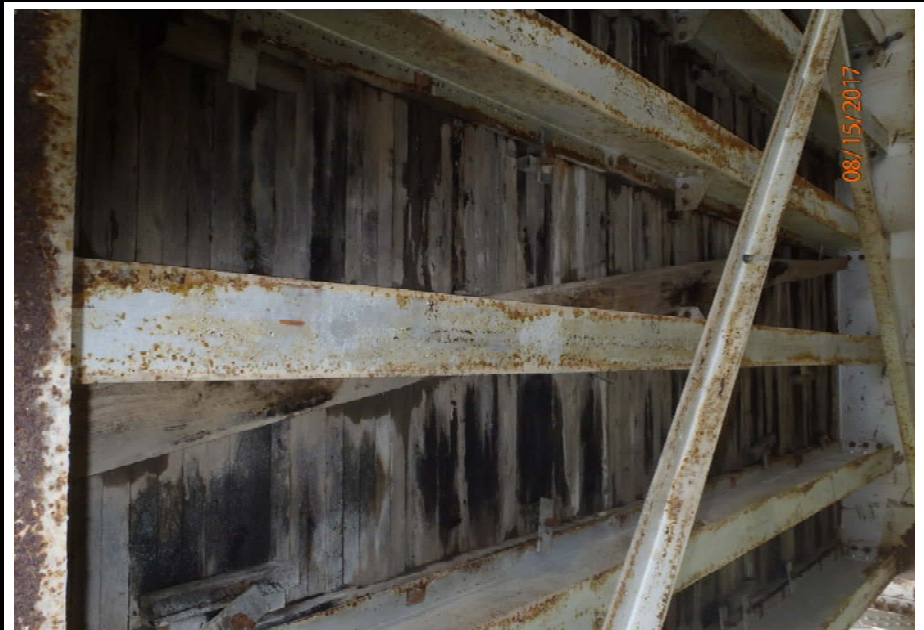
Bridge No.	1193	Br. Name	Chokosna River	Date	08/15/17
Inspector	Levings / Henry		Frame	32	
Deck nailer board displaced between floorbeam 2'-1', stringer 3
