Routine Inspection Report

Date: 8/9/2017

Br No 605 SNOW RIVER CNTR CHANNEL

Bridge No. 0605, SNOW RIVER CNTR CHANNEL

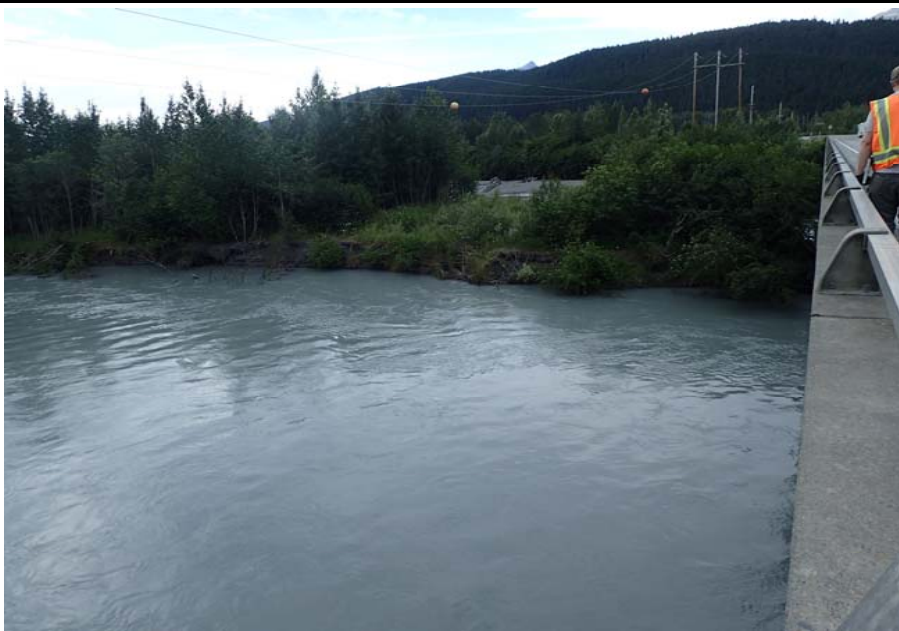
Island between piers 3-5 has vertical
banks with undercutting. Does not
appear to be a detriment to bridge or
channel.

Bridge No. **0605** Br. Name **Snow River Cntr Channel** Date **08/09/17**
 Inspector **Murray / Murph** Frame **11**
NE US island

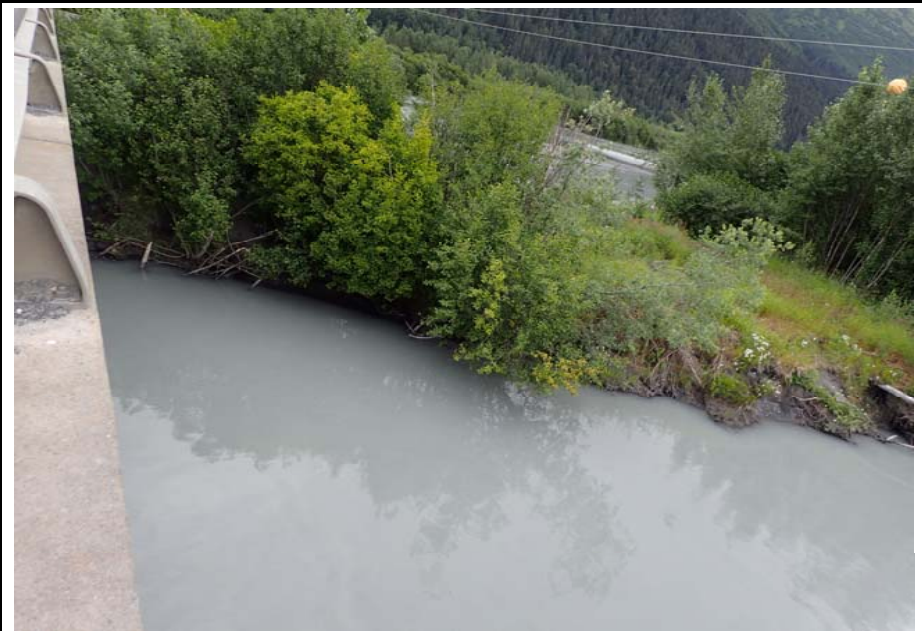
Bridge No. **0605** Br. Name **Snow River Cntr Channel** Date **08/09/17**
 Inspector **Murray / Murph** Frame **12**
FE US island

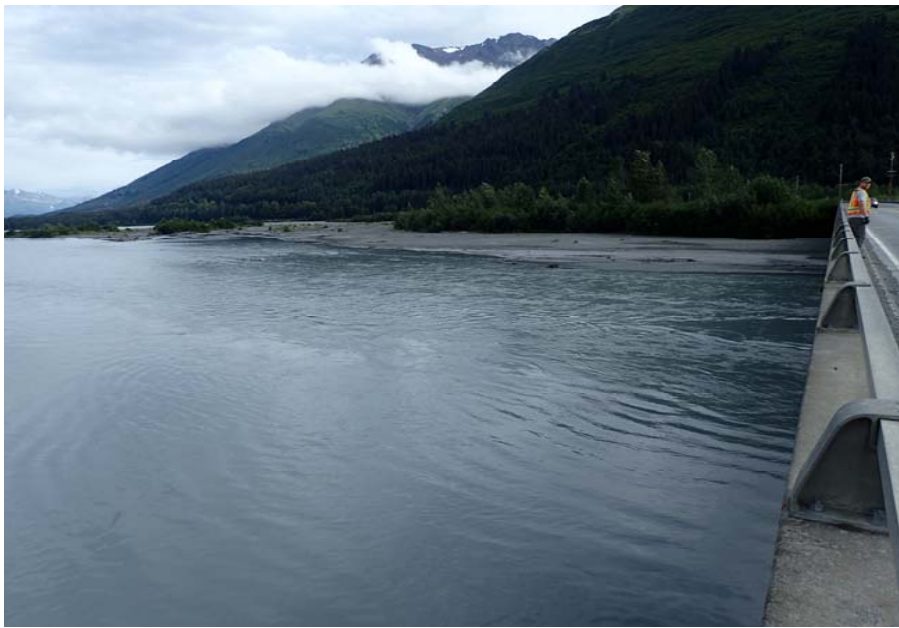
Bridge No.	0605	Br. Name	Snow River Cntr Channel	Date	08/09/17
Inspector			Murray / Murph	Frame	13
	FE DS island

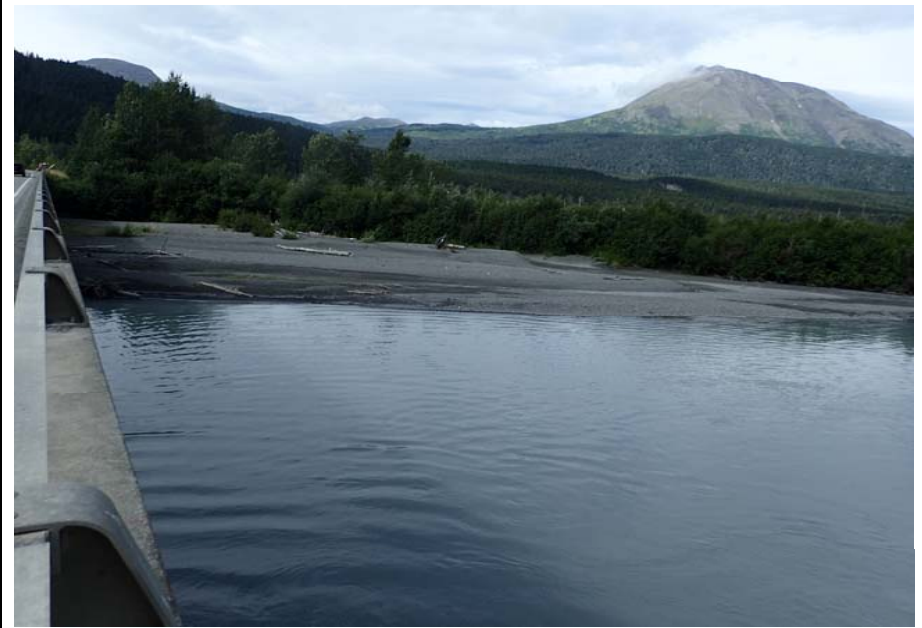
Bridge No.	0605	Br. Name	Snow River Cntr Channel	Date	08/09/17
Inspector			Murray / Murph	Frame	14
	NE DS island

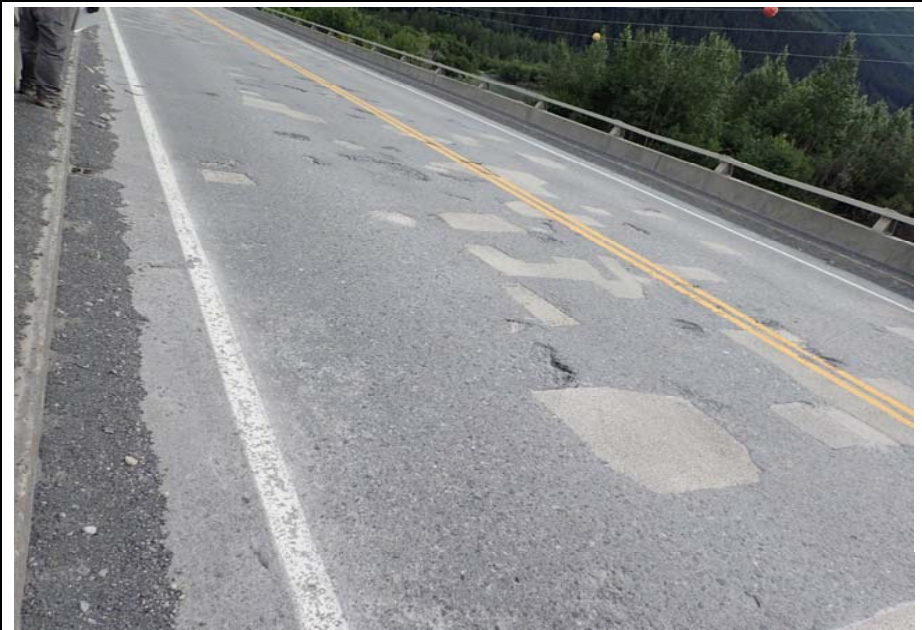
<i>Element</i>	<i>Description</i>	<i>Observations</i>
12	Reinforced Concrete Deck	<p>From 2015 In-Depth Insp: Span 1 US - 43SF delams, 63SF sound patch material, 0SF exposed rebar Span 2 US - 100SF delams, 125SF sound patch material, 97SF exposed rebar Span 3 US - 75SF delams, 124SF sound patch material, 12SF exposed rebar Span 4 US - 52SF delams, 51SF sound patch material, 3SF exposed rebar Span 5 US - 23SF delams, 21SF sound patch material, 1SF exposed rebar Span 6 US - 46SF delams, 31SF sound patch material, 1SF exposed rebar Span 1 DS - 82SF delams, 62SF sound patch material, 2SF exposed rebar Span 2 DS - 132SF delams, 188SF sound patch material, 17SF exposed rebar Span 3 DS - 92SF delams, 240SF sound patch material, 9SF exposed rebar Span 4 DS - 72SF delams, 132SF sound patch material, 3SF exposed rebar Span 5 DS - 17SF delams, 40SF sound patch material, 5SF exposed rebar Span 6 DS - 42SF delams, 62SF sound patch material, 3SF exposed rebar</p> <p>Several patched areas are delaminated or have adjacent delaminations. Delaminations adjacent to many spalled areas.</p>

Bridge No.	0605	Br. Name	Snow River Cntr Channel	Date	08/09/17
Inspector			Murray / Murph	Frame	16
	Wearing surface, typ.

<i>Priority</i>	<i>Description</i>	<i>Quantity</i>	<i>Work Needed</i>
High	Deck-Rehab (SF)	2053	Rehabilitate deck.
High	Misc-Install Sign (EA)	5	Install name place signs. Install NE bridge number plate. Replace FE object markers and posts.
High	Drainage-Correct Deck Drainage (EA)	1	Install DS drainage swales under approach rail to prevent roadway runoff onto bridge.
High	Approach Railing-Repair (EA)	1	Replace damaged approach rail posts and spacers at FE.
High	Approach Railing-Repair (EA)	1	Replace damaged post and spacer blocks. Replace sliced w-beam sections.
High	Channel-Remove Debris (EA)	1	Remove pier debris.

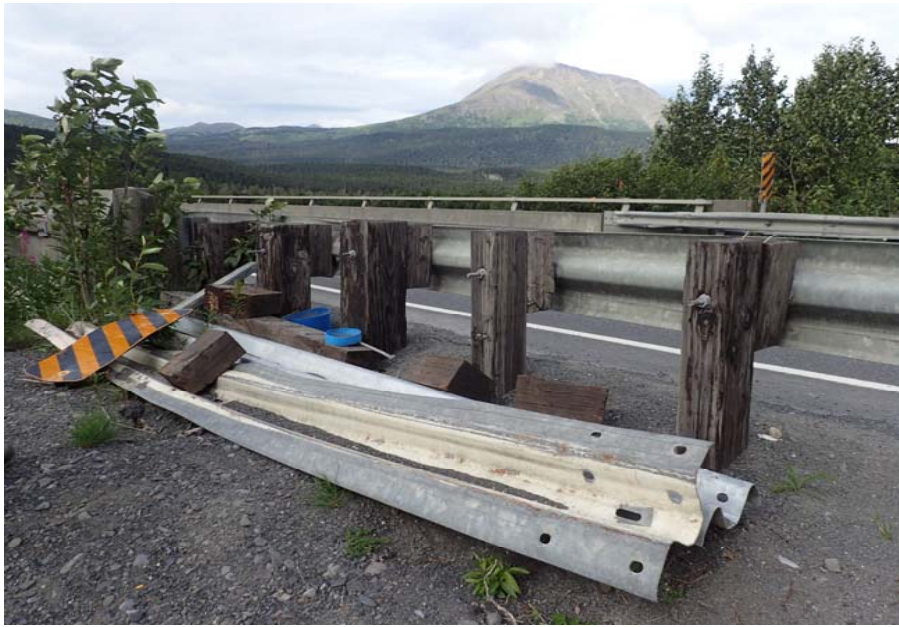
Bridge No.	0605	Br. Name	Snow River Cntr Channel	Date	08/09/17
Inspector			Murray / Murph	Frame	17
			US FE replacement rail

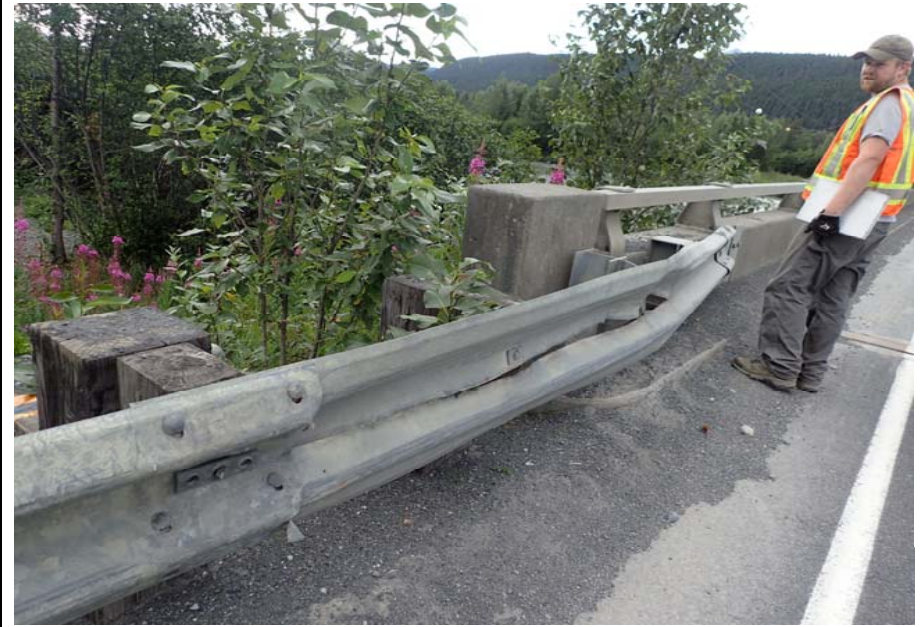
> 515	<i>Steel Protective Coating</i>	
333	Other Bridge Railing	Span 2 US top tube bent about 2 inches US. Span 6 DS parapet, 45ft from Pier 7, 12 inch x 18 inch spall. Approximately 50ft of minor parapet cracking with efflorescence.
600	Signs Smart Flag	No name place signs. No NE bridge number plate. NE DS and FE DS object markers are missing.
602	Approach Rail Smart Flag	5th post from FEUS, split spacer block. FEUS transition w-beam sliced. Up to 100ft from FEUS, broken post and 3 broken spacers. 5th post from FEUS, broken timber post and 2 w-beam sections sliced.
603	Stay-in-Place Form Smart Flag	5% surface rust in Span 6. Less than 1% surface rust on remainder of SIP forms.
605	Debris Smart Flag	Debris and logs at Piers 2-3, 6-7. Minor debris at Piers 4-5.
606	Approach Fill Erosion Smart Flag	6-9 inch gap under NE abutment, piles are visible underneath. 5-8 inch gap under FE abutment, piles are visible underneath.

Bridge No.	0605	Br. Name	Snow River Cntr Channel	Date	08/09/17
Inspector			Murray / Murph	Frame	18
			FE US damaged rail

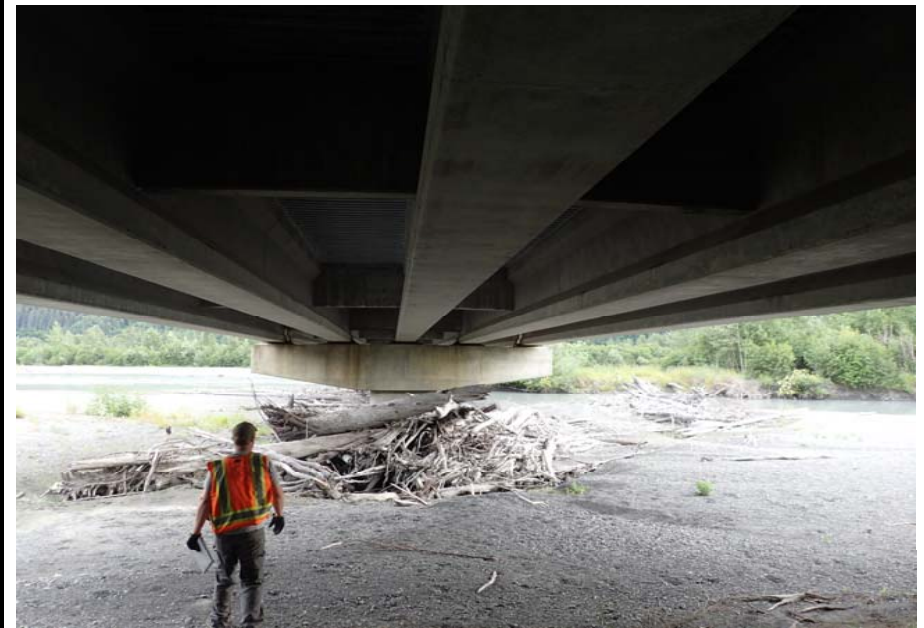
Large build up of trees, logs, etc. at every
pier except for pier 5. Scour holes 2-3ft
deep at all piers in the dry, particularly
pier 2.

Bridge No.	0605	Br. Name	Snow River Cntr Channel	Date	08/09/17
Inspector			Murray / Murph	Frame	28
			Pier 2 NE face

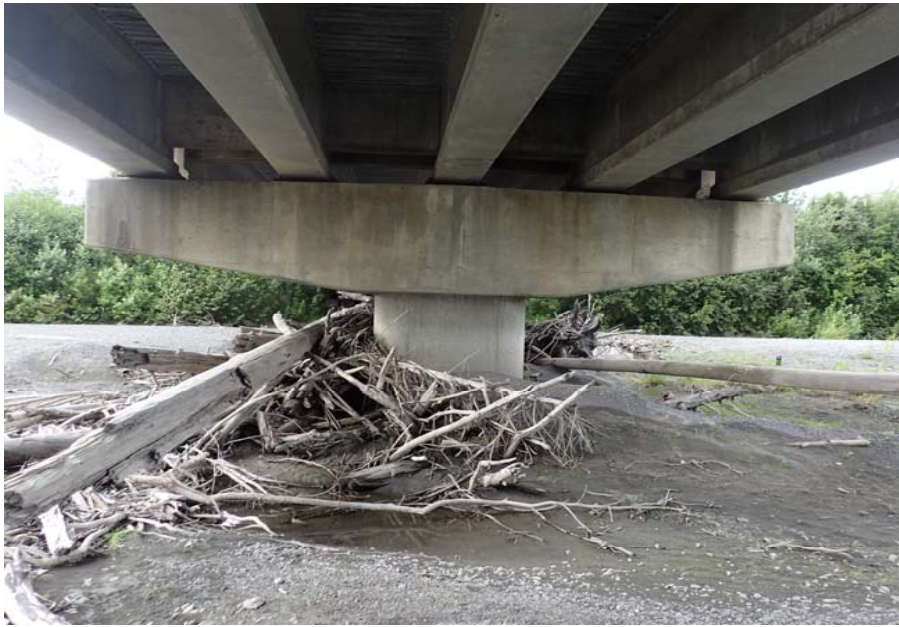
Bridge No. **0605** Br. Name **Snow River Cntr Channel** Date **08/09/17**
 Inspector **Murray / Murph** Frame **29**
Pier 2 FE face

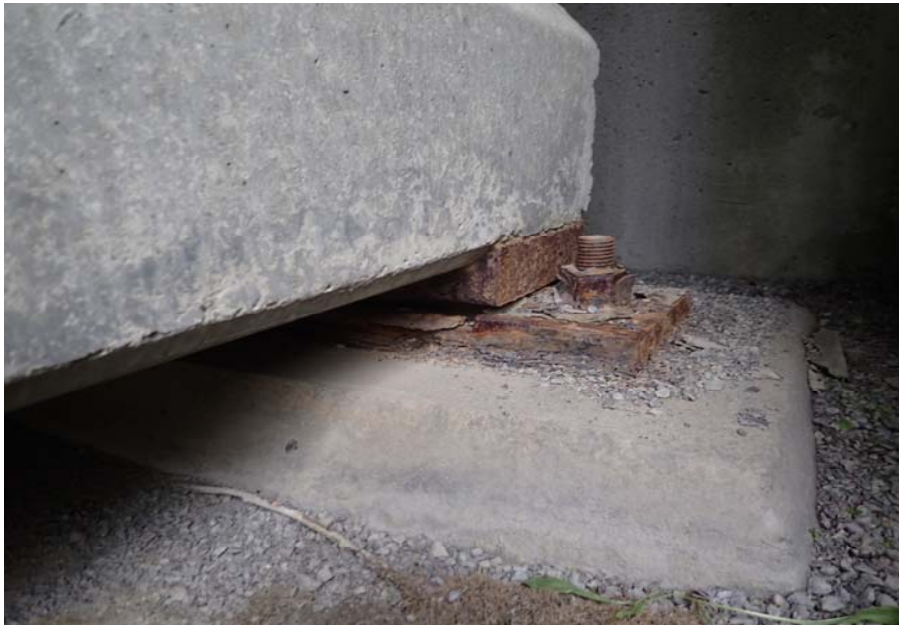
109	Prestressed Concrete Open Girder/Beam	<p>Span 1 NE Girder 3 from DS, 2 inch x 8 inch spall with exposed stirrup. Steel has surface rust. Span 2 NE Girder 2 from DS, 6 inch diam. spall with two exposed stirrups. Steel has surface rust. Span 3 DS girder has multiple vertical cracks with efflorescence.</p>
205	Reinforced Concrete Column	None.
215	Reinforced Concrete Abutment	Dirt and debris on abutment caps from leaking joints.
234	Reinforced Concrete Pier Cap	NE Pier 6 minor spall at bridge centerline.
301	Pourable Joint Seal	<p>NE 2ft failed. FE 1ft failed. Remainder of seals are cracking.</p>
303	Assembly Joint With Seal	<p>18ft NEDS and 14ft FEUS sliding plate replaced with pourable joint seal. FEDS nosing torn. Surface rust throughout.</p>
311	Movable Bearing	<p>100% surface rust on abutment bearings. Laminar rust up to 3/8 inch thick on 75% of abutment bearings. Binocular inspection indicates remainder of bearings have surface rust.</p>

Bridge No.	0605	Br. Name	Snow River Cntr Channel	Date	08/09/17
Inspector			Murray / Murph	Frame	37
			NE DS bearing, typ.

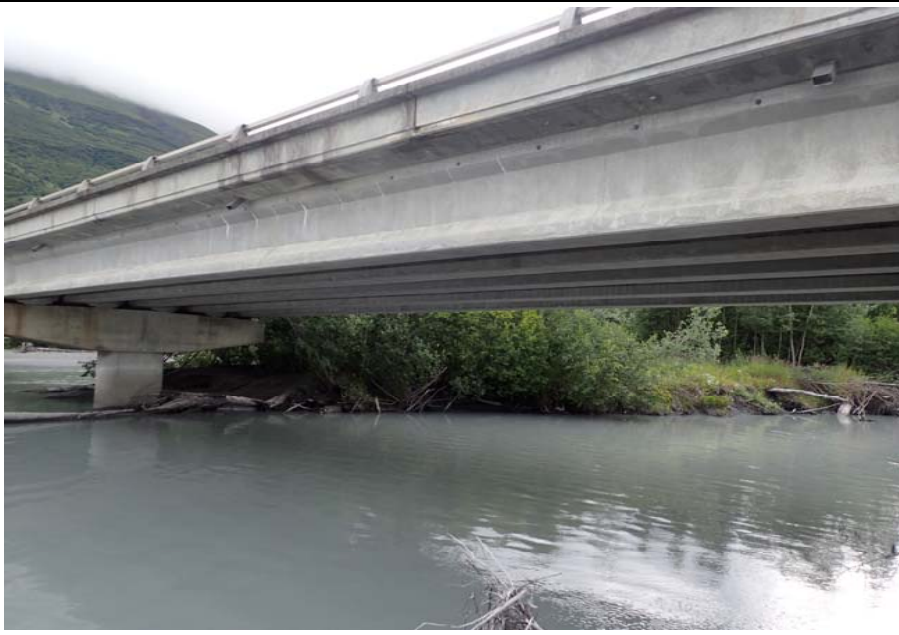
Bridge No.	0605	Br. Name	Snow River Cntr Channel	Date	08/09/17
Inspector			Murray / Murph	Frame	39
			DS span 3 girder efflorescence

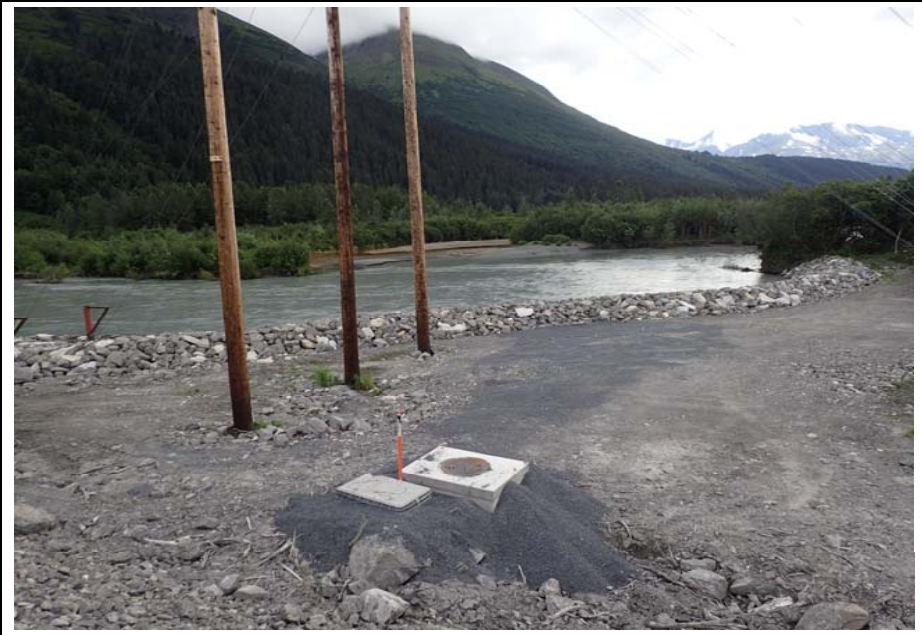
Channel migration at FE US. Area around electrical
poles has been armored with large riprap.

Bridge No.	0605	Br. Name	Snow River Cntr Channel	Date	08/09/17
Inspector			Murray / Murph	Frame	40
			Looking FE US, note new riprap
