Routine Inspection Report

Date: 8/9/2017

Br No 607

VICTOR CREEK

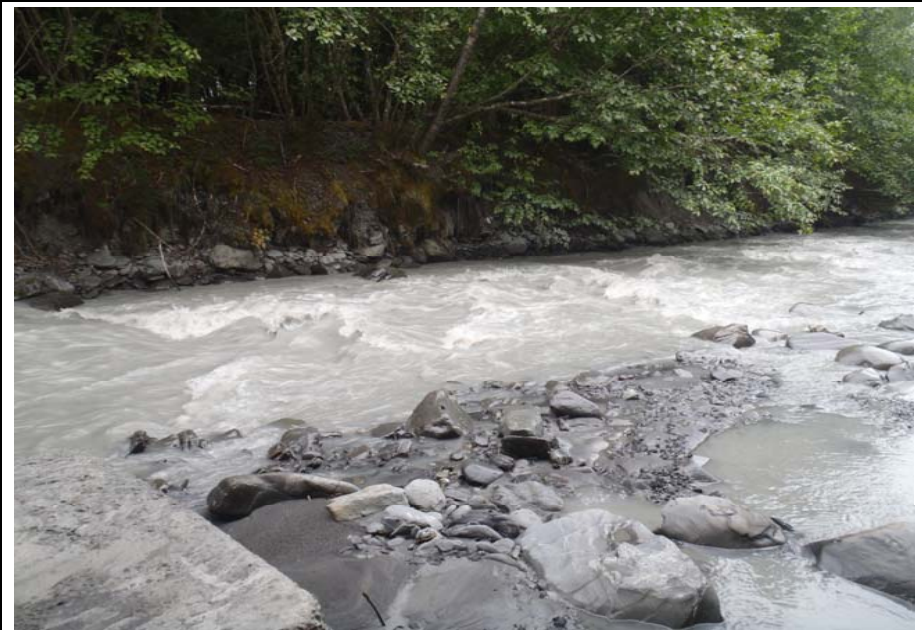
8 ft vertical banks NE DS for 200+ feet
as well as FE US for 200+ ft.

Bridge No. **0607** Br. Name **Victor Creek** Date **08/09/17**
 Inspector **Murray / Murph** Frame **12**
DS NE undercutting along bank

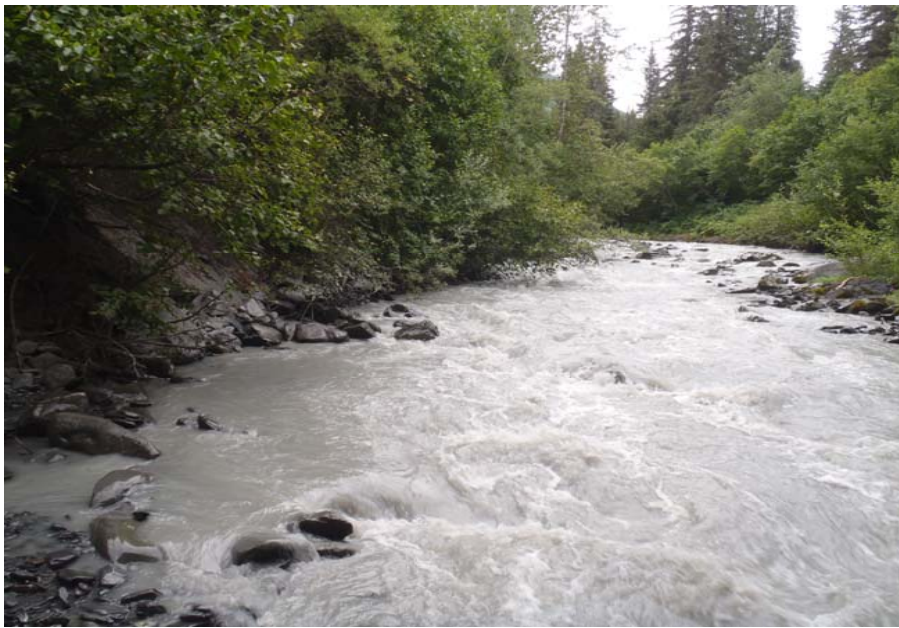
Bridge No.	0607	Br. Name	Victor Creek	Date	08/09/17
Inspector			Murray / Murph	Frame	13
			FE US undercutting along bank

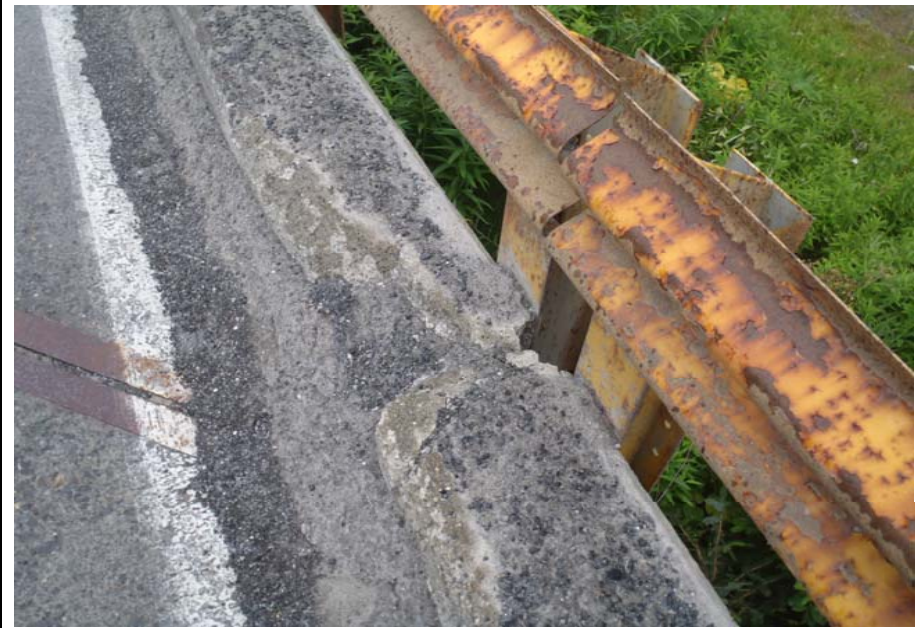
Bridge No.	0607	Br. Name	Victor Creek	Date	08/09/17
Inspector			Murray / Murph	Frame	14
			DS NE rail spall

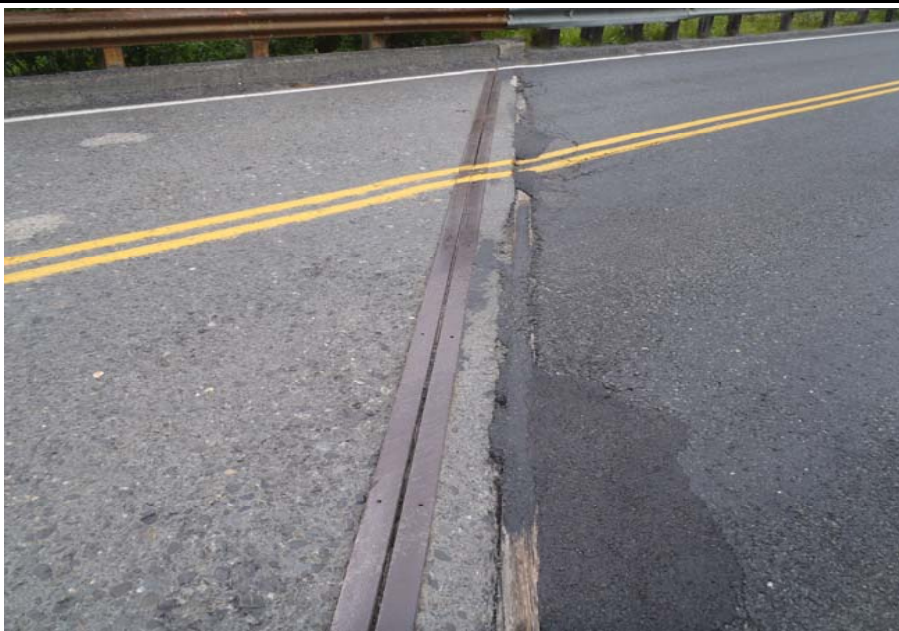
> 6000	Scour	
301	Pourable Joint Seal	<p>Various segments failed at each joint. Remaining sections are cracked. Pier 3 DS, angle armor missing for about 9ft. Attachments exposed but appear below deck surface.</p>

Bridge No.	0607	Br. Name	Victor Creek	Date	08/09/17
Inspector			Murray / Murph	Frame	15
			DS NE expansion joint

<i>Priority</i>	<i>Description</i>	<i>Quantity</i>	<i>Work Needed</i>
High	Bridge-Replacement		Bridge programmed for replacement.
High	Joints-Repair (LF)	30	Replace joints. Install new Pier 3 nose armor. Patch soffit spalls adjacent to joints.
High	Paint-Structural (SF)	1	Sandblast and repaint bearings and girders near joints.
Medium	Deck-Patch spalls->Deck-Repair (Potholes) (SF)	1	Patch open core holes, spalls, and spalls patched with asphalt. Do not use asphalt for patch material.
Low	Misc-Install Sign (EA)	1	Install NE name place sign.

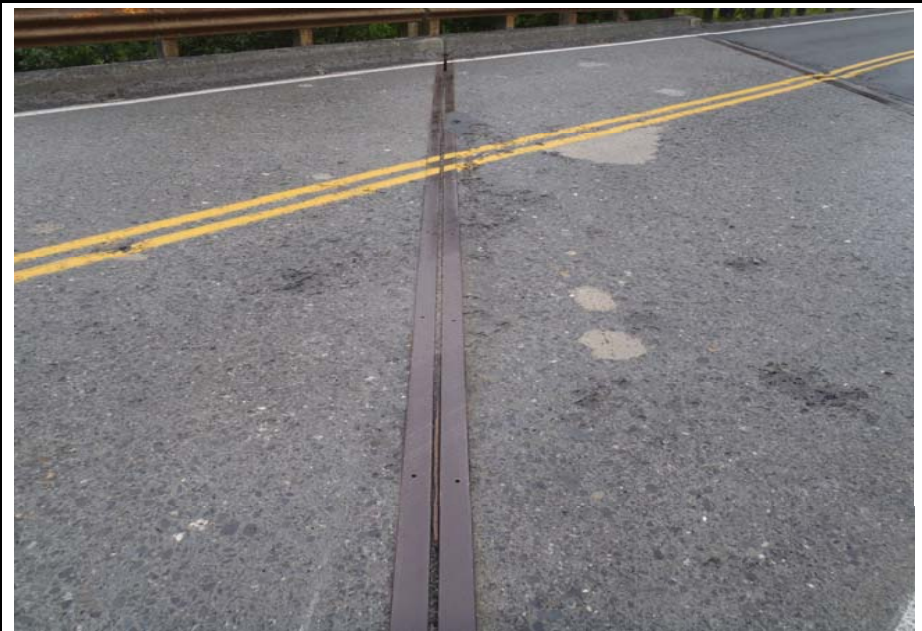
Bridge No.	0607	Br. Name	Victor Creek	Date	08/09/17
Inspector			Murray / Murph	Frame	16
			DS Pier 2 expansion joint

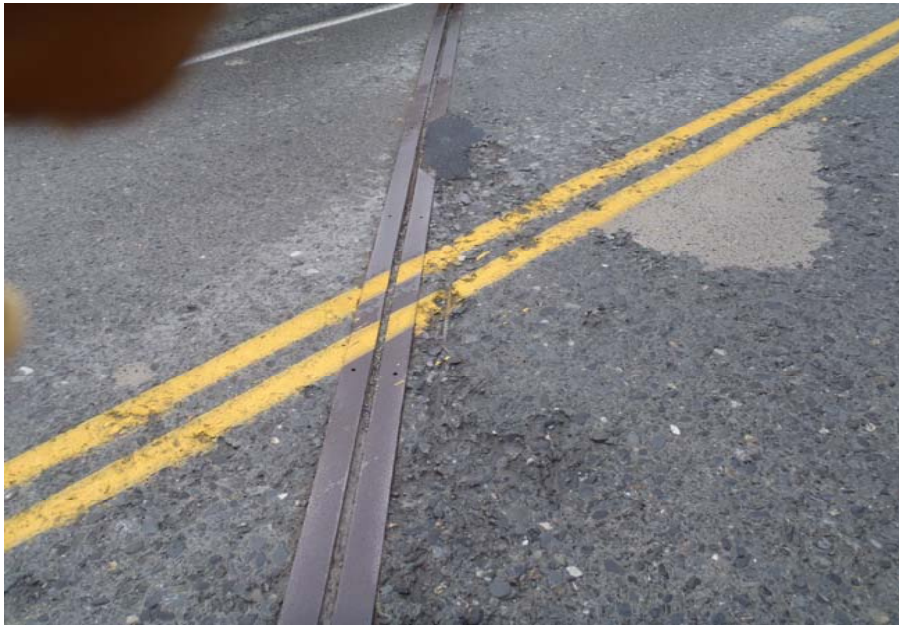
Bridge No.	0607	Br. Name	Victor Creek	Date	08/09/17
Inspector	Murray / Murph		Frame	17	
Expansion joint 2 exposed rebar at centerline

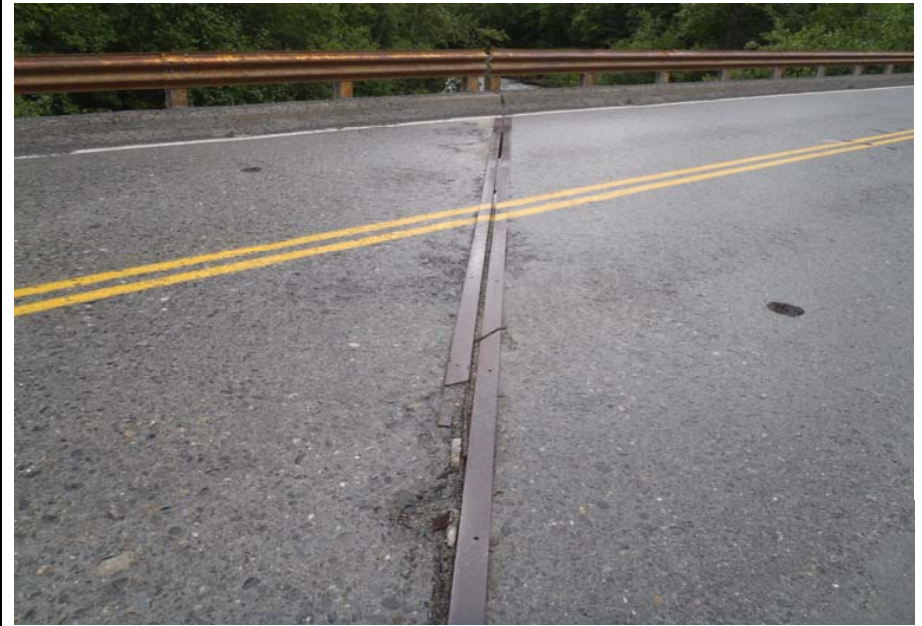
Bridge No.	0607	Br. Name	Victor Creek	Date	08/09/17
Inspector	Murray / Murph		Frame	18	
DS Pier 3 expansion joint

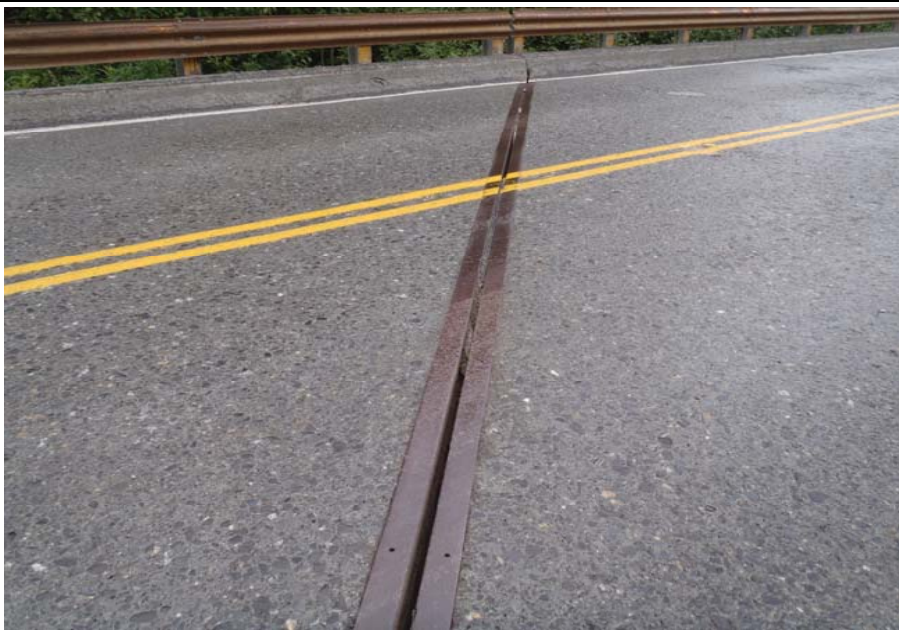
Bridge No.	0607	Br. Name	Victor Creek	Date	08/09/17
Inspector	Murray / Murph		Frame	19	
DS Pier 4 expansion joint

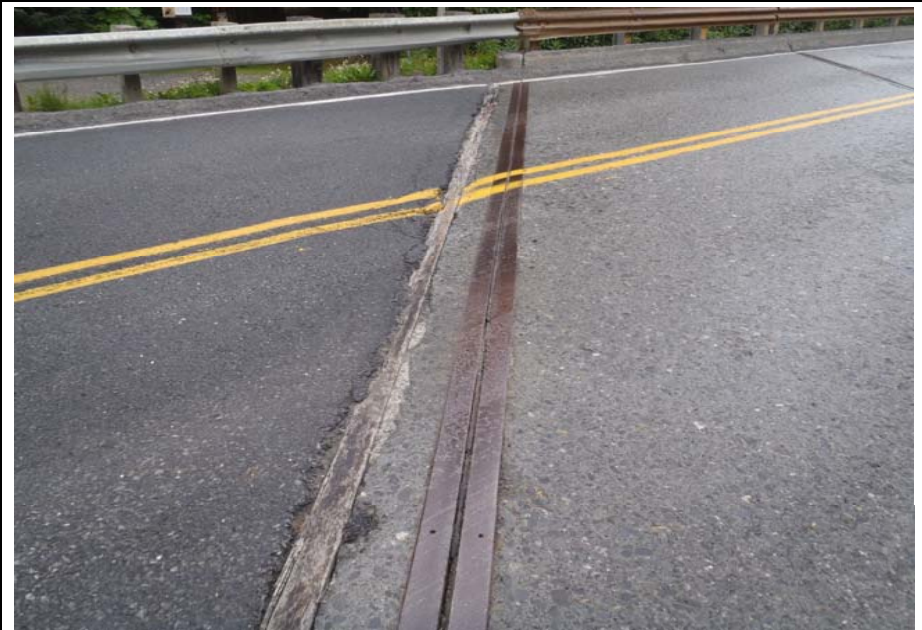
Bridge No.	0607	Br. Name	Victor Creek	Date	08/09/17
Inspector	Murray / Murph		Frame	20	
DS FE expansion joint

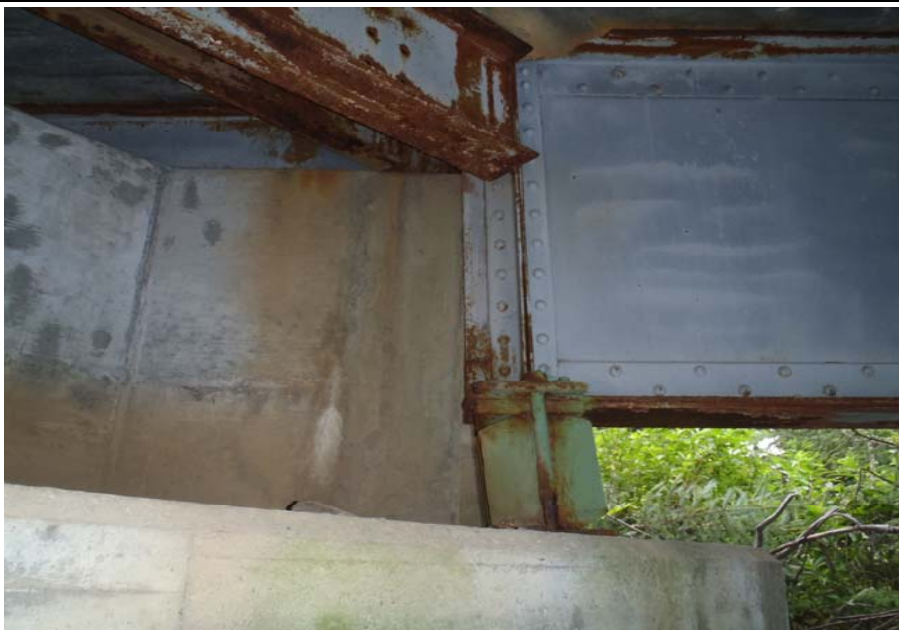
311	Movable Bearing	Span 2 bearings rocked toward NE; DS girder web is in contact with Pier 2 stemwall. Minor laminar rust on bearings. Moderate laminar rust on anchor rods.
> 515	<i>Steel Protective Coating</i>	
313	Fixed Bearing	Surface rust throughout.
> 515	<i>Steel Protective Coating</i>	
330	Metal Bridge Railing	100% w-beam surface rust on road face, 25% on back face. Minor coating loss on posts. NEDS, 6 inch dia. curb spall. Pier 2 DS, curb spalled with exposed rebar for about 4ft. Span 2 DS midspan rail damage. Post is bent outward but anchorages are intact. FEUS, minor exterior curb spall.
> 515	<i>Steel Protective Coating</i>	
600	Signs Smart Flag	NE name place sign is missing.
601	Brush Smart Flag	Brush encroaching approach rail and NEUS bridge rail.
607	Seismic Retrofit Smart Flag	Longitudinal restrainers in good conition. FE bearing plate gap about 1 inch.

Bridge No. **0607** Br. Name **Victor Creek** Date **08/09/17**
 Inspector **Murray / Murph** Frame **23**
DS pier 2 concrete and girder contact

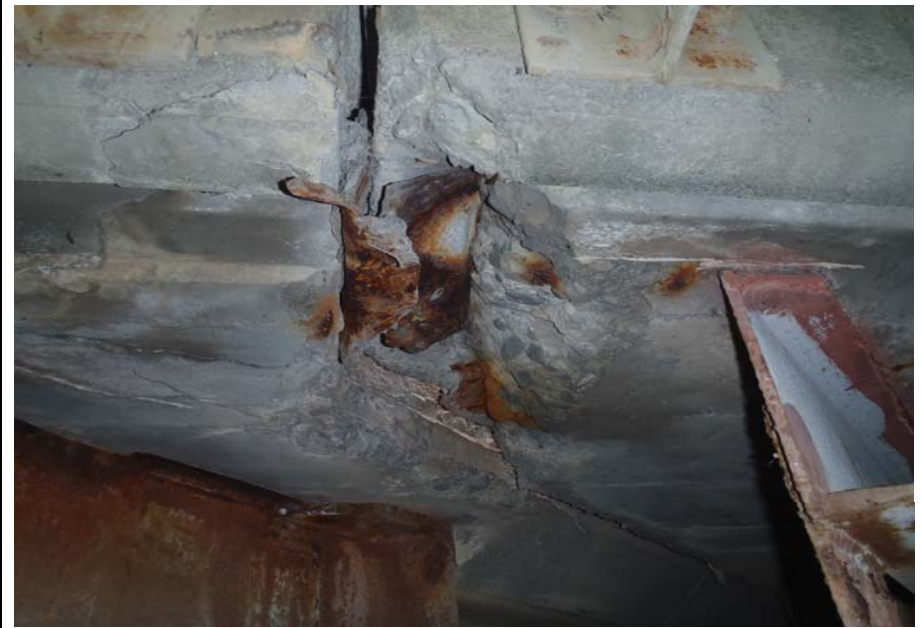
Bridge No.	0607	Br. Name	Victor Creek	Date	08/09/17
Inspector	Murray / Murph		Frame	26	
US NE spalling along expansion joint

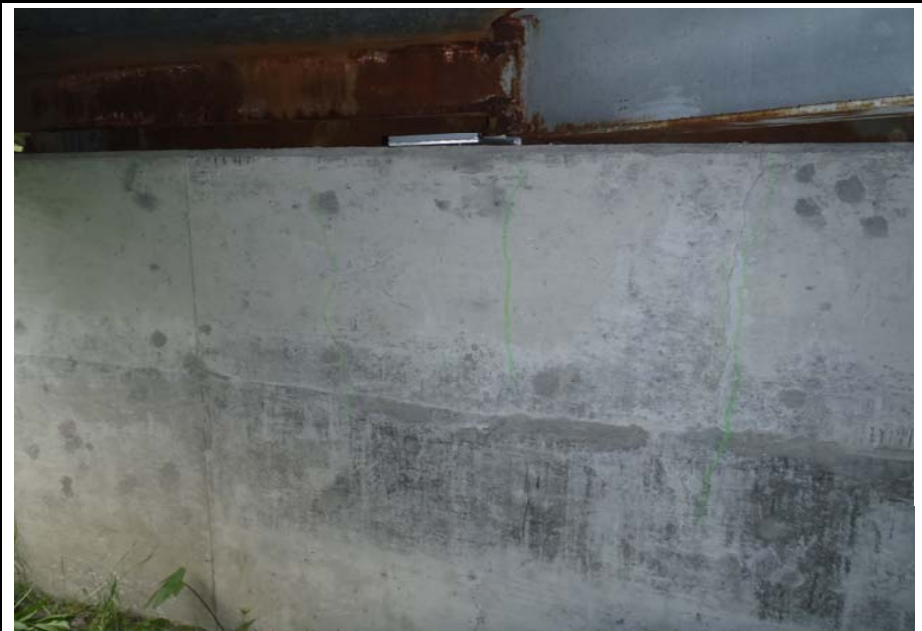
> 515	Steel Protective Coating	
210	Reinforced Concrete Pier Wall	<p>Pier 2 NE face multiple hairline cracks half height. One full height cracked measured at 0.040in. Pier 3 NE, two hairline cracks full-width about mid-height and 1 full-height hairline crack. Pier 3 NEDS, 2SF spall with exposed rebar at footing. Pier 3 FE, two cracks full width about mid-height. US side is 3/16 inch wide for about 6ft. Pier 3 FE, one full-height hairline crack. Pier 3 US footing exposed about 3ft deep and 4ft wide. Remaining length 1.5 feet deep. As-builts indicate footing is pile supported. Pier 4 NE, 1SF spall near mudline. Pier 4 FE, full-width hairline crack at construction joint. US side is about 0.3 inches wide for about 5ft.</p>
> 6000	Scour	
215	Reinforced Concrete Abutment	<p>NEDS, minor wingwall spall. 40 inch long x 5 inch high x 40 inch deep void under NE cap near centerline. NEDS and FEUS 8ft vertical banks for about 200ft starting at bridge.</p>

Bridge No.	0607	Br. Name	Victor Creek	Date	08/09/17
Inspector	Murray / Murph		Frame	28	
NE face Pier 2 cracks

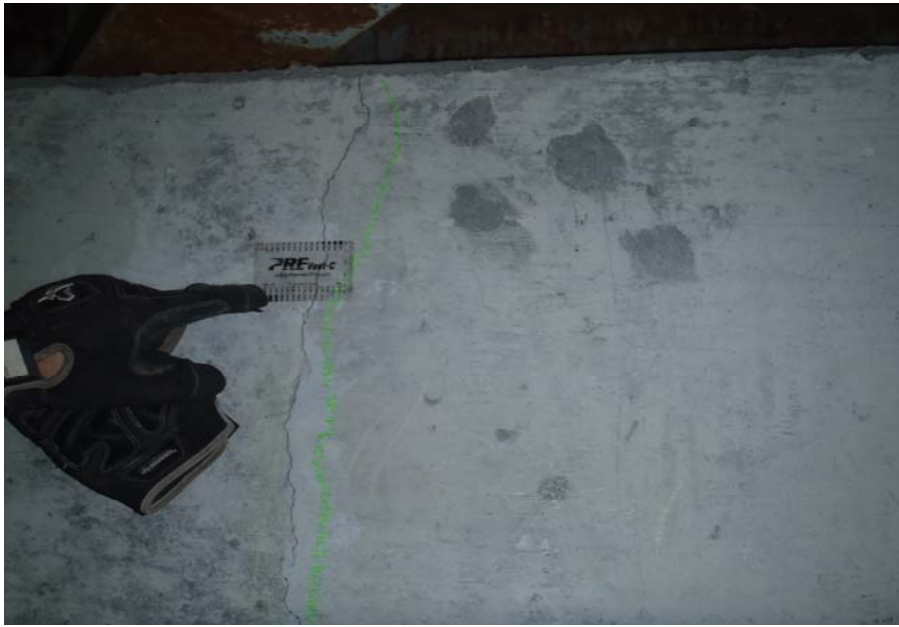
Bridge No.	0607	Br. Name	Victor Creek	Date	08/09/17
Inspector	Murray / Murph		Frame	29	
NE face Pier 2 crack 10' from DS

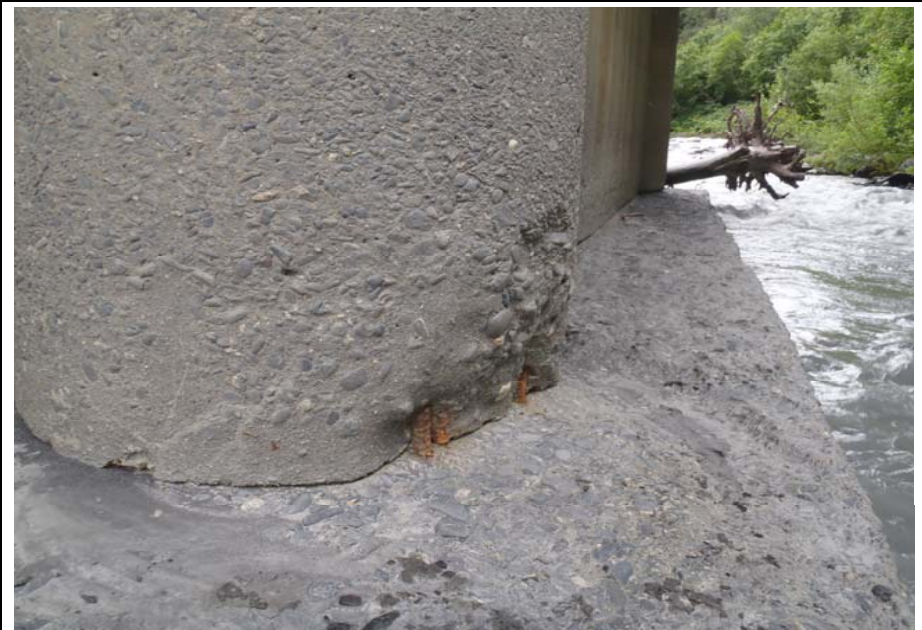
Bridge No.	0607	Br. Name	Victor Creek	Date	08/09/17
Inspector	Murray / Murph		Frame	32	
DS NE face pier 3 spall with exposed rebar

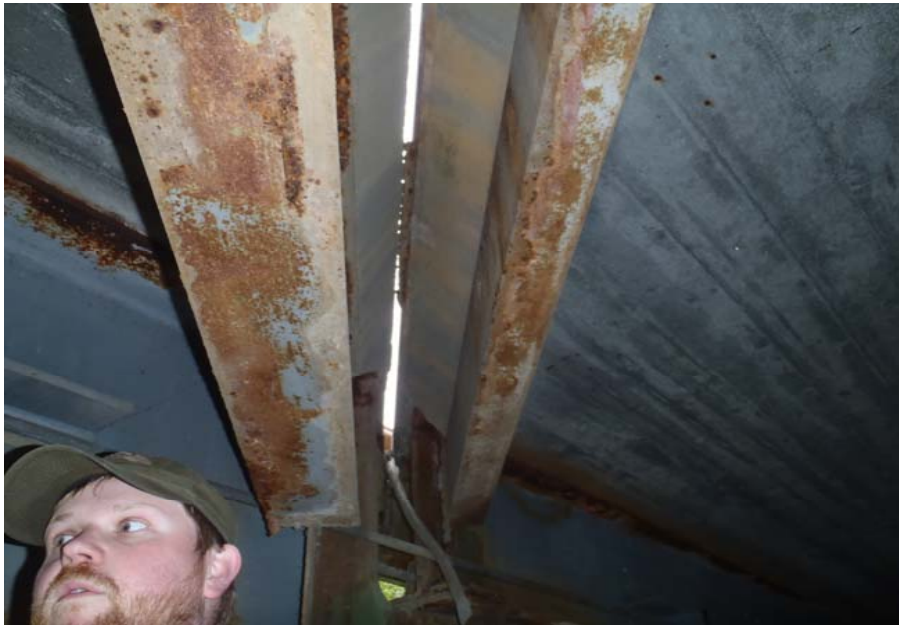
Bridge No.	0607	Br. Name	Victor Creek	Date	08/09/17
Inspector			Murray / Murph	Frame	37
	Span 4 DS joint failure
