Routine Inspection Report

Date: 6/25/2017

Br No 253

HERRING COVE

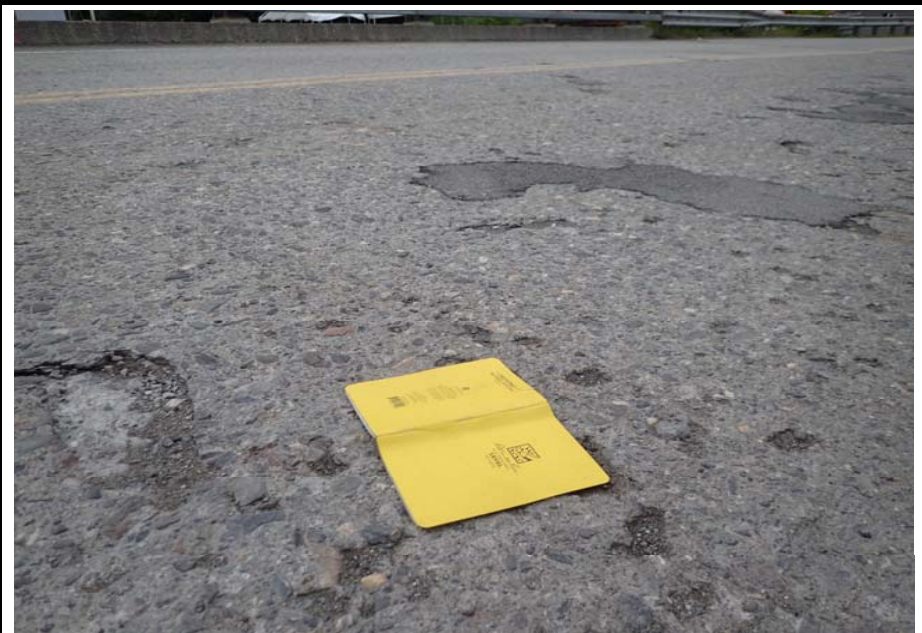
Element	Description	Observations
12	Reinforced Concrete Deck	<p>Scale and abrasion throughout. Numerous spalls, popouts, and several exposed rebar.</p> <p>Delaminations and Spalls: Span 1 LT - Approximately 50% of total area Span 1 RT - Approximately 40% of total area Span 2 LT - Approximately 20% of total area Span 2 RT - Approximately 50% of total area</p> <p>Exposed Rebar: Span 1 LT - 16SF; 3ft x 8ft section (14SF of total) with 6 transverse and 1 longitudinal bar(s) exposed, partially patched with asphalt, rebar still exposed Span 1 RT - 3SF; 1 section mostly covered with asphalt patch material Span 2 LT - 1SF FE, patched Span 2 RT - 10SF; 2SF at midspan, remaining in 1SF increments; 1SF found, 9 SF patched with asphalt</p> <p>Soffit: Minor cracking with efflorescence typical near rail post anchor plates and drains. Span 1 G2 DS haunch spalled 15ft near NE abutment Span 1 G3 US haunch spalled 20ft near NE abutment; both haunches spalled 5ft US and 10ft DS near Pier 2 Span 1 G4 haunch spalled 12ft US near Pier 2 Span 2 G2 US haunch spalled 4ft near Pier 2 Span 2 G2 DS haunch spalled 1ft near Pier 2 Span 2 G2 DS haunch spalled 1ft near Abutment 3 Span 2 G3 DS haunch spalled 2 ft with delamination near Abutment 3 Span 2 G3 DS haunch delaminated 1ft near Pier 3 Span 2 G4 US haunch spalled 0.5 ft near Abutment 3</p>

Bridge No.	0253	Br. Name	Herring Cove	Date	06/25/17
Inspector		Manning / Escamilla		Frame	12
		Deck typical

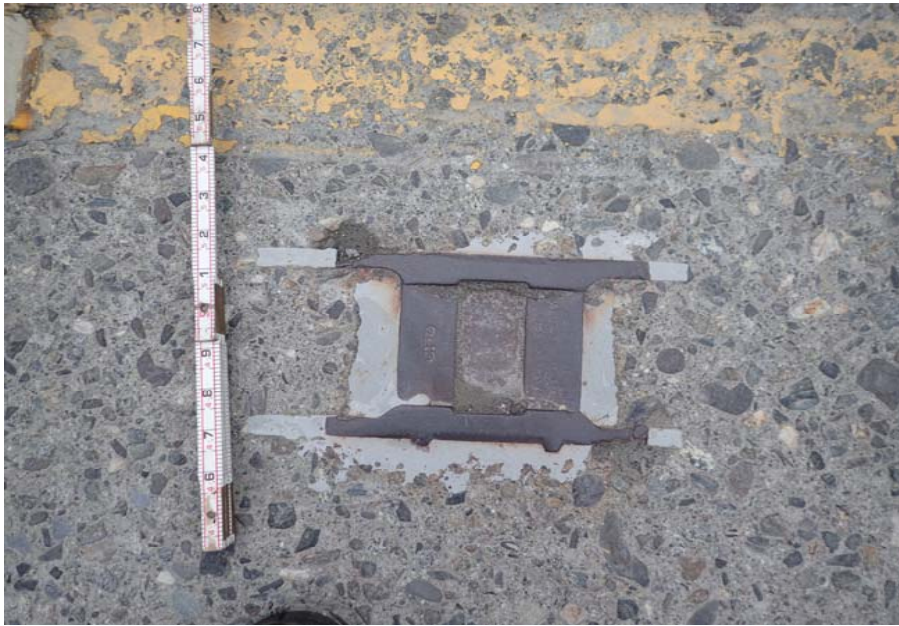
Bridge No. **0253** Br. Name **Herring Cove** Date **06/25/17**
 Inspector **Manning / Escamilla** Frame **13**
Deck embedded hardware

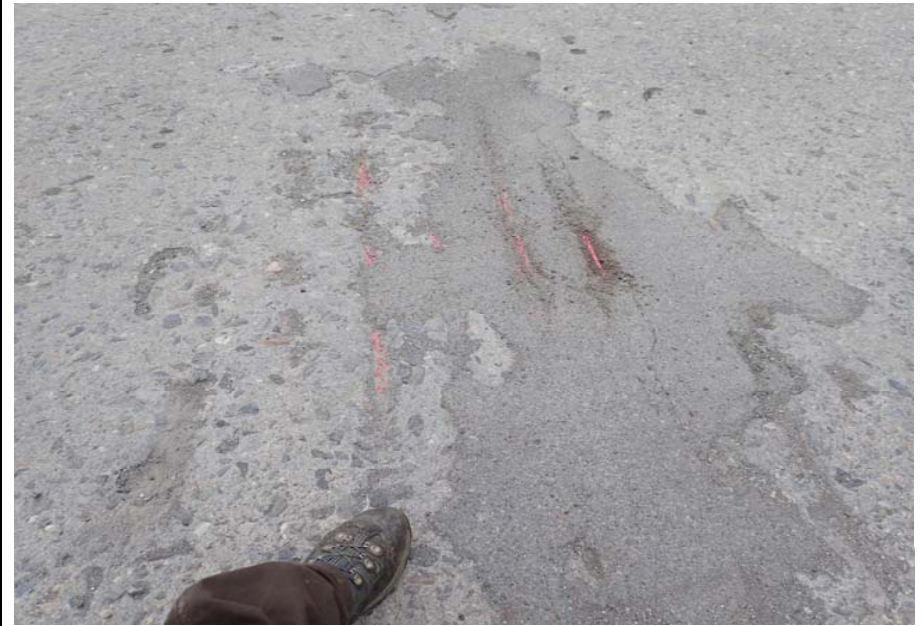
Bridge No. **0253** Br. Name **Herring Cove** Date **06/25/17**
 Inspector **Manning / Escamilla** Frame **14**
Exposed deck bar

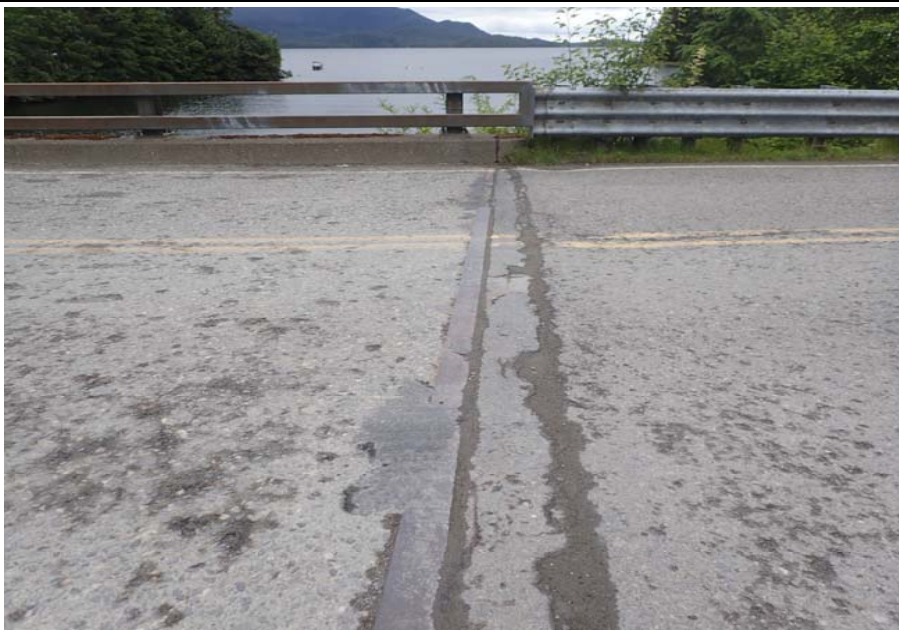
215	Reinforced Concrete Abutment	FE G3 concrete pedestal has minor spalls with exposed rebar. NE abutment erosion and undermining from 1 ft US to 3 ft DS. FE abutment undermined up to 14 inches.
301	Pourable Joint Seal	Joints filled with dirt and easily removed with geopick.
311	Movable Bearing	Surface rust.
> 515	<i>Steel Protective Coating</i>	
313	Fixed Bearing	Surface rust with laminar rust on bottom of sole plates.
> 515	<i>Steel Protective Coating</i>	
330	Metal Bridge Railing	NERT 23.5ft rail segment coating loss with surface rust. Remaining rail with 5% coating loss and discoloration. Minor scrapes along rail throughout. Heavy moss growth on curb. Bolt damage at 4th post from FE DS.
> 515	<i>Steel Protective Coating</i>	
600	Signs Smart Flag	Missing NELT object marker. Incorrect FELT object marker installed (stripes should angle toward roadway).
601	Brush Smart Flag	Brush encroaching bridge corners.

Bridge No. **0253** Br. Name **Herring Cove** Date **06/25/17**
 Inspector **Manning / Escamilla** Frame **15**
NE joint

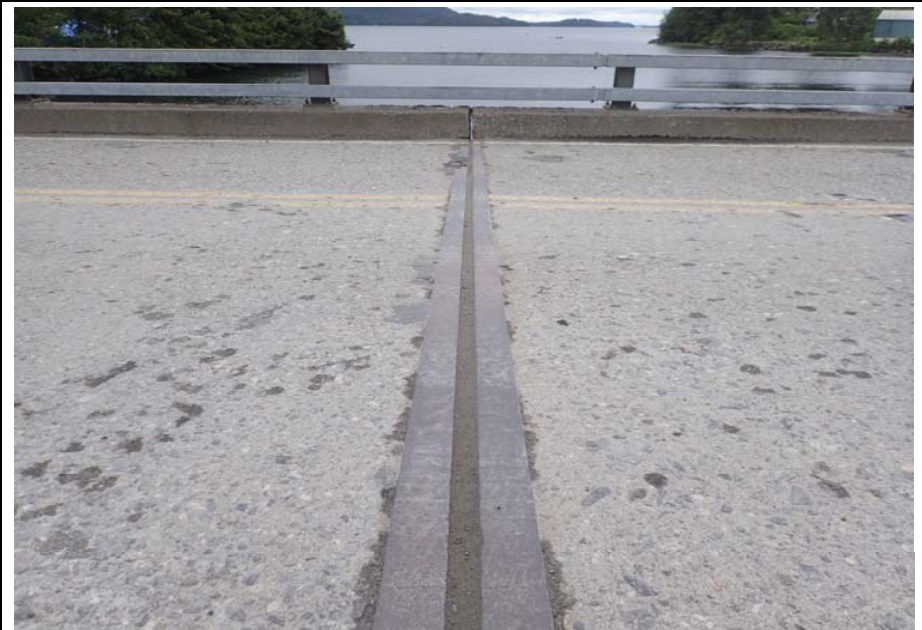
Bridge No. **0253** Br. Name **Herring Cove** Date **06/25/17**
 Inspector **Manning / Escamilla** Frame **16**
Pier 2 joint

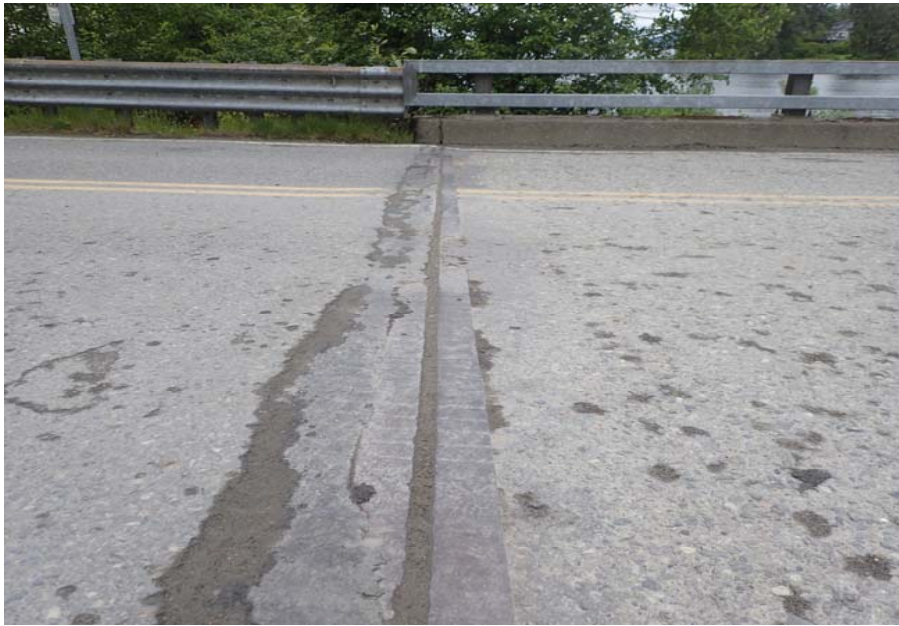
Bridge No.	0253	Br. Name	Herring Cove	Date	06/25/17
Inspector		Manning / Escamilla		Frame	17
		FE joint

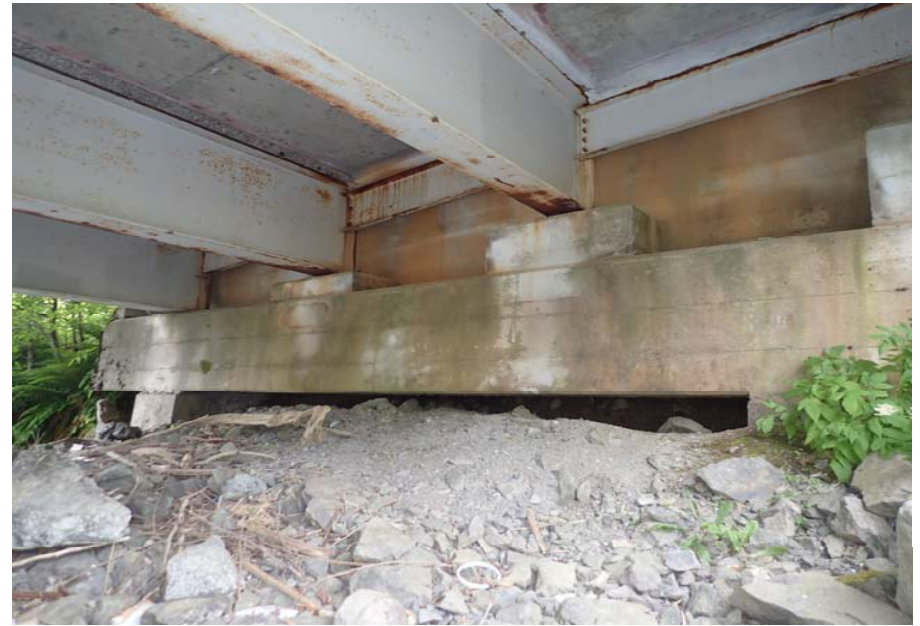
Bridge No.	0253	Br. Name	Herring Cove	Date	06/25/17
Inspector		Manning / Escamilla		Frame	18
		NE abutment up to 3' undermined

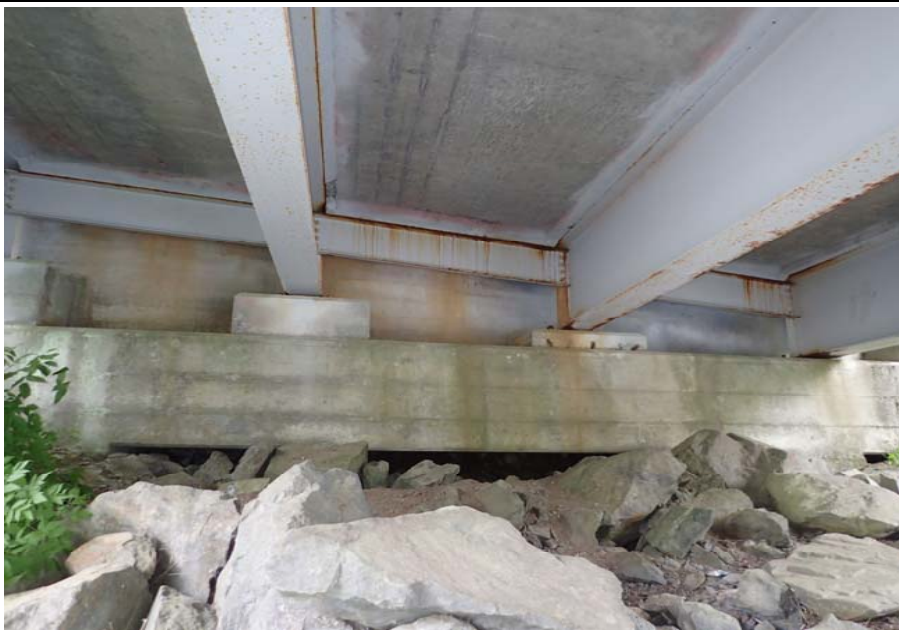
Bridge No.	0253	Br. Name	Herring Cove	Date	06/25/17
Inspector		Manning / Escamilla		Frame	19
		FE abutment

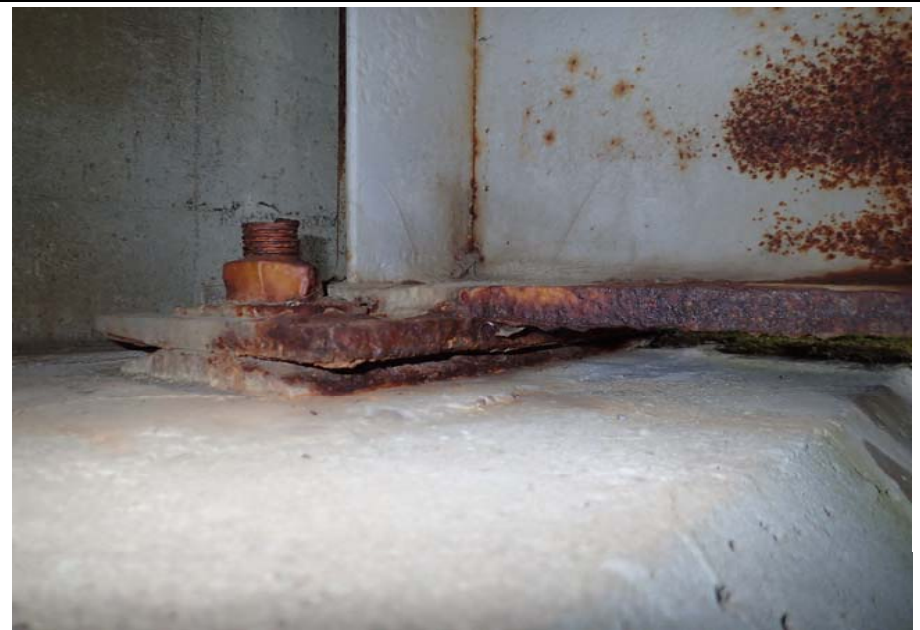
Bridge No.	0253	Br. Name	Herring Cove	Date	06/25/17
Inspector		Manning / Escamilla		Frame	20
		NE bearing typical

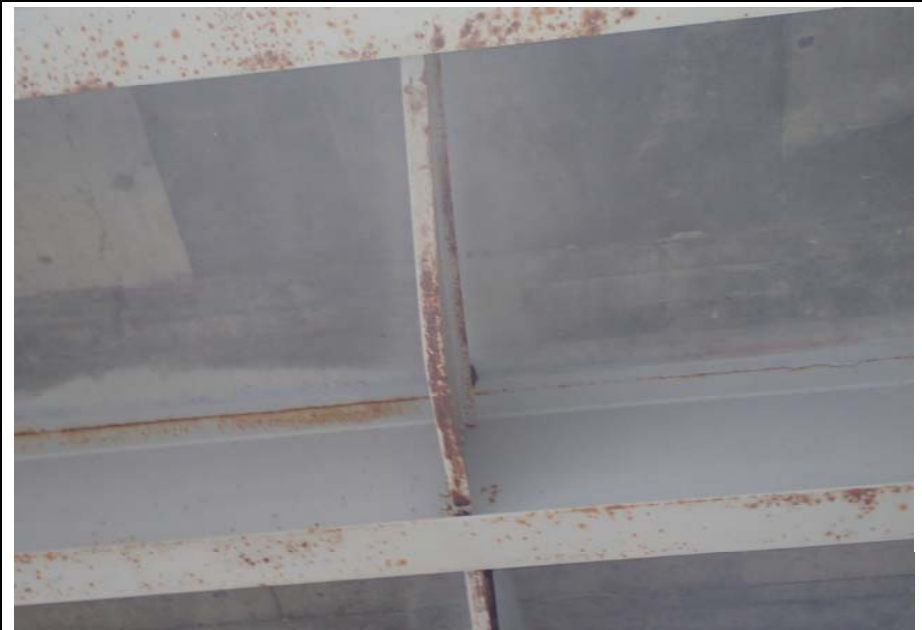
Bridge No.	0253	Br. Name	Herring Cove	Date	06/25/17
Inspector		Manning / Escamilla		Frame	24
Span 2 Bay 3 diaphragm near Pier 2 bowed
