Routine Inspection Report

Date: 6/21/2017

Br No 725

HOADLEY CREEK

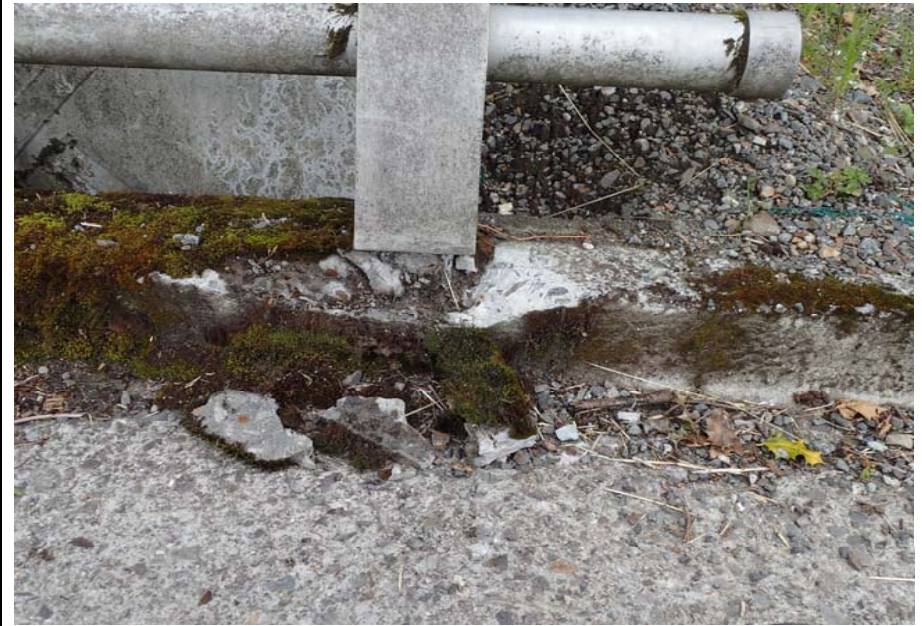
> 515	<i>Steel Protective Coating</i>	
330	Metal Bridge Railing	Curb and bridge rail posts covered with moss. Damaged and spalled concrete at NEUS rail post.

Bridge No.	0725	Br. Name	Hoadley Creek	Date	06/21/17
Inspector	Manning / McRae		Frame	14	
Damage and spall at NE US rail post

<i>Priority</i>	<i>Description</i>	<i>Quantity</i>	<i>Work Needed</i>
High	Deck-Rehab (SF)	167	Patch spalls with exposed rebar. Repair or replace concrete overhang supports. Epoxy inject concrete deck cracks.
High	Misc-Remove Vegetation (EA)	1	Cut brush at bridge corners and US side.
High	Bridge Rail-Repair	1	Repair spalled concrete at NEUS post.

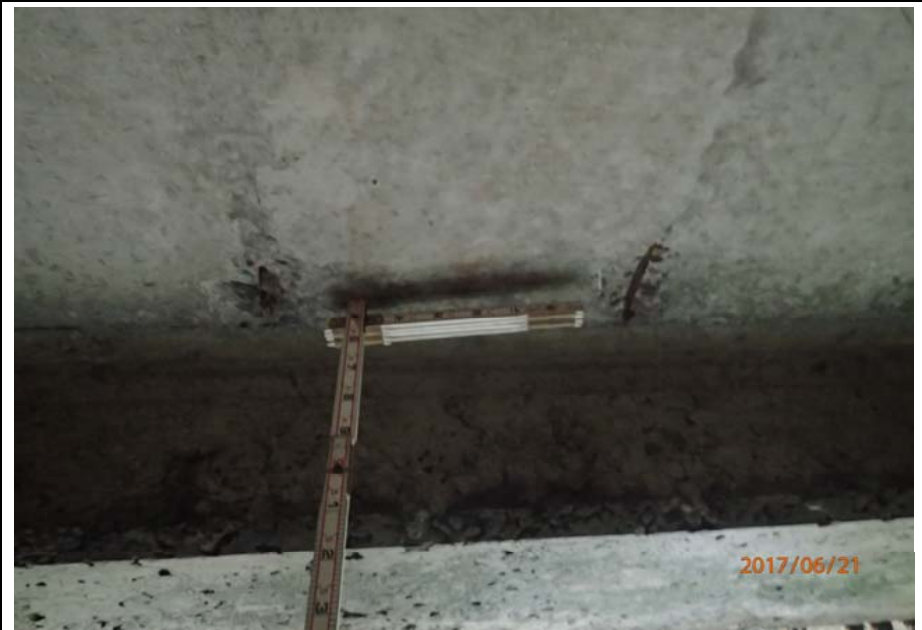
Bridge No.	0725	Br. Name	Hoadley Creek	Date	06/21/17
Inspector	Manning / McRae		Frame	16	
FE US abutment spalls with exposed rebar

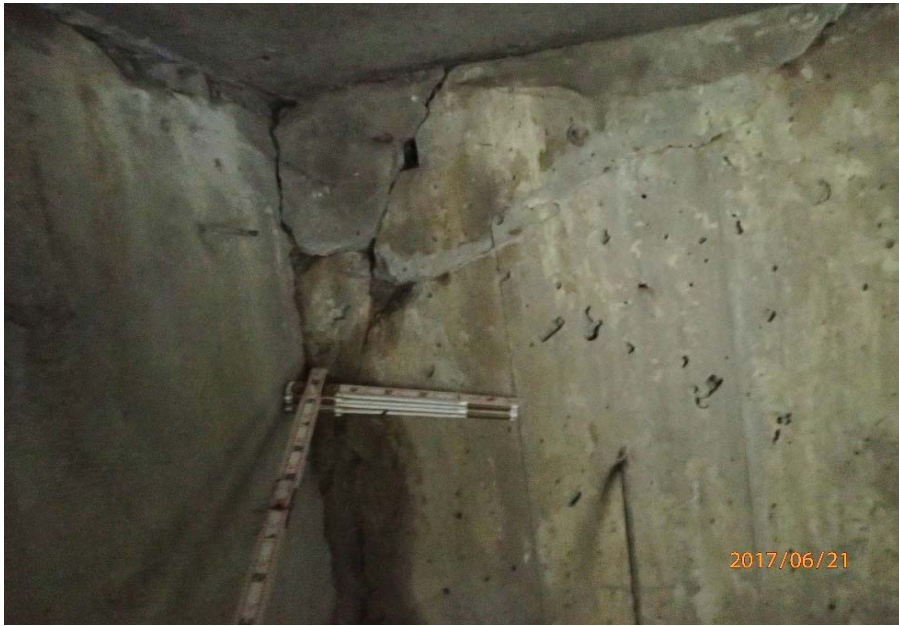
Bridge No.	0725	Br. Name	Hoadley Creek	Date	06/21/17
Inspector	Manning / McRae		Frame	17	
FE US abutment spalls with exposed rebar

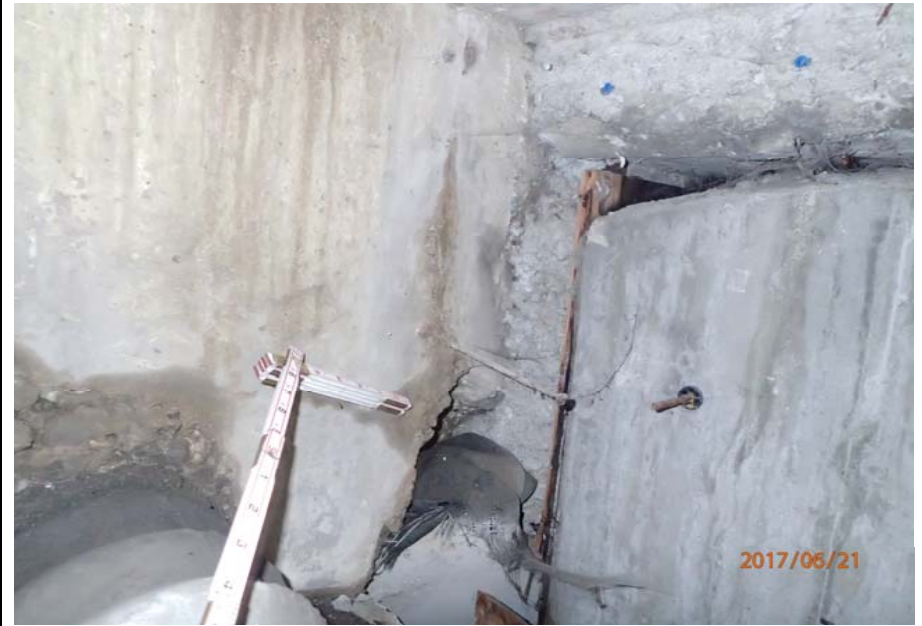
Bridge No.	0725	Br. Name	Hoadley Creek	Date	06/21/17
Inspector	Manning / McRae		Frame	18	
FE US abutment spalls with exposed rebar

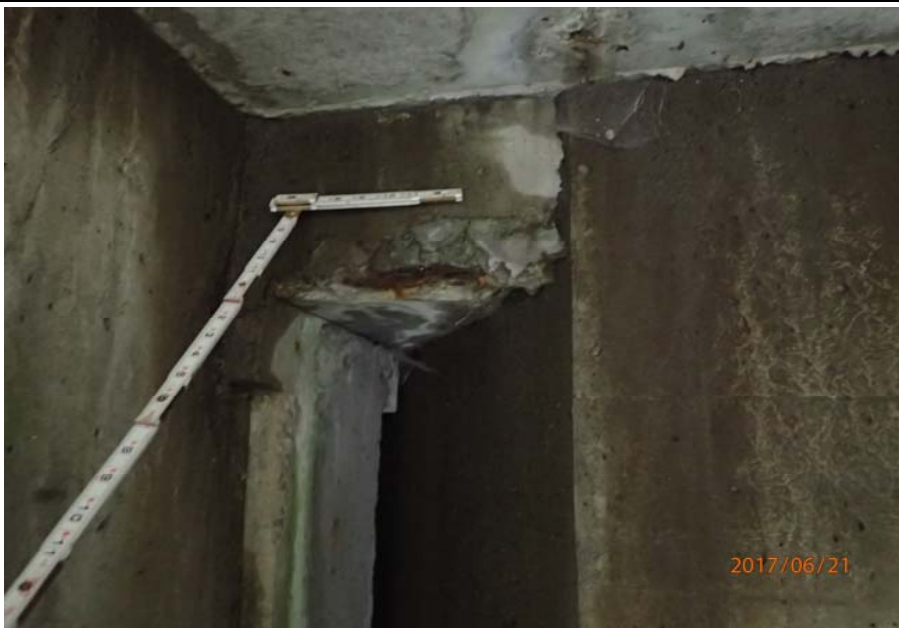
Bridge No.	0725	Br. Name	Hoadley Creek	Date	06/21/17
Inspector	Manning / McRae		Frame	19	
FE US girder at abutment, spall with exposed rebar

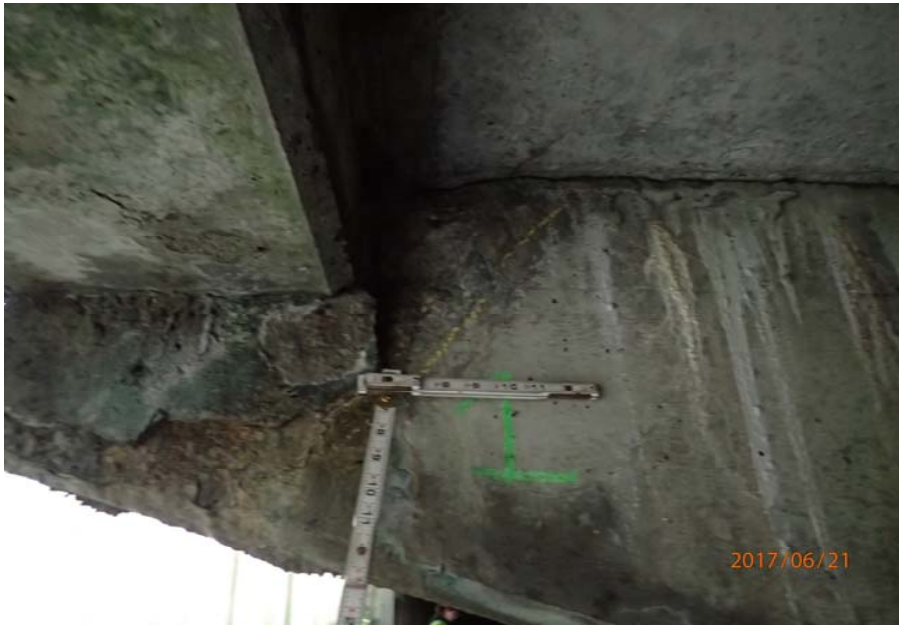
Bridge No.	0725	Br. Name	Hoadley Creek	Date	06/21/17
Inspector	Manning / McRae		Frame	21	
US cantilever support side 1 spall

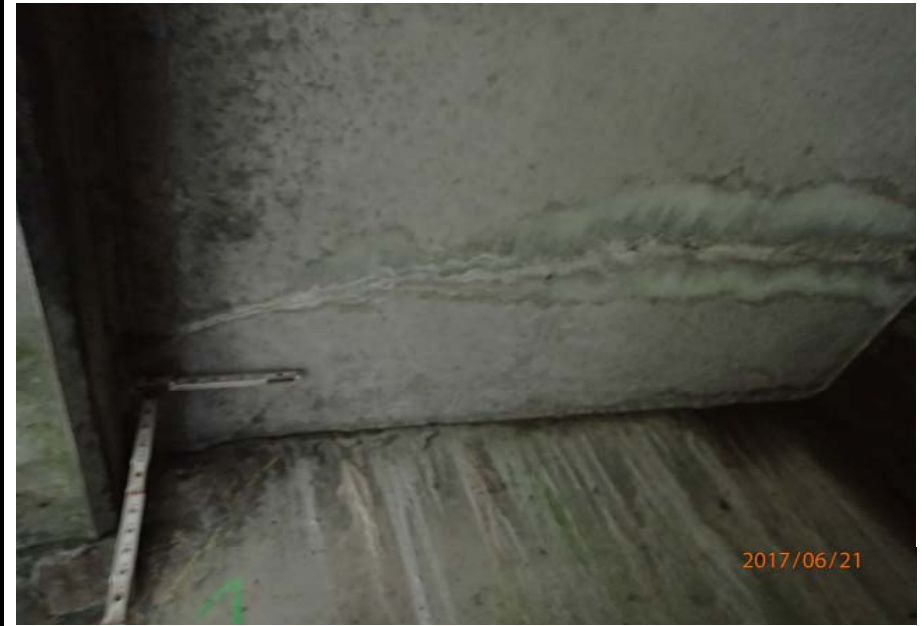
Bridge No.	0725	Br. Name	Hoadley Creek	Date	06/21/17
Inspector	Manning / McRae		Frame	22	
US cantilever support side 1 crack in soffit

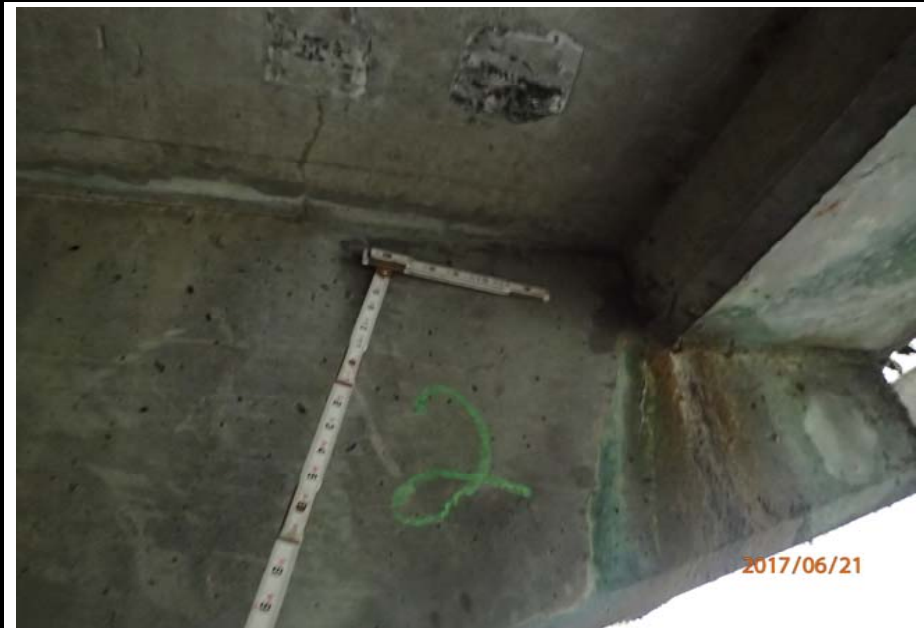
Bridge No.	0725	Br. Name	Hoadley Creek	Date	06/21/17
Inspector	Manning / McRae		Frame	24	
US cantilever support side 2 rust stain, cracks

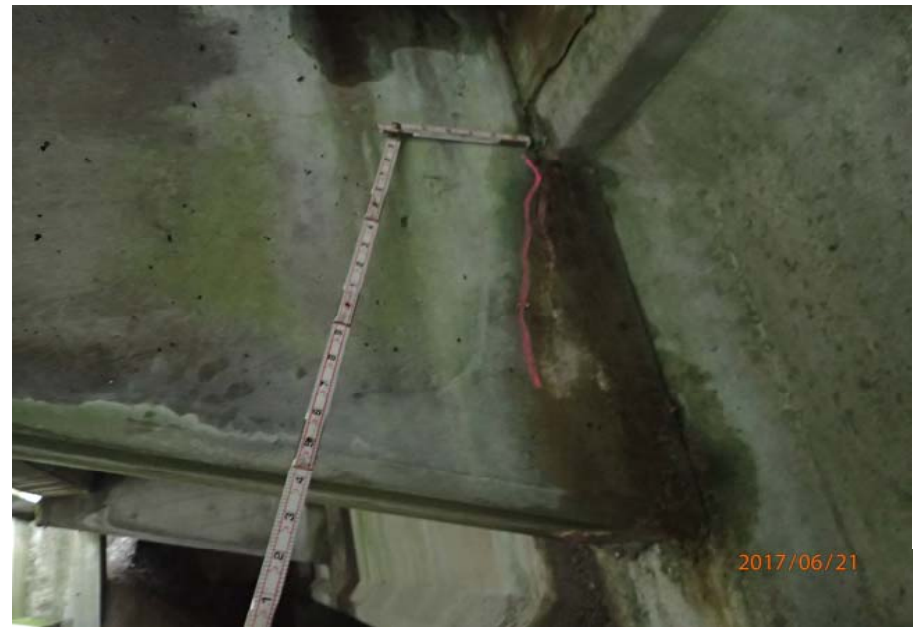
Bridge No.	0725	Br. Name	Hoadley Creek	Date	06/21/17
Inspector	Manning / McRae		Frame	26	
US cantilever support side 3 crack

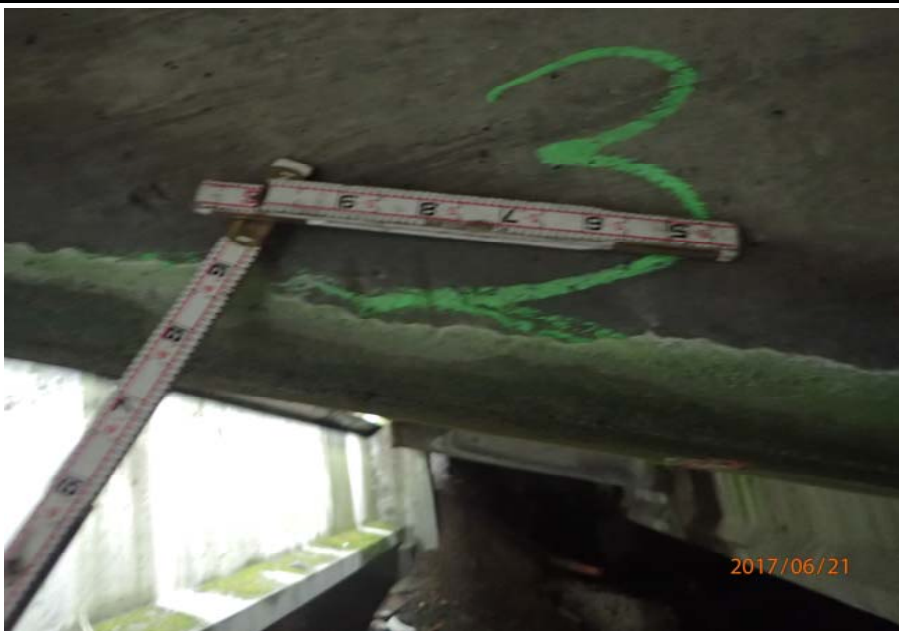
Bridge No.	0725	Br. Name	Hoadley Creek	Date	06/21/17
Inspector	Manning / McRae		Frame	27	
US cantilever support side 3 crack

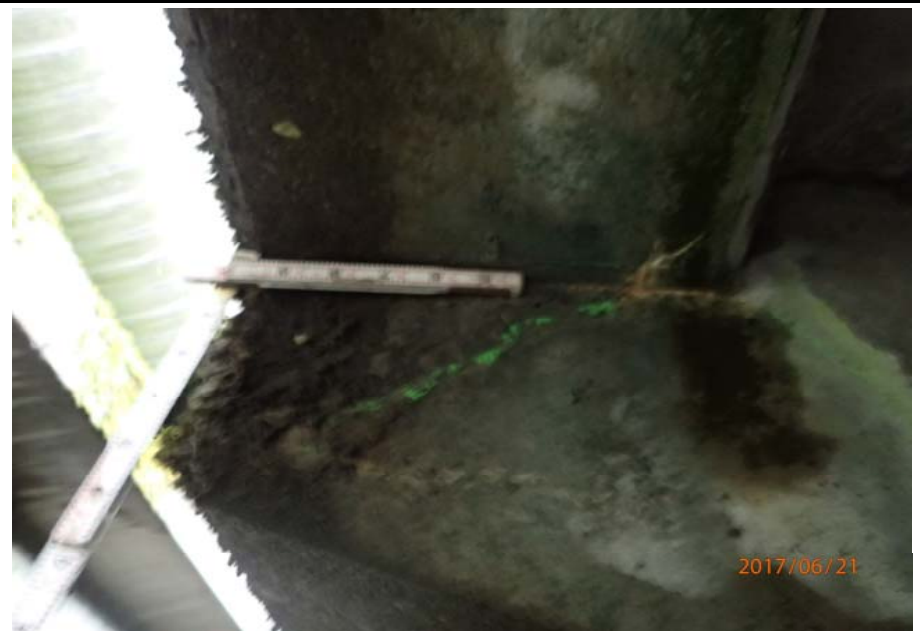
Bridge No.	0725	Br. Name	Hoadley Creek	Date	06/21/17
Inspector	Manning / McRae		Frame	28	
US cantilever support side 3 crack

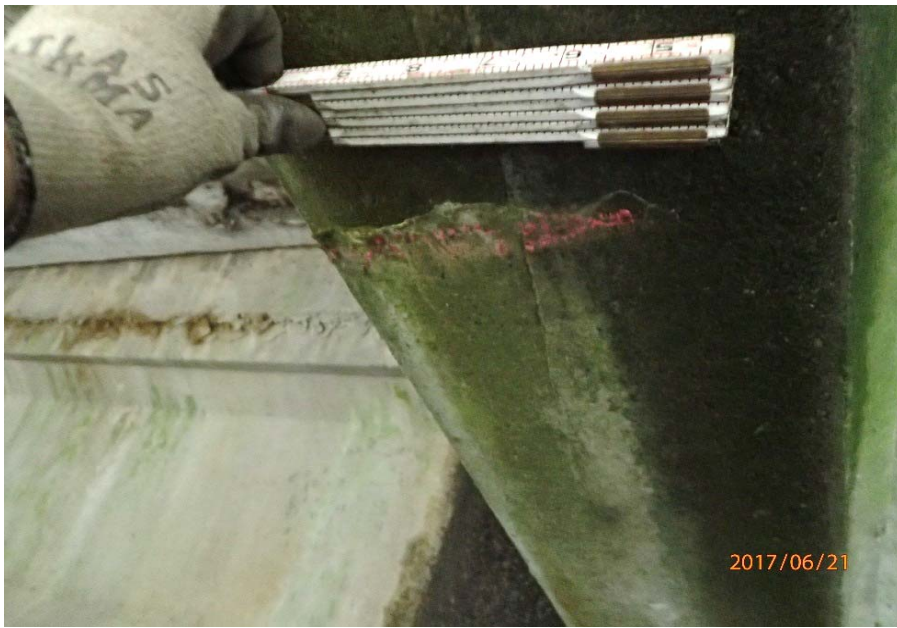
Bridge No.	0725	Br. Name	Hoadley Creek	Date	06/21/17
Inspector	Manning / McRae		Frame	29	
Cracks bottom cantilever support #2 (RT/LT faces are sides 3 & 4)

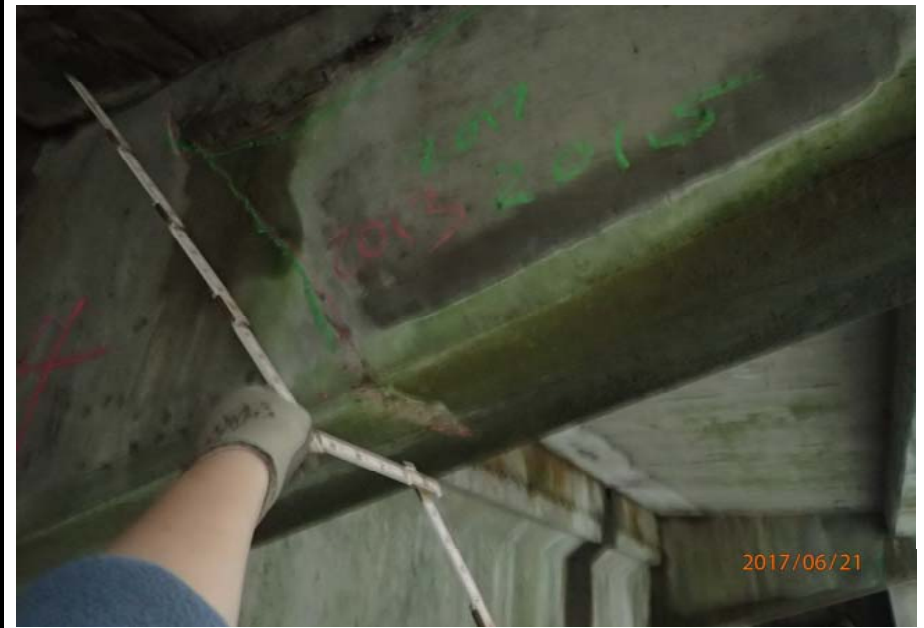
Bridge No.	0725	Br. Name	Hoadley Creek	Date	06/21/17
Inspector	Manning / McRae		Frame	30	
US cantilever support side 4 crack

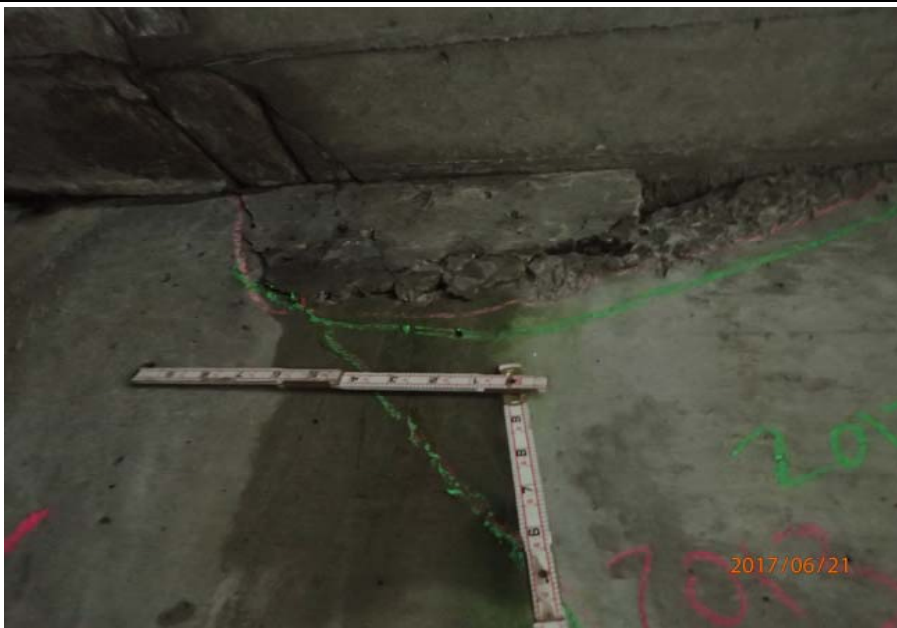
Bridge No.	0725	Br. Name	Hoadley Creek	Date	06/21/17
Inspector	Manning / McRae		Frame	31	
US cantilever support side 4 crack and spall

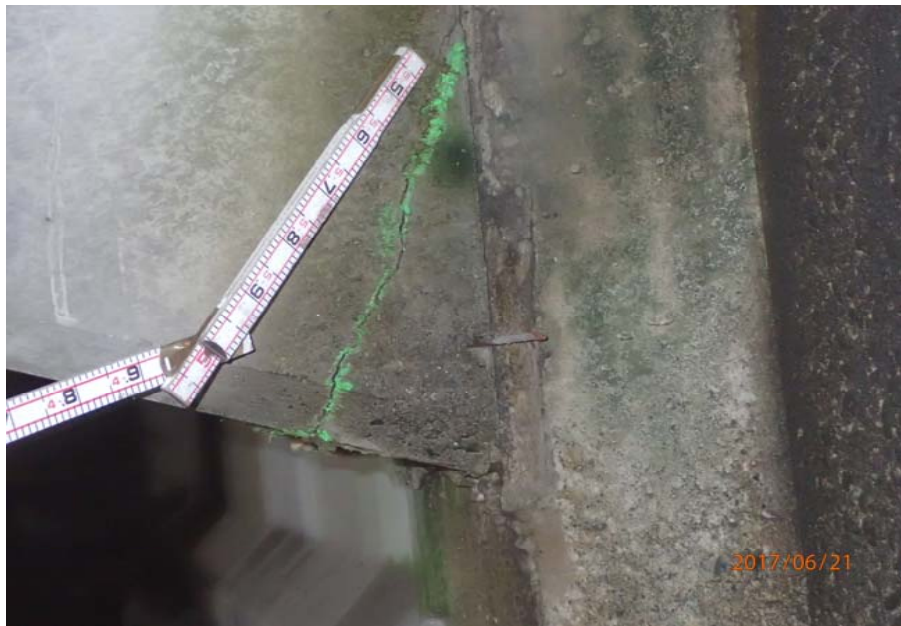
Bridge No.	0725	Br. Name	Hoadley Creek	Date	06/21/17
Inspector	Manning / McRae		Frame	33	
US cantilever support side 5 crack

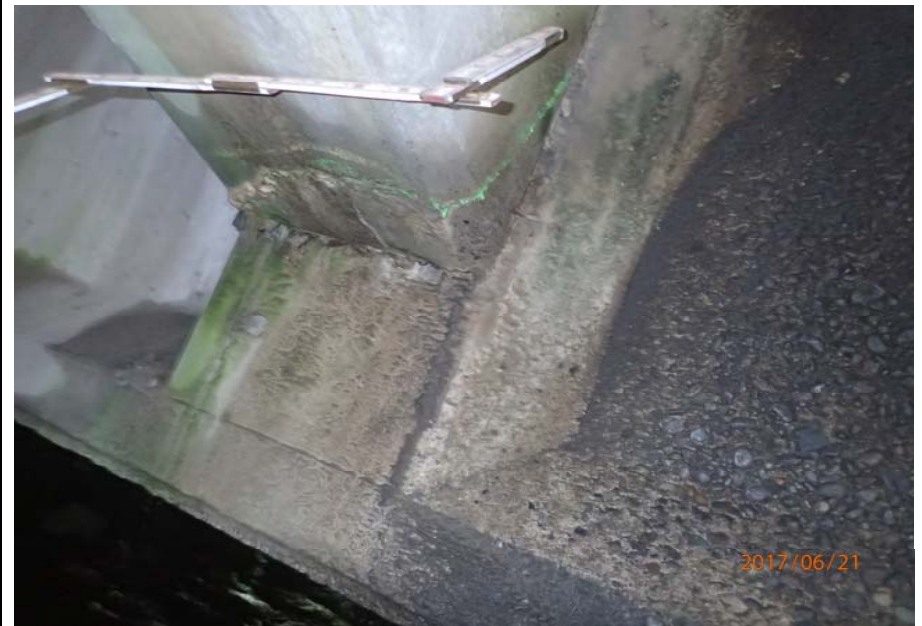
Bridge No.	0725	Br. Name	Hoadley Creek	Date	06/21/17
Inspector	Manning / McRae		Frame	34	
Crack bottom US cantilever support #3 (RT/LT faces are sides # 5 & 6)

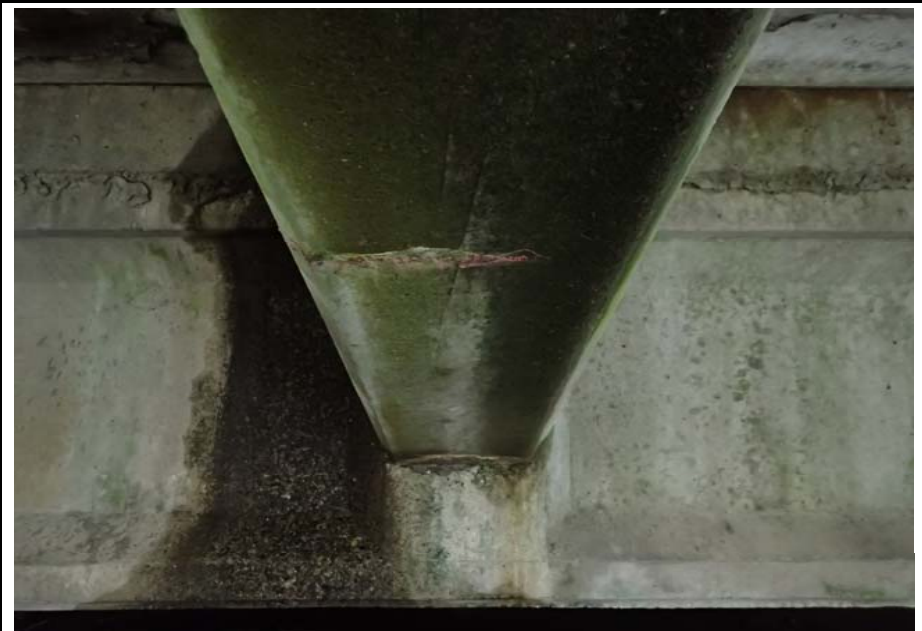
Bridge No.	0725	Br. Name	Hoadley Creek	Date	06/21/17
Inspector	Manning / McRae		Frame	36	
US cantilever supports cracked on underside, typical

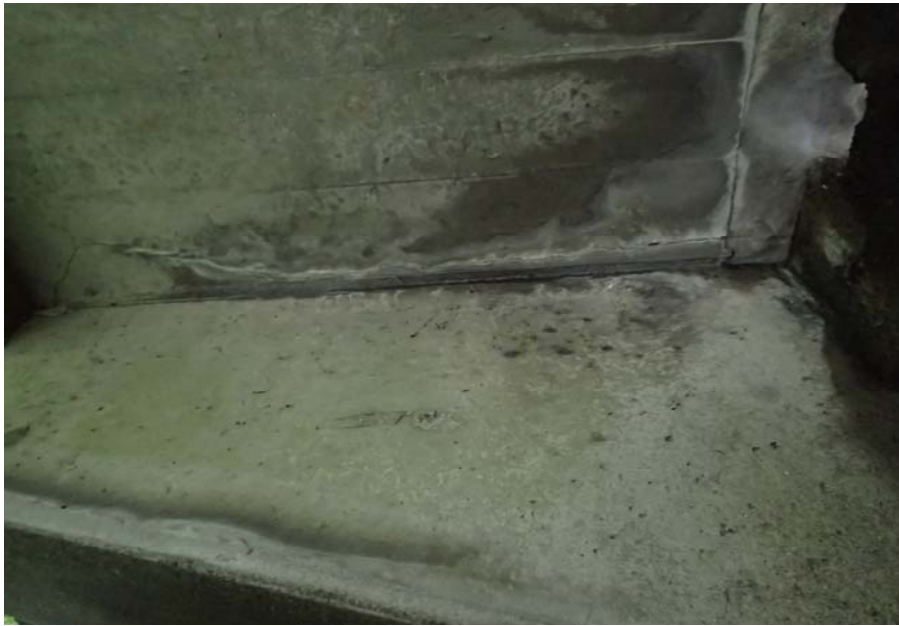
Bridge No.	0725	Br. Name	Hoadley Creek	Date	06/21/17
Inspector	Manning / McRae		Frame	37	
Crack full width of cantilever support

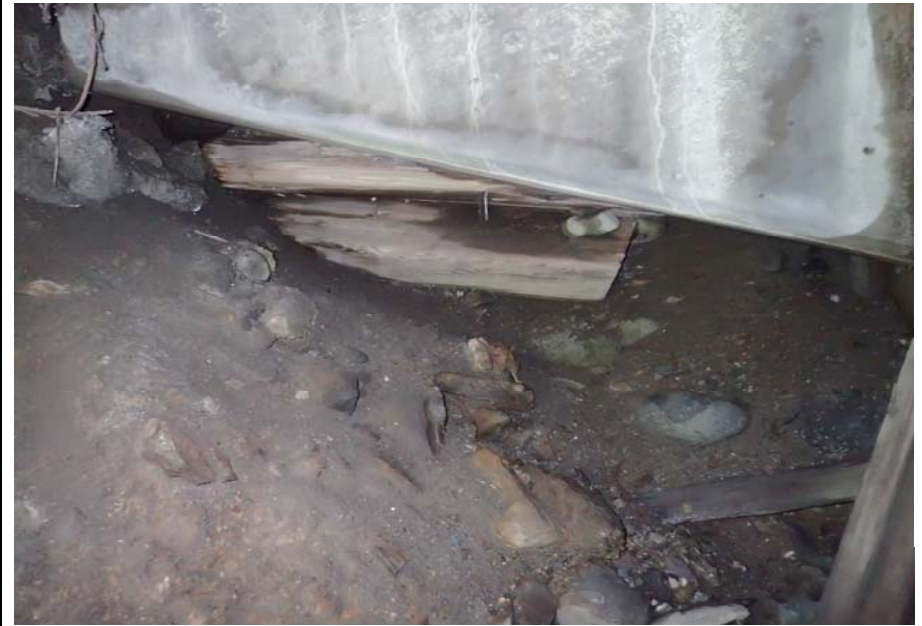
Material sloughing from under cantilever
and sidewalk at FEDS.

Bridge No.	0725	Br. Name	Hoadley Creek	Date	06/21/17
Inspector	Manning / McRae		Frame	38	
FE DS material spilling around wingwall

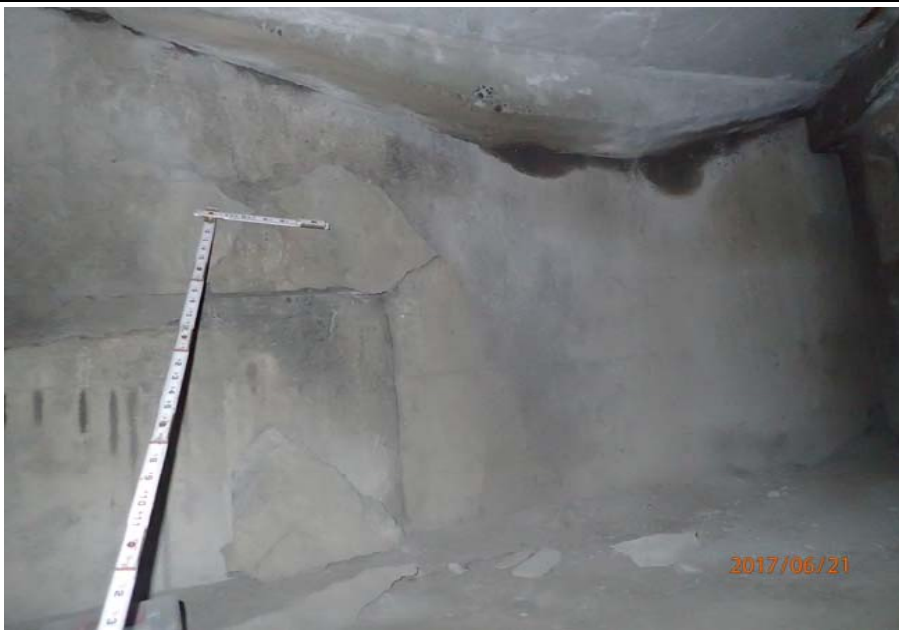
Bridge No.	0725	Br. Name	Hoadley Creek	Date	06/21/17
Inspector	Manning / McRae		Frame	39	
FE backwall cracks, 3rd bay from US

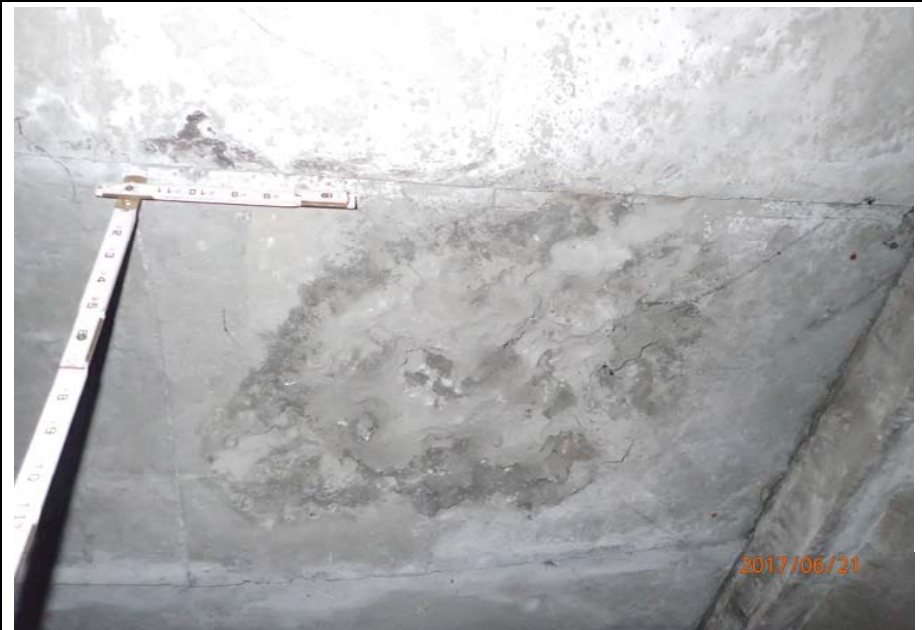
Bridge No.	0725	Br. Name	Hoadley Creek	Date	06/21/17
Inspector	Manning / McRae		Frame	40	
Spall near FE backwall, 3rd bay from US

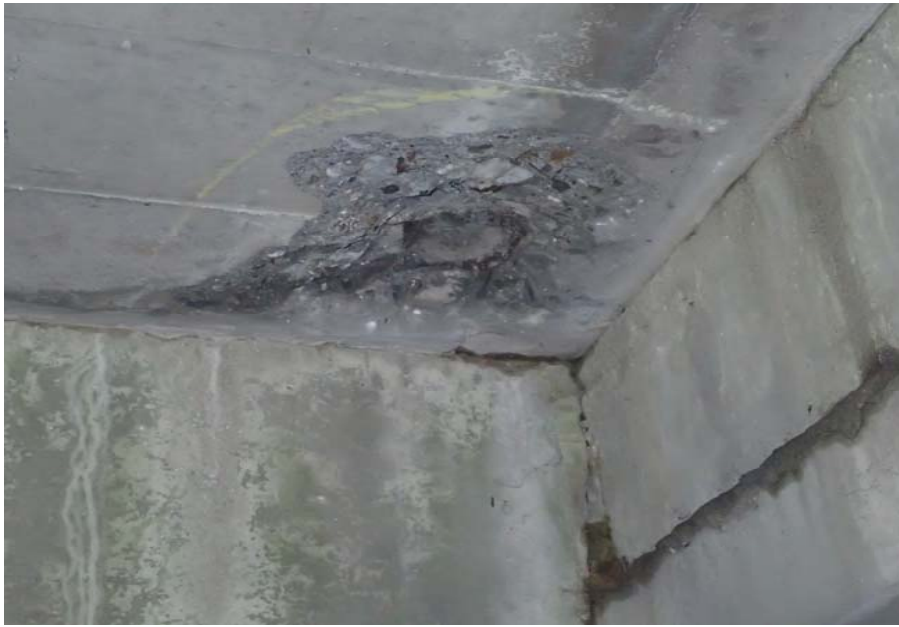
Bridge No.	0725	Br. Name	Hoadley Creek	Date	06/21/17
Inspector	Manning / McRae		Frame	41	
FE DS 1 SF cantilever deck spall with exposed rebar

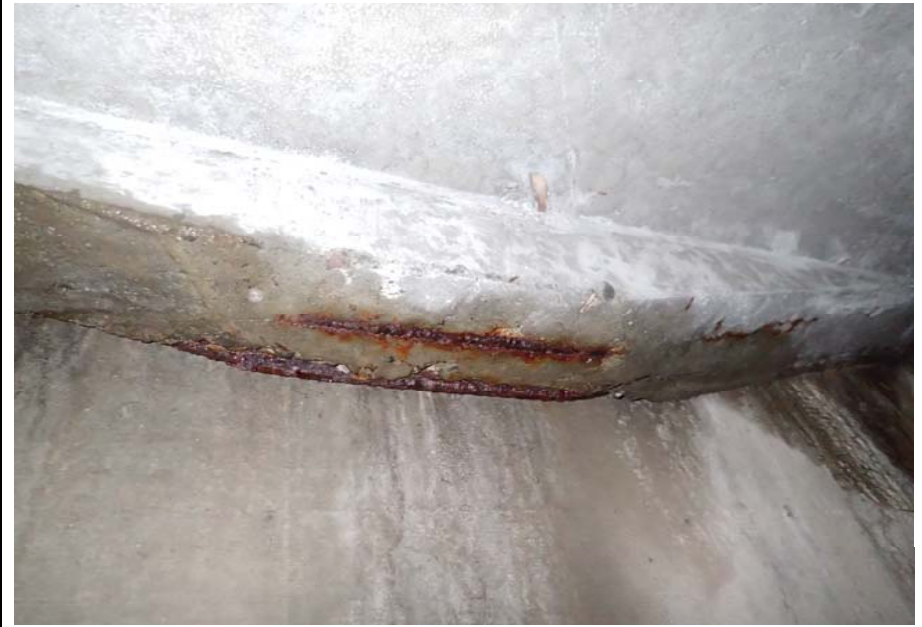
Bridge No.	0725	Br. Name	Hoadley Creek	Date	06/21/17
Inspector	Manning / McRae		Frame	42	
NE abutment, 2nd bay from DS, exposed rebar

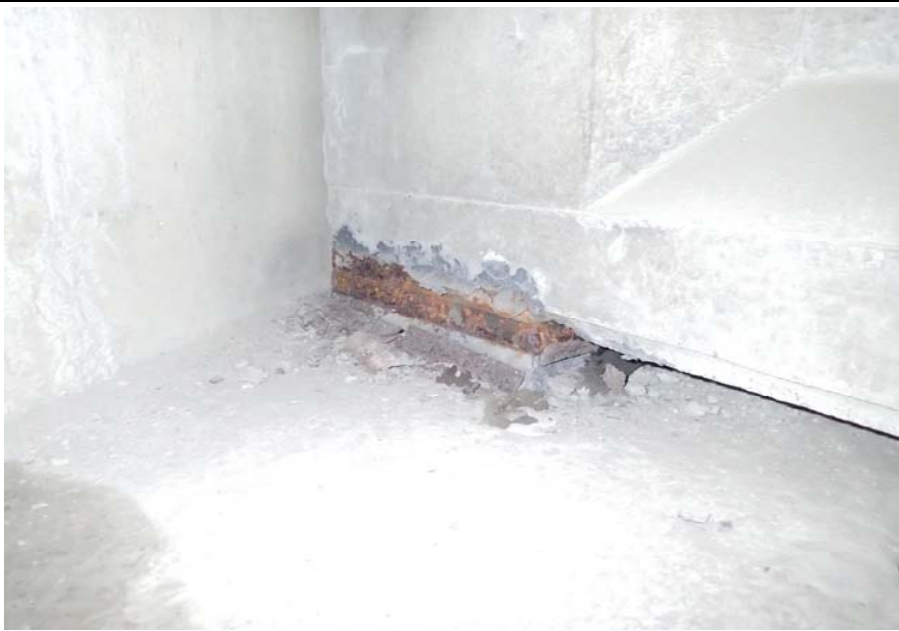
Bridge No.	0725	Br. Name	Hoadley Creek	Date	06/21/17
Inspector	Manning / McRae		Frame	43	
Metal bearing surface rust and minor section loss typical

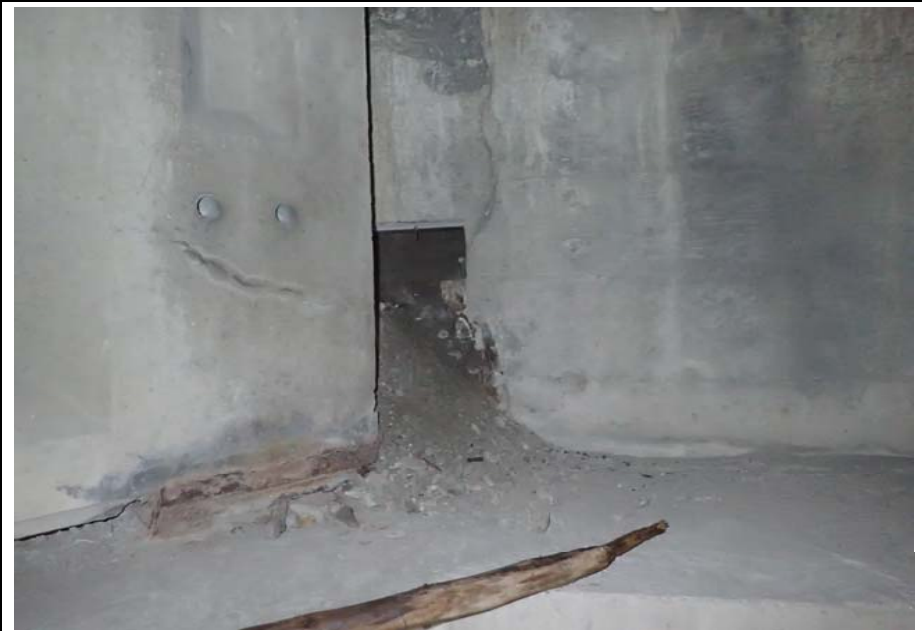
Bridge No.	0725	Br. Name	Hoadley Creek	Date	06/21/17
Inspector	Manning / McRae		Frame	44	
Wet soil spilling through backwall and resting against girder ends

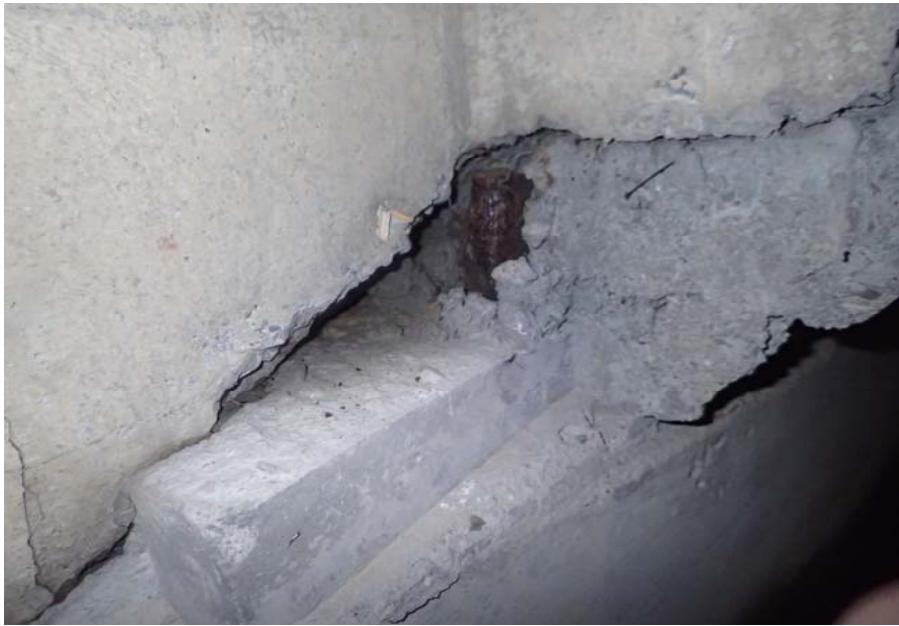
Bridge No.	0725	Br. Name	Hoadley Creek	Date	06/21/17
Inspector	Manning / McRae		Frame	45	
NE abutment, 2nd bay from DS, void 22" deep x 9"

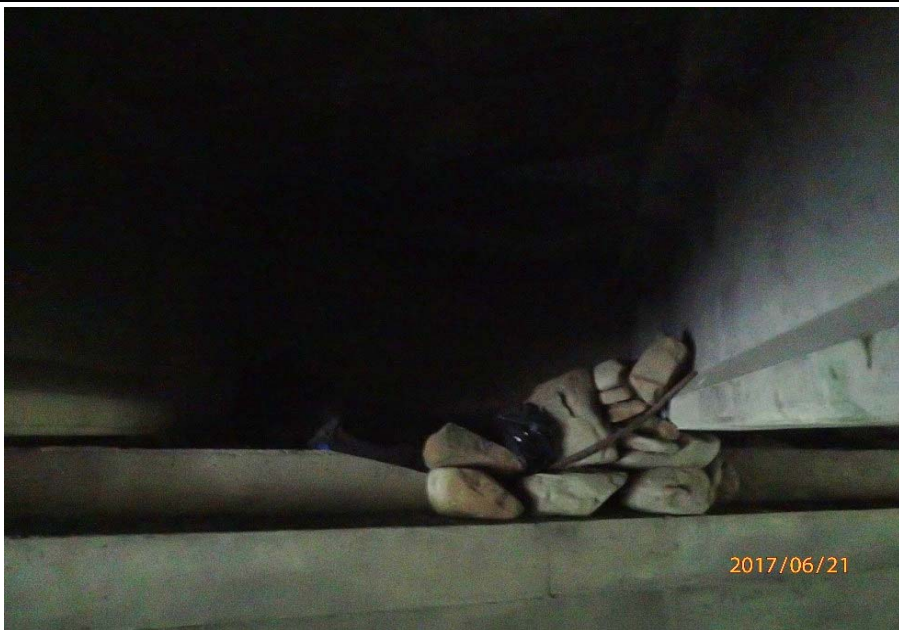
Bridge No.	0725	Br. Name	Hoadley Creek	Date	06/21/17
Inspector	Manning / McRae		Frame	47	
Rocks on FE abutment
