Routine Inspection Report

Date: 6/20/2017

Br No 747 **WARD CREEK**

Bridge No. 0747, WARD CREEK

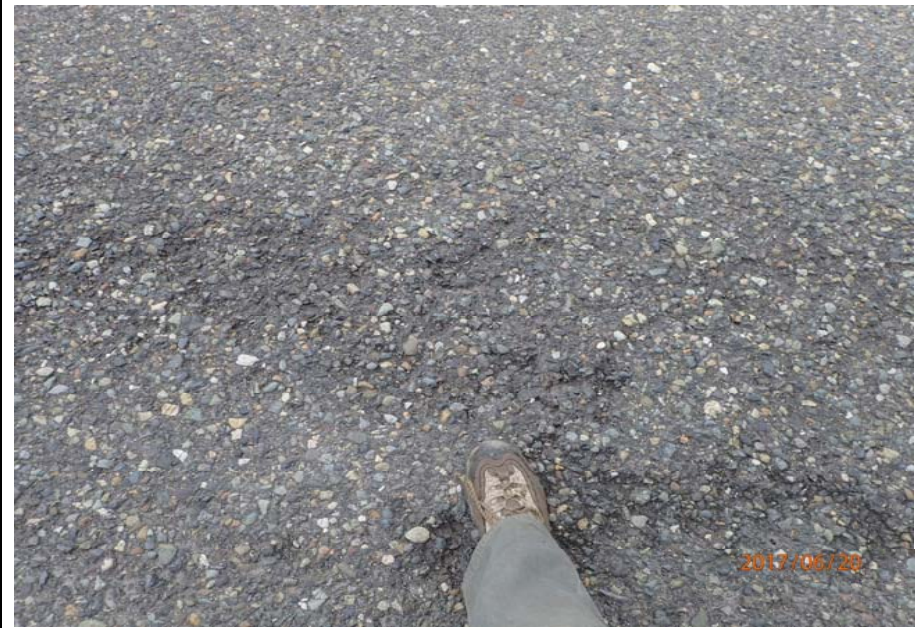
Bridge No.	0747	Br. Name	Ward Creek	Date	06/20/17
Inspector	Manning / McRae		Frame	6	
Wearing surface condition in wheel lines, typical

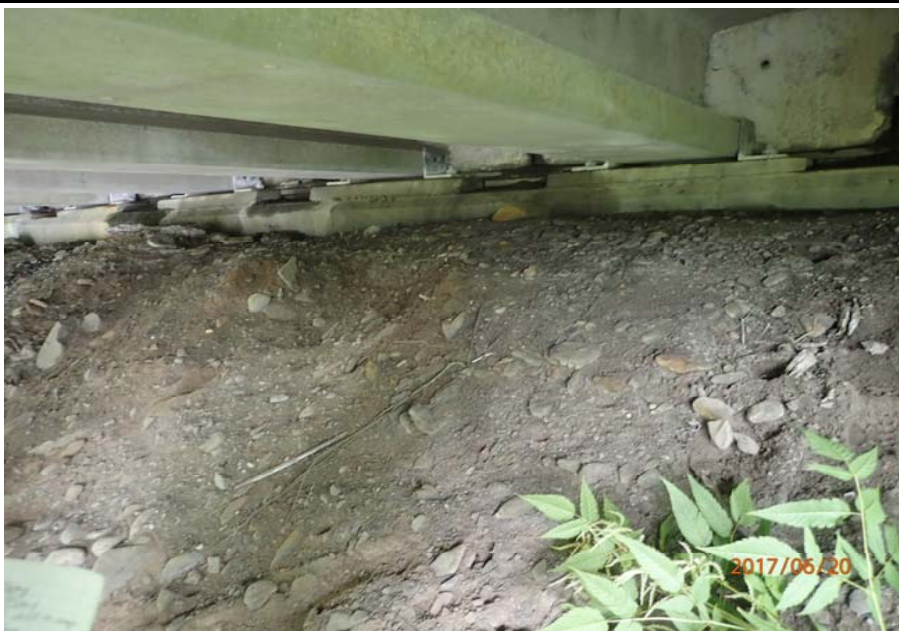
Bridge No.	0747	Br. Name	Ward Creek	Date	06/20/17
Inspector	Manning / McRae		Frame	7	
NE abutment

Undercutting and bank sloughing within
15 ft of NE and FE Abutments.

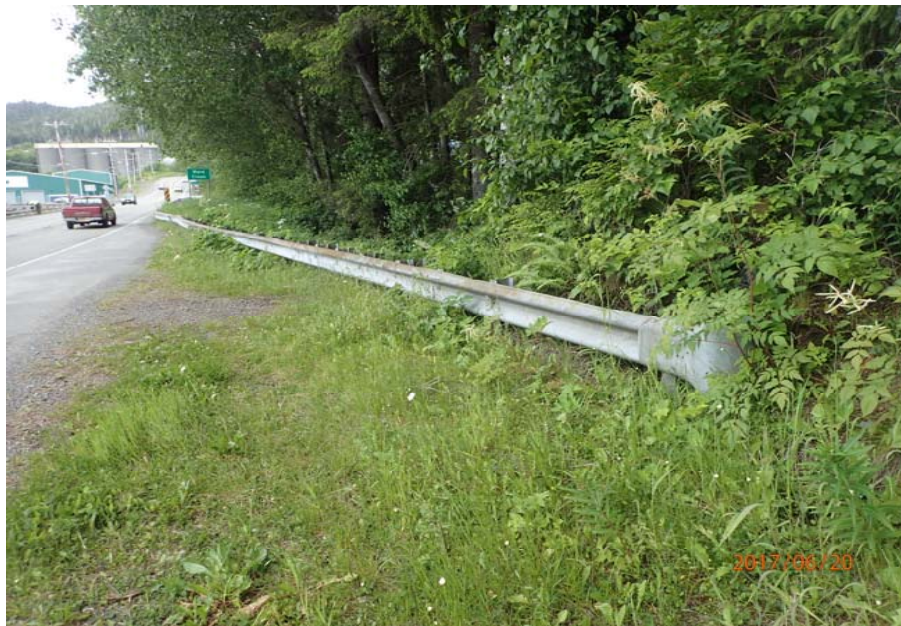
Bridge No.	0747	Br. Name	Ward Creek	Date	06/20/17
Inspector	Manning / McRae		Frame	13	
NE RT end treatment buried in hill

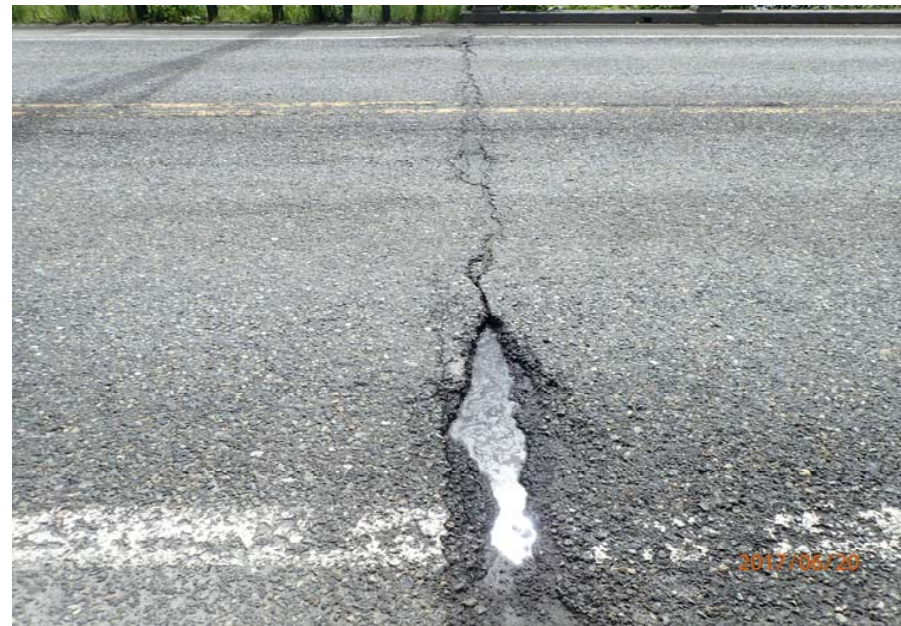
Bridge No.	0747	Br. Name	Ward Creek	Date	06/20/17
Inspector	Manning / McRae		Frame	14	
NE joint, potholes in RT lane

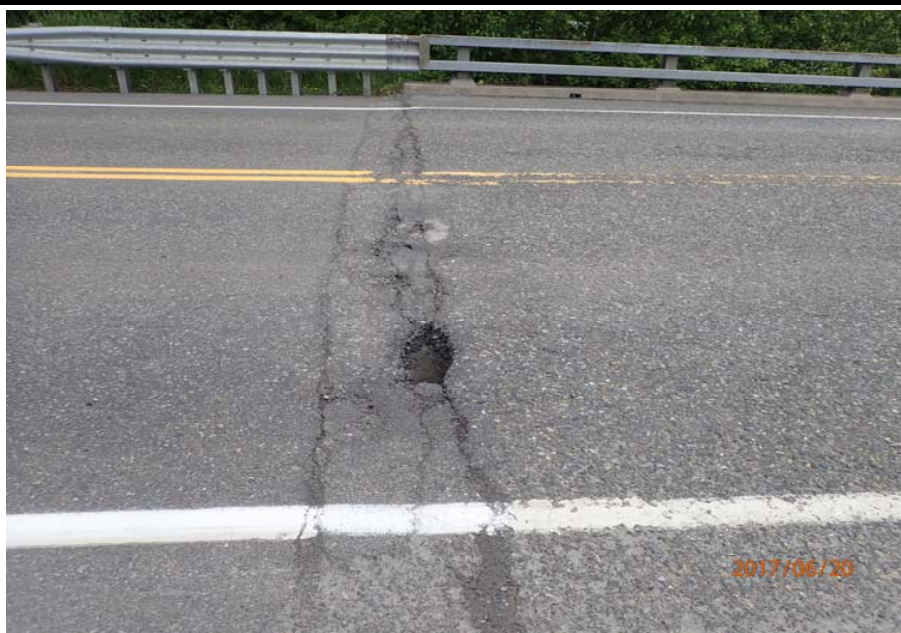
Bridge No.	0747	Br. Name	Ward Creek	Date	06/20/17
Inspector	Manning / McRae		Frame	15	
FE joint, potholes in LT lane

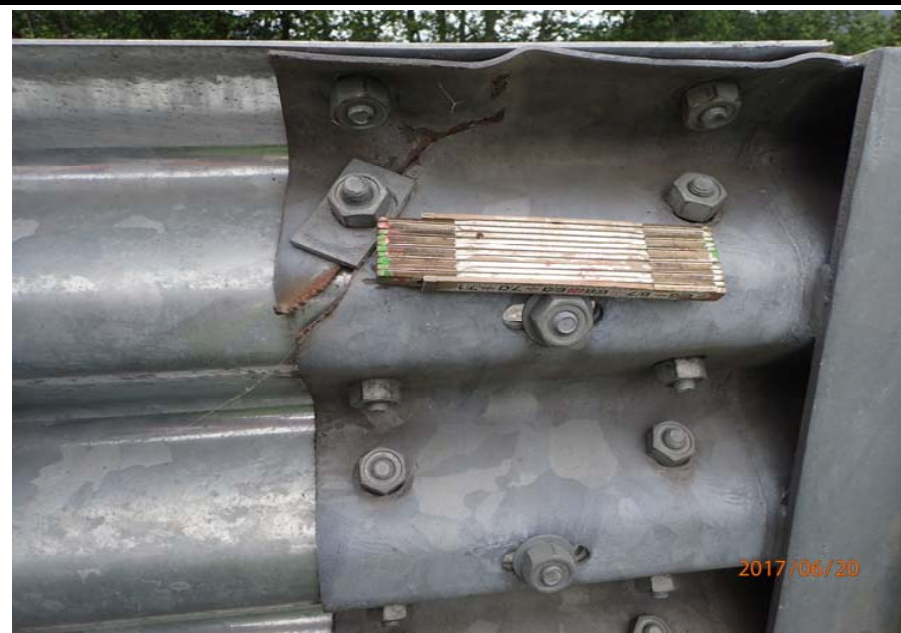
Bridge No.	0747	Br. Name	Ward Creek	Date	06/20/17
Inspector	Manning / McRae		Frame	16	
FE LT transition rail damage

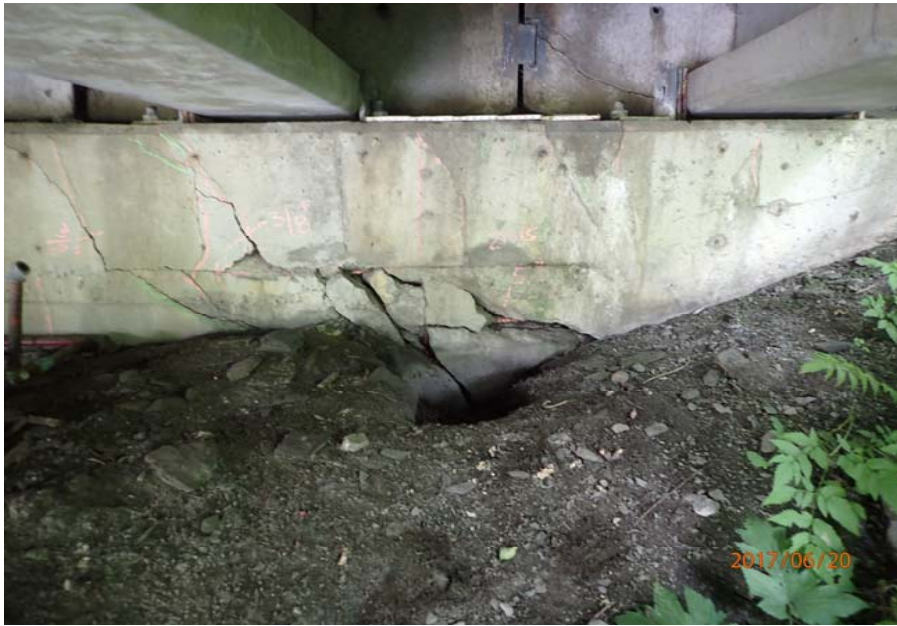
Bridge No.	0747	Br. Name	Ward Creek	Date	06/20/17
Inspector	Manning / McRae		Frame	17	
Damage to cap and backwall at FE RT bay

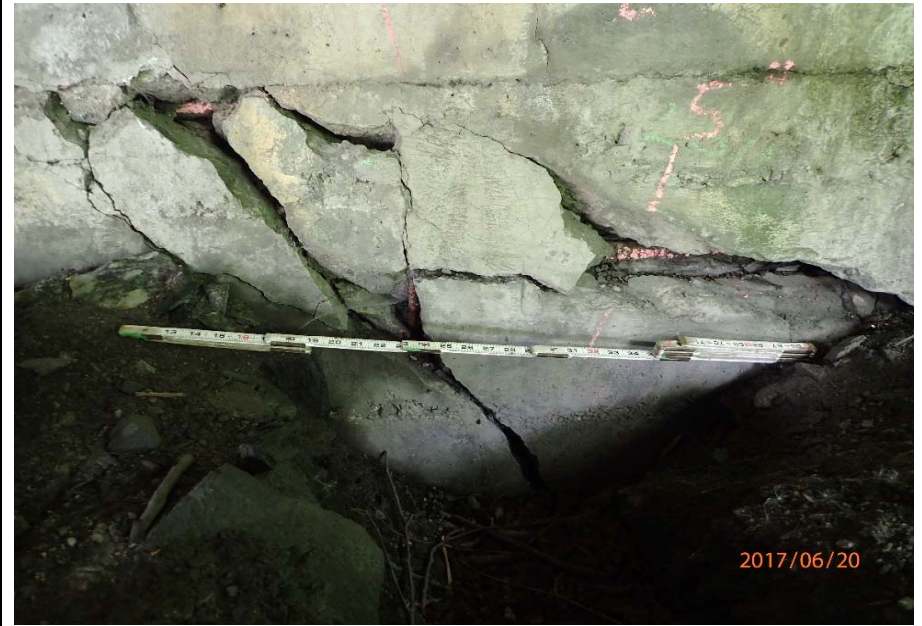
Bridge No.	0747	Br. Name	Ward Creek	Date	06/20/17
Inspector	Manning / McRae		Frame	18	
FE abutment, RT bay, close up of cap damage, exposed rebar

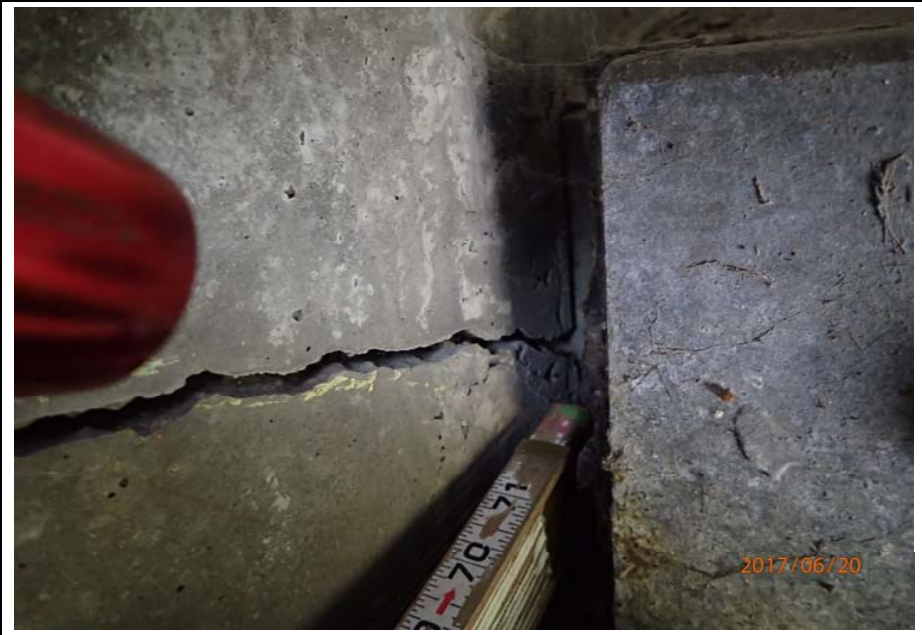
Bridge No.	0747	Br. Name	Ward Creek	Date	06/20/17
Inspector	Manning / McRae		Frame	20	
FE abutment, RT bay, terminus of backwall crack behind girder bottom flange

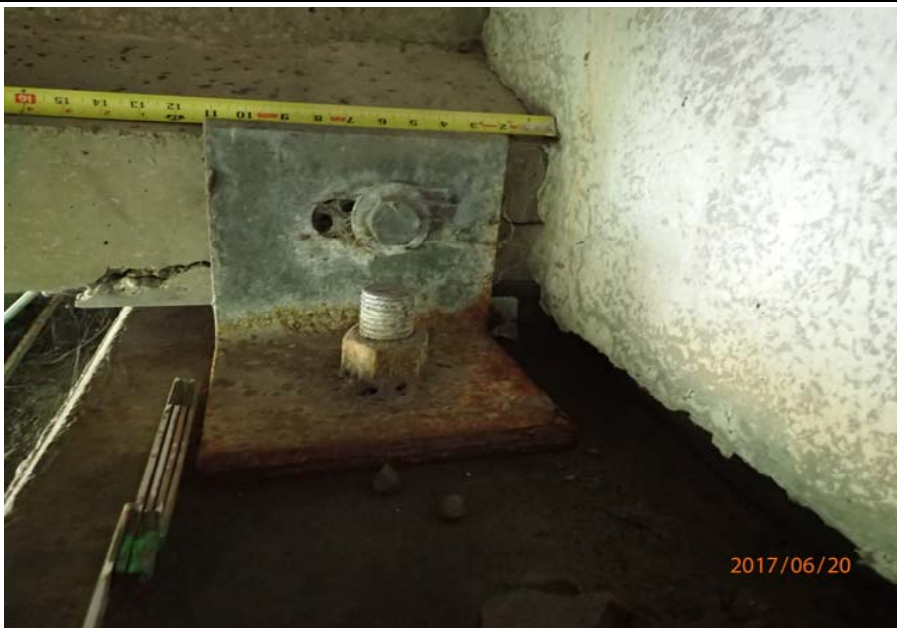
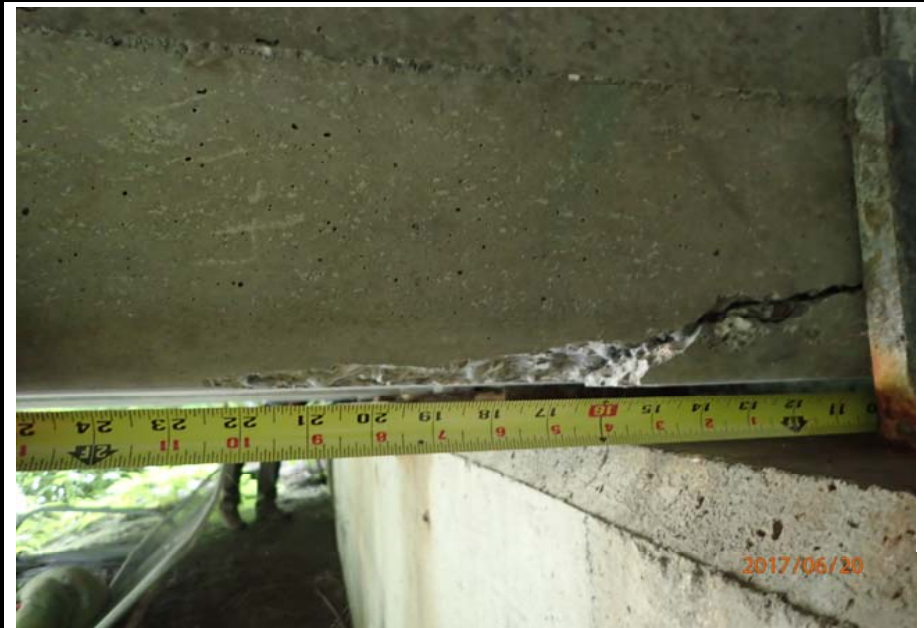
Bridge No.	0747	Br. Name	Ward Creek	Date	06/20/17
Inspector	Manning / McRae		Frame	23	
FE abutment, 2nd bay from RT, G4 RT side crack in bottom flange

Bridge No.	0747	Br. Name	Ward Creek	Date	06/20/17
Inspector	Manning / McRae		Frame	24	
FE abutment, 2nd bay from RT, G4 RT side crack in bottom flange

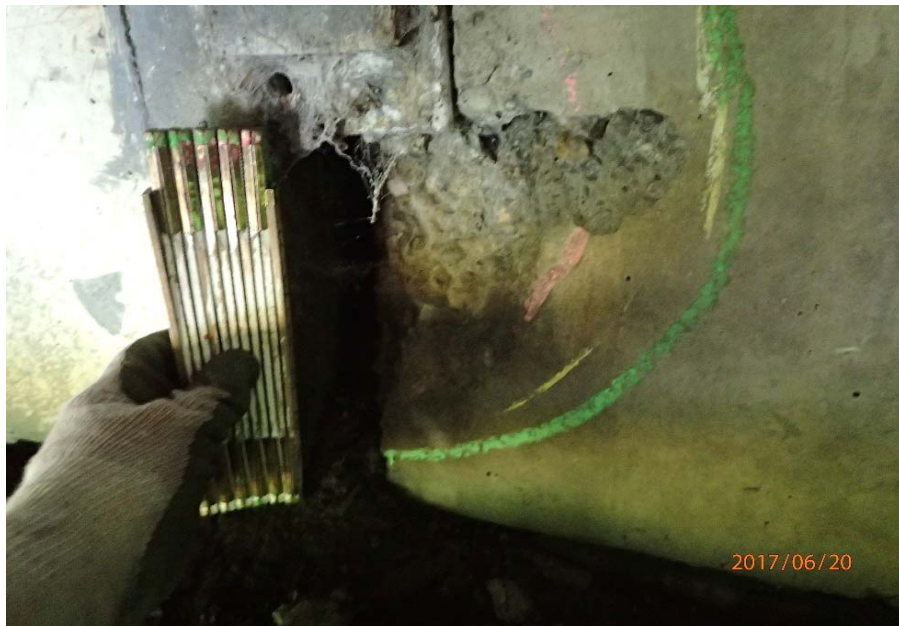
Bridge No.	0747	Br. Name	Ward Creek	Date	06/20/17
Inspector	Manning / McRae		Frame	25	
FE abutment, 2nd bay from RT, spall in backwall

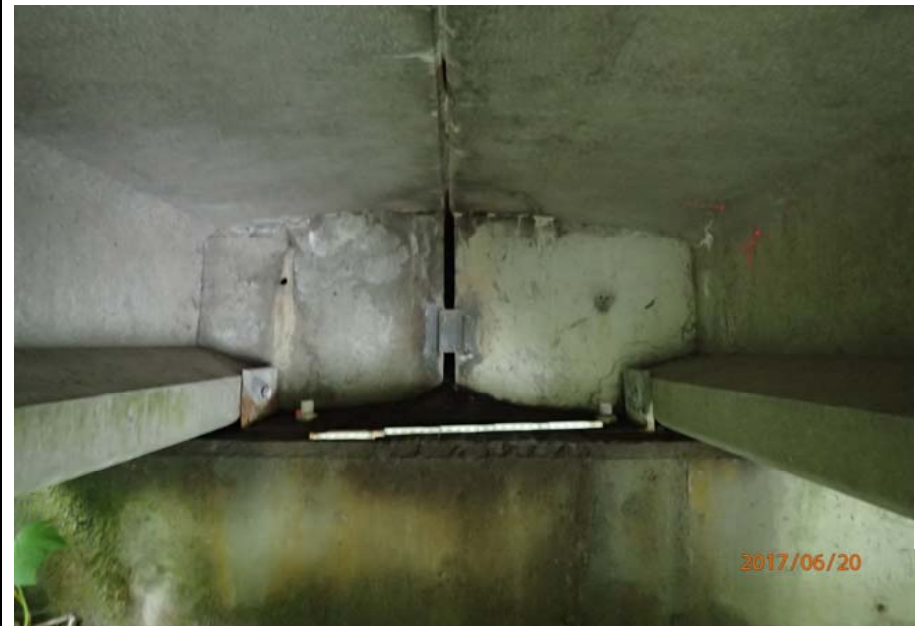
Bridge No.	0747	Br. Name	Ward Creek	Date	06/20/17
Inspector	Manning / McRae		Frame	26	
Fill coming through backwall typical (FE abutment, LT bay shown)

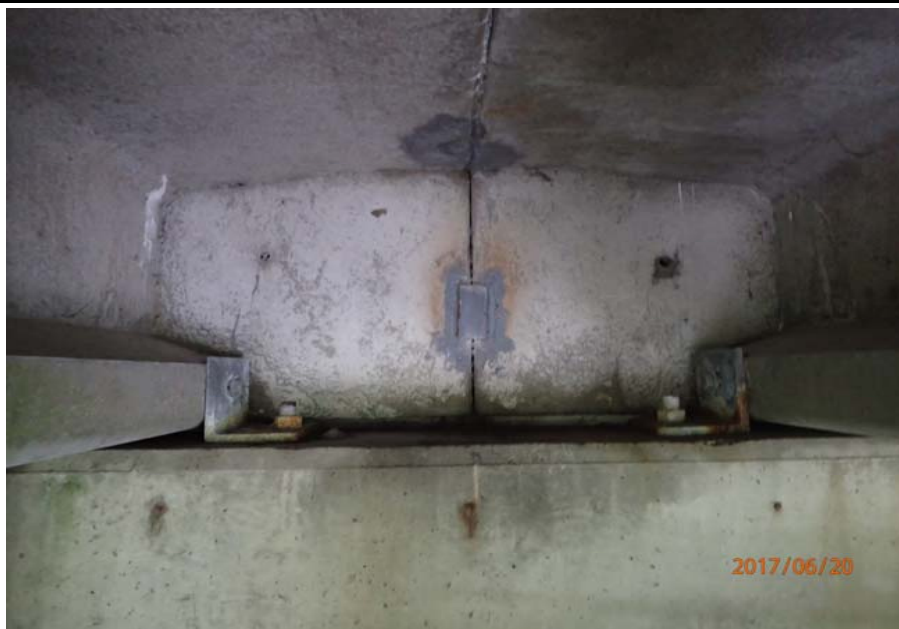
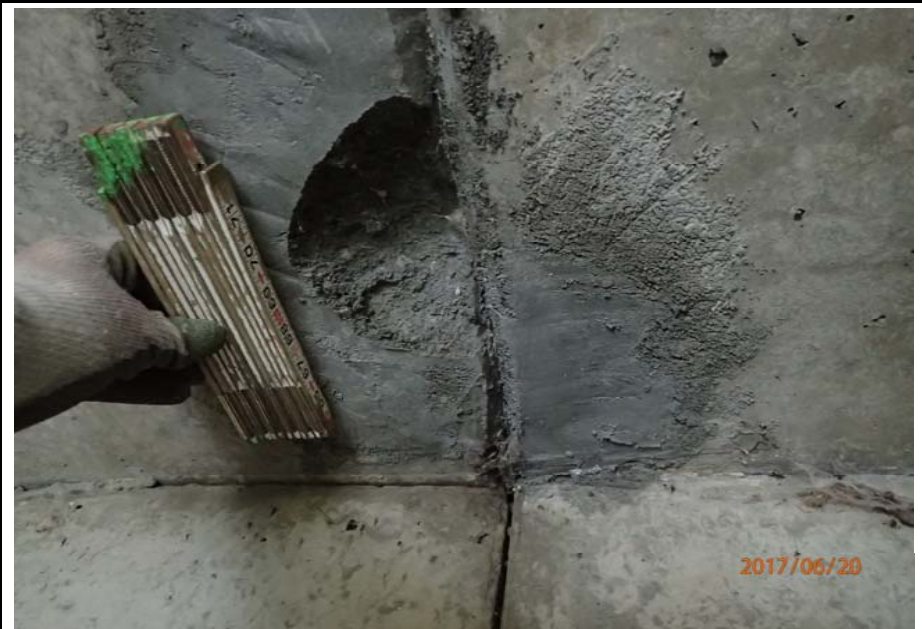
Bridge No.	0747	Br. Name	Ward Creek	Date	06/20/17
Inspector	Manning / McRae		Frame	27	
FE, 4th bay from RT, spall in bottom of deck at backwall

Bridge No.	0747	Br. Name	Ward Creek	Date	06/20/17
Inspector	Manning / McRae		Frame	28	
FE, 4th bay from RT, spall in bottom of deck at backwall

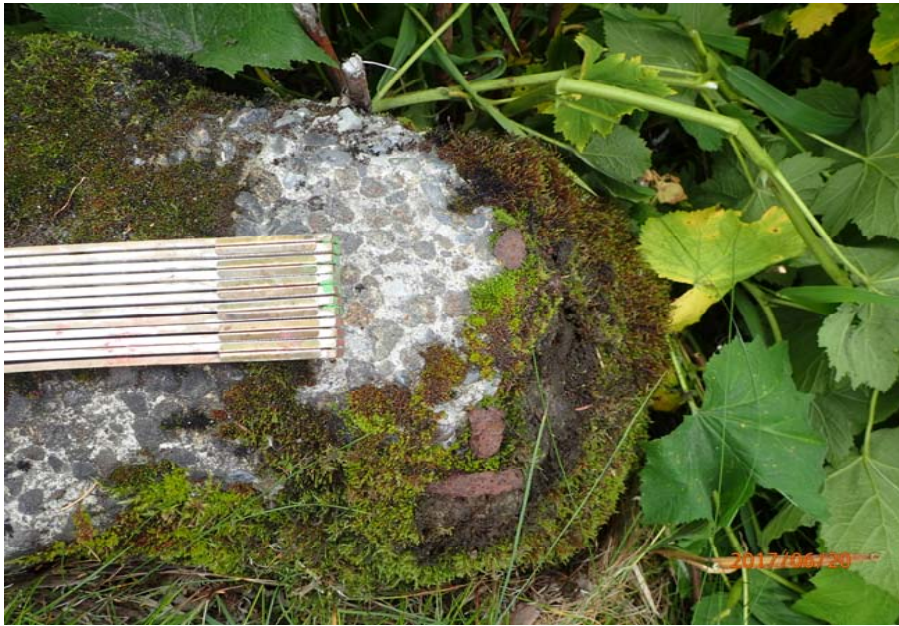
Bridge No. 0747 Br. Name Ward Creek Date 06/20/17
 Inspector Manning / McRae Frame 29
FE LT wingwall spall with exposed rebar

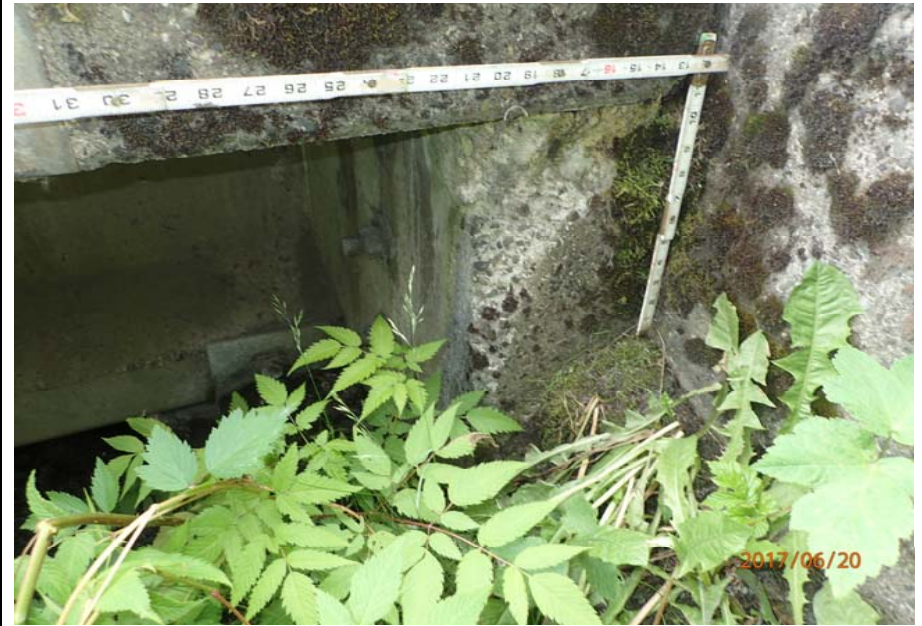
Bridge No. 0747 Br. Name Ward Creek Date 06/20/17
 Inspector Manning / McRae Frame 30
FE RT spall in hider wall

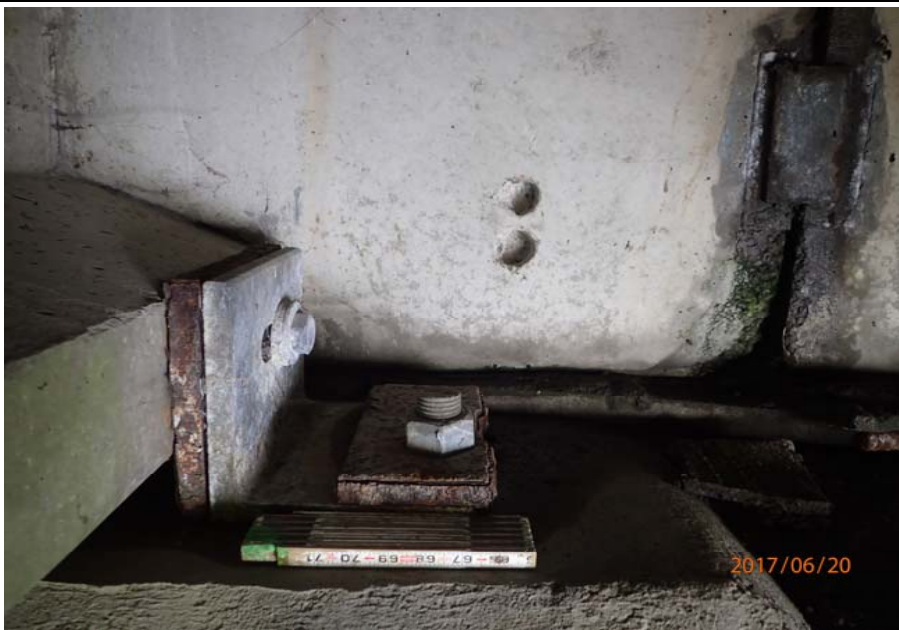
Bridge No. 0747 Br. Name Ward Creek Date 06/20/17
 Inspector Manning / McRae Frame 31
NE RT girder anchor showing rust and section loss

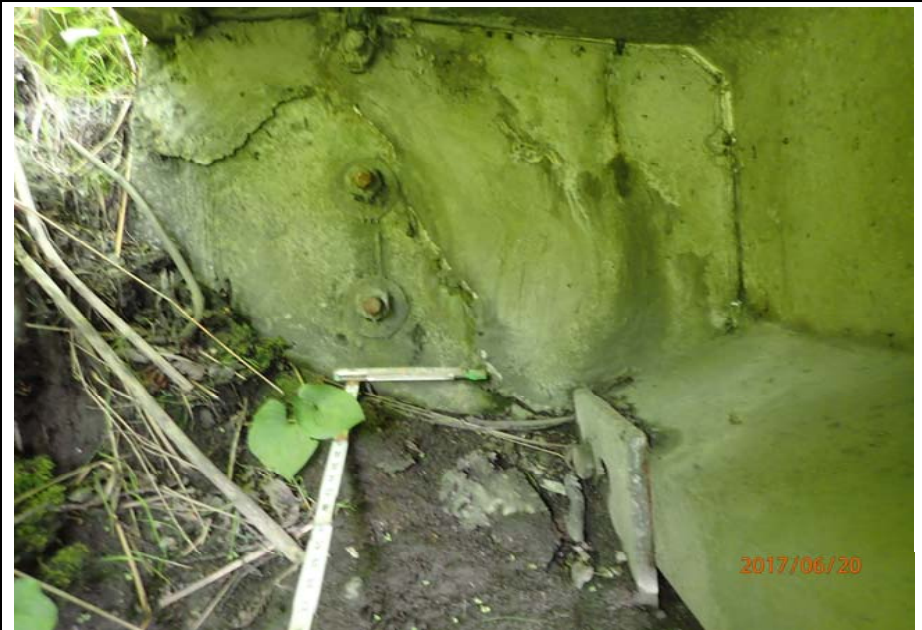
Bridge No. 0747 Br. Name Ward Creek Date 06/20/17
 Inspector Manning / McRae Frame 32
NE RT corner, spalls in backwall

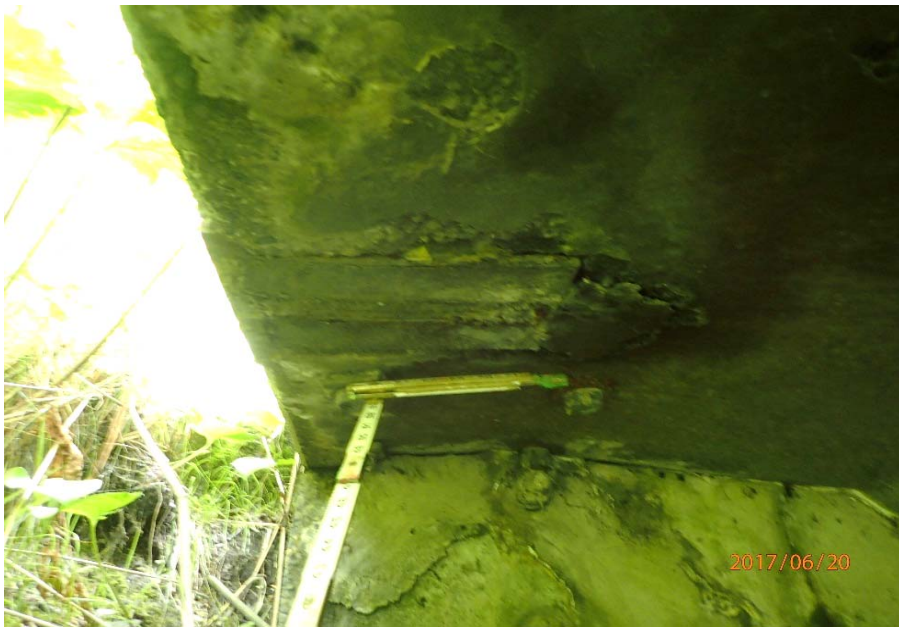
Bridge No. **0747** Br. Name **Ward Creek** Date **06/20/17**
 Inspector **Manning / McRae** Frame **33**
NE RT corner, spall in soffit

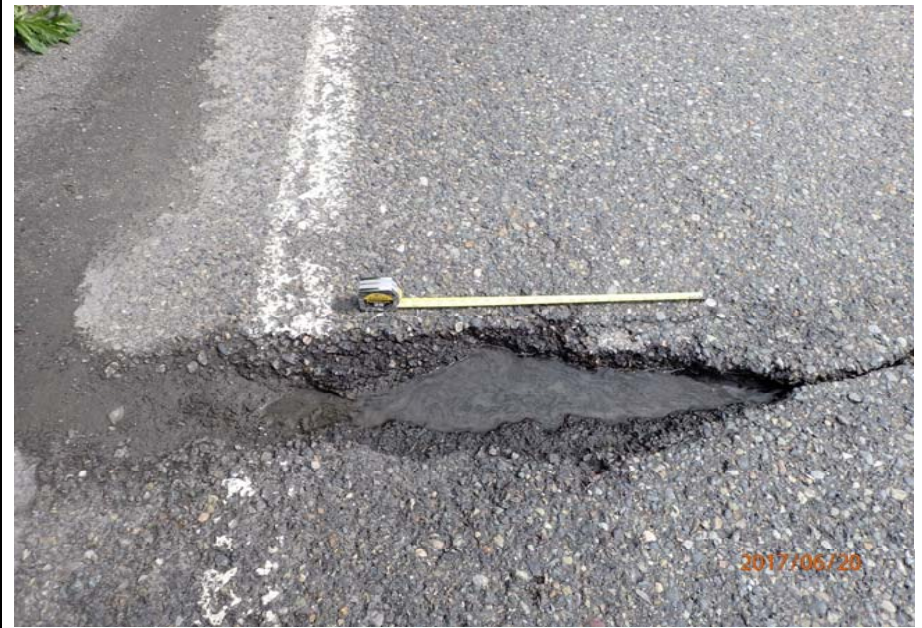
Bridge No. **0747** Br. Name **Ward Creek** Date **06/20/17**
 Inspector **Manning / McRae** Frame **34**
NE RT lane, pothole at joint

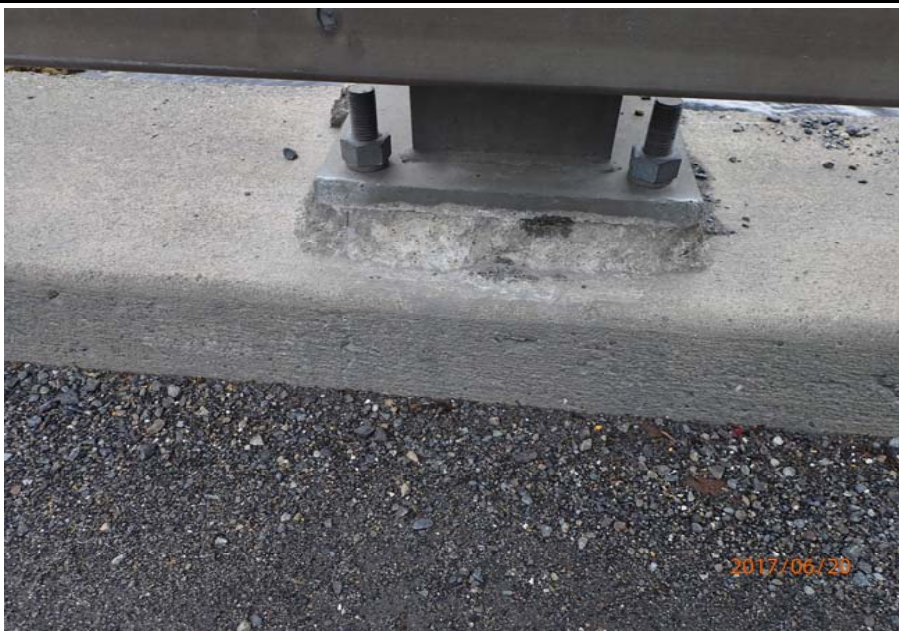
> 515	<i>Steel Protective Coating</i>	
310	Elastomeric Bearing	None.
330	Metal Bridge Railing	Eight DS rail post grout pads spalled or cracked. 75% paint loss on rail with 5% surface rust.
> 515	<i>Steel Protective Coating</i>	
600	Signs Smart Flag	NERT object marker damaged. No FE object markers.
602	Approach Rail Smart Flag	5th post from NELT tension side flange torn and three others nicked. NERT 2 steel spacers twisted and two w-beam sections damaged.
604	Bank Protection Smart Flag	Bank sloughing at NE and FE.

Bridge No. **0747** Br. Name **Ward Creek** Date **06/20/17**
 Inspector **Manning / McRae** Frame **35**
Damaged grout pads, typical of span 2 LT

<i>Priority</i>	<i>Description</i>	<i>Quantity</i>	<i>Work Needed</i>
High	Bridge Rail-Repair (LF)	8	Replace DS spalled grout pads.
High	Approach Railing-Repair (EA)	8	Replace NELT rail post. Replace NERT twisted spacers. Replace NERT damaged W-beam (about 25ft).
High	Superstructure-Rehab (EA)	7	Rehab or replace FE abutment cap.
Medium	Misc-Install Sign (EA)	3	Install FE object markers. Replace NERT object marker.
Medium	Misc-Remove Vegetation	1	Remove brush from all four corners of the bridge.

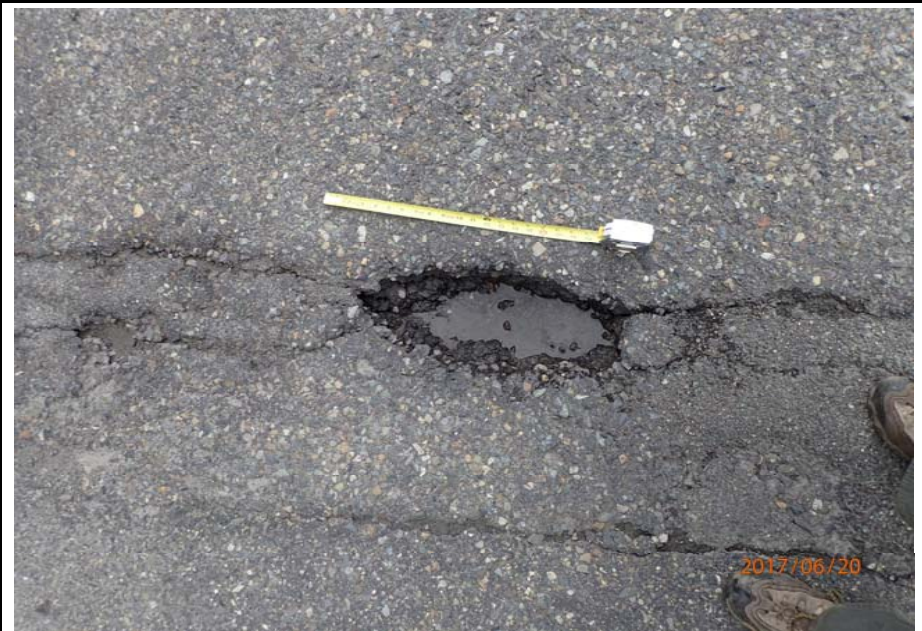
Bridge No. **0747** Br. Name **Ward Creek** Date **06/20/17**
 Inspector **Manning / McRae** Frame **36**
FE LT lane, pothole at joint
