ANALYSIS OF RUTTING FOR ANCHORAGE PAVEMENTS

PURPOSE

Understand Rutting Mechanisms and Recommend Methods to Reduce Rutting in Anchorage.

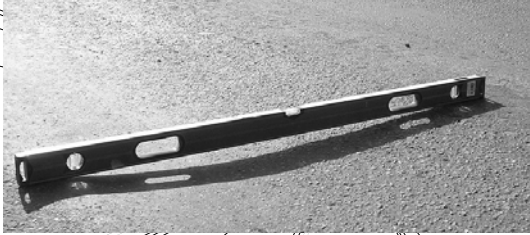
Wheel path voids were consistently lower than 3% and below 1.5% for many dense graded Mixes

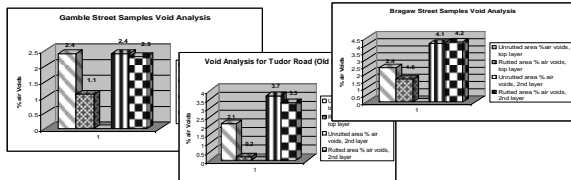
Wheel path voids increased in wheel path for SMA's except for Diamond.

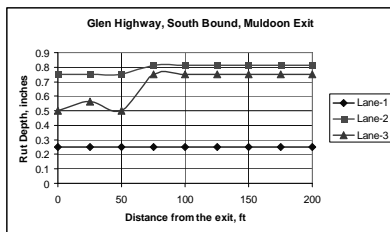
Glenn highway exhibited stripping between layers.

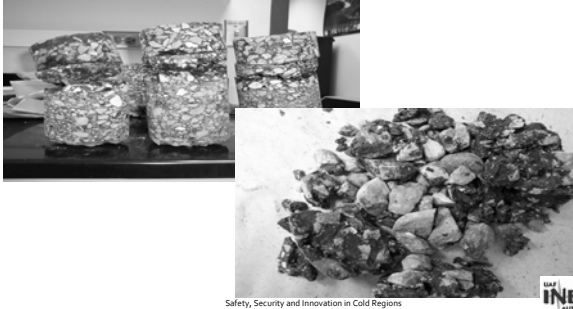
PlusRide mix on C-Street performing well even though voids are between 1.7 and 2% after 20 years.
