Alaska Department of
Transportation & Public Facilities

Microsurfacing Experimental Feature Minnesota Drive Ramps

Drew Pavey
Pavement Management
November 2023

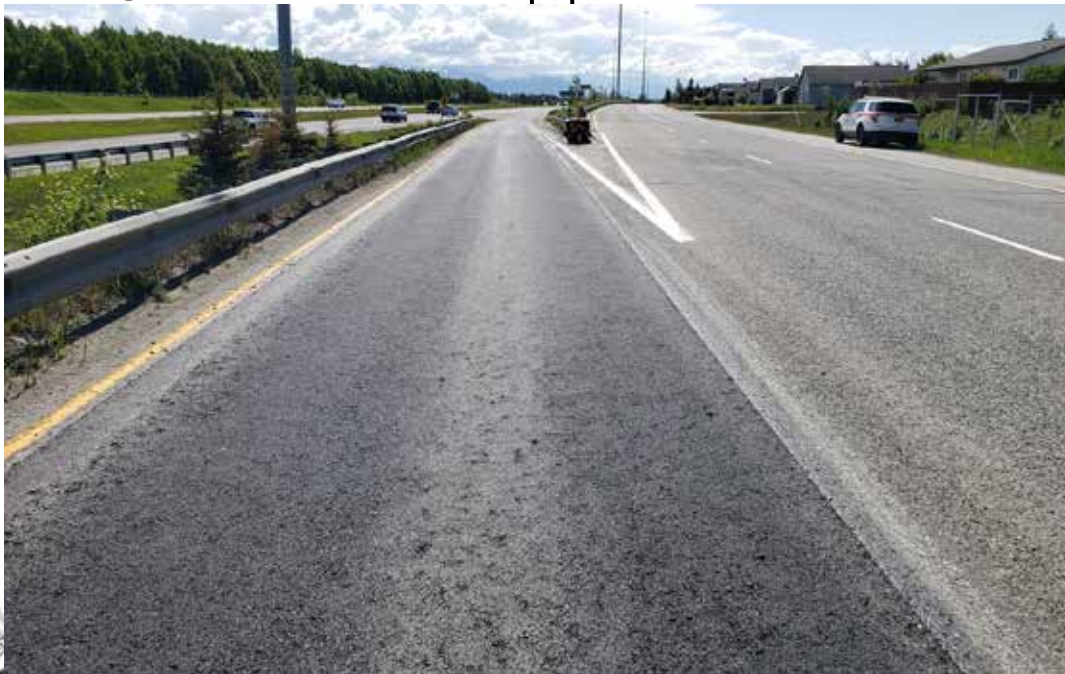
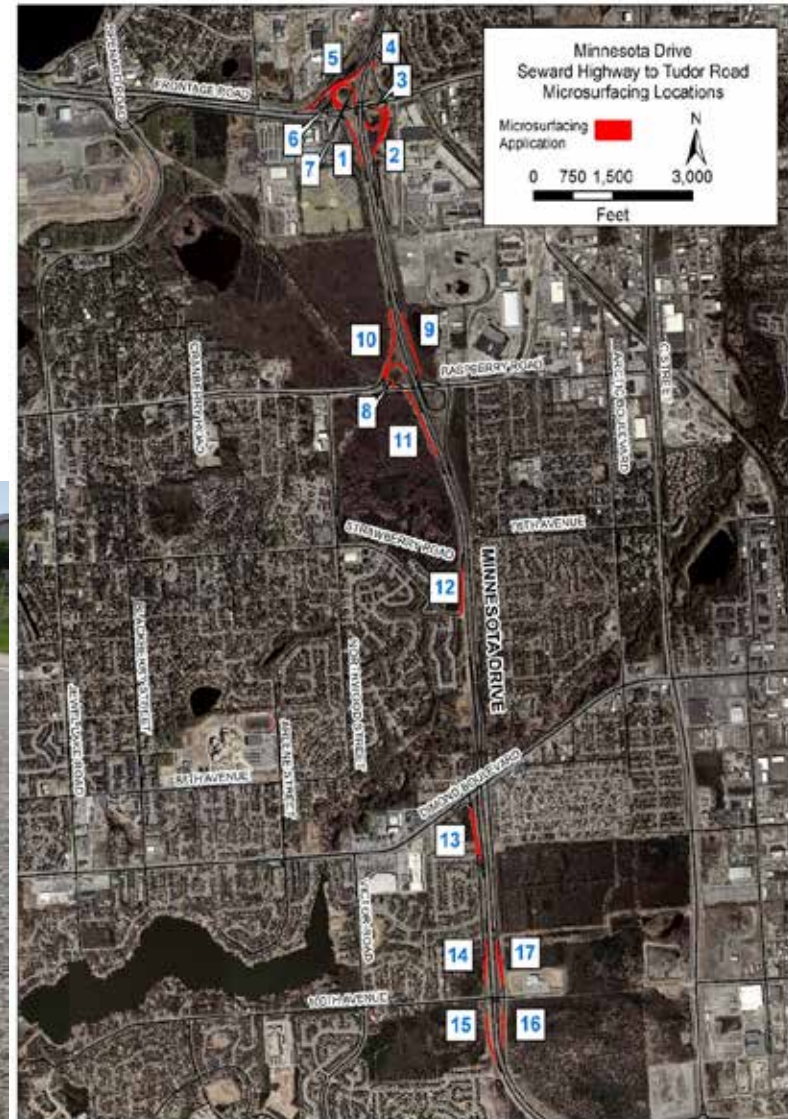
- Placed on Minnesota Ramps
 - § Ruts had deepened, added a pre-level to rut fill on some ramps (change order)
 - § Did crack filling and then a tack coat prior to microsurfacing application
 - § See Dimond ramp pre-level below

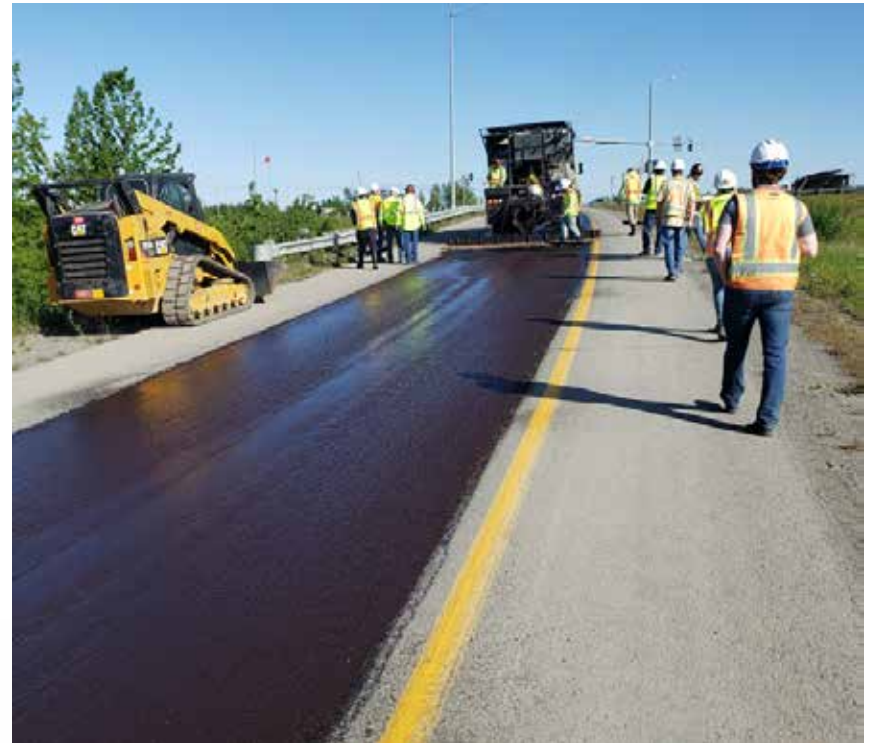
- Started off smooth, then things went south
 - § 3 hours to get roller on micro – slower, not faster than test strip
 - § In curves on ramp started breaking too fast – clogging in spreader box
 - § So, it is becoming unworkable but not hardening
- Lots of testing done to determine what changed
- Informed the binder was different. Oil production shut down – different reaction from original mix design.

- Ramps reopened after about 3 hours – shut down production to investigate
- Shut down for 2 days (also due to weather)
- Additives were changed from **Lime** to **Cement and Aluminum Sulphate**. New Mix Design Performed. This change allowed rollers to get back within 2 hours.
- Now lateral displacement is within spec

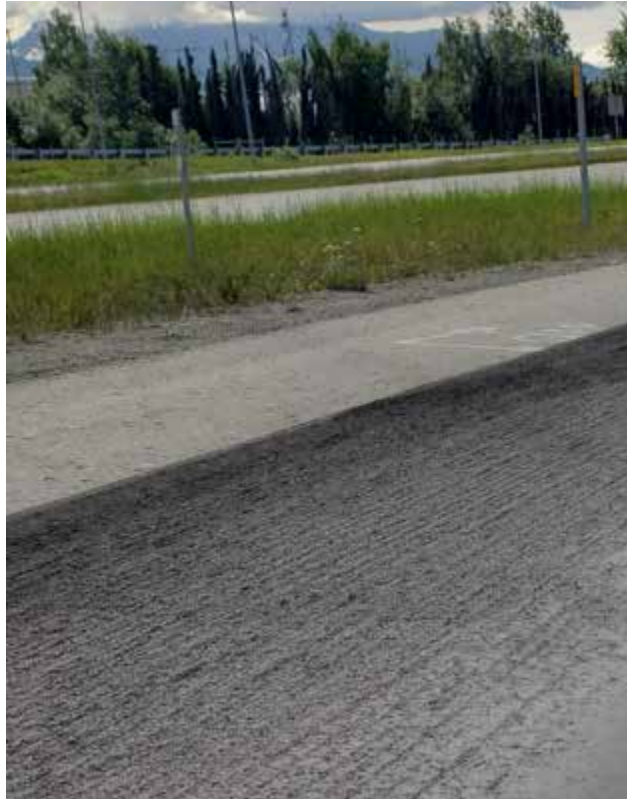
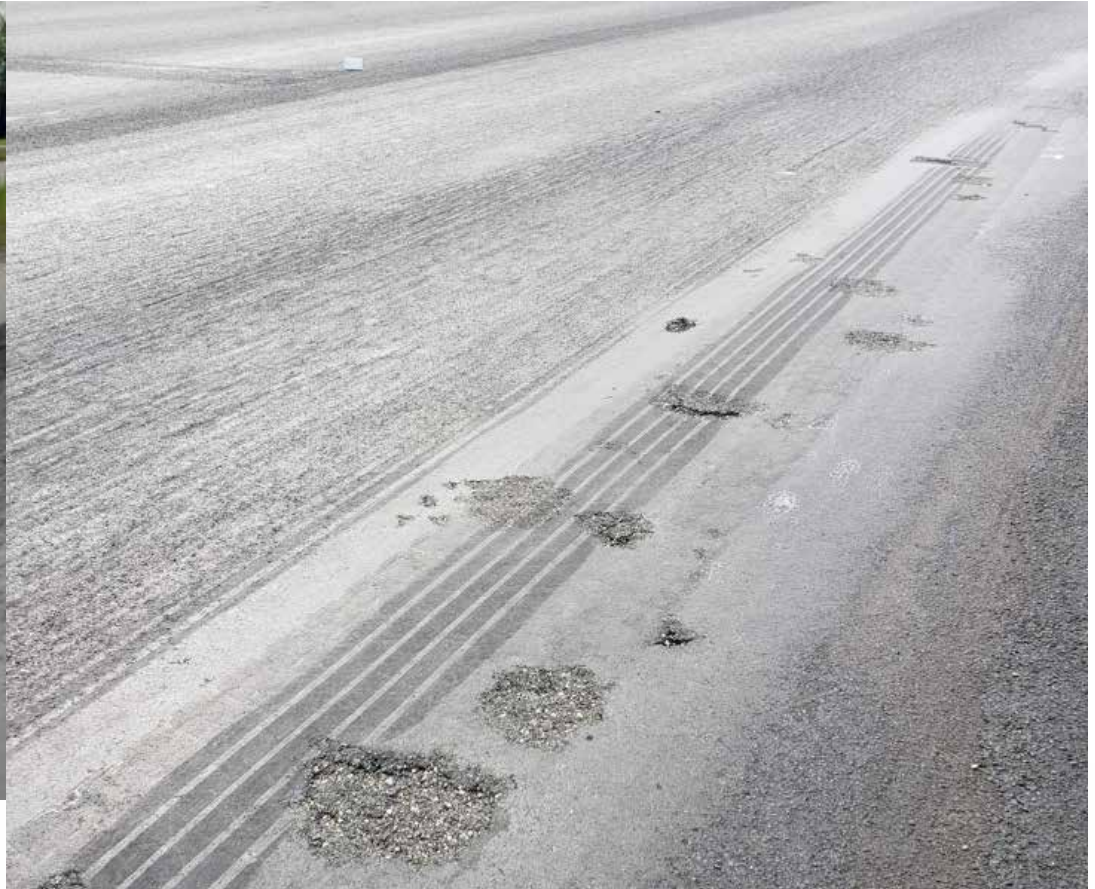
- Production continued – seemed to be going smooth
- International Airport Ramps Flushed/Damaged

- From the flushing distress there was a friction concern
- Performed friction testing – showed loss in flushed areas – mill/fill with 1.5" HMA at 5 ramps with friction loss.
- Most ramps removed were being used to haul gravel to AIA. Heaviest loads.
- Remaining ramps are being monitored. This year the final report going out on for the ramp performance and lessons learned.

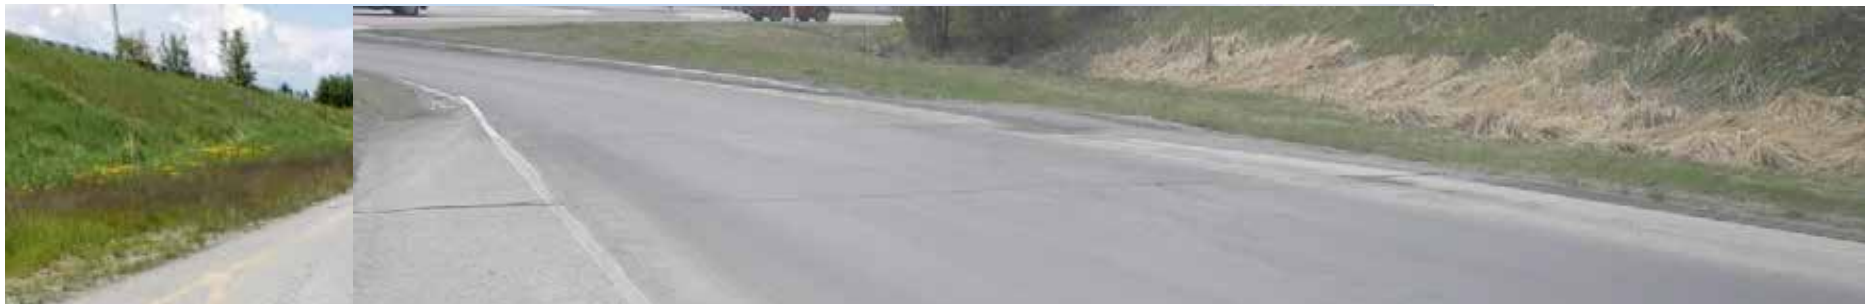
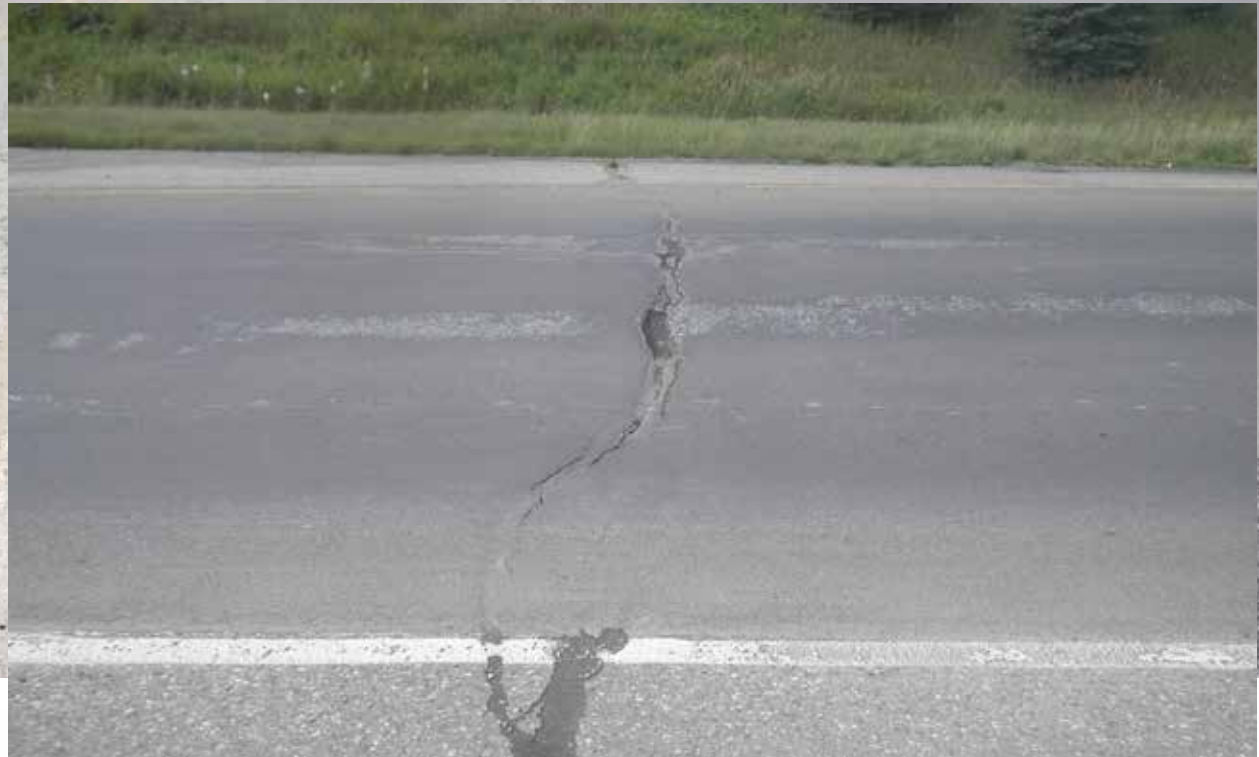
100th Avenue - NB Off Ramp

- Performance is mixed based on original ramp condition
 - § Cracks reflected through (expected)
 - § Ramps that were in poor condition are back in poor
 - § Ramps that were fair or good are in fair or good condition
- Cored and Prall tested the micro post-construction
 - § Needed value after changing additives
 - § Unfortunately, increased to 30 – not resistant to studs
 - § Cement likely made brittle, prone to wear
