CONCRETE BRIDGE DECK CORROSION

IN ALASKA

FINAL REPORT

March 1984

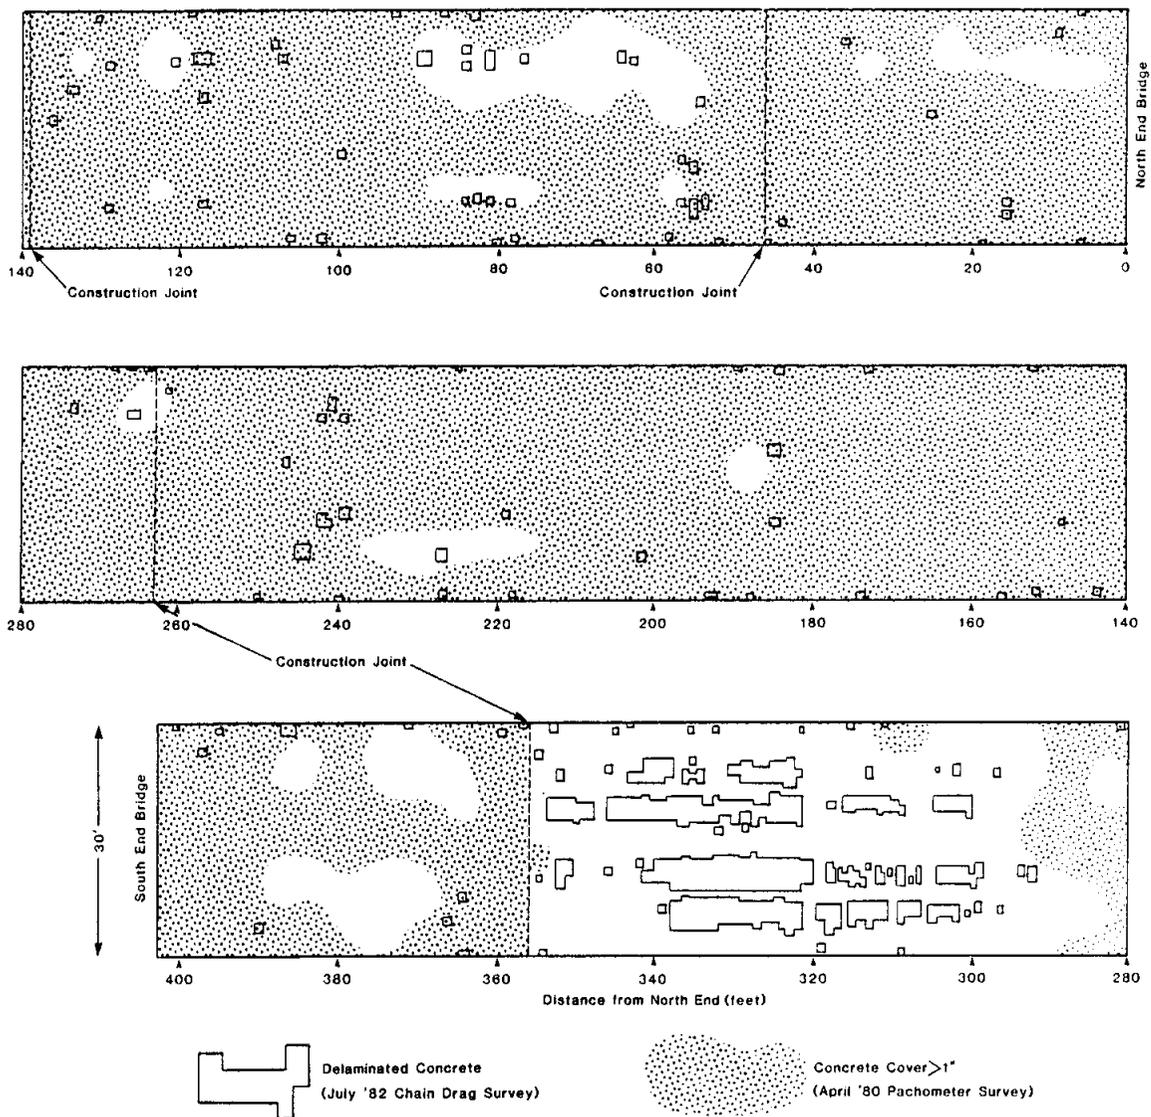
Figure 4-3: Concrete Cover Depth and Delaminations, Wendell Street Bridge

The correlation between insufficient cover over rebars and concrete damage was most striking on the Wendell Street Bridge deck. Nearly all of the unsound concrete removed during repairs was located in an area, about sixty feet long, where cover was less than one inch (see Figure 4-3). The remainder of the deck, where cover in most places exceeded one inch, was in fairly good condition.

The cathodic protection system installed on the Wendell Street Bridge used anode wires grouted into slots spaced two feet apart along the length of the bridge. It was planned to saw the slots in the original concrete, and cover them with a single concrete overlay. Due to insufficient cover in some areas (3/4 of an inch was needed) this could not be done without locating anodes too close to the rebar. An initial overlay was therefore needed in which to cut the anode slots. This resulted in significantly higher costs for the project. Cathodic protection system costs on Wendell Street would have been more than 40% lower if there had been as much concrete cover as was shown in the original bridge plans.

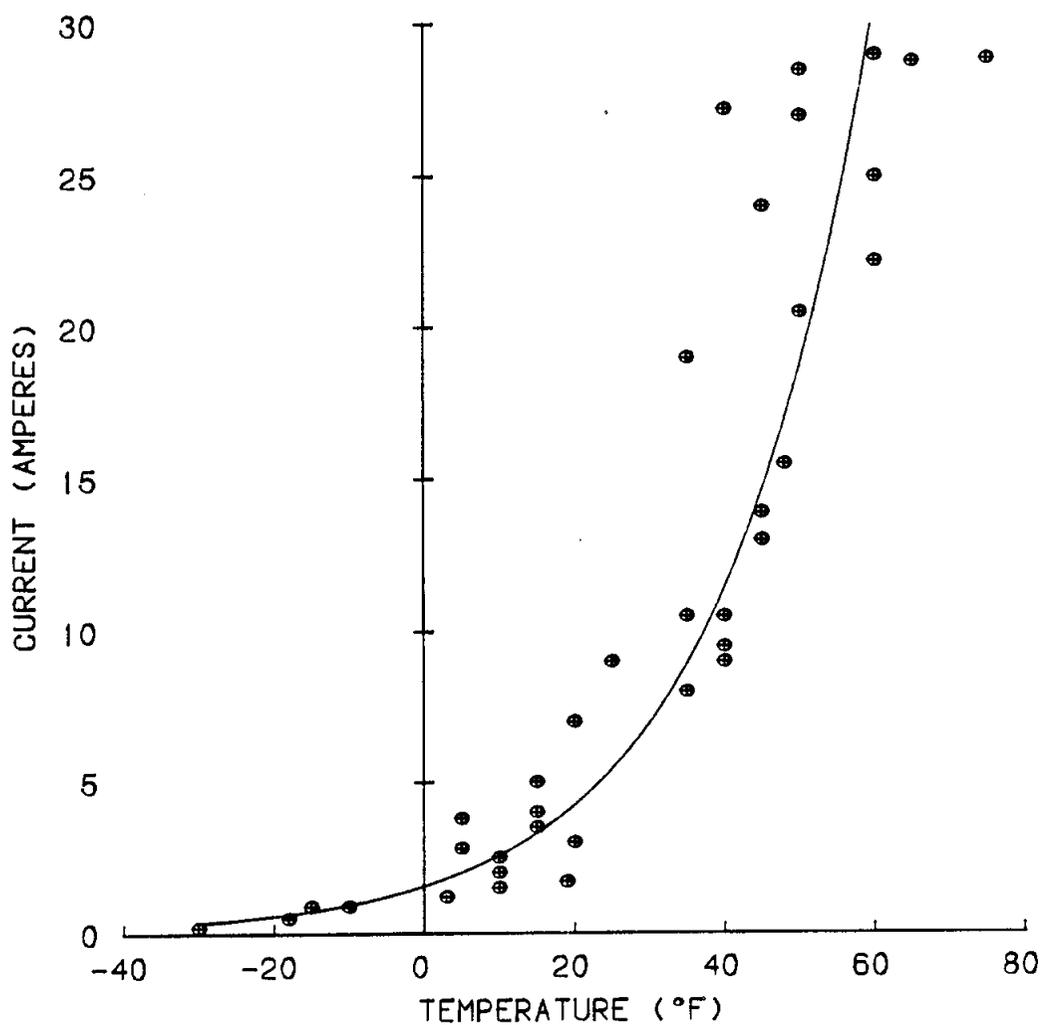
Figure 4-4: Protective Current versus Temperature, Wendell Street Bridge

The amount of current passing through the Wendell Street cathodic protection system is automatically controlled to maintain a "safe" potential with respect to reference electrodes embedded in the deck. The amount of current required for protection is highly variable with respect to temperature, as shown in Figure 4-4. The data shown in the figure were recorded during the first 18 months operation of the system.

The precision of this relationship can be questioned, since air temperatures (not concrete temperatures) were recorded, and the controls are set to limit the current to 30A maximum. The general trend, however, is quite clear. The amount of corrosion which would occur without the cathodic protection would probably demonstrate a somewhat similar variation with temperature.
