The Effects of a Winter Ice Jam Event On Bioengineered Bank Stabilization Along The Kenai River

Prepared by: Kenneth F. Karle, P.E.
Hydraulic Mapping and Modeling

Date
October 2007

FHWA-AK-RD-07-03

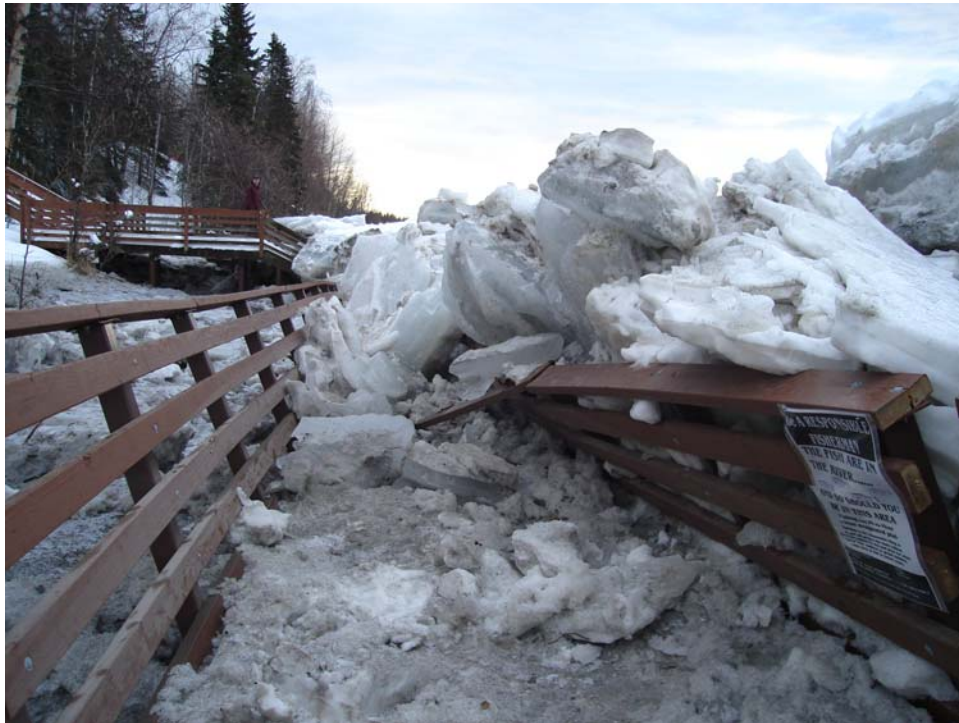
Figure 1. Elevated walk at Soldotna Park damaged by ice jam event, January 2007. ADOT&PF photo.

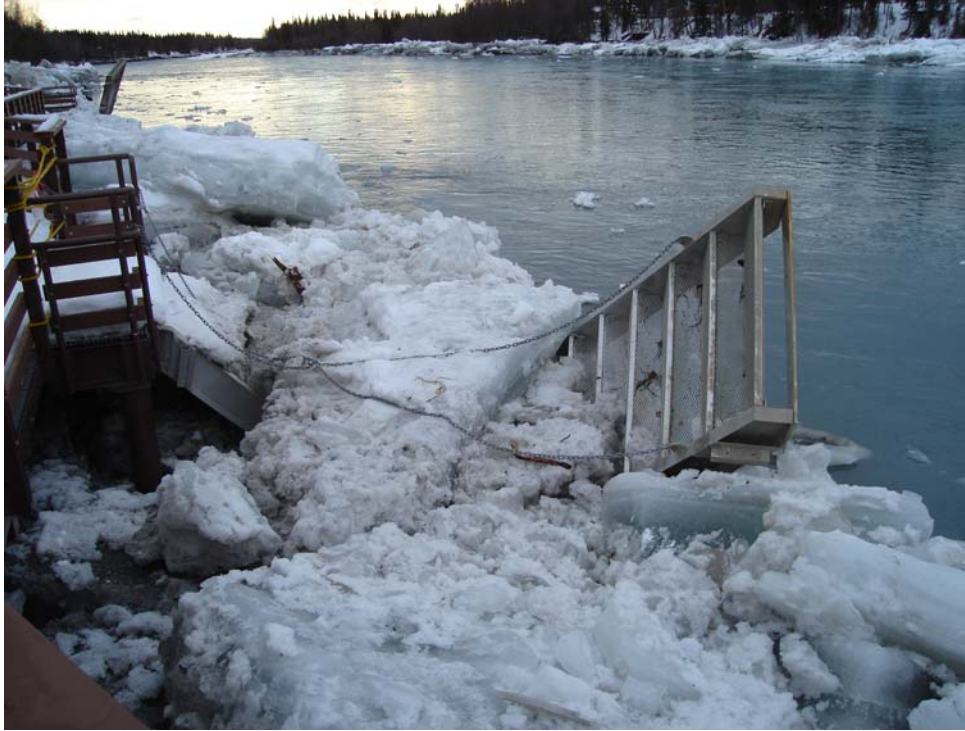
As the ice jams moved downriver, they damaged or destroyed a large number of manmade structures, including staircases, handrails, fish-cleaning tables, docks, fishing platforms, and other items (Peninsula Clarion, 2007). Many of these structures were either crushed by the ice as it pushed onto the banks, or were ripped from their pilings and taken downriver in the ice floe movement. Many of the staircases that provide access to the river were bent downstream or torn off completely by ice jam forces. See Figure 4.

Figure 4. Damaged folding aluminum staircase at Soldotna Park. ADOT&PF photo.

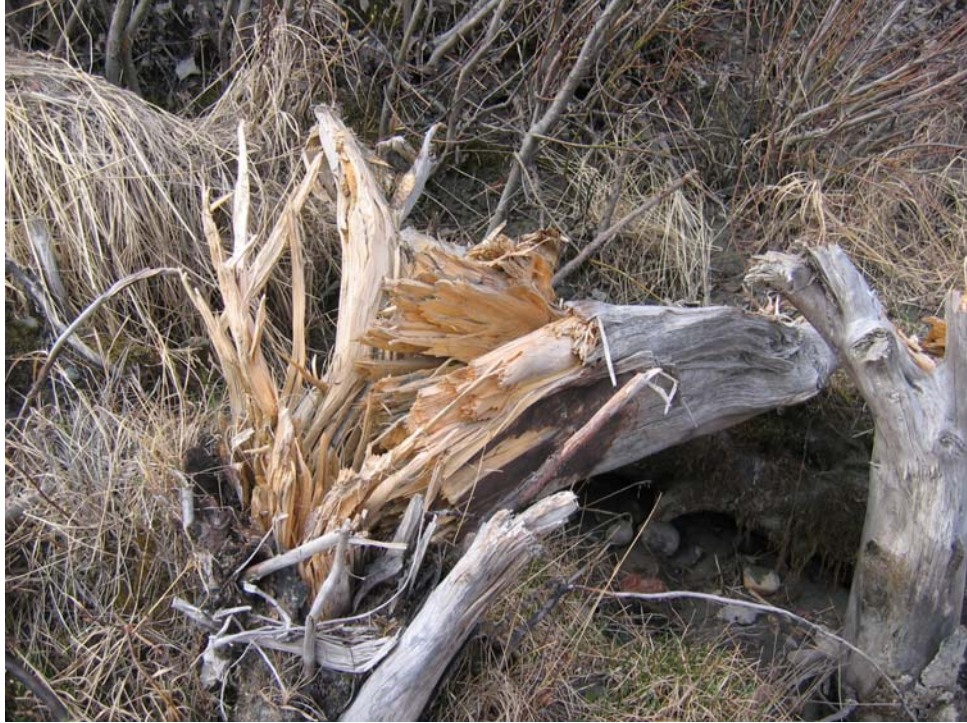
At Centennial Park, many of the root wads suffered damage to the roots or tines forming the wad (Figure 5). Root stems up to 8 inches in diameter were snapped off by ice floes, generally in a downstream direction. Generally, the longer stems were damaged, though some stems down to 1 foot in length were also broken. A substantial number of stems were broken from numerous root wads.

Figure 5. Root wad with damaged root tines at Centennial Park.

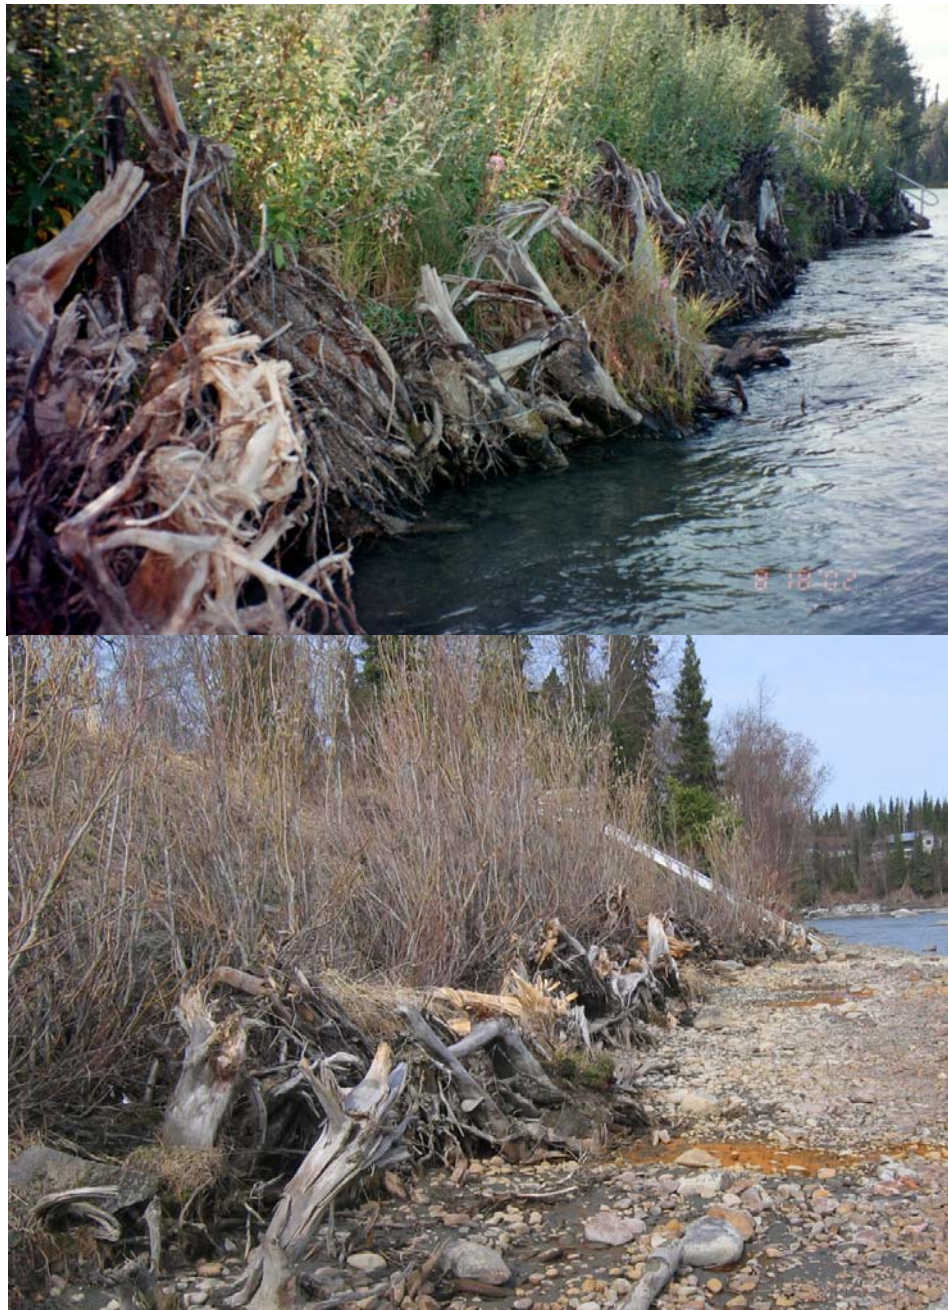
With one exception, the boles appeared to be undamaged in any way. At Centennial Park, one root wad bole had been pulled away from the bank approximately 1 foot. In many root wad installations, header and/or footer logs are used to secure and anchor the individual boles. However, such logs were not used in this section of the Centennial Park project.

In Figure 6, a photographic comparison of several individual root wads at the Centennial Park site shows their condition before the ice jam event (July 2002) and after (May 2007).

Figure 6. Root wads at Centennial Park. Top photo taken July 2002, bottom photo taken May 2007.

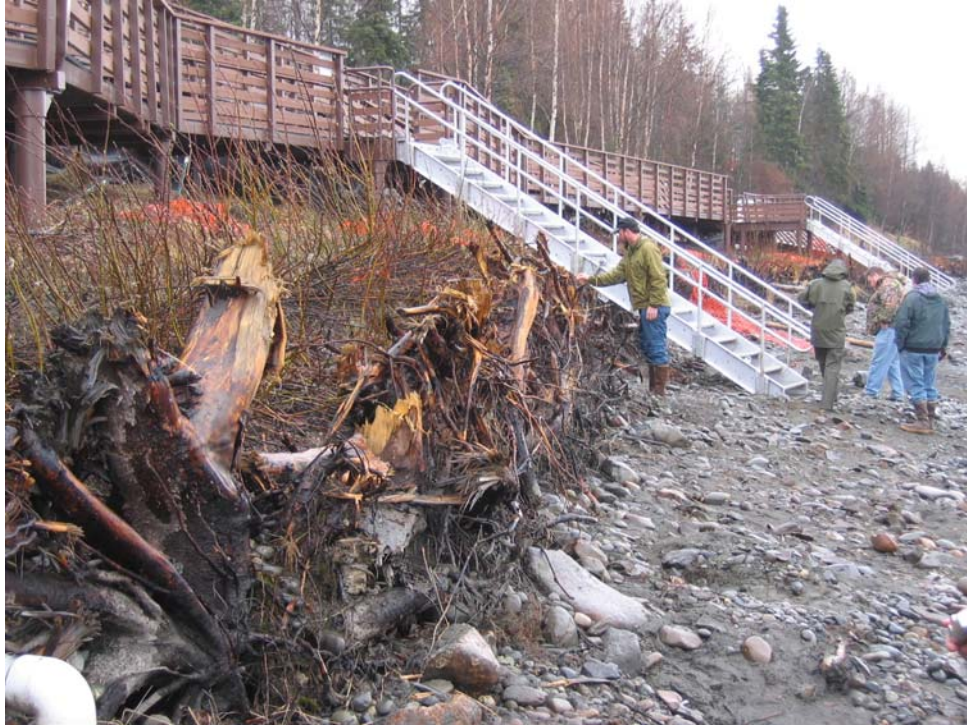
Root wads at Soldotna Park were installed in the spring of 2006. These root wads also showed signs of damage, though not as severe as the Centennial Park site. Again, root wads suffered damage to the roots or tines forming the wad, and the boles appeared to be undamaged. Header logs were used at this site. See Figure 7.

Figure 7. Root wads with broken root stems at Soldotna Park.

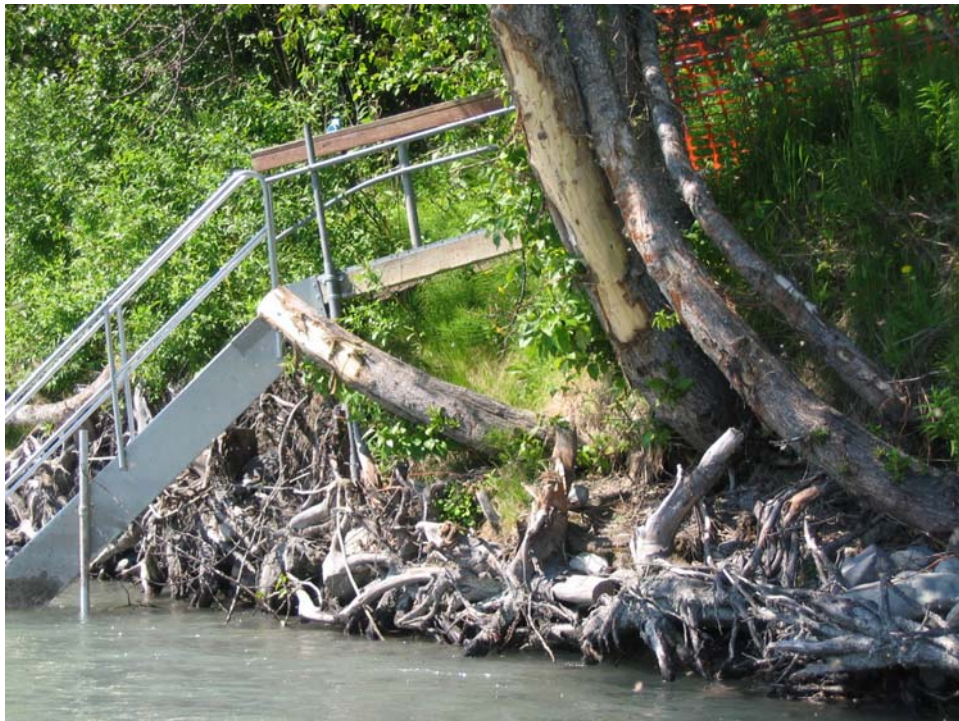
four years old. Though some root tines were broken, most of the installation appeared to be in excellent condition. A tree on the bank above the root wads shows the effects of bark being stripped off the trunk by the ice floes. See Figure 8.

Figure 8. Root wad installation at Soldotna B&B Lodge.

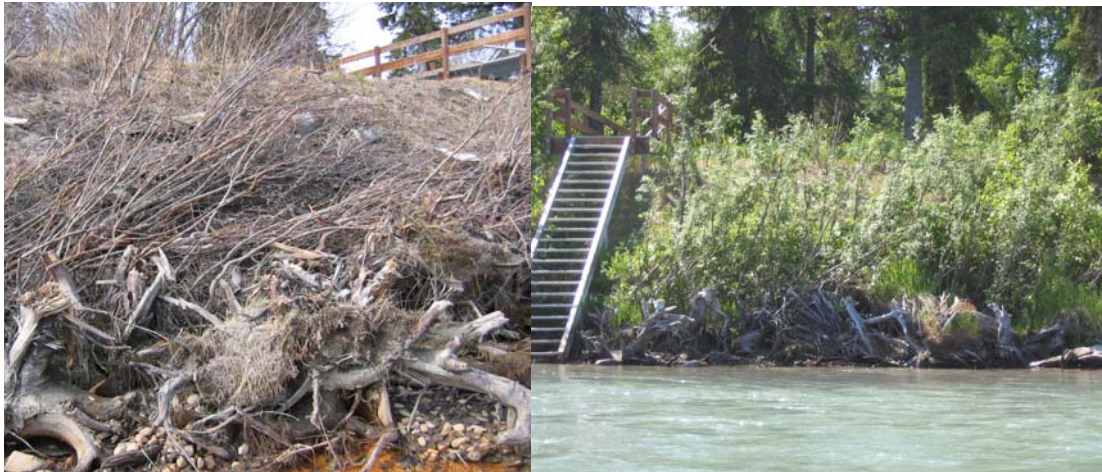
At the Centennial Park root wad installations, the upper bank above the root wads appeared to be well-protected by the willow trees growing there. The willows, planted as part of the brush-layering structure built on top of the root wads, are up to 1.5" diameter breast height (dbh), and up to 12 feet in height. During the May 2007 field visit, many of the willow trees were severely bent over in a downriver direction. This appeared to be the result of the ice-jam event; ice floes either knocked the willows over as they moved downstream, or flattened them as the water levels receded and the floes were left on the bank. During the late June visit, the vast majority of the willows appeared to be healthy. Stalks had straightened out, and were in the process of leafing out. See Figure 9.

Figure 9. Upper bank brushlayering at Centennial Park. Left photo taken May 2007, right photo taken June 2007.

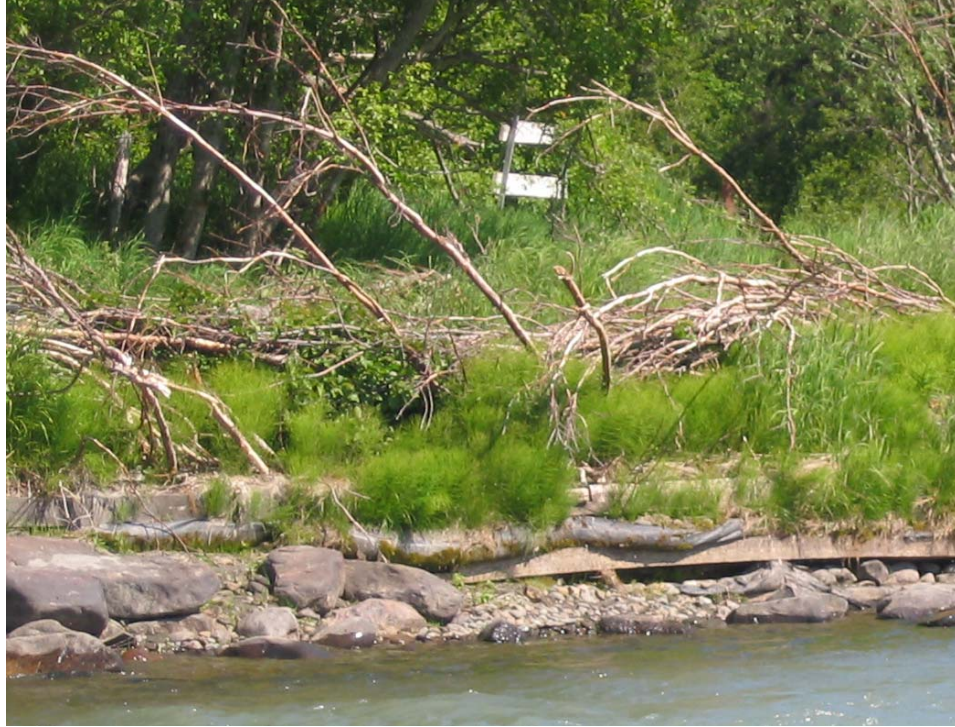
The upstream section of the Soldotna Park installation was constructed in 1997, using cribwalls to protect the toe of the bank. On this bank, the trees are mature, 15 to 20 feet in height, and a 2 to 3 inch dbh. Following the ice jam, many of these trees were flattened in a downstream direction, and had much of their bark scraped off by ice floes. In June 2007, they were in poor condition, still flattened, and were not leafing. See Figure 10.

Figure 10. Bark stripped from trees at the Soldotna Park cribwall site.

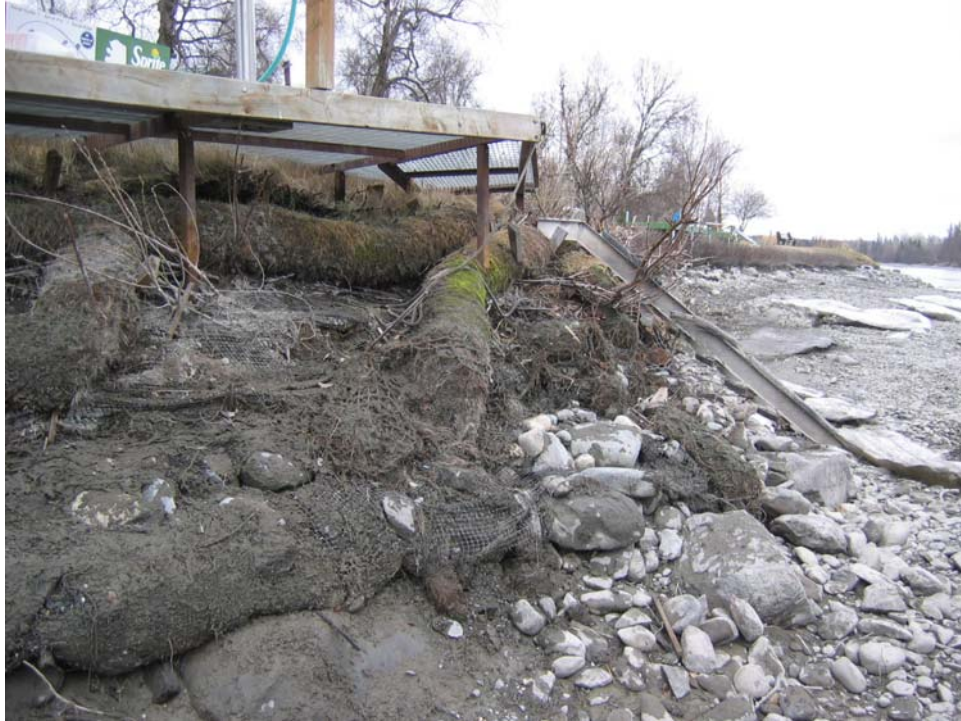
Several smaller bioengineered installations were inspected during the 2007 field visits. A small coir log/brush layer installation is located on the bank adjacent to a commercial guiding operation, at approximately Mile 16 on the Kenai River. This structure is approximately 10 years old. Some damage to the coir logs was noted. Coir logs were displaced and pulled out away from the bank. The culprit for the damage was likely ice floes moving downstream. The installation is still functional; however, it is scheduled for replacement soon using more current techniques. The original near-vertical installation may have contributed to the damage that occurred, and such an installation is now generally discouraged. See Figure 11.

Figure 11. Ice damage to coir log installation.

In the 2003 report, field evidence at one site indicated some damage to coir fabric used in fabric-encapsulated soil lifts from ice floes moving downstream. Though we found no examples of such damage for this project, the potential for such damage on streams that experience ice floes and ice jams should be of concern to project planners. The installation of root wads in front of such fabric-encapsulated soil lifts could be one potential solution for providing protection against annual ice floes.

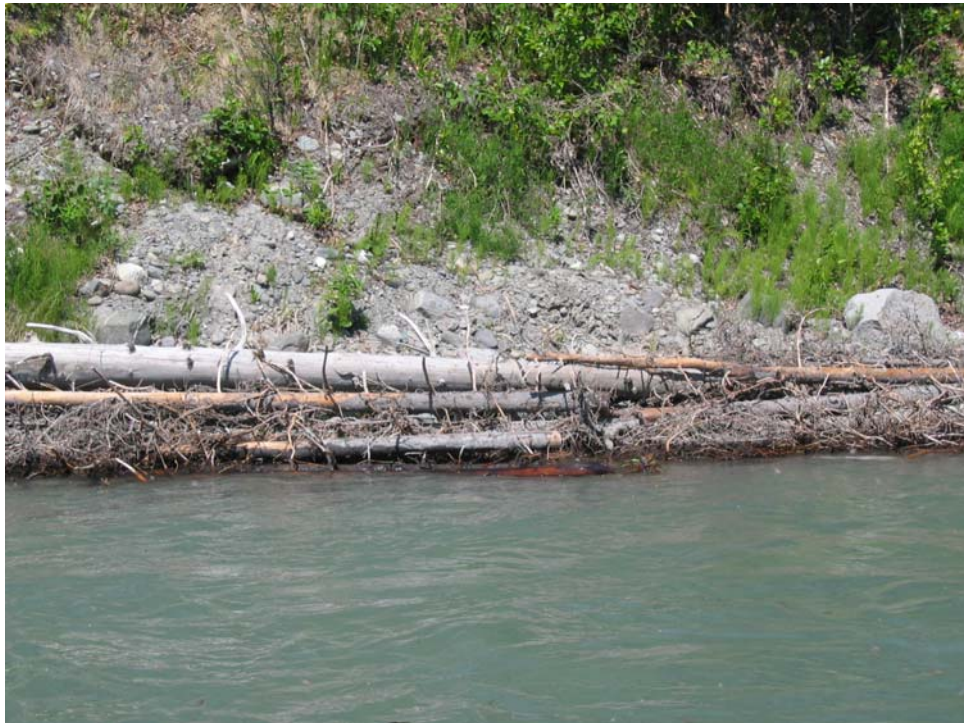
The Soldotna Lodge root wad installation described earlier also includes a spruce tree revetment section, located downstream from the root wad section. The spruce trees cabled to the bank appeared to be in excellent condition, and were not damaged by the ice jam event. See Figure 12.

Figure 12. Spruce tree revetment at Soldotna B&B Lodge.

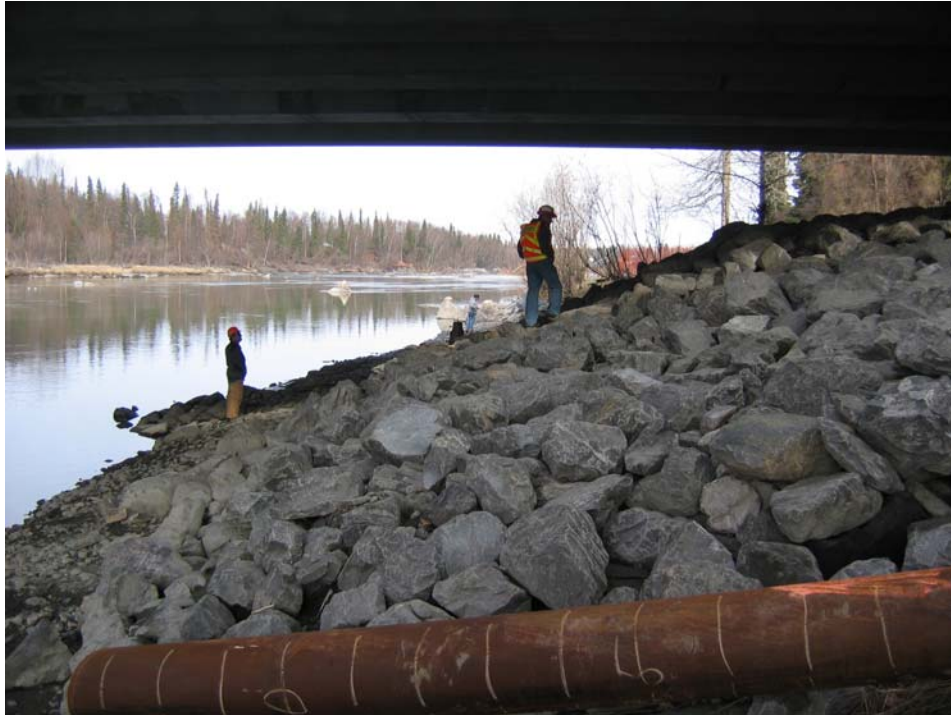
Though pre-flood photographs were not available, the post-flood inspection showed the riprap installation to be in excellent condition. There was no indication that any of the rock was displaced by either the water or the ice floe movement. See Figure 13.

Figure 13. Riprap beneath the new Sterling Highway Bridge.
