THERMAL EROSION OF CUT SLOPES IN ICE-RICH SOIL

FINAL REPORT

Daniel W. Mageau
and
James W. Rooney

April 1984

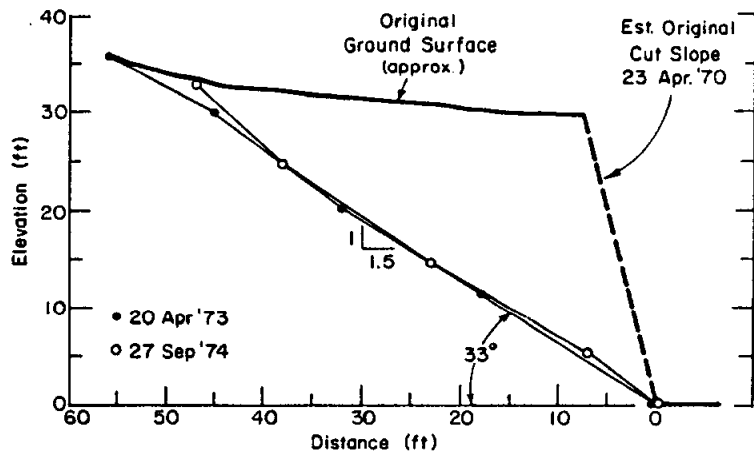
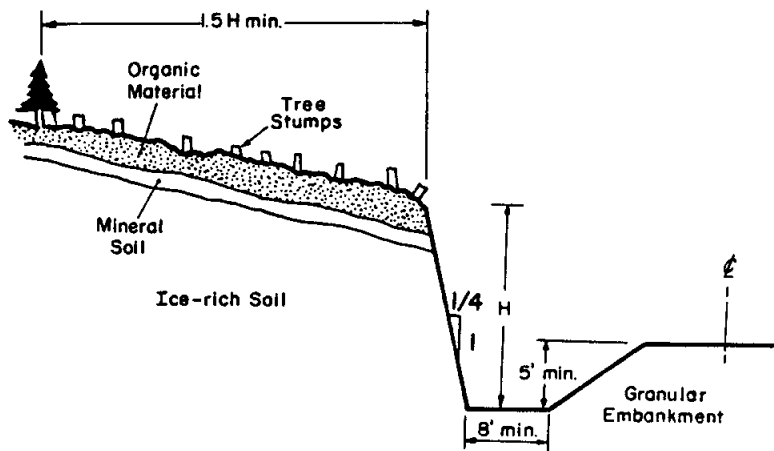
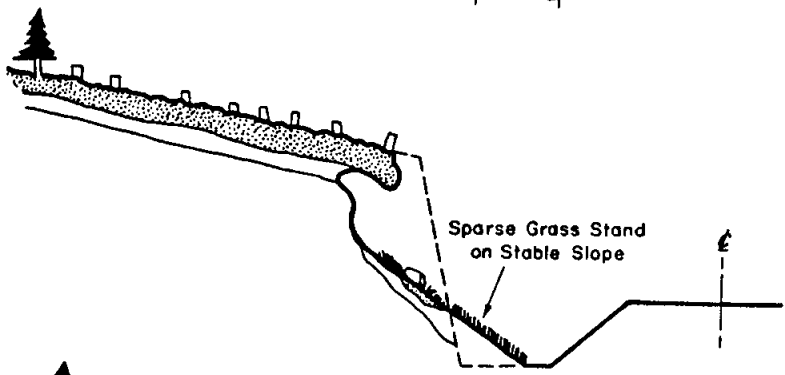
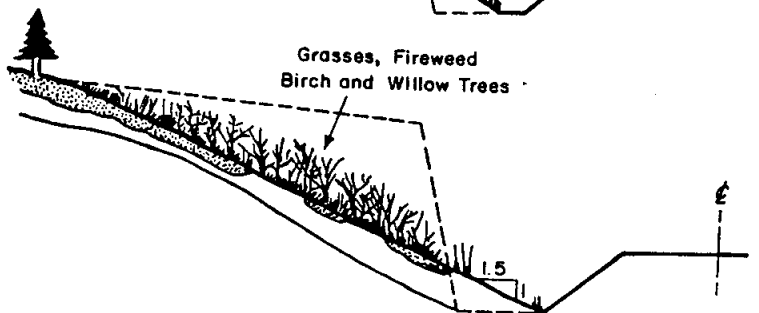
FIGURE 1.

Approximately 1000 feet north of this test section, Berg and Smith (1976) evaluated the performance of a near vertical cut constructed without any surface treatment in similar ice-rich material. As seen in Figure 1, significant deterioration of the slope surface was observed during the first thaw season. By the fifth or sixth thaw season, the slope had stabilized at a grade significantly less than the original cut. Vegetation was fairly well established at this time. It was anticipated by APSC that the performance of such cut slopes would be improved with the addition of surface treatments which would retard thermal erosion. Thus, it is of interest to examine the performance of the surface treatment at the nearby Hess Creek test site.

(c) End of first thaw season. Slope is mostly unstable and very unsightly; ditch will require cleaning if massive ice is present.

(d) End of fifth or sixth thaw season. Slope stabilizes with reduced thaw and vegetation established. Free water from minimal thawing is used by plants whose root systems develop new organic material.

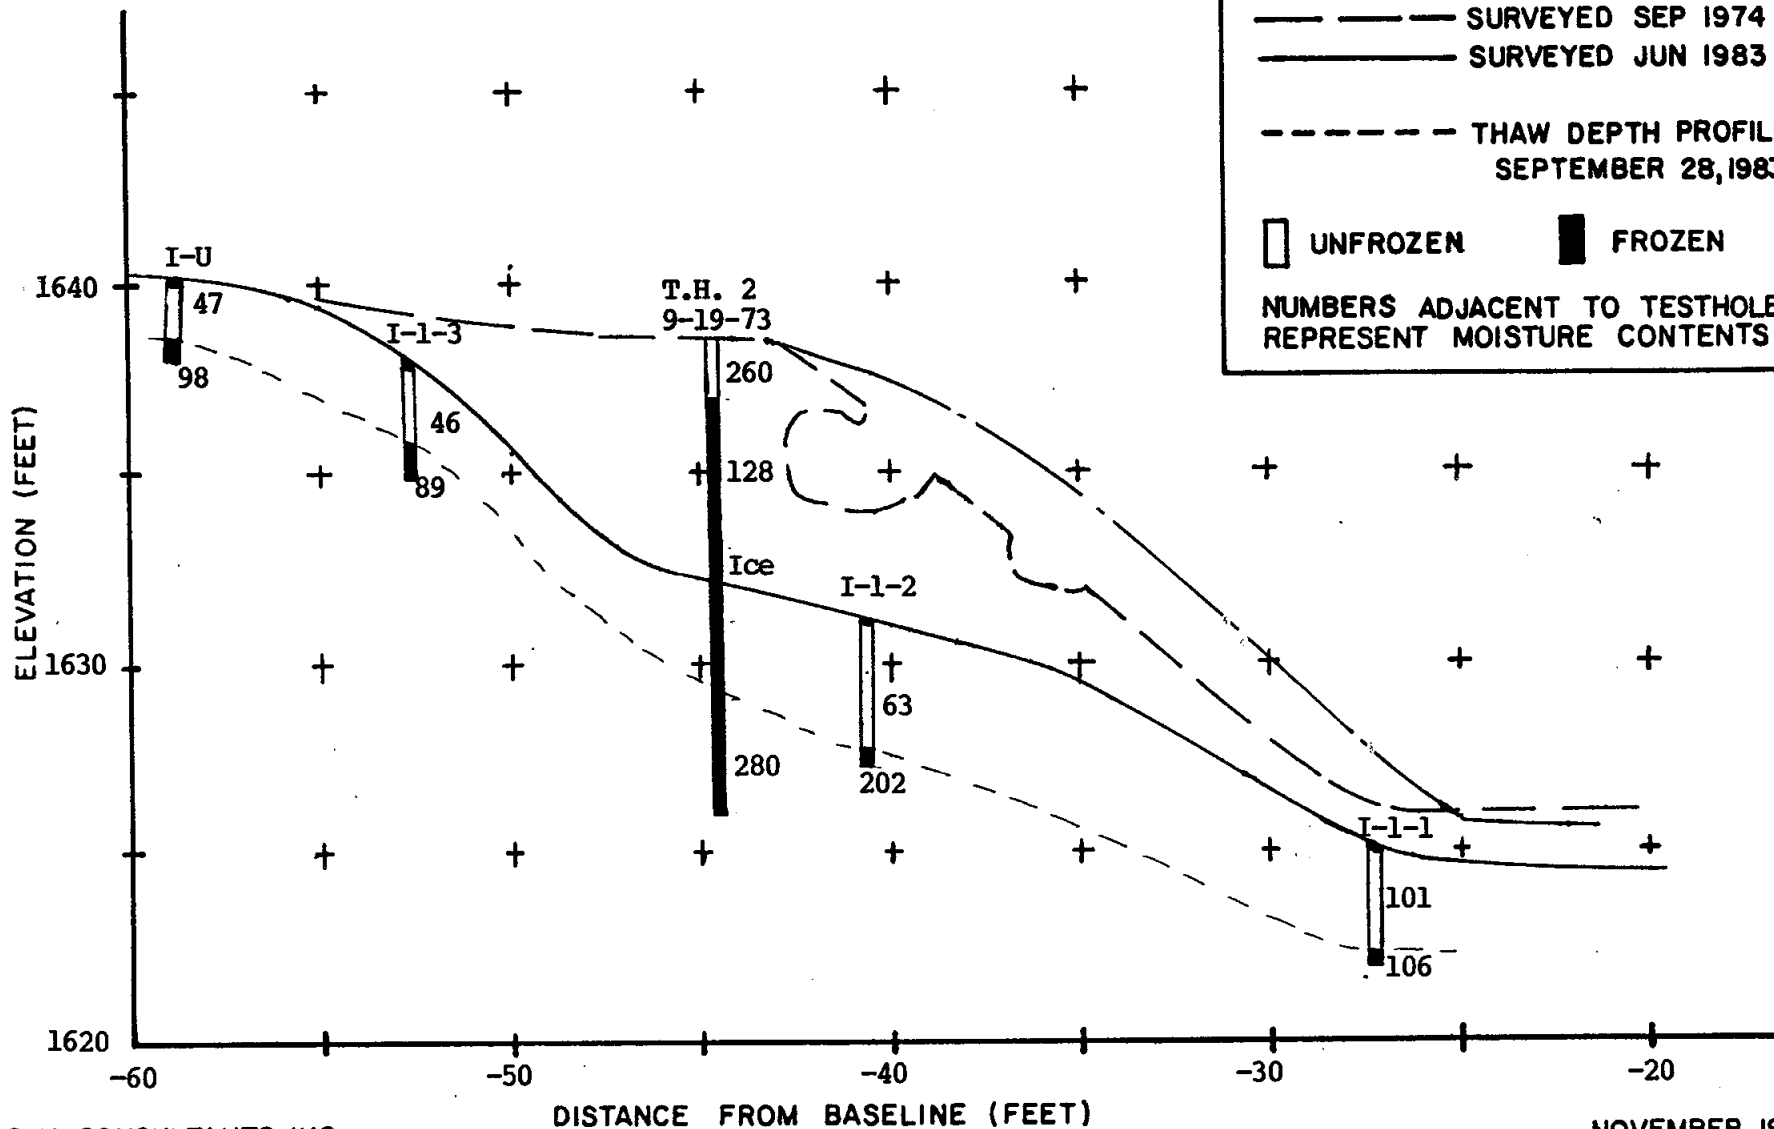
FIGURE A-2

The 1983 elevation profile of the slope presented in Figures A-1 and A-3 shows a marked increase in degradation had occurred along the slope face since 1974. The slope surface was very irregular with many scarps. Remnants of the insulation were visible over only about ten percent (10%) of the area. Much of the insulation that was visible was broken and covered with moss and lichen. The high moisture content value of 83% by weight (Appendix D) indicates the insulation had absorbed a considerable amount of moisture over the previous ten (10) years.

The September 1983 thaw depths presented in Figures A-1 and A-2, range from 1.7 feet in the undisturbed area at the top of the slope to about 4.5 feet at the toe. This represented an increase in observed thaw depth of about 1.5 feet from those observed in 1974.

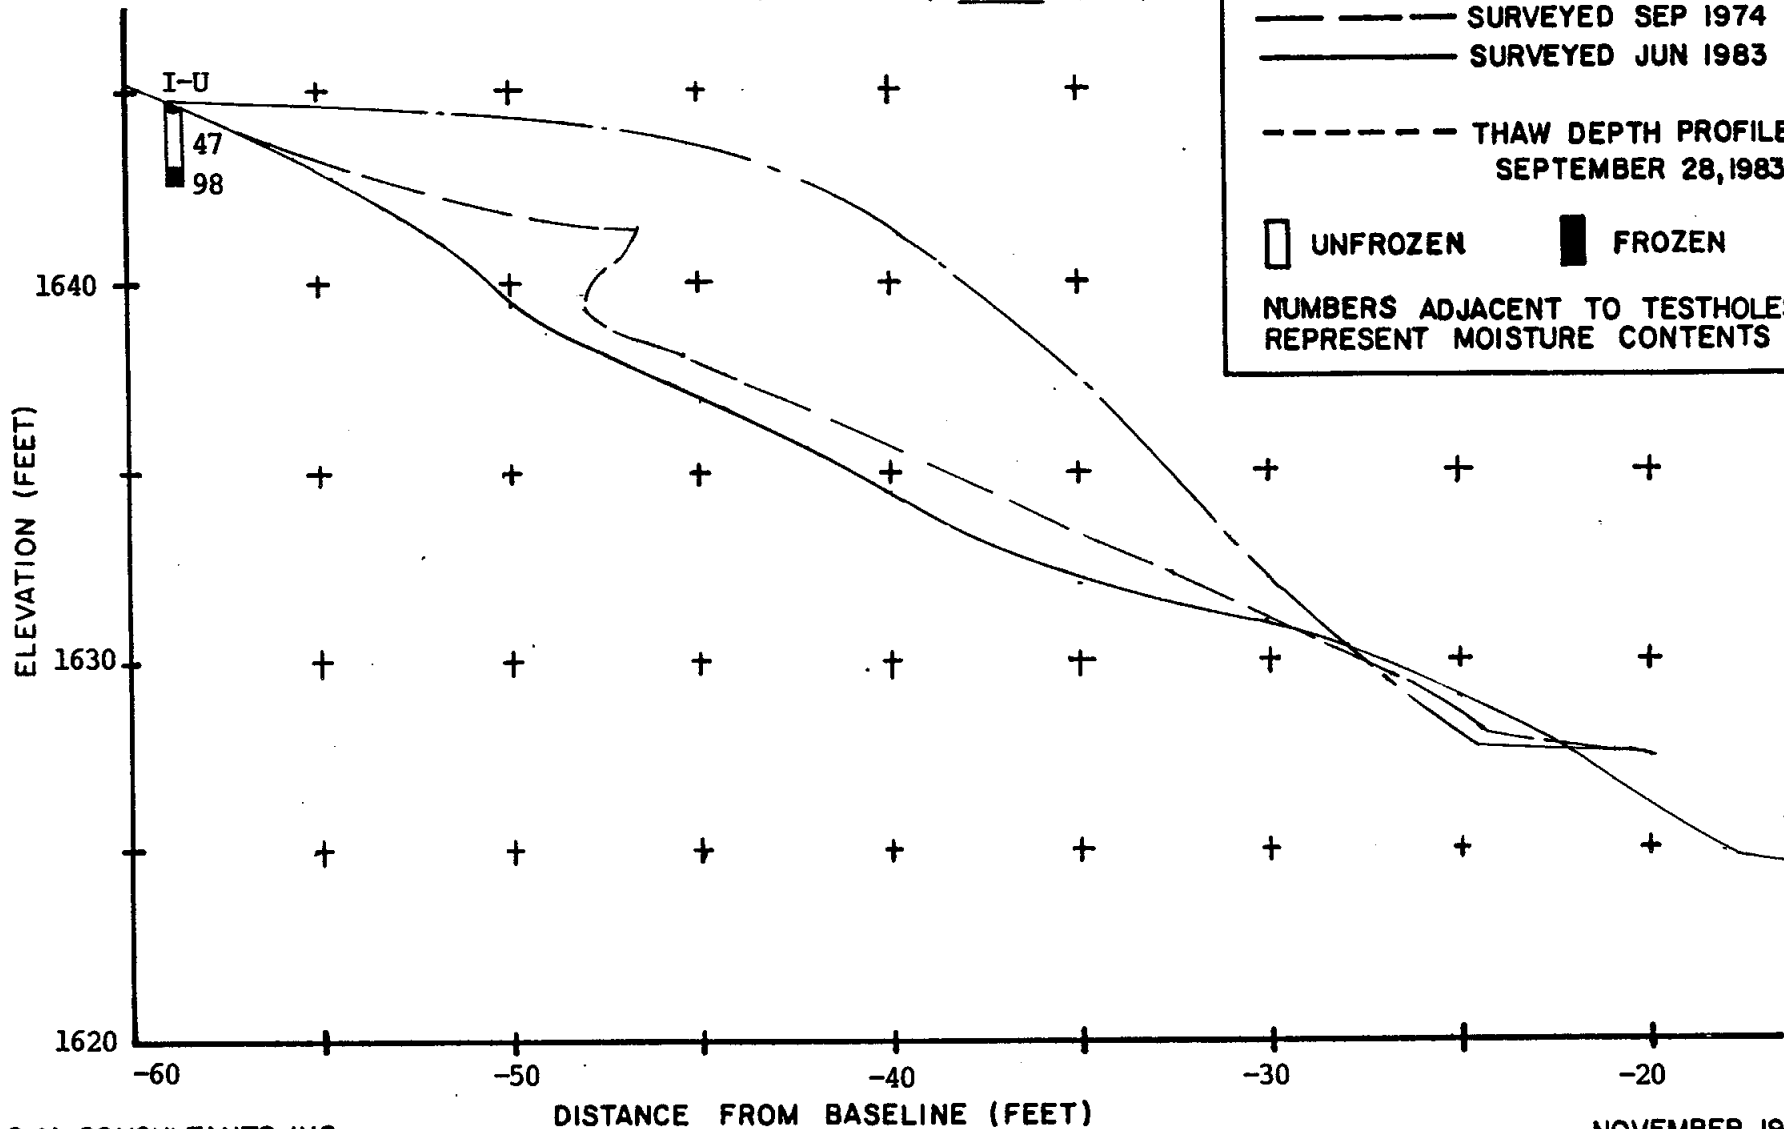
FIGURE A-4

As seen from Figures A-4 through A-6, the 1983 slope configuration had changed significantly from that measured in 1974. The 1983 slope angle was very high at the top while the central portion of the slope in this test section had a more gentle, almost flat grade which transitioned to a steeper grade near the toe of the slope. Very little of the excelsior blanket could be identified due to degradation of the material and vegetation growth. The topography of the slope in Test Section II was irregular with many scarps and small fracture zones.

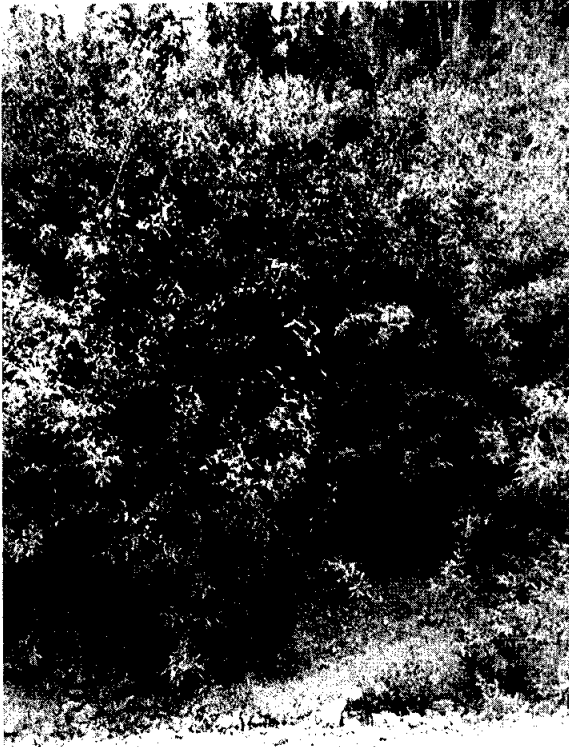
TEST SECTION I

VEGETATION AT TOE OF SLOPE

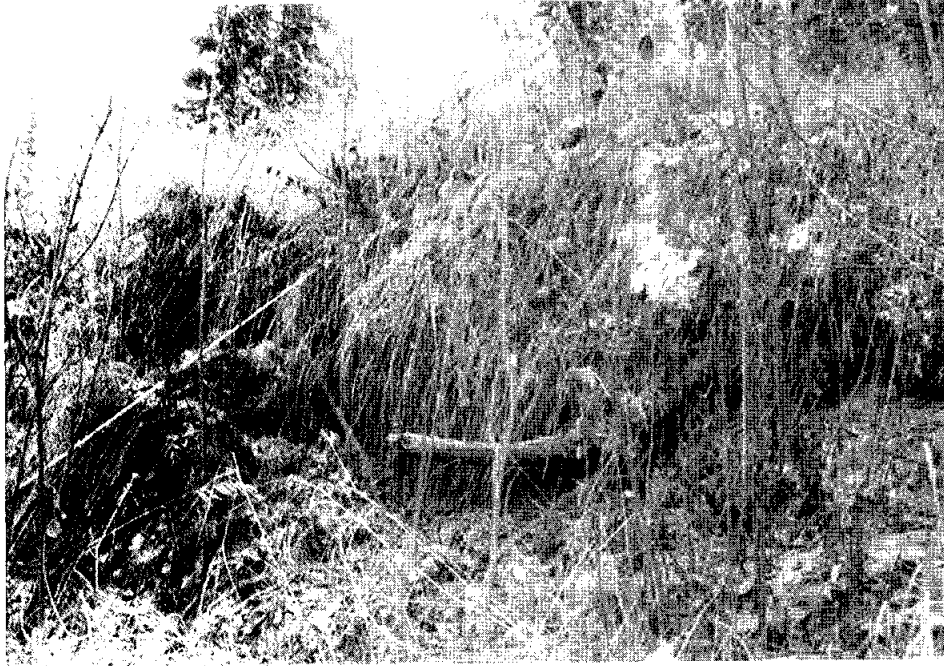
TEST SECTION V

VIEW OF GRASS-COVERED VERTICAL SCARP (~ 3 FT. IN HEIGHT) NEAR TOP OF SLOPE.

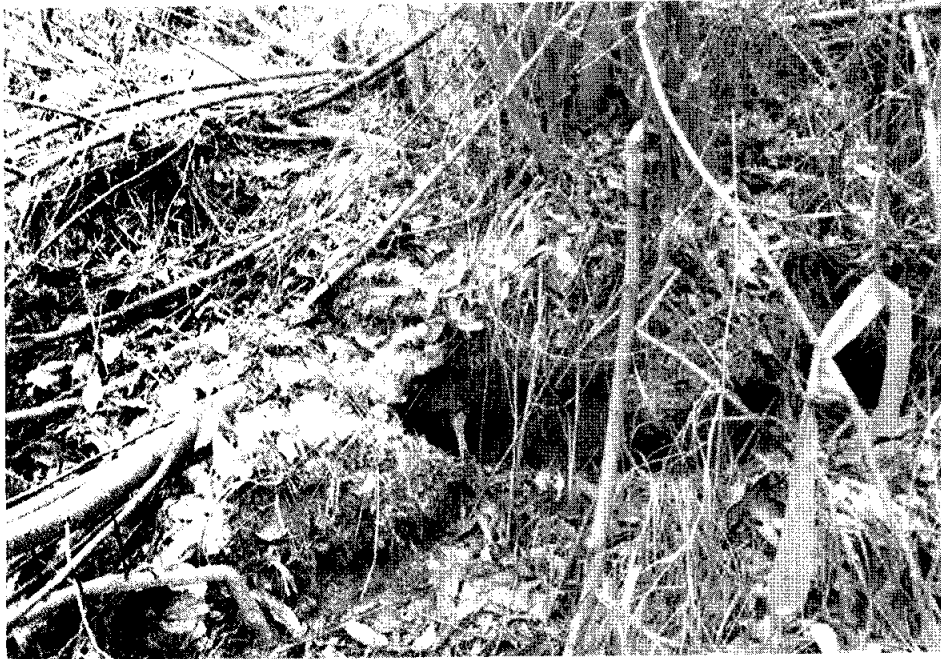
TEST SECTION V

VIEW OF 6 INCH DEEP SURFICIAL CRACK NEAR BOTTOM OF SLOPE
