November 18, 2024

RE: FINAL 2024 FAIRBANKS INTERNATIONAL AIRPORT FIRE TRAINING PIT
INSTITUTIONAL CONTROL DOCUMENTATION, FAIRBANKS, ALASKA

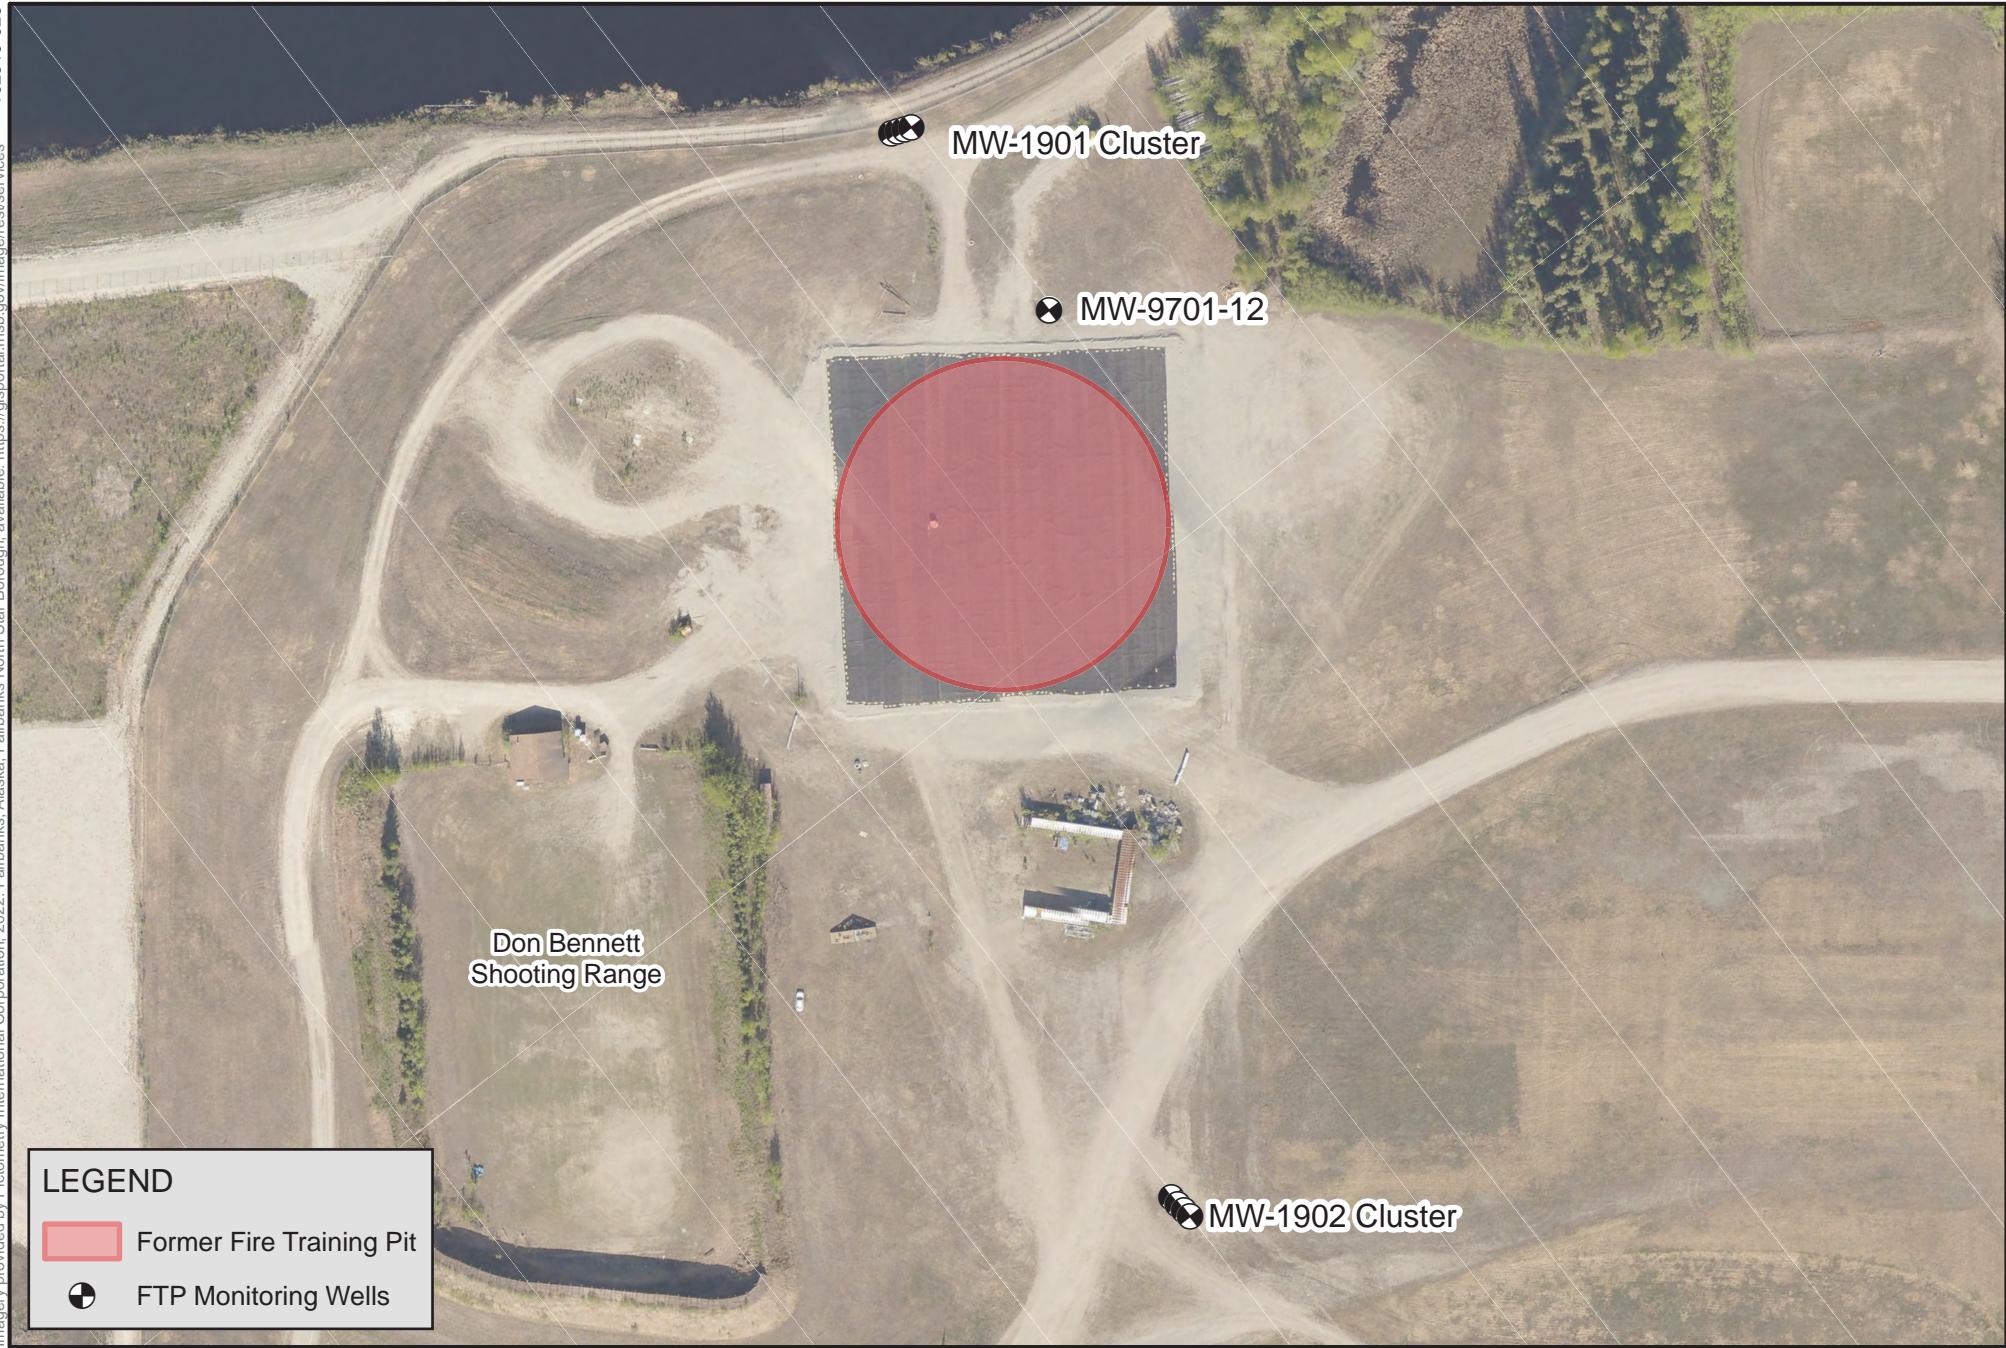
FTP MONITORING WELLS**Figure 2**

Monitoring well inspections are conducted on the two FTP monitoring wells nests (MW-1901 and MW-1902) and the Don Bennett Range wells (DBR-MW01 and DBR-MW02) during the monitoring well sampling event. Frost jacking was noted on MW-1902-15 during the July 2024 event and the casing was cut down by 0.33 ft. For MW-1902-80 it was noted that the concrete monument has frost jacked a few inches and the PVC casing is leaning against the metal casing, however the PVC casing is fully functional. For MW-1902-150, it was noted that the concrete monument has frost jacked several inches. As of July 2024, each monitoring well inspected fully functional and no major repairs are needed. Monitoring well maintenance should continue to occur during monitoring well sampling events.

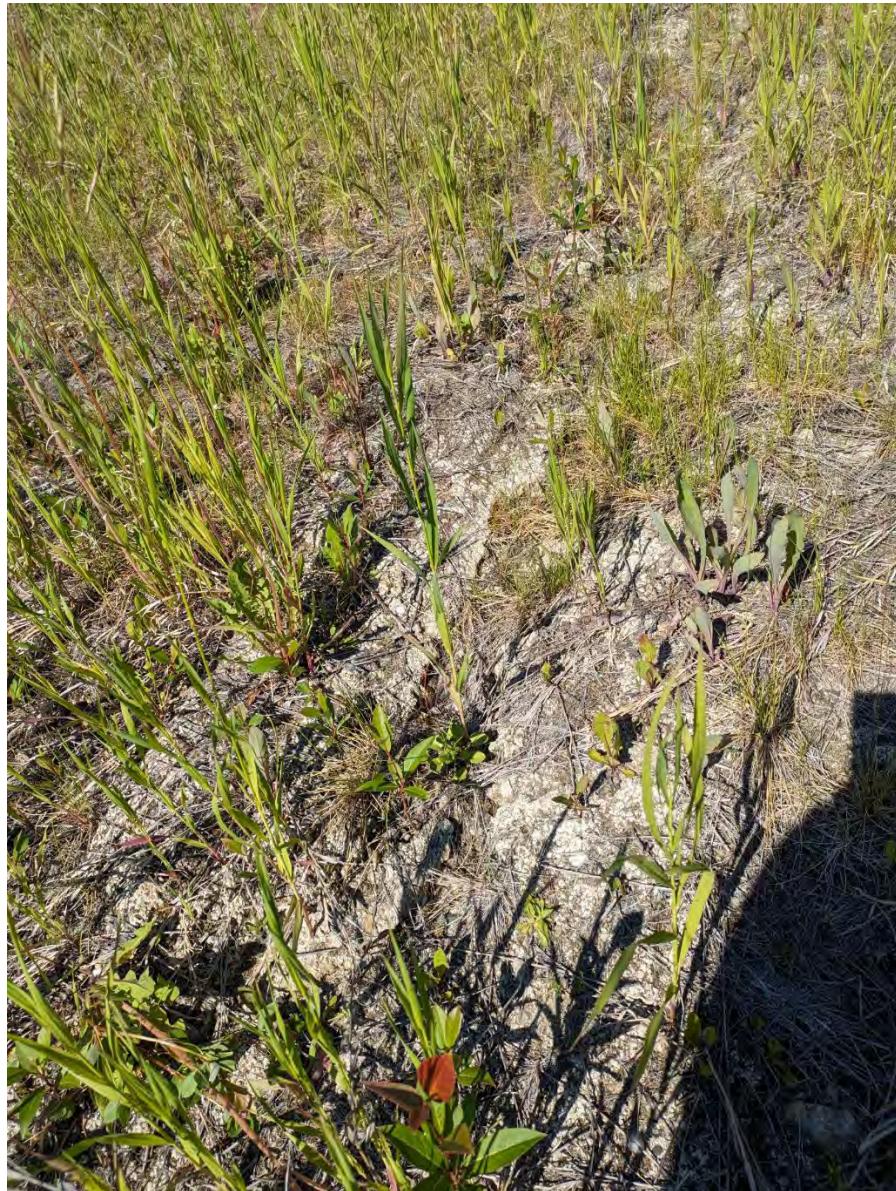
- ✓ 1. Is there any visible signs of erosion: Yes- Small rill on south west side
- ✓ 2. Slope Stability:
 - ✓ a. Are there visible cracks? Circle one: No
 - ✓ b. Did there appear to be moisture changes? Circle one: No
 - ✓ c. Is there leaning or turned vegetation? Circle one: No
- ✓ 3. Is there vegetation cover? Circle one: Yes- mixture of bushes and grasses, Spotty areas on top of dead grass,
- ✓ 4. Are there any visible animal burrows? Circle one: Yes 1 small burrow at North side
- ✓ 5. Does the geomembrane appear to be exposed? Circle one: No
- ✓ 6. Is there exposed woody vegetation? Circle one: No
- ✓ 7. Are there any other irregularities? Yes- previously mentioned tire tracks are still visible but don't seem to have changed since 21 & 22 inspections

Rills On Western side

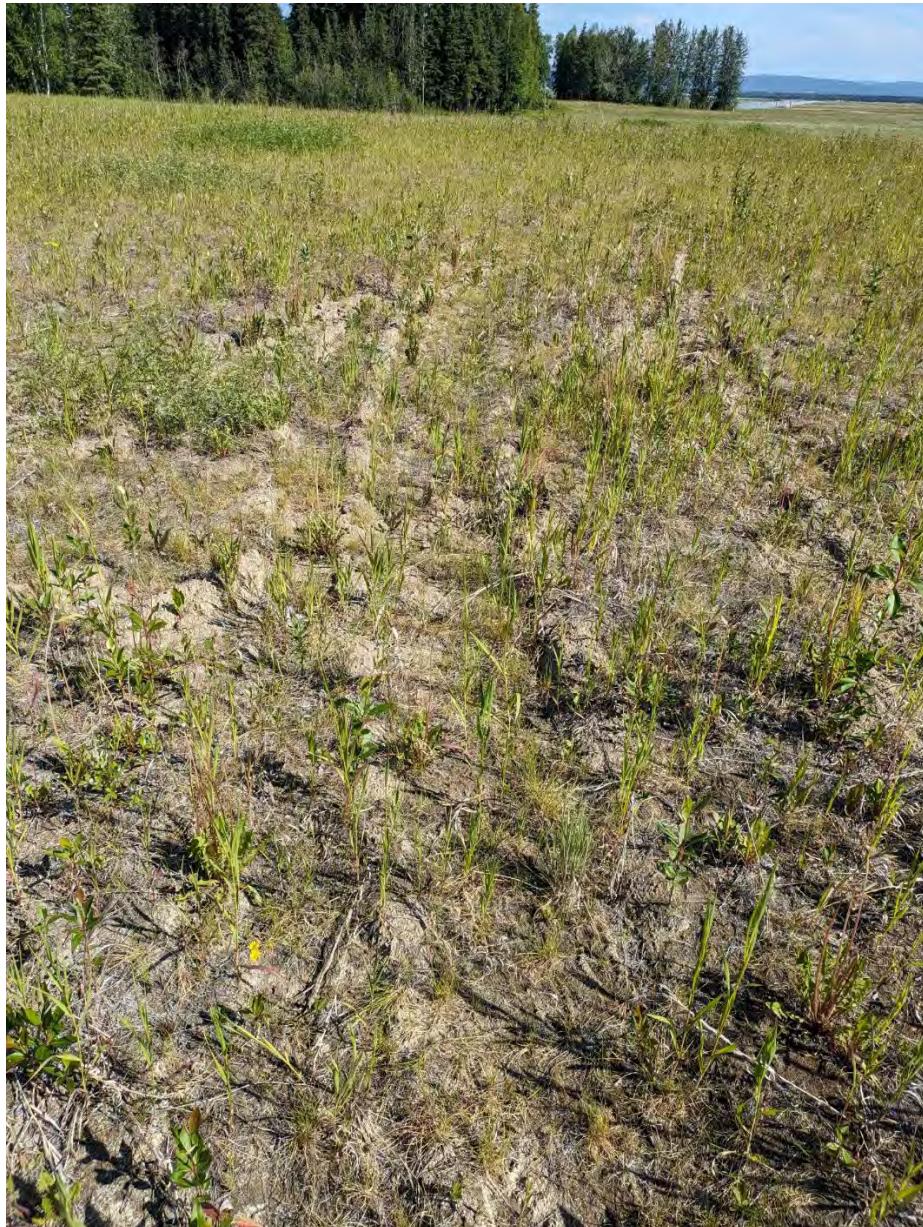
Old tire tracks noted from 21/22 insectcions

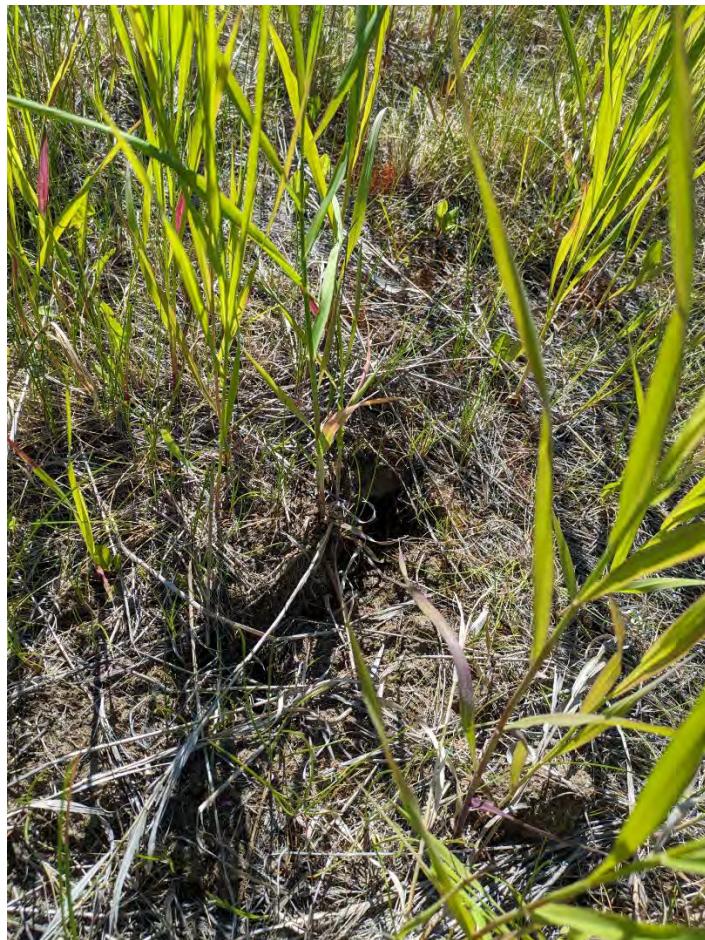
Small Animal Burrow at top of sloped edge on northern side

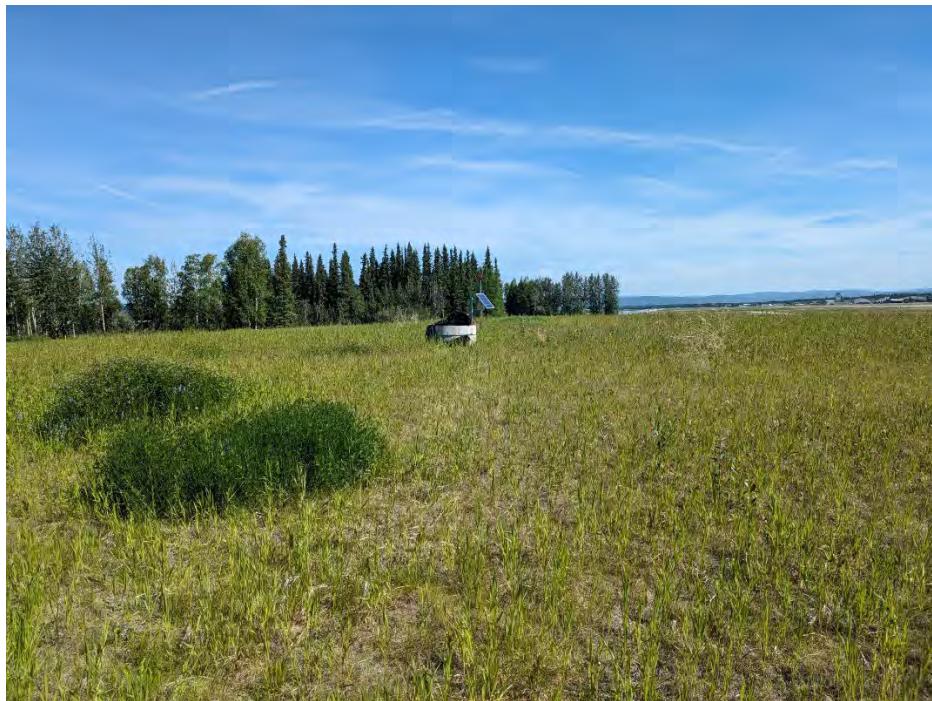
FTP cap viewed from base of hill at south side

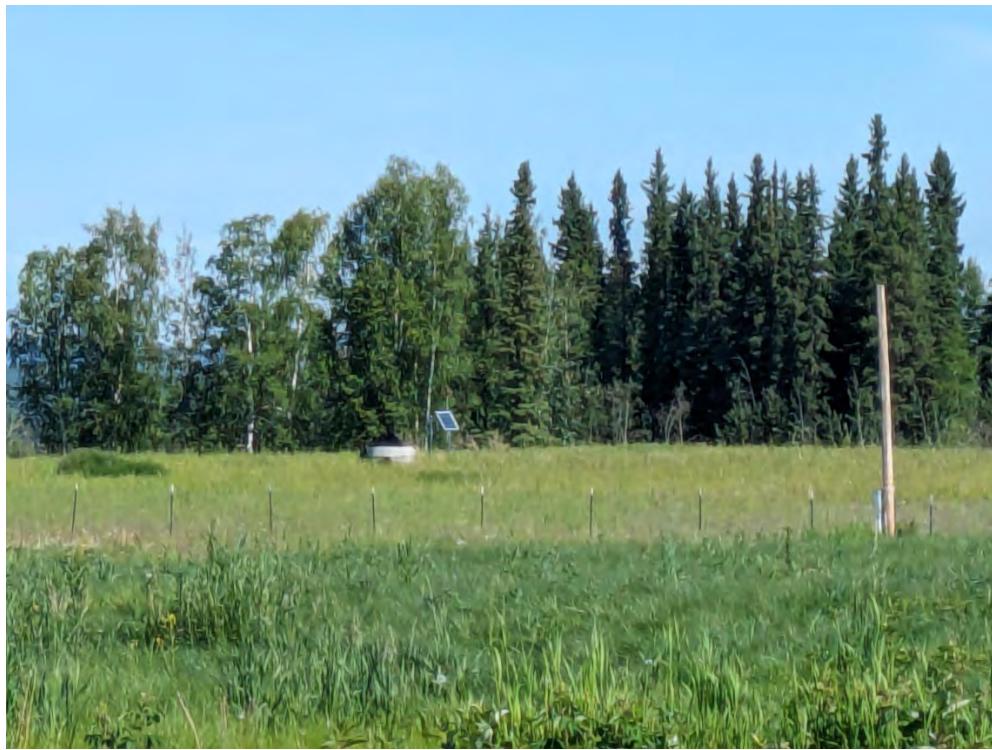
View of Cap from southeast approach road
