**ALASKA DEPARTMENT OF TRANSPORTATION &
PUBLIC FACILITIES - CENTRAL REGION**

HSIP SIGN INVENTORY

FINAL PROJECT REPORT

March 2013

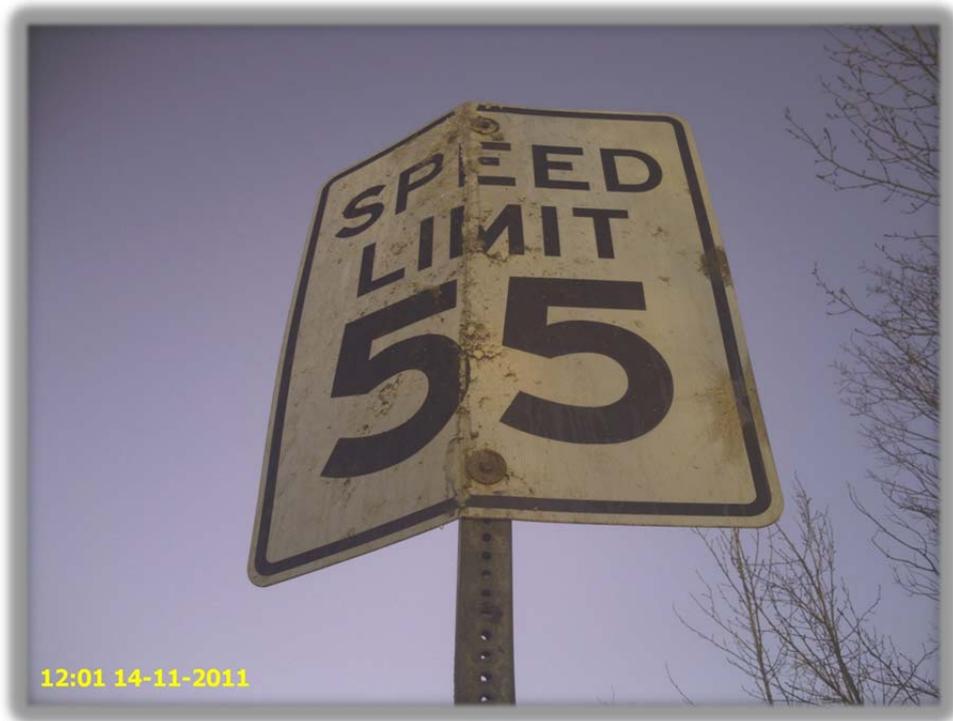
Figure 4 – Sign photograph documenting ‘unacceptable’ condition

The photographs taken of each sign were essential in USKH's internal procedures for both engineering analysis and quality assurance/quality control (QA/QC). Photographic documentation of each sign helped confirm that the physical attributes of each sign were logged correctly in the field. For example, because signs marked as 'unacceptable' have special significance to DOT&PF Central Region, they were cross-checked with the sign photograph to avoid signs being unnecessarily tagged for replacement.

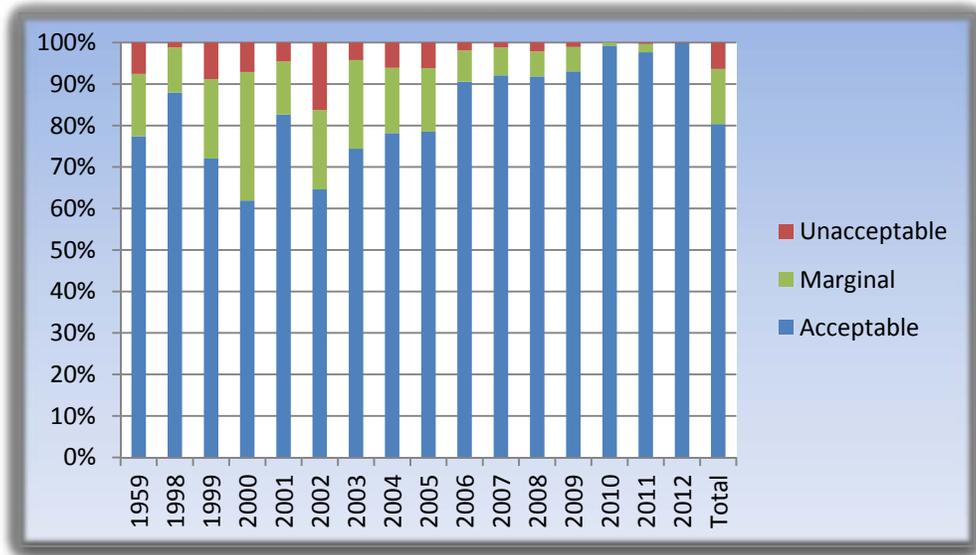
Figure 11 – Sign Condition Summary by Age

The earliest installation date we observed on a sign was 1990, and that sign was in Marginal condition. The earliest year with more than a few observations was 1995, and 40 percent of those signs were in Acceptable condition, 45 percent were in Marginal condition, and 15 percent were in Unacceptable condition. To determine what role age plays in sign condition, Figure 13 below contains a plot of sign condition versus sign age. The data reflect a linear relationship between age and condition, but the sign conditions are not consistent throughout the range of observed sign ages. The R-square value for the regression line is 0.533, which tells us that only about half of the variation in sign condition is explained by sign age.

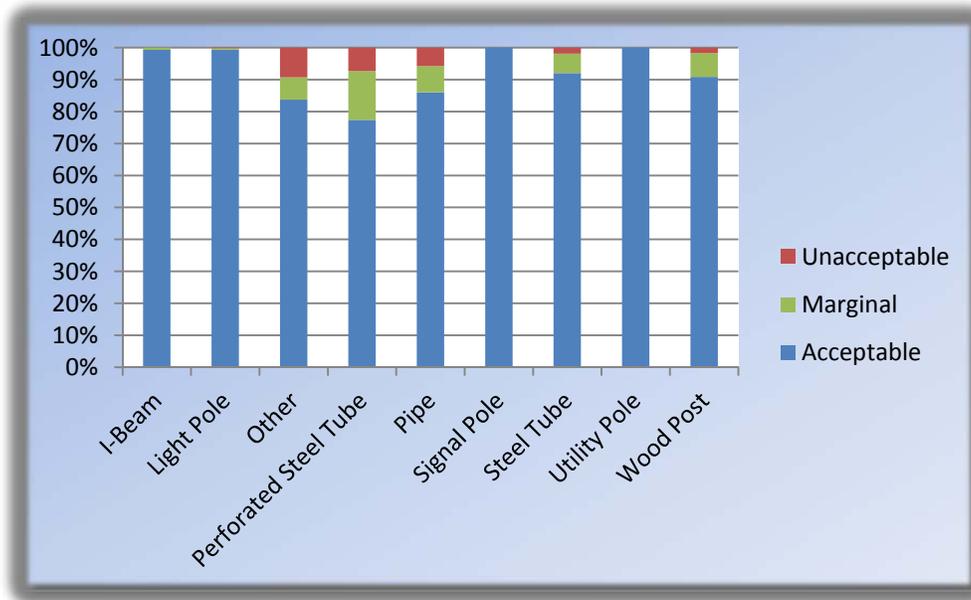
Figure 12 - Post Condition by Type

Post Type	Acceptable	Marginal	Unacceptable	Total Posts	Percent Fail	SF of Attached Signs
I-Beam	134	1	-	135	0.0%	-
Light Pole	462	2	1	465	0.2%	8
Other	35	3	4	42	9.5%	20
Perforated Steel Tube	7,240	1,426	686	9,352	7.3%	6,971
Pipe	178	17	12	207	5.8%	119
Signal Pole	274	-	-	274	0.0%	-
Steel Tube	2,068	136	43	2,247	1.9%	536
Utility Pole	18	-	-	18	0.0%	-
Wood Post	159	13	3	175	1.7%	28
Total	10,568	1,598	749	12,915	5.8%	7,682

Assuming posts cost 50-percent of the assembly replacement cost, the overall cost of replacing the unacceptable signs and posts would be about \$1.5 million.

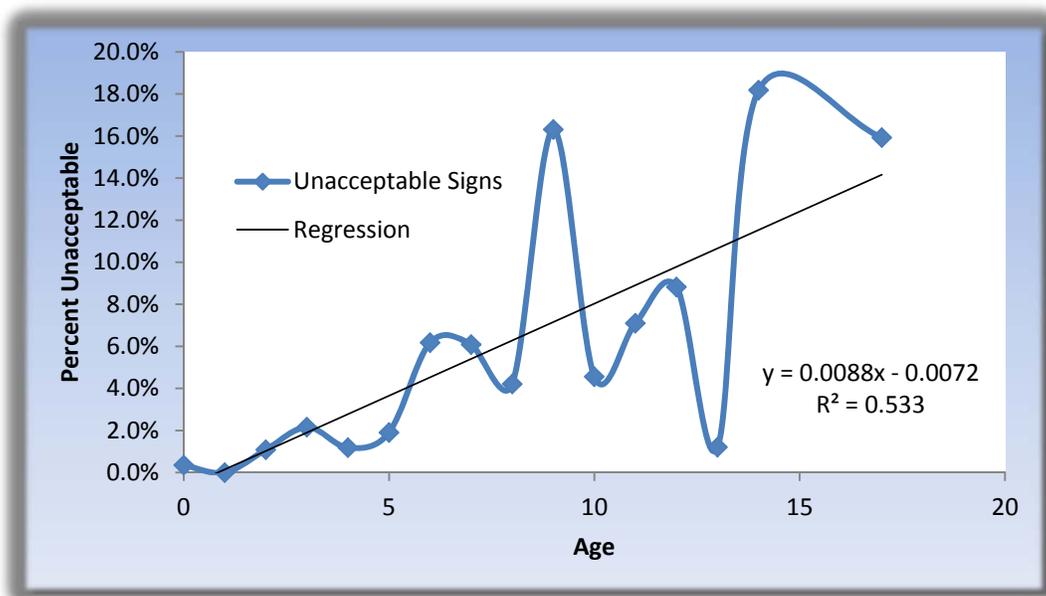
Figure 13 – Sign Condition by Age

In fact, these data likely understate the effect of age on signs. This is because the longer a sign is in service, the more likely it is to be replaced due to knockdown or resident complaints. This probably has the effect of weeding out some of the worse-condition signs as time goes by. However, based on the observations, there does not appear to be a distinct age of failure for signs.

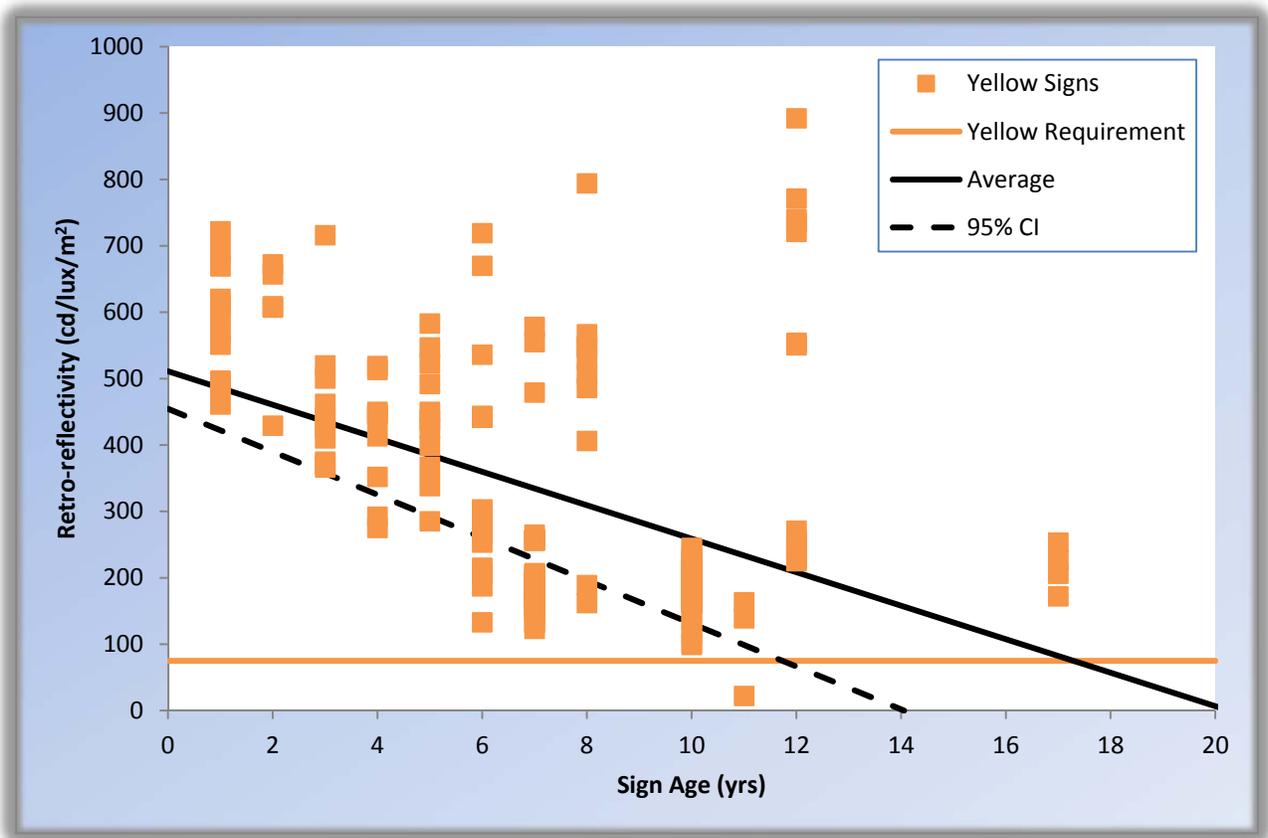
Figure 14 – Retro-reflectivity versus Age for Yellow Signs

Retro-reflectivity measurements were taken throughout the project. The MUTCD lists minimum required retro-reflectivity values for white, yellow, red, and green signs. Overall, 15.6 percent of signs failed the retro-reflectivity test. This varied depending on sign color, with green signs failing to meet retro-reflectivity 50 percent of the time. This is likely a result of the fact that 83 percent of the green signs tested were un-dated, meaning they are potentially older signs. This cannot be stated for certain, since two-sided green signs are common and do not have date stickers. Overall, 68 percent of the tested signs were undated, compared to 63 percent of the observed signs.

Applying regression analyses to the data collected for the various sign types results in an anticipated timeframe when the average sign is expected to no longer meet the retro-reflectivity requirements. While this data may assist in considering a sign replacement schedule and budget, methods of directly assessing retroreflectivity should be considered in the ultimate decision to replace a sign. By the time the estimated lifetime of a sign has passed, fully half of the signs are expected to not meet standards. That would be an unacceptable number of failing signs. On the other hand, it would be unreasonable to plan a replacement schedule around the premise of ensuring no signs fall below the retro-reflectivity requirements, since even signs a couple of years old were observed at failing retro-reflectivity levels. As a compromise, we analyzed the data to determine the regression line at the lower end of a 95 percent confidence interval. Essentially, we are saying that there is 95 percent confidence that the average retro-reflectivity value for any given year is higher than the value predicted by the line. The 95 percent confidence interval lines are included in the retroreflectivity figures.

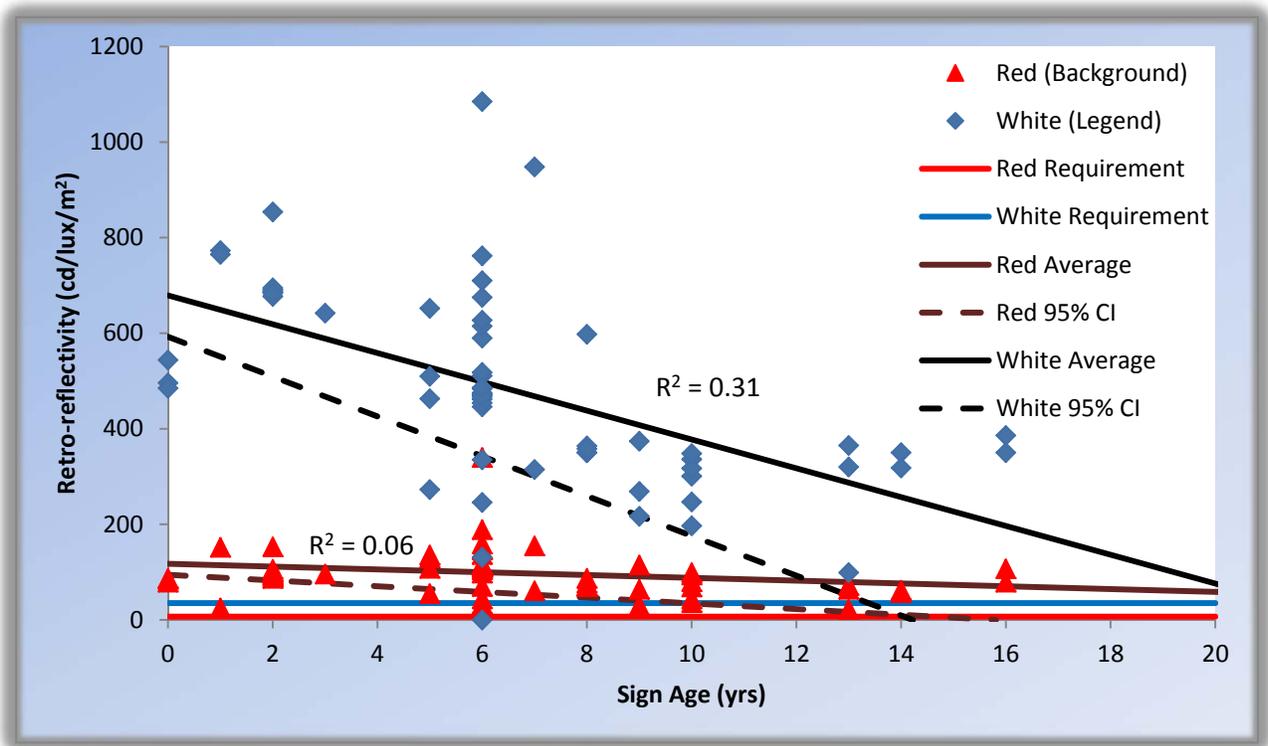
Figure 16 - Retro-reflectivity versus Age for Red Signs

The red and green colors exhibit nearly a 50 percent decline in expected life when comparing the average and the 95 percent confidence interval retro-reflectivity lifespans. This reflects relatively large variability in the observed retro-reflectivity values across the signs sampled. It is surprising that the green signs have such low life spans, since the current regional sign specification requires a 10-year manufacturer warranty on sign sheeting.
