# TECHNICAL MEMORANDUM

**Subject:** Old Seward Highway & Huffman Road Pavement Preservation  
Guardrail Analysis Report - Draft  
Project No. 0537010/CFHWY00886

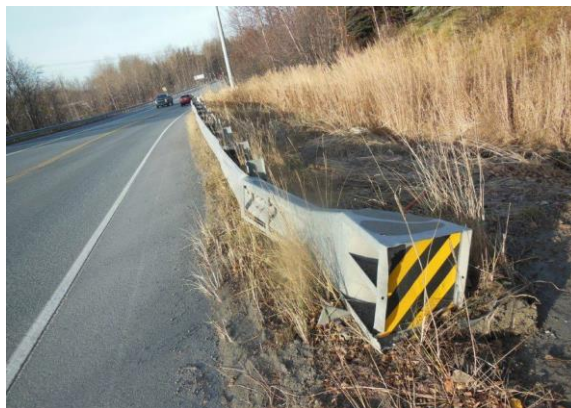
Photo 1 – FT-HIT-TERM

- FT-HGT: This code is applied when the height of the terminal did not fall in the range of 26.5 to 32 inches, which is the acceptable height of guardrail to meet NCHRP 350 or MASH testing standards.
- FT-HIT-TERM: This code is applied to an activated or “kinked” energy absorbing terminal or crash cushion when more than one post is sheared or cracked or there is damage to foundations that disallows repair.

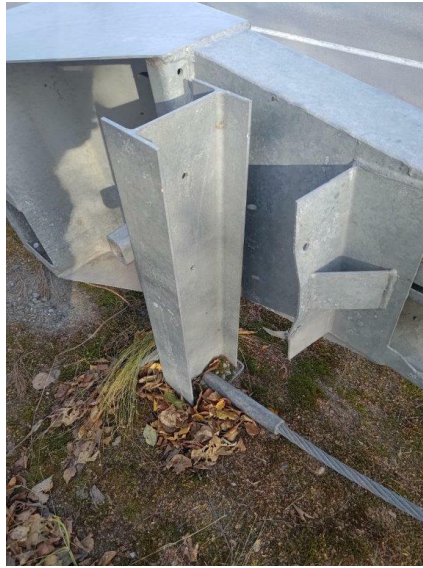
Photo 2 – FT-LAG

- FT-LAG: This code is used when lag screws in a wood post are missing or have failed, or there are extruding terminals. It is also used when non galvanized bolting is rusting, has a poor fit, is missing or there is an improper use of nails.

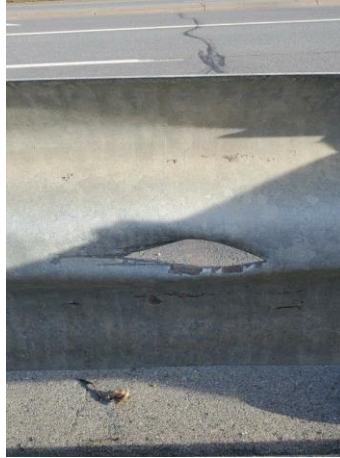
Photo 3 – F-HOLES

- F-HGT: This code is applied when the height from the asphalt to the top of the W-beam does not fall in the range of 26.5 to 32 inches, which is the acceptable height of guardrail to meet NCHRP-350 or MASH testing standards.
- F-HOLES: This code is used when there are crash-induced holes, lug nut damage, or holes rusted through the guardrail. Included are any holes over 1-inch in height, more than two holes less than 1-inch high over a 12.5-foot stretch of rail, and any hole which intersects the top or bottom edge of rail.
