Alaska Department of Transportation and Public Facilities Central Region

NHS STORM DRAIN INSPECTION CONDITION REPORT PROJECT NO. 0A31055 / Z591280000

Dimond Boulevard from Jewel Lake Road to Old Seward Highway
Muldoon Road from Boundary Avenue to Northern Lights Boulevard
Debarr Road from Bragaw Street to Muldoon Road
Downtown: 5th and 6th Avenue from Gambell Street to Orca Street and
Ingra Street from 6th Avenue to 9th Avenue

May 20th, 2019

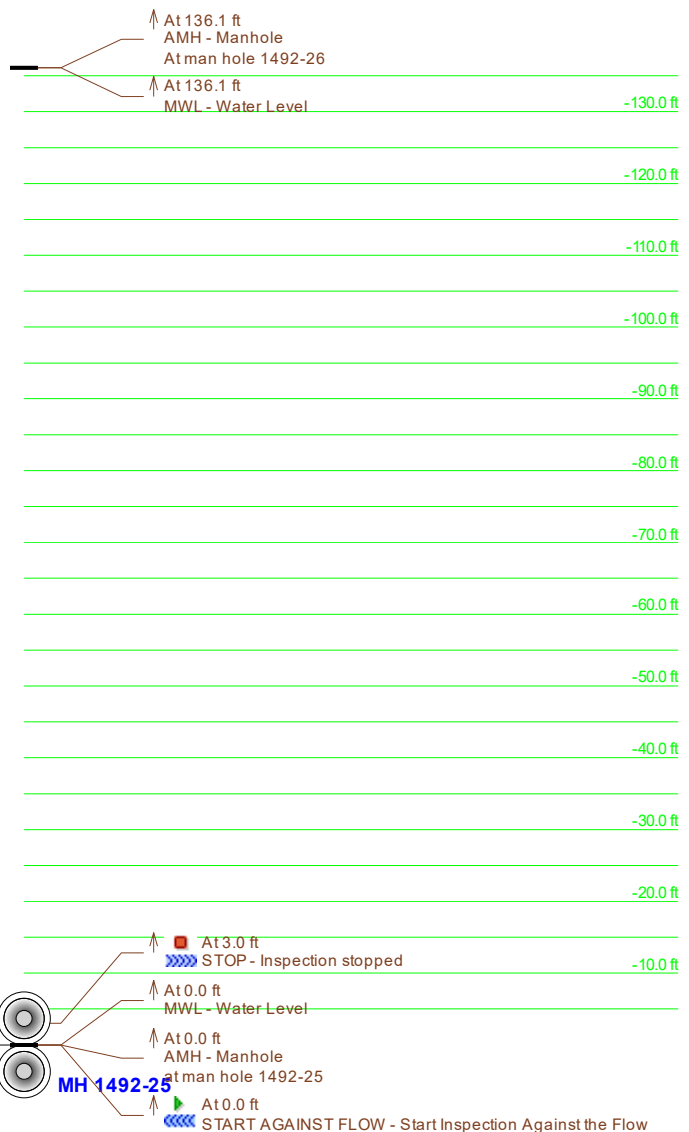
- Physically probed downstream invert, evidence of surface corrosion in invert throughout pipe
- Evidence of infiltration throughout pipe
- 1-3" of debris in pipe
- Evidence of infiltration 4:00 position Sta. 0+23
- Evidence of infiltration at joint Sta. 0+27, 0+32, 0+65, 0+82
- Evidence of infiltration/corrosion 4:00 and 8:00 position Sta. 0+41
- Evidence of infiltration 3:00 position Sta. 0+50
- Possible hole in invert at Sta. 0+60
- Evidence of infiltration at 4:00 position Sta. 0+65
- Evidence of pipe belly from Sta. 0+60 to Sta. 0+70
- 1-2" deflection 2:00 position Sta. 0+77
- Flow: 1" to 2"
- Grade score of: 3

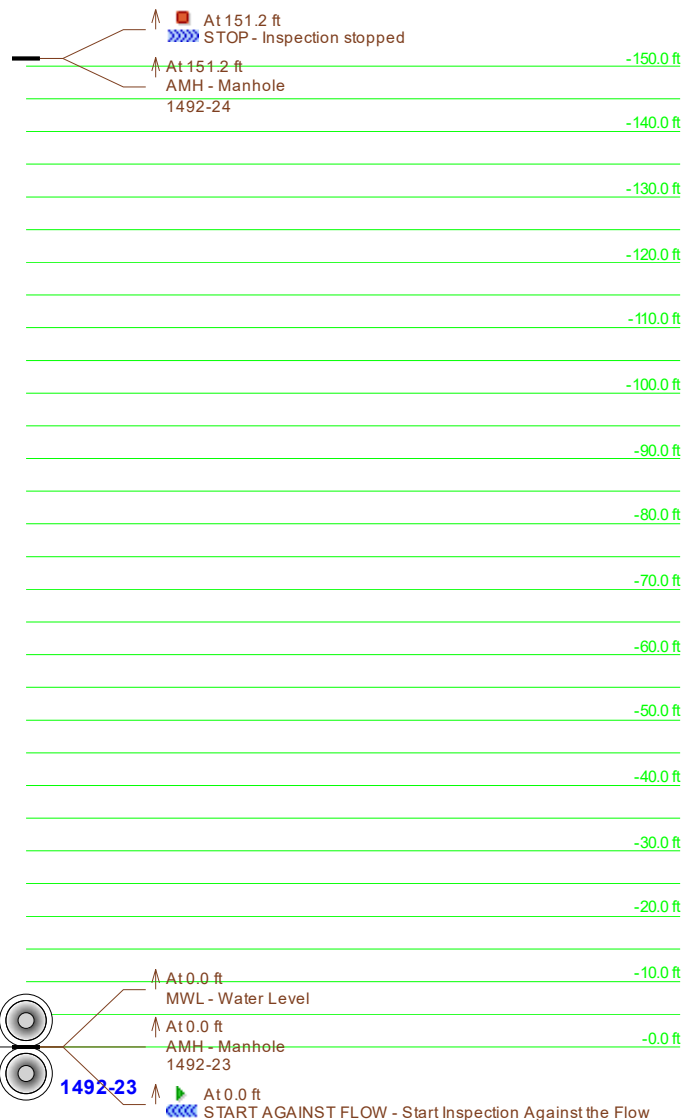
- 30-in. CMP
- 151 LF
- Numerous corrosion spots (0.5" to 3" Dia.)w/material loss, some w/pin holes, 7:00 to 5:00 position, mainly between Sta. 0+00 to 0+80.
- Most joints have leaks with mineral buildup.
- Deformation 1:00 position Sta.1+23 < 5% flow reduction, no corrosion.
- Flow: 1" over 2" debris/mud.
- Grade score of: 3

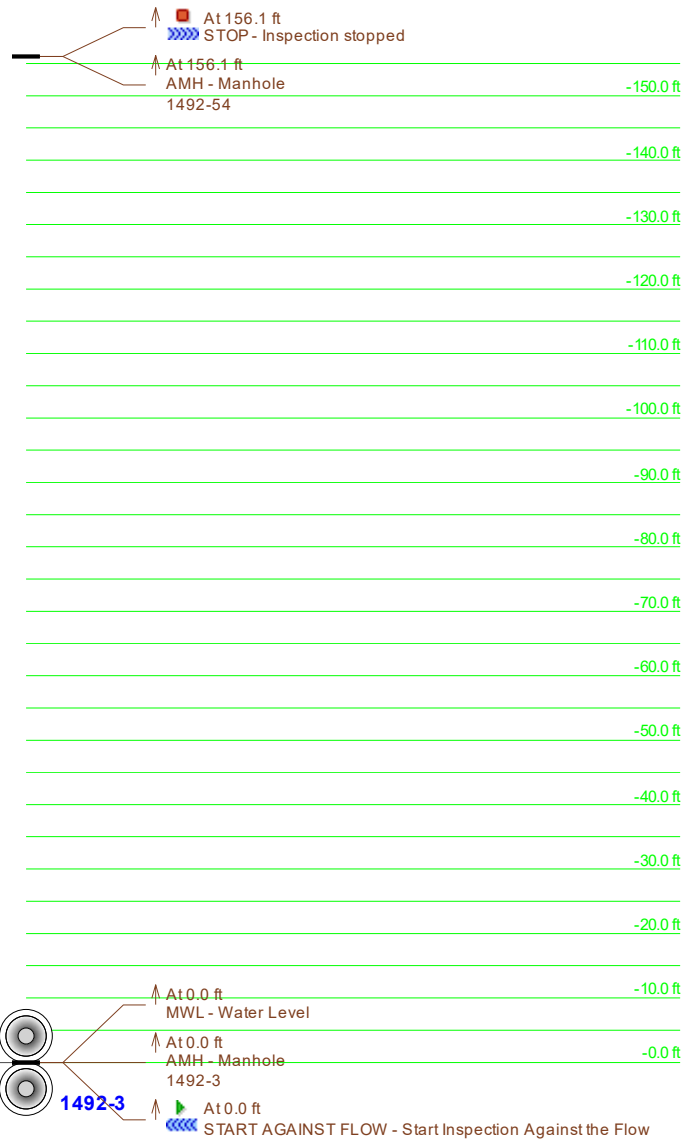
- 18-in. CMP
- 156 LF
- Discoloration & some corrosion in the invert.
- Flow: Minimal
- Grade score of: 1

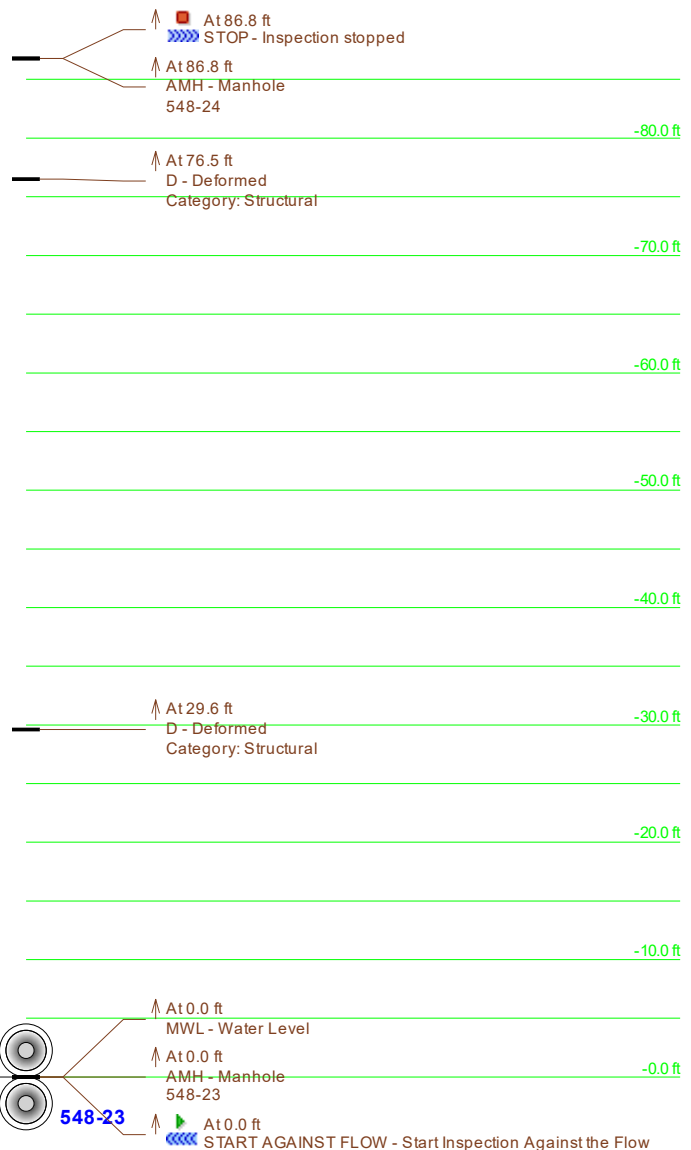
- 18-in. CMP
- 87 LF
- Minor corrosion 5:00 & 7:00 position along length pipe.
- Corrosion w/pitting, 3:00 & 9:00, Sta. 0+75 to 0+85.
- Two deformations 12:00 & 1:00 at Sta. 0+29 & 0+75. No pipe flow reduction.
- Flow: Minimal
- Grade score of: 2

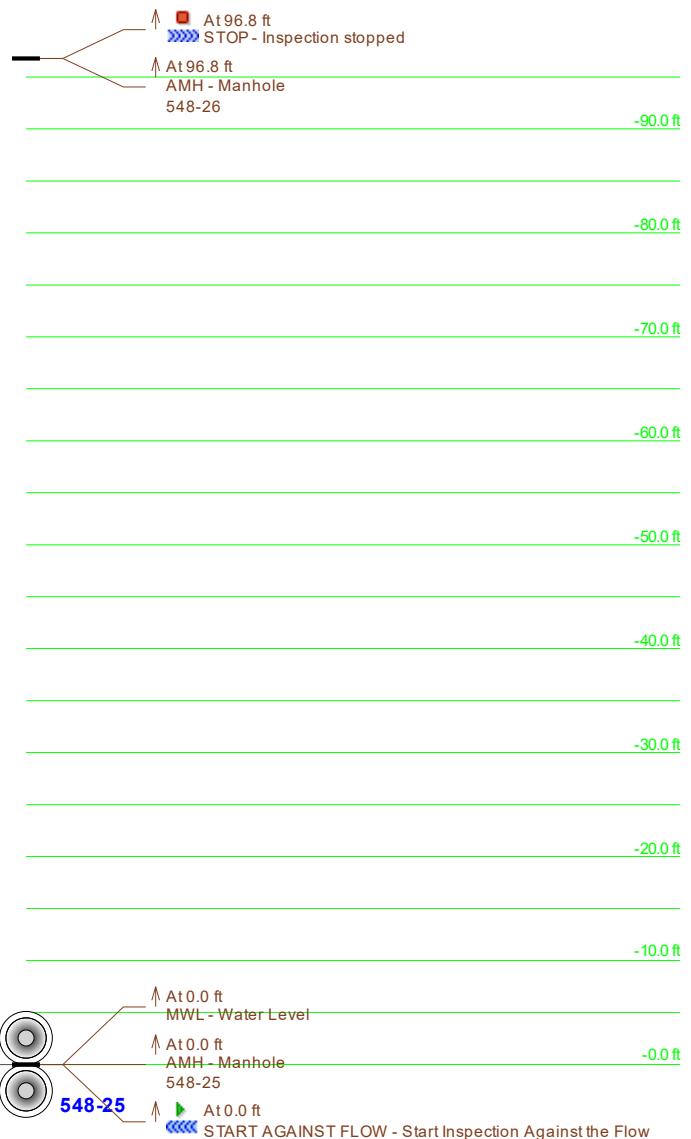
- 18-in. CMP
- 97 LF
- Heavy corrosion w/metal loss, 3:00 5:00 position, Sta. 0+89 to 0+94.
- Joint separation 1" to 2" gap 11:00 to 2:00, Sta. 0+30.
- Debris 5:00 to 7:00 position length of pipe.
- Flow: Minimal
- Grade score of: 3

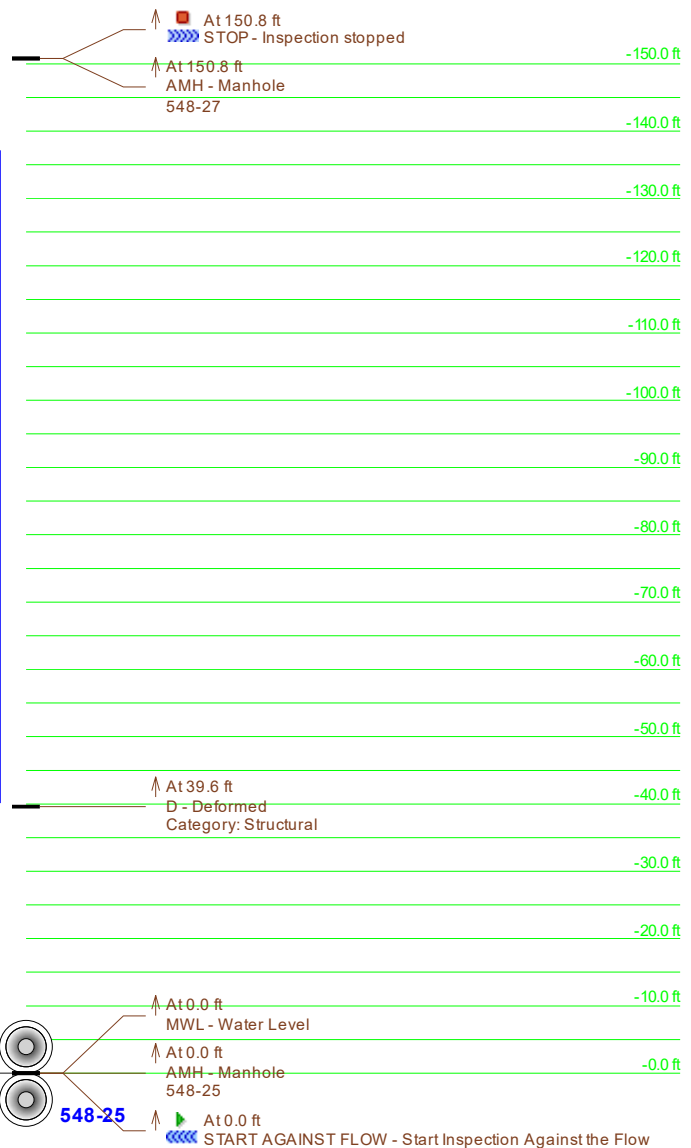
- 36-in. CMP
- 151 LF
- Deep corrosion pitting 5:00 Sta. 0+18 to 0+20.
- Corrosion w/pitting, 5:00 & 7:00, along length pipe.
- Deformations 12:00 at Sta. 0+39. No pipe flow reduction.
- Pipe makes several deflections to the to the south.
- Flow: 2" to 4"
- Grade score of: 3

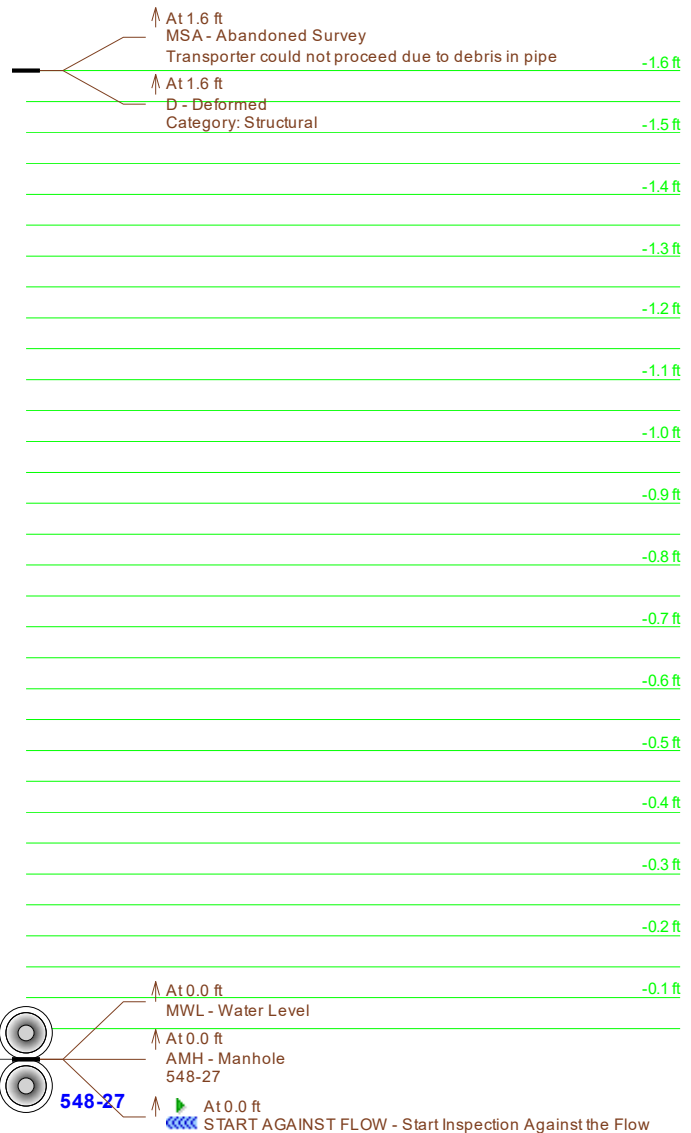
- 18-in. CMP
- 35 LF
- 2-4" of debris in pipe
- 1-2" deflection visible in 1:00 position
- Camera transporter could not proceed due to debris, pipe walls appear to be in good condition from 8:00 to 4:00 position, view of invert obscured, pipe cleaning required to complete inspection
- Flow: None
- Grade score of: 1

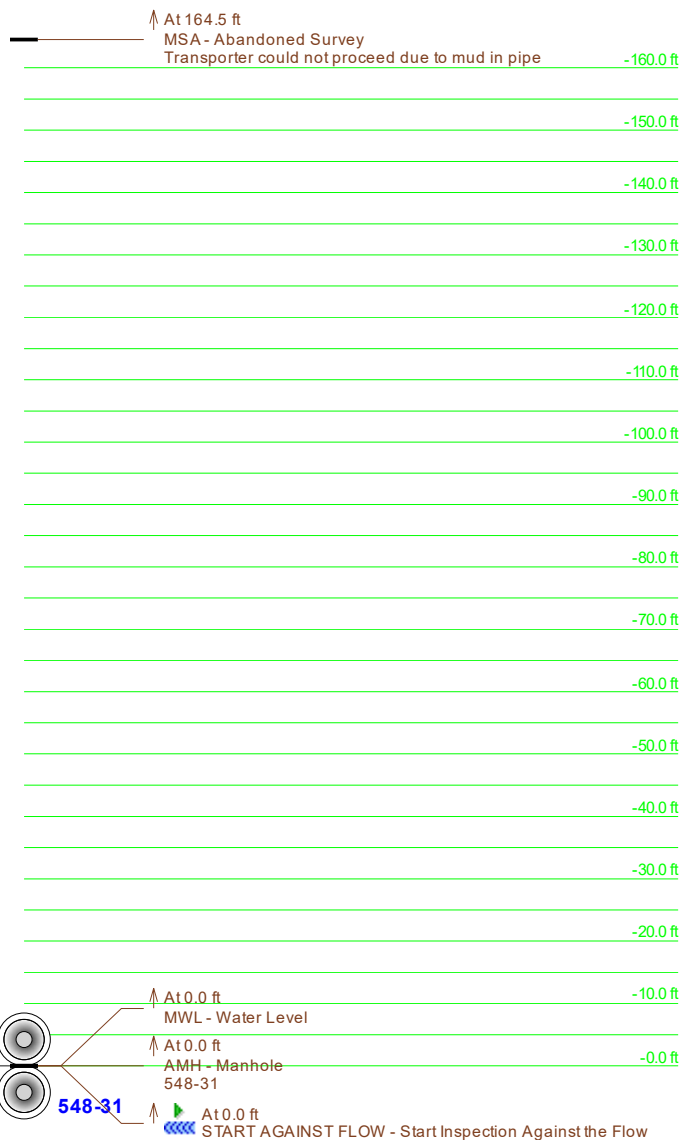
- 12-in. Fin Drain
- 222 LF
- Discoloration in pipe wall from 3:00 position to 9:00 position
- Pipe spigots bent at joint, 24 LF, 84 LF
- 0-1" debris buildup around thaw line, begins increasing at 147 LF to 2-3" at 165 LF, camera could not pass
- Organic material in 11:00-12:00 position at joint, 54 LF, 84 LF
- Visible root infiltration at joint, 115 LF, 147 LF
- Camera zoomed to organic buildup/root infiltration
- Flow: None
- Grade score of: 2

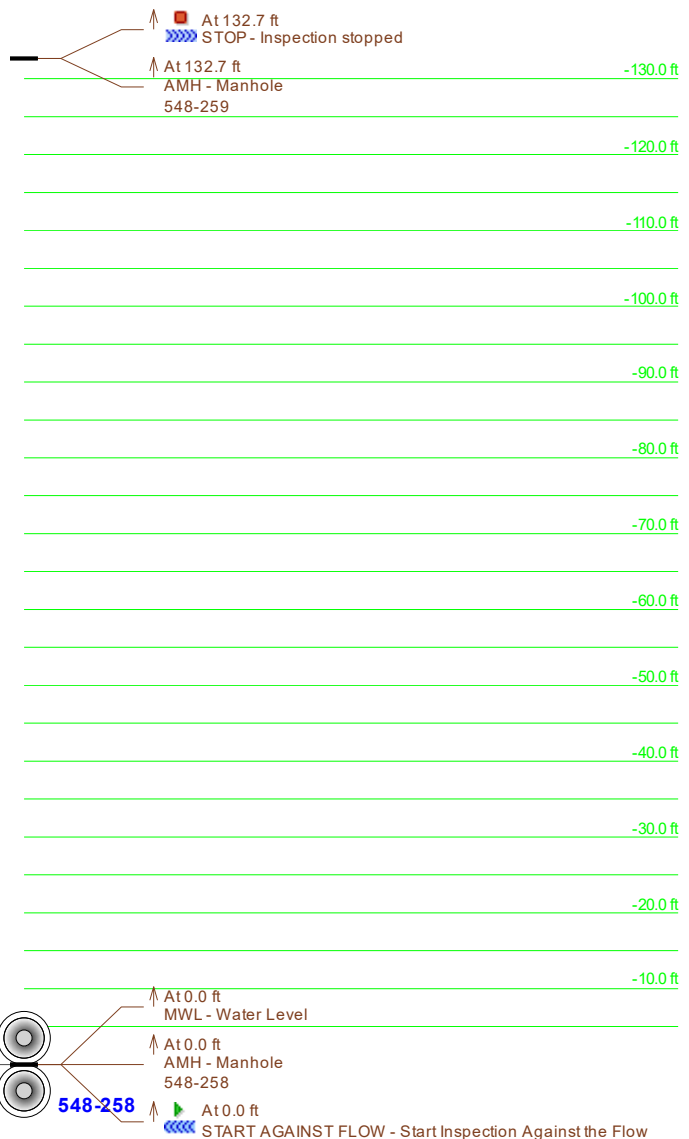
- 18-in. CMP
- 133 LF
- 0-1" of debris
- No visible defects observed
- Flow: Minimal
- Grade score of: 1

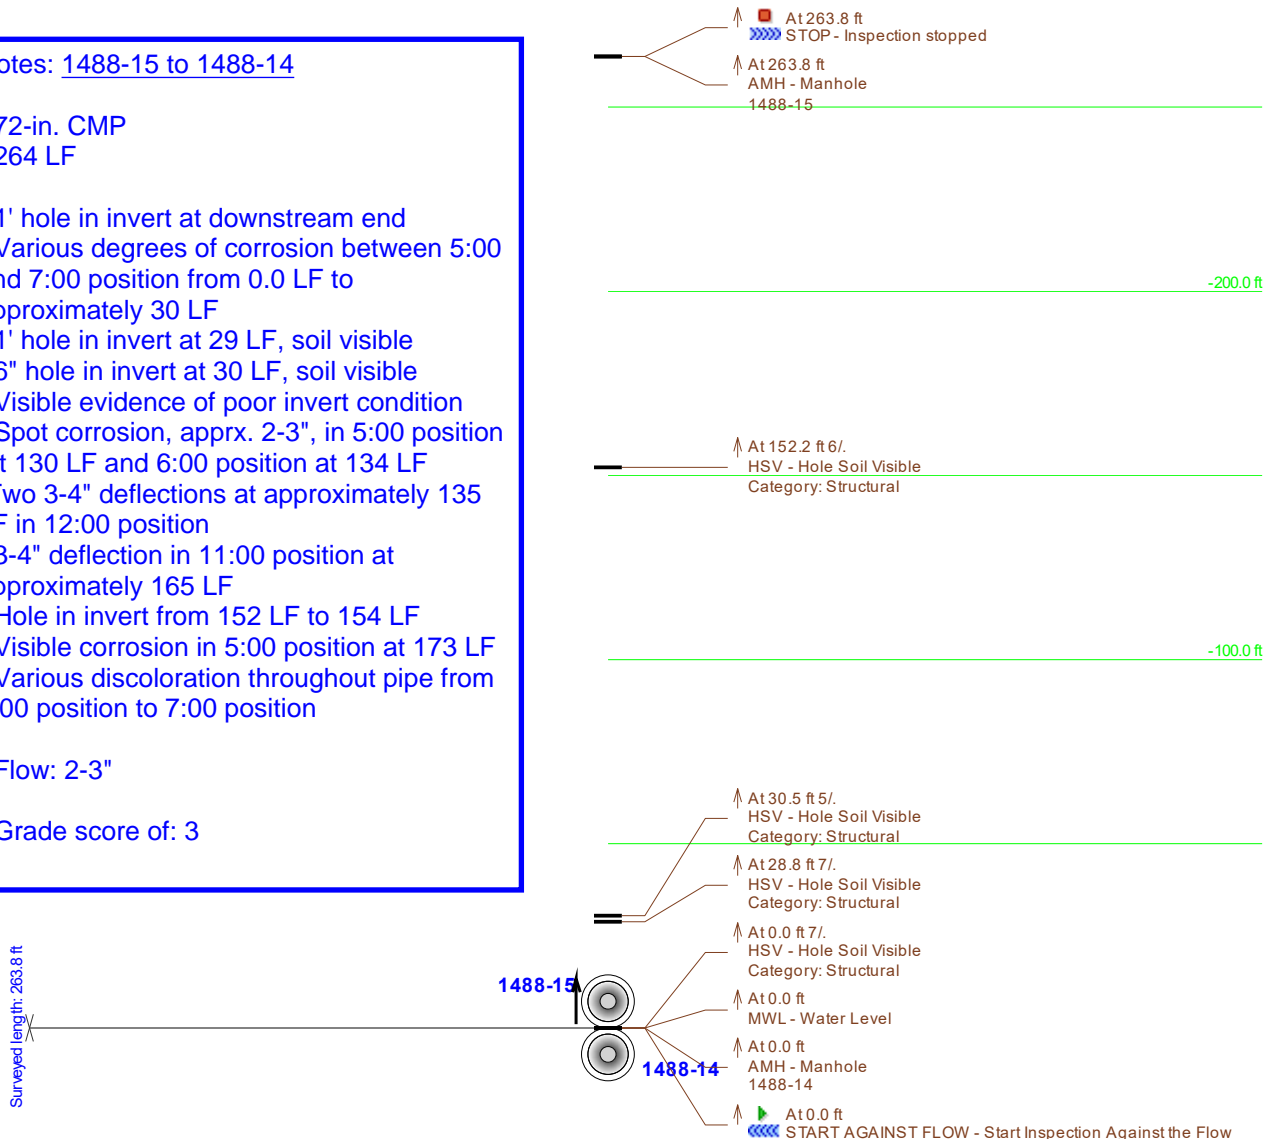
- 72-in. CMP
- 264 LF
- 1' hole in invert at downstream end
- Various degrees of corrosion between 5:00 and 7:00 position from 0.0 LF to approximately 30 LF
- 1' hole in invert at 29 LF, soil visible
- 6" hole in invert at 30 LF, soil visible
- Visible evidence of poor invert condition
- Spot corrosion, appr. 2-3", in 5:00 position at 130 LF and 6:00 position at 134 LF
- Two 3-4" deflections at approximately 135 LF in 12:00 position
- 3-4" deflection in 11:00 position at approximately 165 LF
- Hole in invert from 152 LF to 154 LF
- Visible corrosion in 5:00 position at 173 LF
- Various discoloration throughout pipe from 5:00 position to 7:00 position
- Flow: 2-3"
- Grade score of: 3

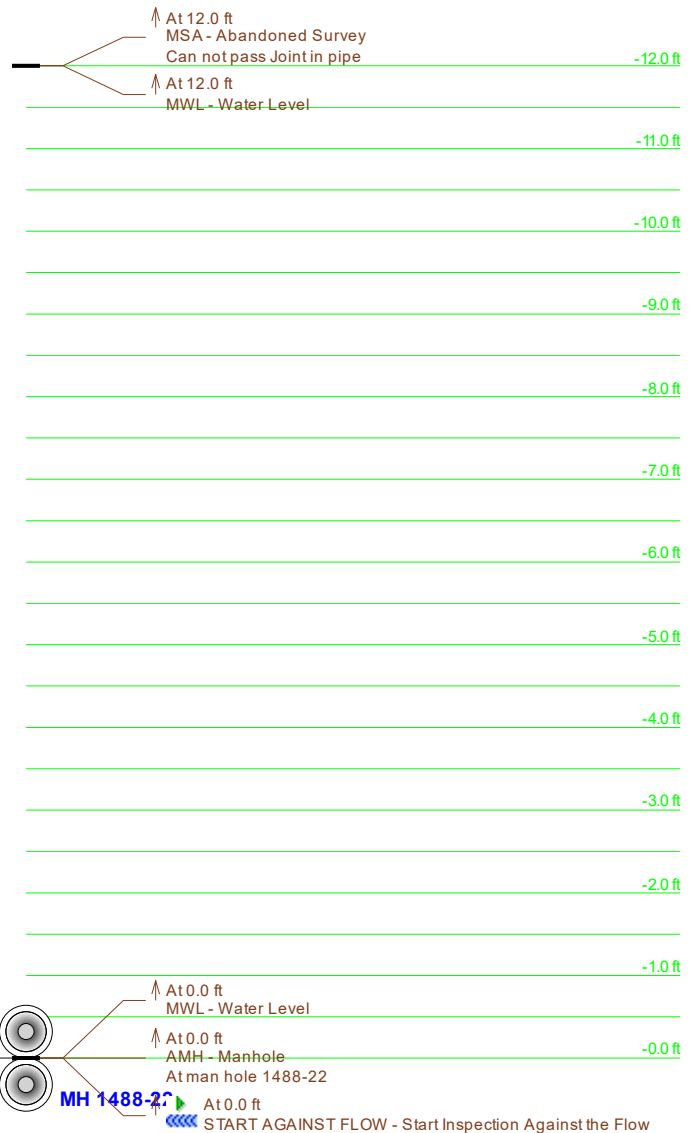
- 12-inch CMP, Fin Drain Pipe
- 52 LF
- 0-1" of debris and discoloration in invert
- Broken pipe end at joint at 12 LF, camera unable to pass
- Camera zoomed to end, debris in downstream end, no structural defects observed
- Flow: None
- Grade score of: 2

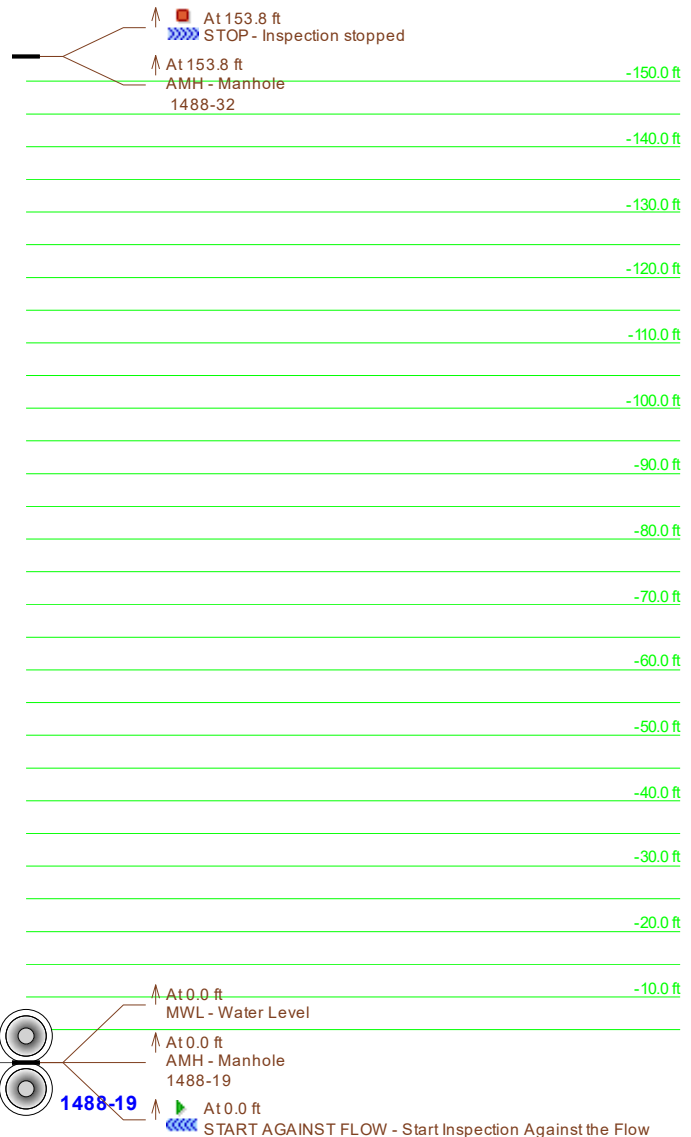
- Arch CMP
- 154 LF
- Discoloration/corrosion at bottom 4-6" of CMP arch
- Evidence of minor infiltration/mineralization at joints at 90% of joints
- Spigot end bent at joint 32 LF, soil visible at 10:00 to 12:00 position
- Corrosion in 7:00 to 8:00 position at 86 LF
- Flow: 2-3"
- Grade score of: 2

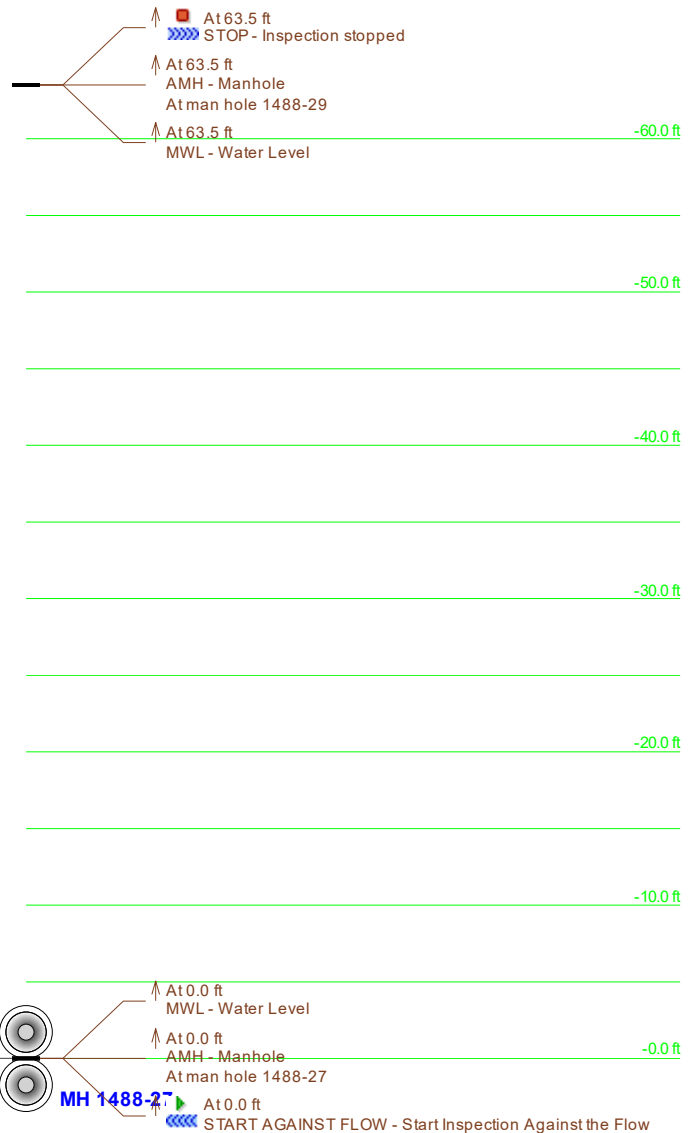
- 12-inch CMP
- 64 LF
- Minimal debris in pipe
- No major defects observed
- Flow: None
- Grade score of: 1
