**NOATAK RIVER BANK EROSION STUDIES**

***NOATAK RIVER BANK EROSION STUDY  
AT NOATAK, ALASKA***

ANTHC Project No. AN01-Q55

**R&M CONSULTANTS, INC.**  
9101 Vanguard Drive  
Anchorage, Alaska 99507

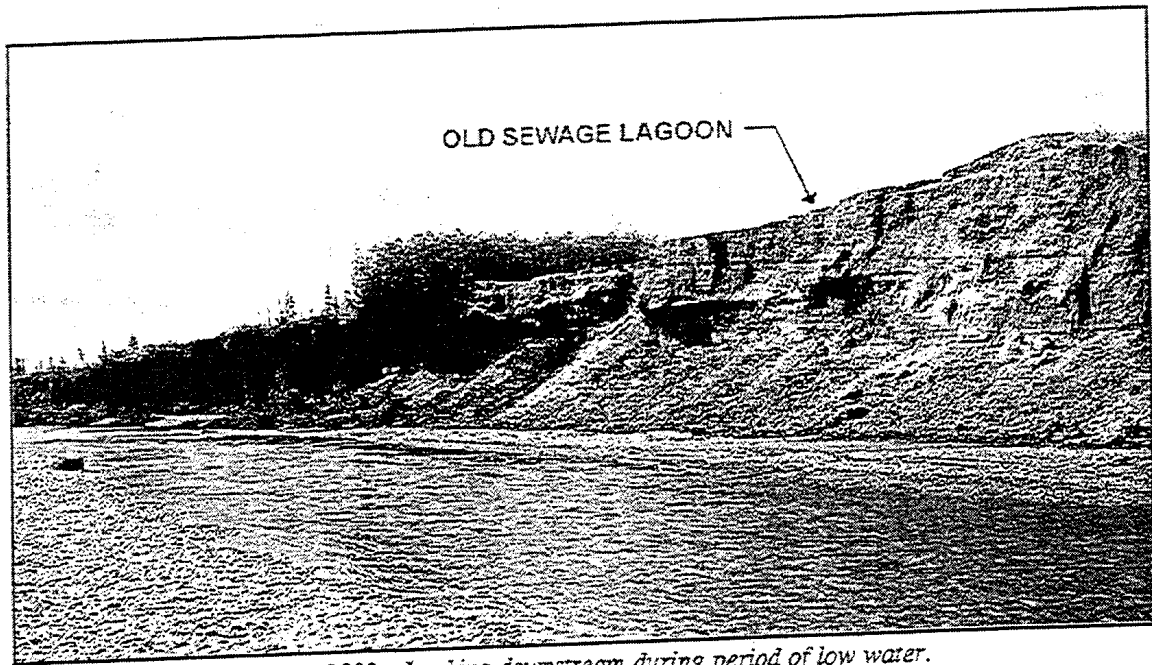
FIGURE 5

August, 2002 - Looking downstream during period of low water.

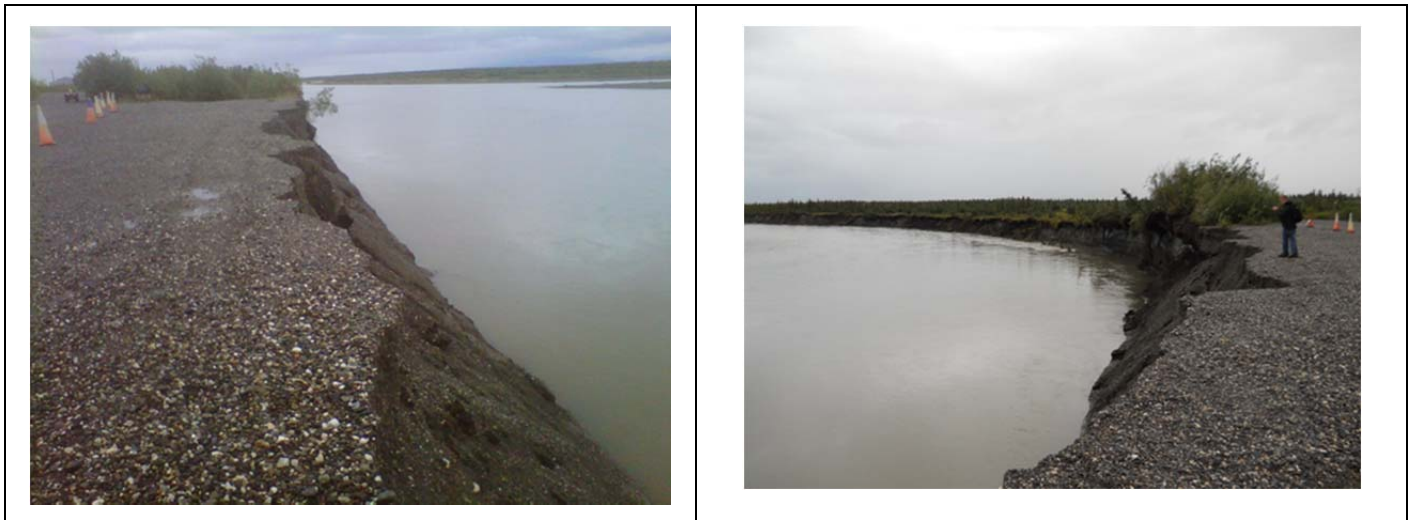
**Figure 5: Bank Erosion August 2012 Orange cones set along east side of Pit Road. (Left) looking upriver from Point C (Right) looking downriver from Point B**

4. August 2012. Significant erosion occurred southeast of the airport apron during a very rainy late summer period.
- A DOT&PF sketch based on GPS coordinates collected on August 1, 2012, site visit and aerial imagery (Figure 6), indicates the distance from the southeast corner of the apron to the riverbank is now about 125 feet. Photos from that site visit (Figure 5) illustrate the bank height and the extent of erosion along the bank. DOT&PF personnel note that active erosion was occurring at Point C shown in Figure 6 and that erosion had occurred both up and downriver from Point C, as illustrated by the red line (“2012 anticipated shoreline”) in Figure 6. The actual location of Point C may be somewhat closer to the river than shown on this figure, due to cloud cover interfering with the GPS satellite signal (Dianoski, 2013). Assuming Point C is only half the distance from the river edge than shown on Figure 3 and comparing this with the 2006 edge of bank, it appears that 20 to 30 horizontal feet had been lost.

- DOT&PF’s contract airport maintenance staff in Noatak described the erosion as occurring over several weeks, losing about a foot a day (Kirk, 2013). He described high water all summer and an eddy effect against the bank during the active erosion. The maintenance staff also observed sinkholes next to Pit Road, between the road and the runway. During the summer rain, runoff from the road entered the sinkholes but didn’t fill them, apparently because water was seeping out. Seepage from the riverbank face on the other side of the Pit Road from the sinkholes was observed. This may indicate that there is direct seepage from the subsurface to the face of the riverbank.

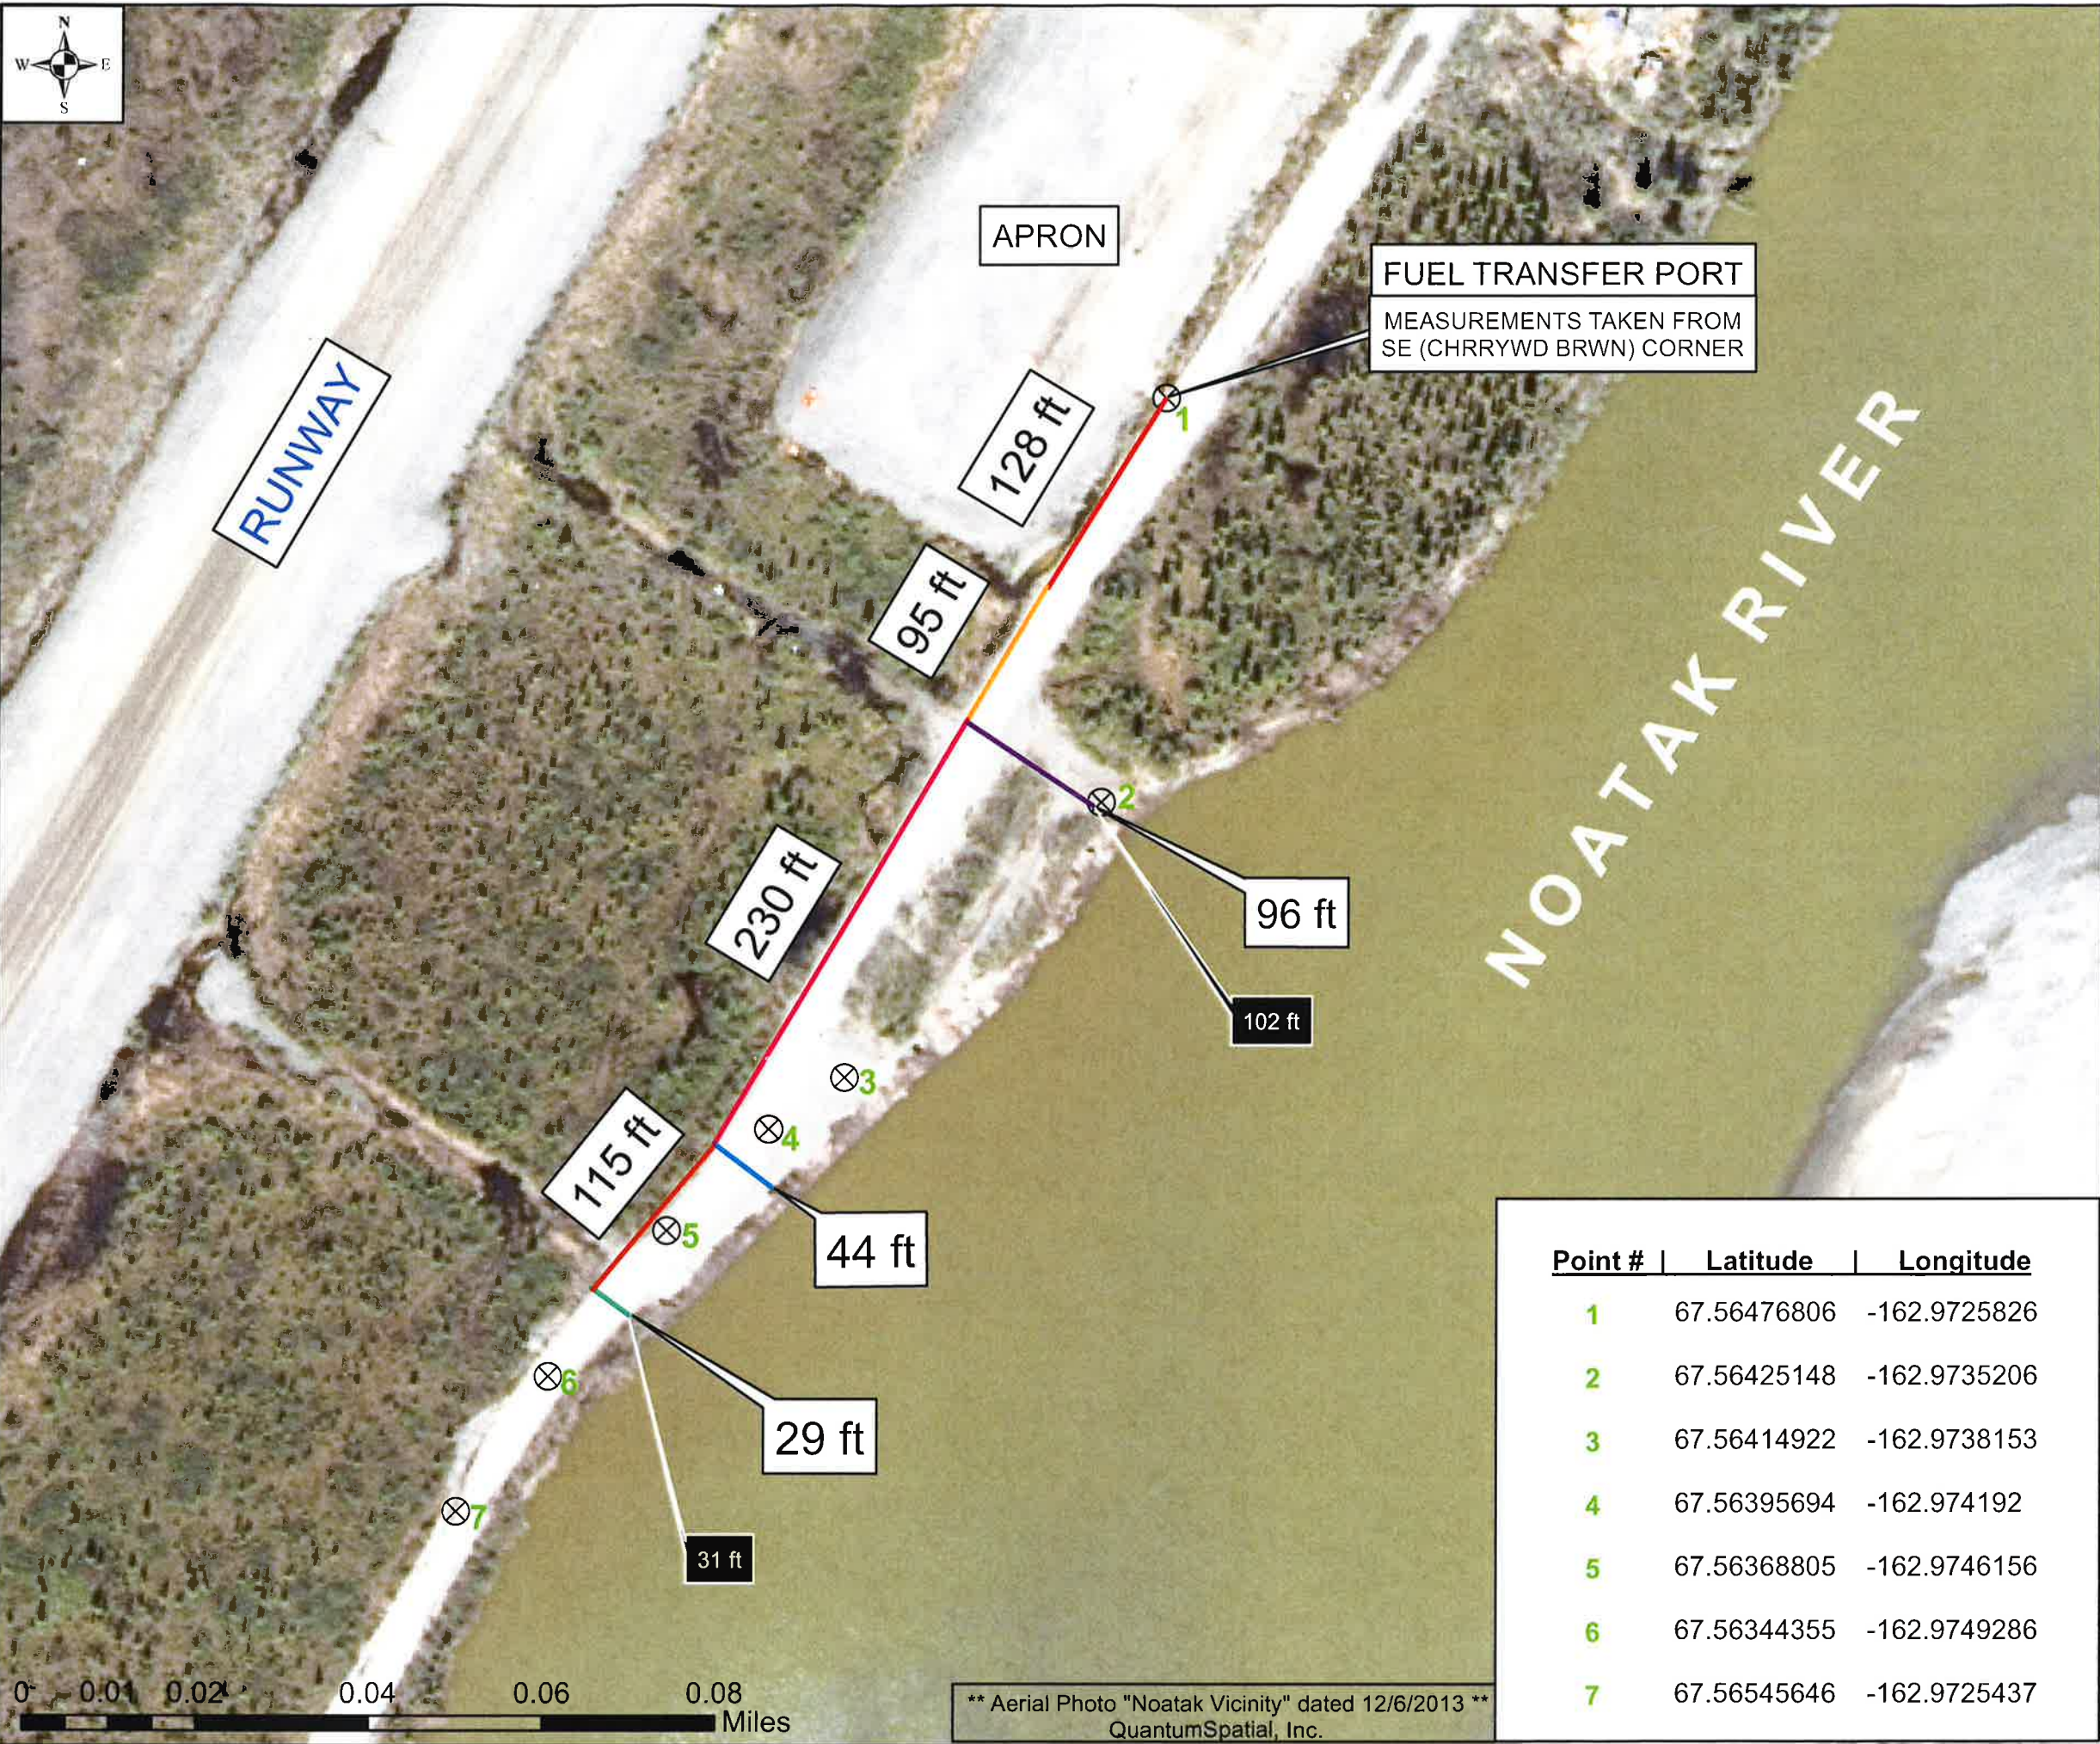
\*\* The DOT&PF recently received notices as well as the provision of photos of the gravel cliff from residents of Noatak, displaying the aftermath of ice-breakup and the effects of the continually thawing and exposed active layer of permafrost.

Following the graphic of the erosion occurring is a few recent photos of the erosion from a community member, for the DOT&PF.
