GEOTECHNICAL REPORT

PARKS HIGHWAY MILE 216 NORTH REHABILITATION

FEDERAL PROJECT NO. I-0A4-3 (07)
STATE PROJECT NO. 64924

JANUARY 1991

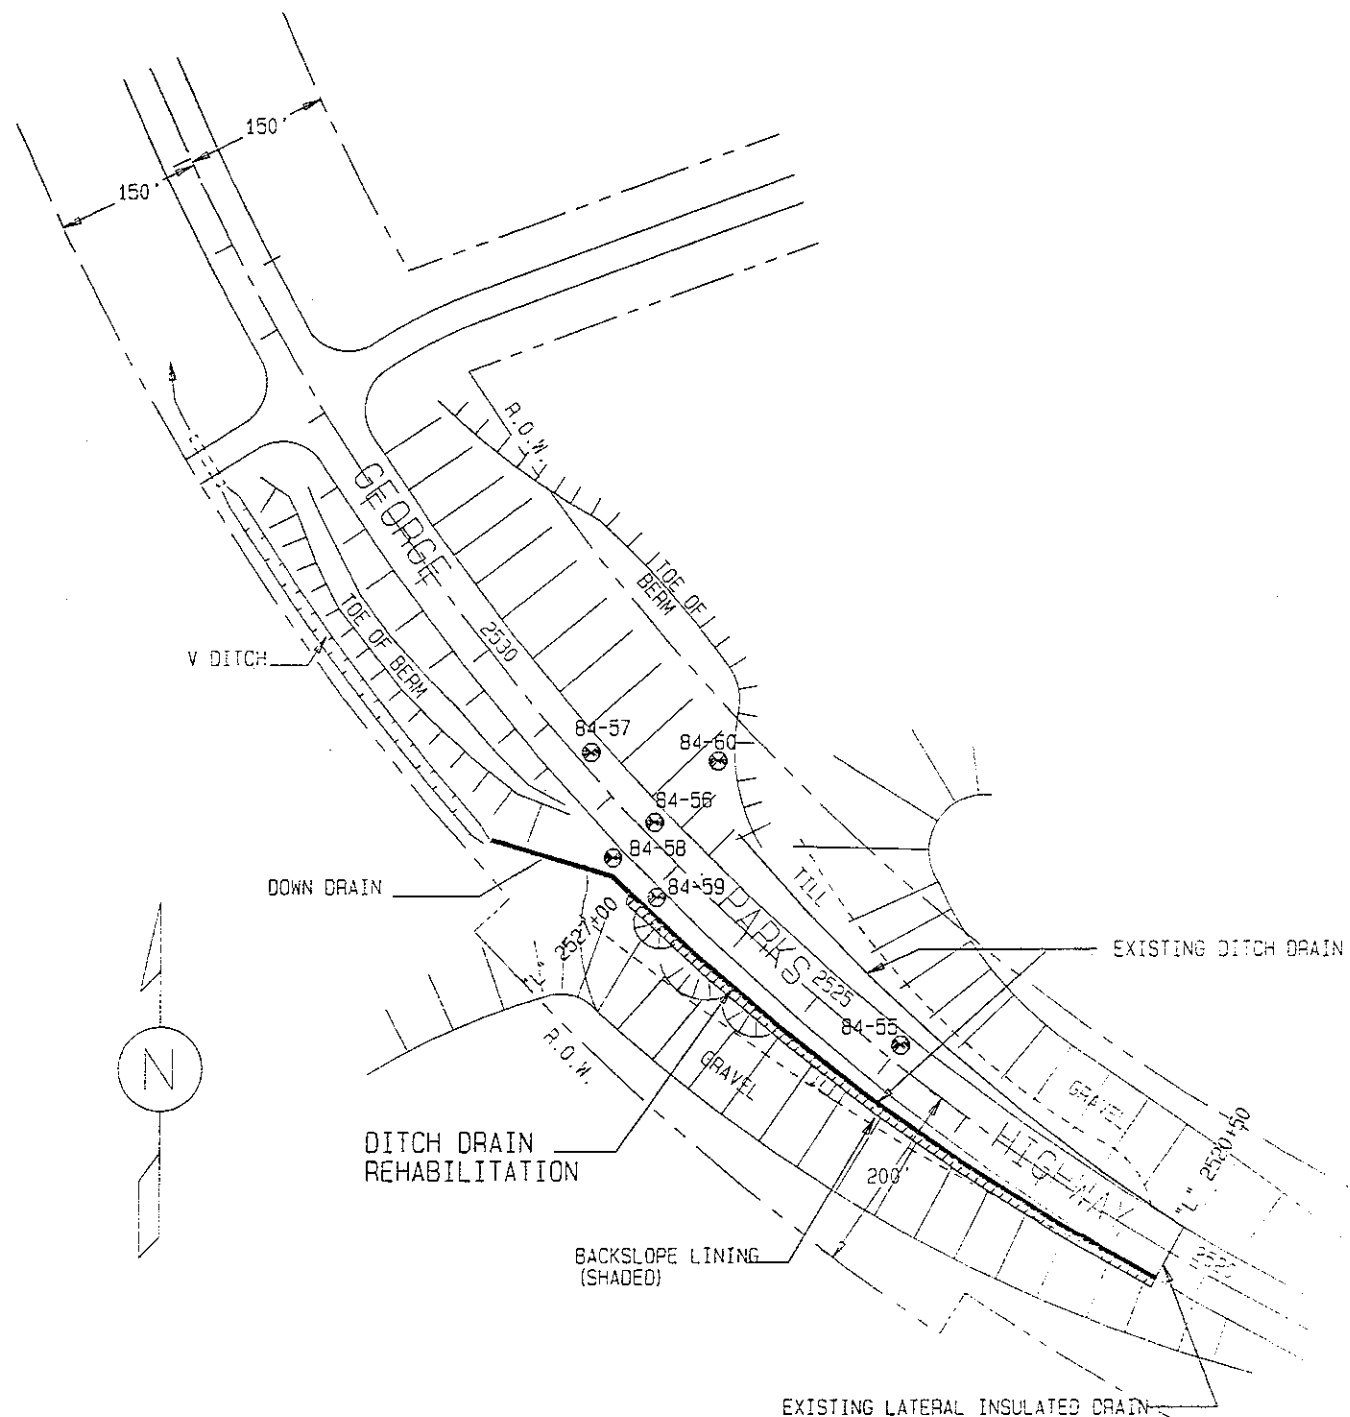
PLAN VIEW

This section is the fill just south of Nenana Bridge No. 2 near M.P. 231. A portion of the fill (Station 2527+50) has settled and moved towards the right (north). The right guard rail has settled about 5 feet and has shifted to the right at least 3 feet. The guard rail on the left has settled about 2 feet. A test hole in the failure showed 7.5 feet of wet, sandy gravel fill over 7 feet of wet, silty sandy gravel fill, all resting on frozen organic silt. The stabilizing berm on the right had 9 feet of sandy gravel fill, wet at a depth of 5 feet beneath the surface. The stabilizing berm rests 5 feet of wet organic silt that was frozen at 14 feet beneath the surface.

This sliding or slumping failure is further complicated by a drain in each ditch of the through cut just east (back) of the fill. The drains are designed to carry water away from the contact between outwash gravels and underlying glacial till exposed in the cut. Test holes attempted in the left drain met refusal in the drain rocks. The drains are supposed to carry the water along both sides of the fill and the right drain appears to be doing so. However, considering the wet condition of the fill and stabilizing berm, some of the water must be entering the fill from the left and from the contact source. See Page 24.

A geosynthetic to help stabilize the embankment is recommended. A single layer of geosynthetic was installed in this fill between Stations 2526+50 and 2530+00 in 1987. The fabric was placed 3 feet beneath the pavement surface and was wrapped on each side. It does not extend the full width of the fill; the guardrails were not removed for the fabric installation. The embankment showed some cracking outside of the geosynthetic in 1990.

Remove the 1987 geosynthetic. Excavate the embankment full width, to 42 inches beneath the final grade between Stations 2525+00 and 2530+00. Replace the excavated soils with Selected Material, Type A or B. In addition, place a high strength, high modulus geosynthetic 1 foot beneath the final grade. This work will require replacing the guardrails.

Additional earth work in this interval should include flattening the right fill slope to 2:1 and increasing the stabilizing berm height to 2/3's of the embankment height. Both will increase the stability of the fill.
