# **STATEWIDE MATERIAL SITE INVENTORY**

## **MATERIAL SITE** **INSPECTION REPORT**

**RICHARDSON HIGHWAY**

**MS 71-1-050-5**  
**16 Mile Quarry**

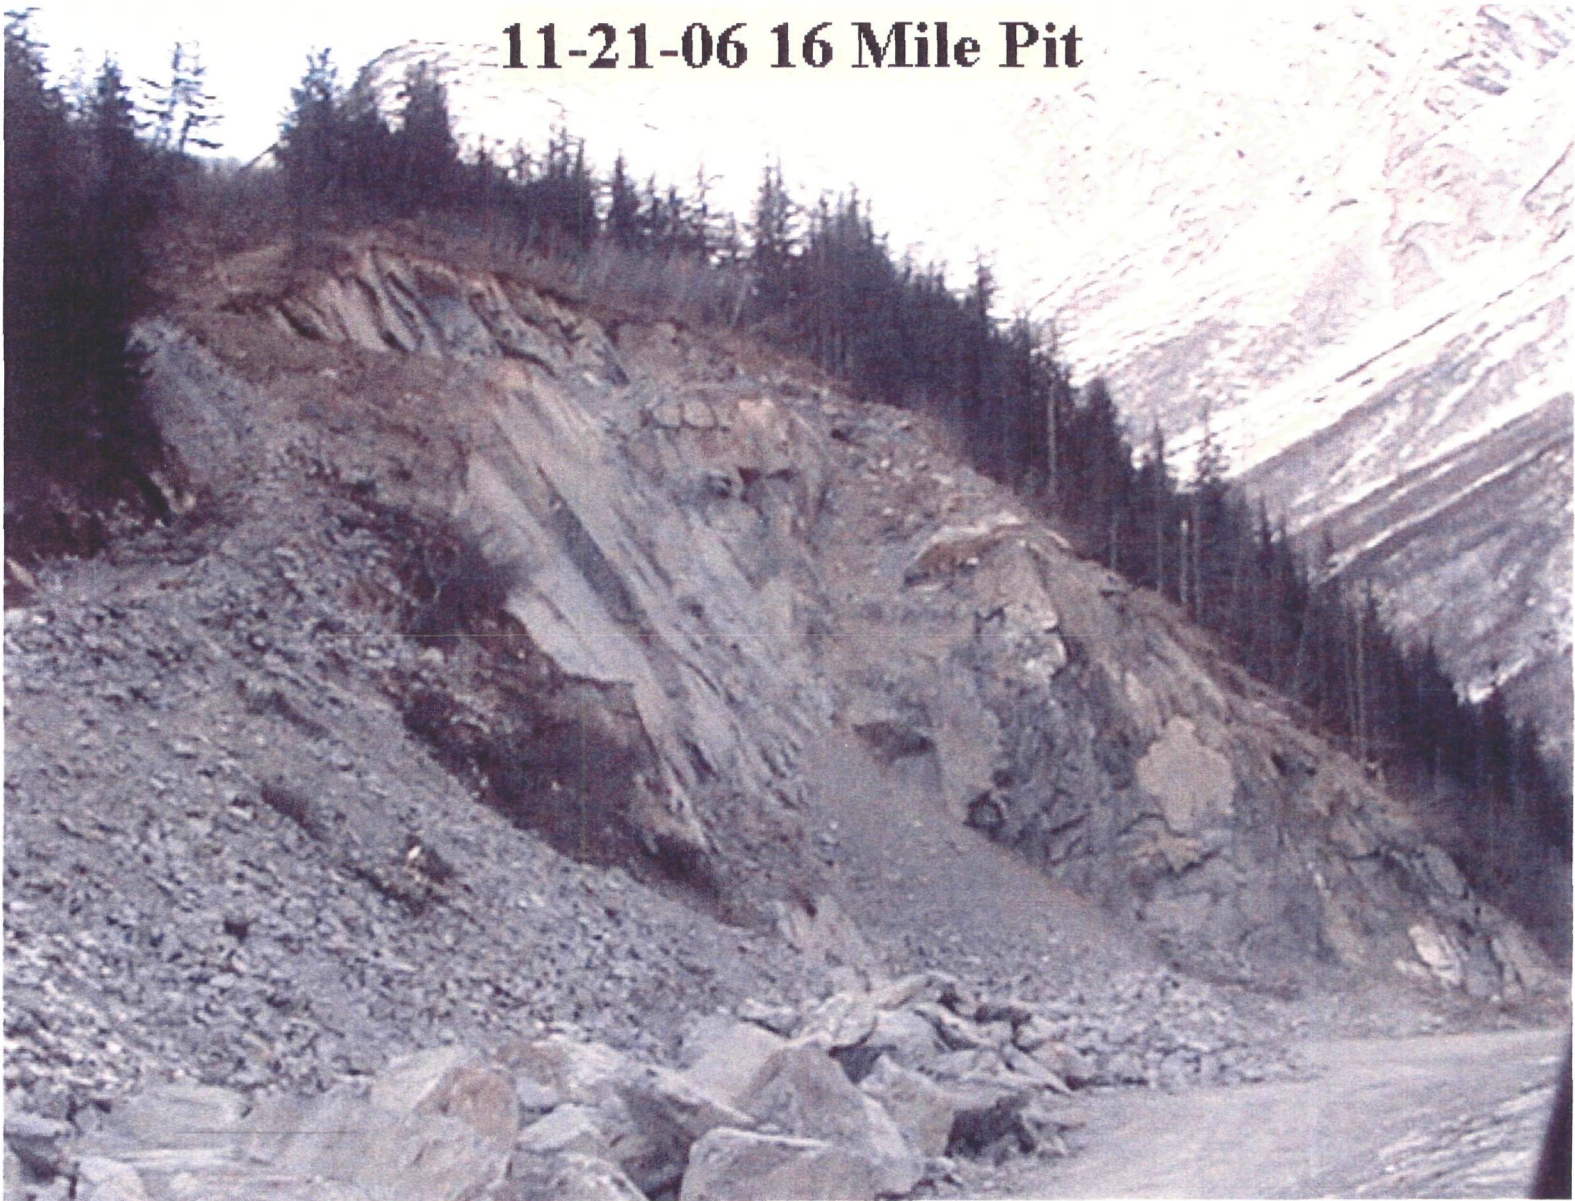
**11-21-06 16 Mile Pit**

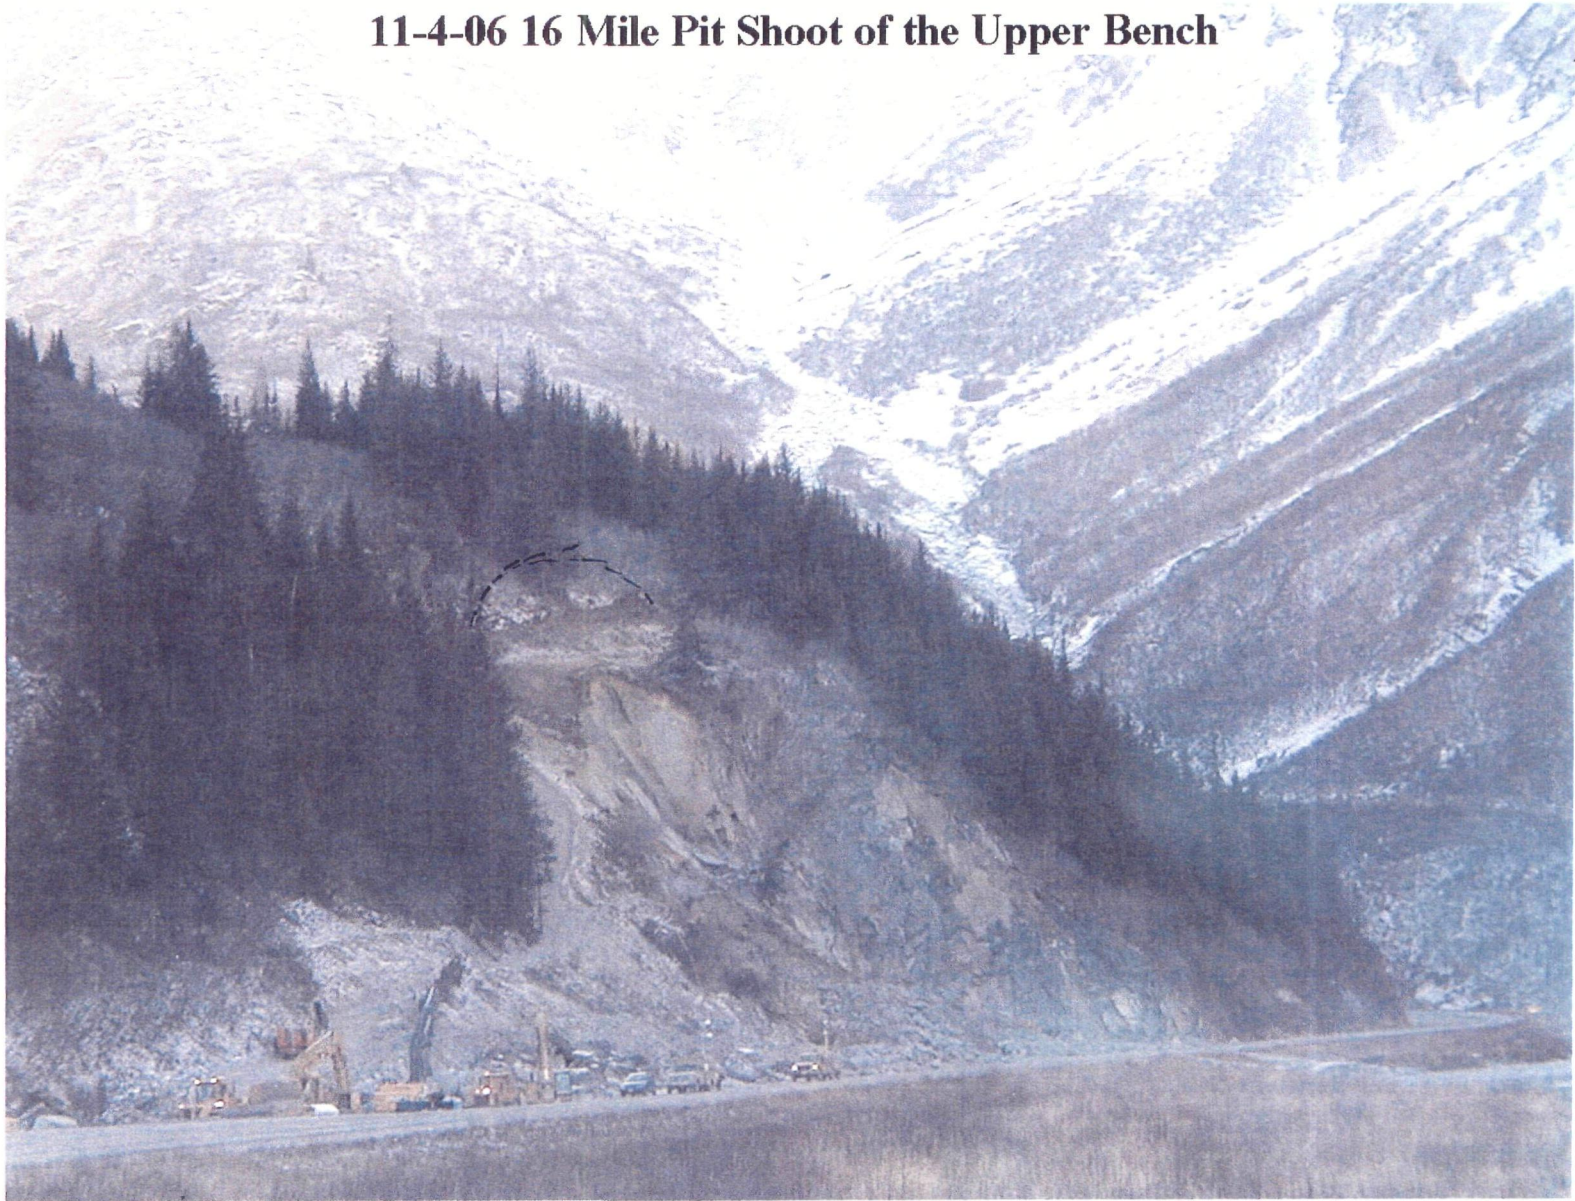
**11-4-06 16 Mile Pit Shoot of the Upper Bench**

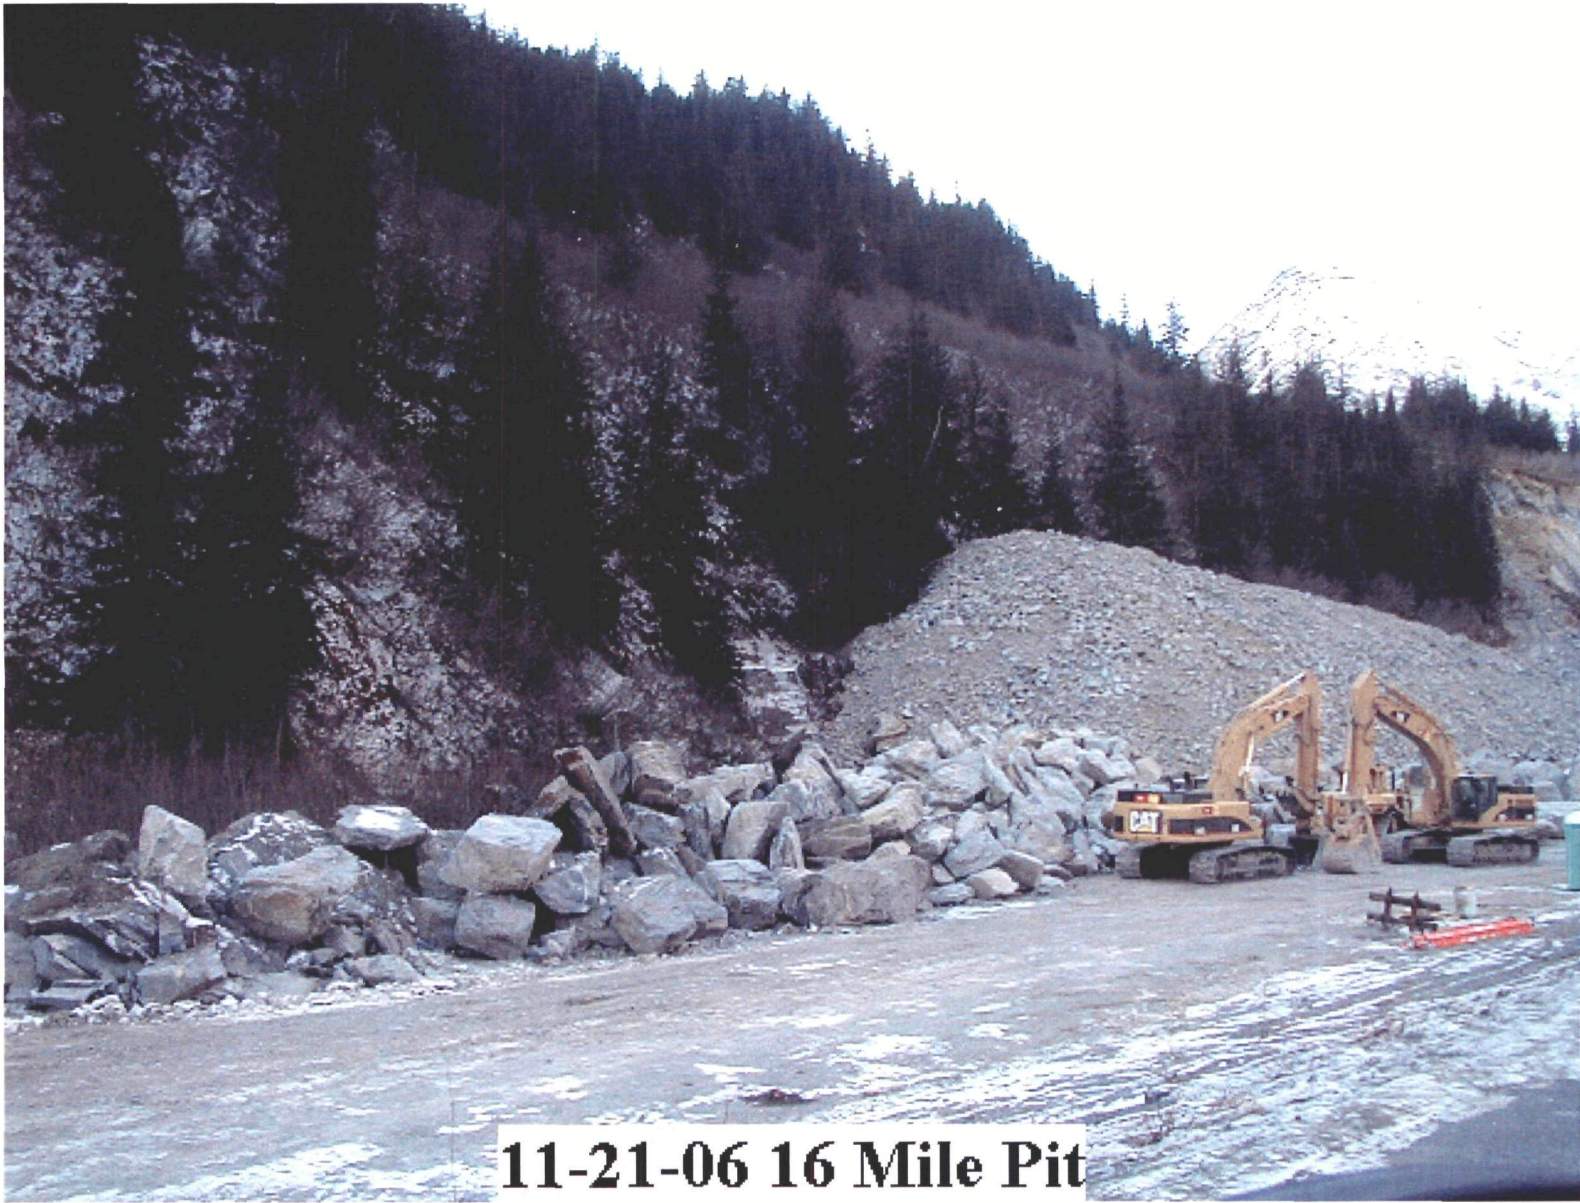
**11-21-06 16 Mile Pit**
