APPENDIX D

DNR-OHMP (ADF&G) Fish Sampling Reports

SUBJECT: Trip Report
Gustavus

SUBJECT: Gustavus Gravel Pits and Airport
Fish Sampling Trip Report

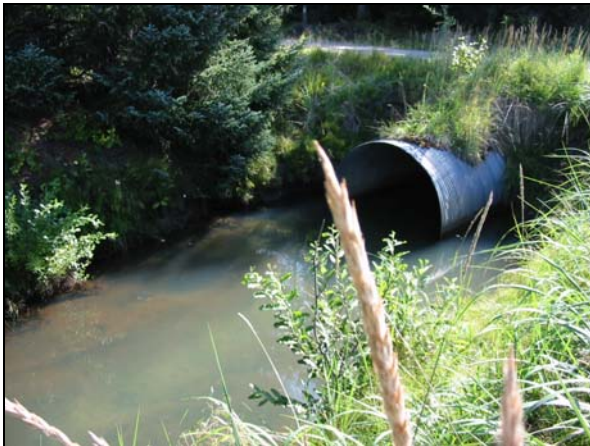
Channel on East Side of Runway

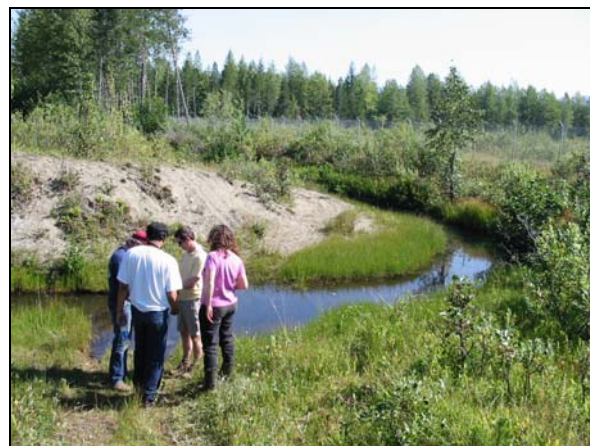
Channel to North of Runway

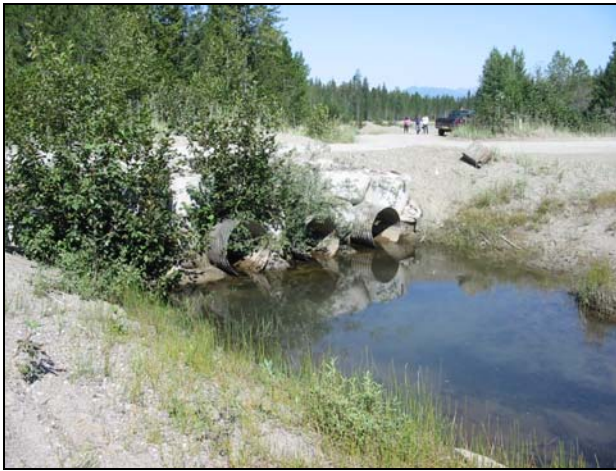
I also inspected the DNR gravel pit area where the cataloged portion of stream #114-23-10199 apparently ends. The area is prone to flooding where Wilson Road crosses the stream. The problem

occurs when the gravel pits full up in the fall and suddenly drain into the waterway. Numerous culverts have been stacked at the crossing to try to alleviate the problem, but this hasn't solved the problem. DOT&PF recently constructed a shallow drainage channel that connects the pits to the stream that allows the area to drain gradually instead of flooding. This has apparently solved the flooding problem. The funky culvert setup remains, but doesn't appear to be blocking fish passage.

Culverts below DNR Gravel Pits

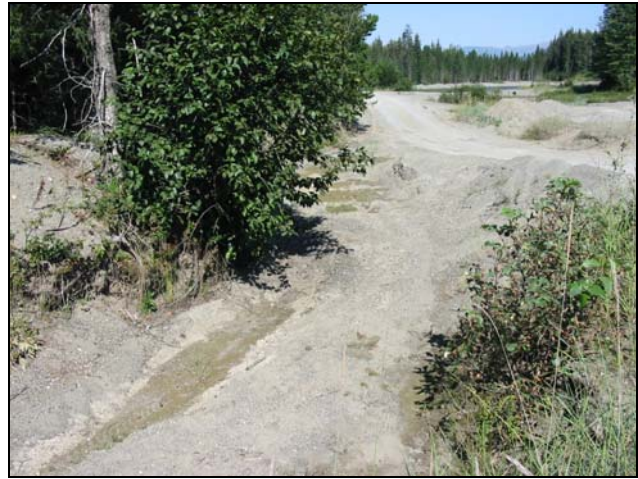
Drainage constructed to reduce flooding

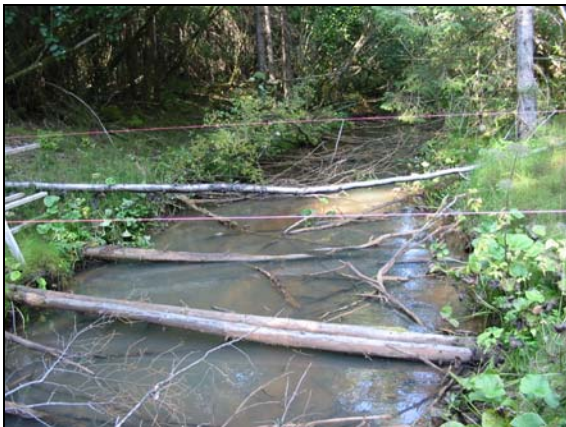
OHMP had received a report of unauthorized construction of a bridge crossing Harry Hall Creek (Stream #114-23-10070-2008). I met with Janucz Kanat, the property owner and we inspected the project. Bridge abutments had been partially constructed adjacent to the stream, and appeared to be within ordinary high water (OHW). However, on close inspection, the bridge abutments were placed on the stream banks in the flood plain, but the bases were a few inches above my call for OHW (tough call because of previous clearing of streambank). The applicant was aware of the requirement for a permit for work below OHW, but did not believe a Fish Habitat permit was needed because the work was above OHW. An interesting point of law, as there would be no disturbance below OHW, but there would be fill on the streambank within the floodplain. Mr. Kanat has a good design for the bridge that is consistent with OHMP and ACMP standards for design and construction. We agreed that to be safe OHMP would issue a permit for the bridge.

Harry Hall Creek at Bridge Crossing

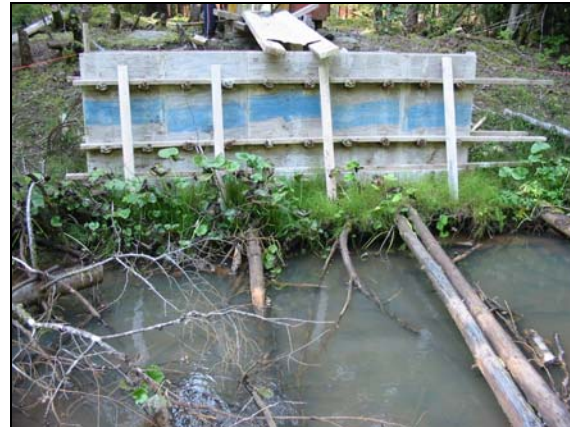
Abutment just above OHW

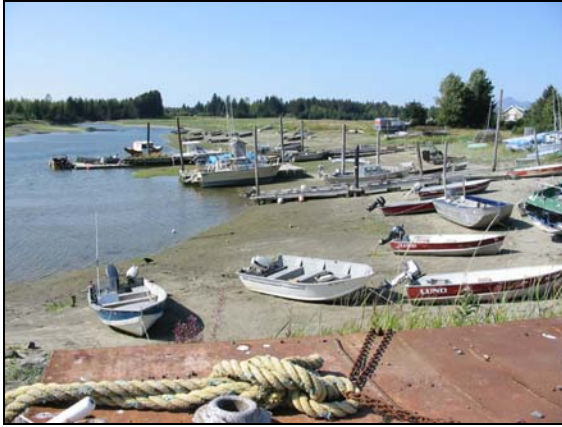
General Haul-out Area

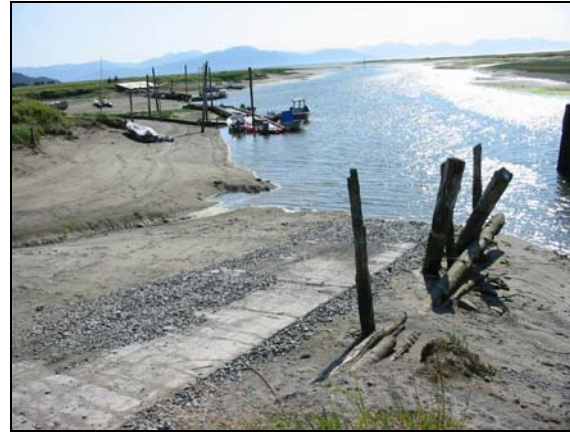
OHMP authorized repair of the Gustavus community boat ramp (FH05-I—0081) on the Salmon River (Stream #114-23-10080). The work was completed earlier this month. I inspected the newly-completed repairs, and documented that the work had been completed as authorized.

Repaired Launch Ramp

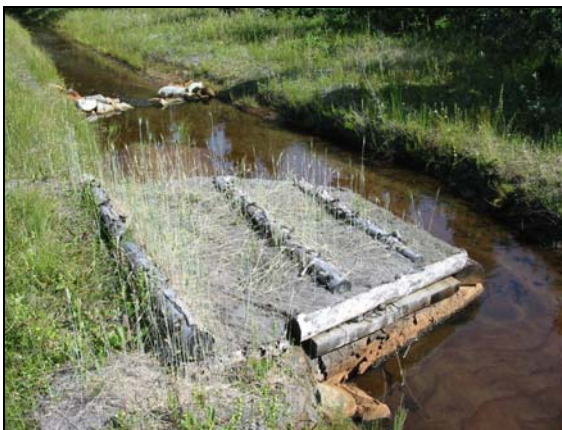
I inspected work completed by the NPS to restore salmon stream habitat that was degraded by sedimentation during reconstruction of the road from Gustavus to Bartlett Cove in 2001-2002. As part of a compliance agreement signed in May 2002, NPS had agreed to construct in-stream structures to improve habitat and hydrology in the effected reaches, and to provide additional bank stabilization. The main problem was that sediment had filled drainage channels adjacent to the road that provide both rearing and migration for salmonids. Absent a thalweg, these channels often go dry, blocking fish passage and eliminating rearing habitat. OHMP had initially directed NPS to remove the sediment and construct a low-flow channel in the affected habitat. We had agreed to give the streams time to stabilize before trying a major sediment removal operation, and to install some in-stream structures to determine if accelerating flow would help restore the habitat. NPS installed numerous instream structures and stabilized stream banks last summer, but OHMP had not conducted an inspection. I found that the work was constructed as agreed-to and appeared to be effective, although some additional sediment removal may also be needed in the future.

In-stream Structures to Accelerate Flow

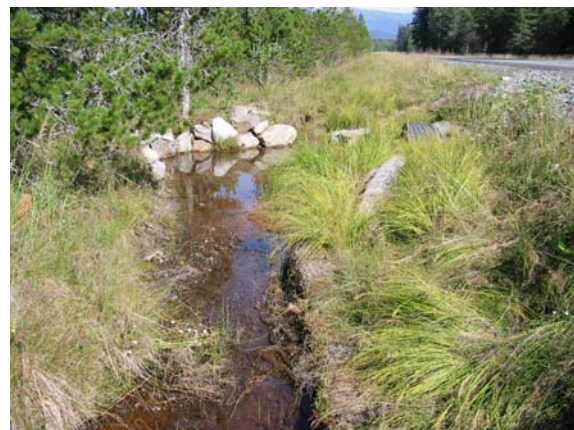
Bank Stabilization/Revegetation

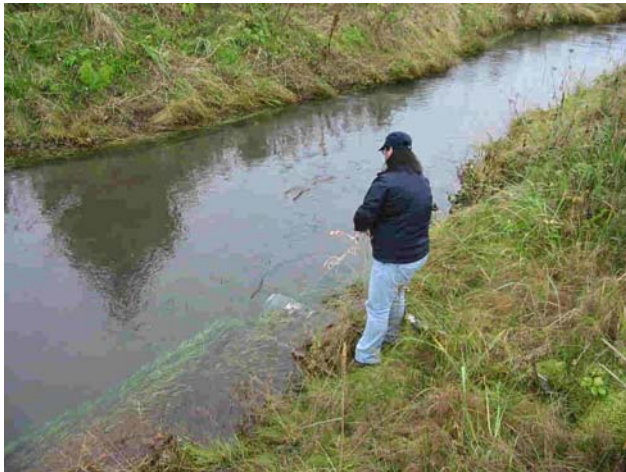
Trapping lower end of airport stream

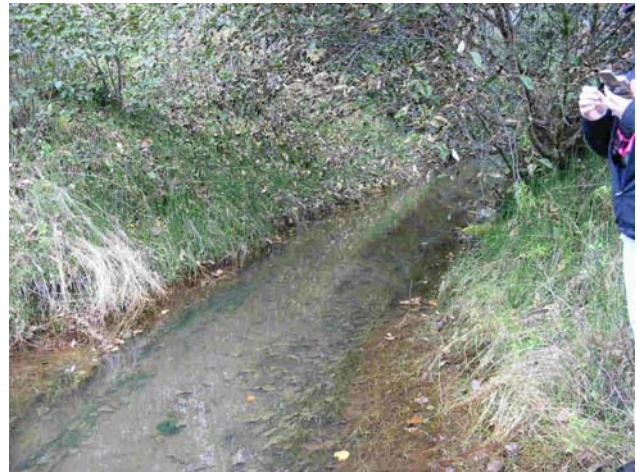
Boey's Ditch at confluence

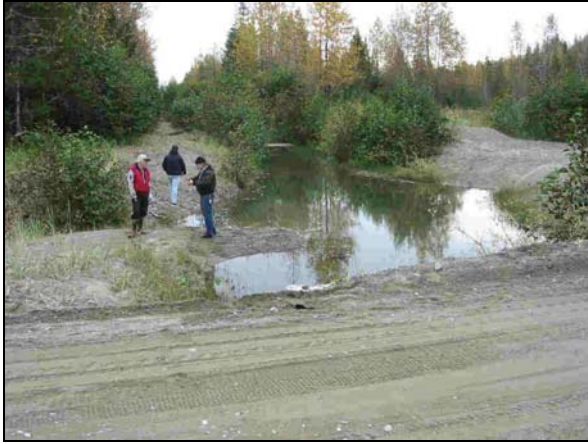
Ditch at lower end of ponds at Wilson Rd.

OHMP will require that drainage be provided between the ponds and the ditch/stream system so that fish can move between the ponds and the stream. The stream currently flows through the western pond, but passage between ponds is restricted by missing or inadequate culverts. With the current pond

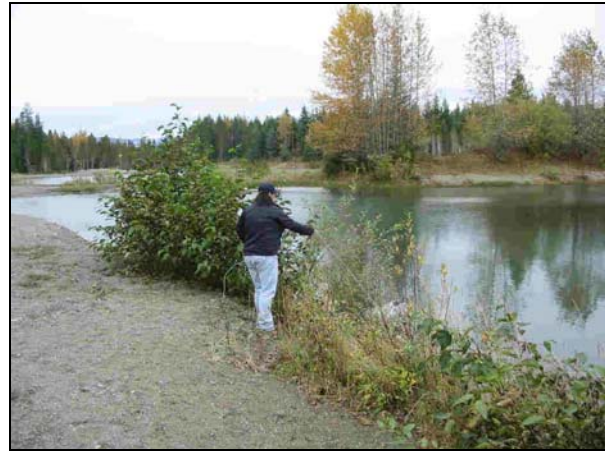
Juvenile coho salmon and sticklebacks were found in all 4 of the main ponds. Field identification of the juvenile salmon based on color and fin shape suggested the fish were king salmon, which haven't been documented in the area, rather than coho which are common. Laboratory examination of several retained specimens confirmed they were coho. We will nominate the ponds for inclusion in the Anadromous Waters Catalog (AWC).

Trapping fish at south central pond

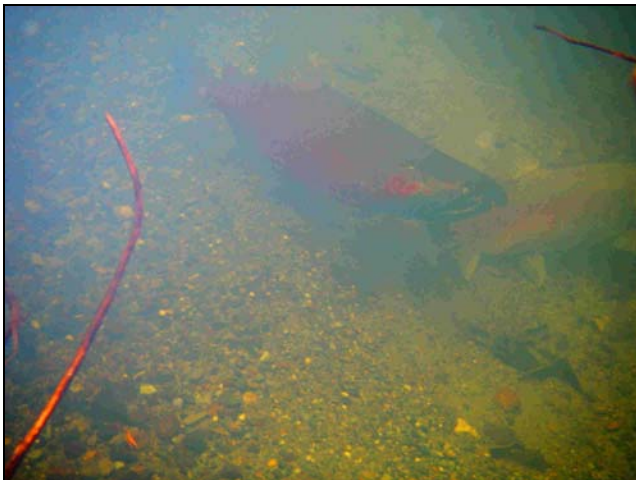
Spawning coho salmon

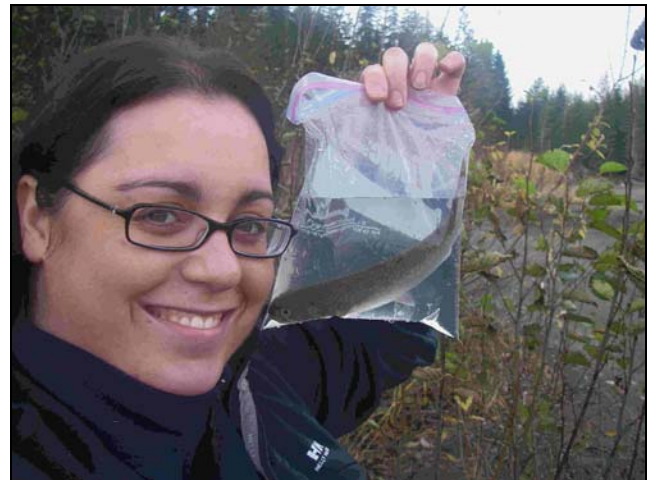
Kate Kanouse with a Dolly Varden char
