HAINES HIGHWAY

ENVIRONMENTAL SITE ASSESSMENT

MARCH 2006

DOT&PF PROJECT NO. 68606
HAINES, ALASKA

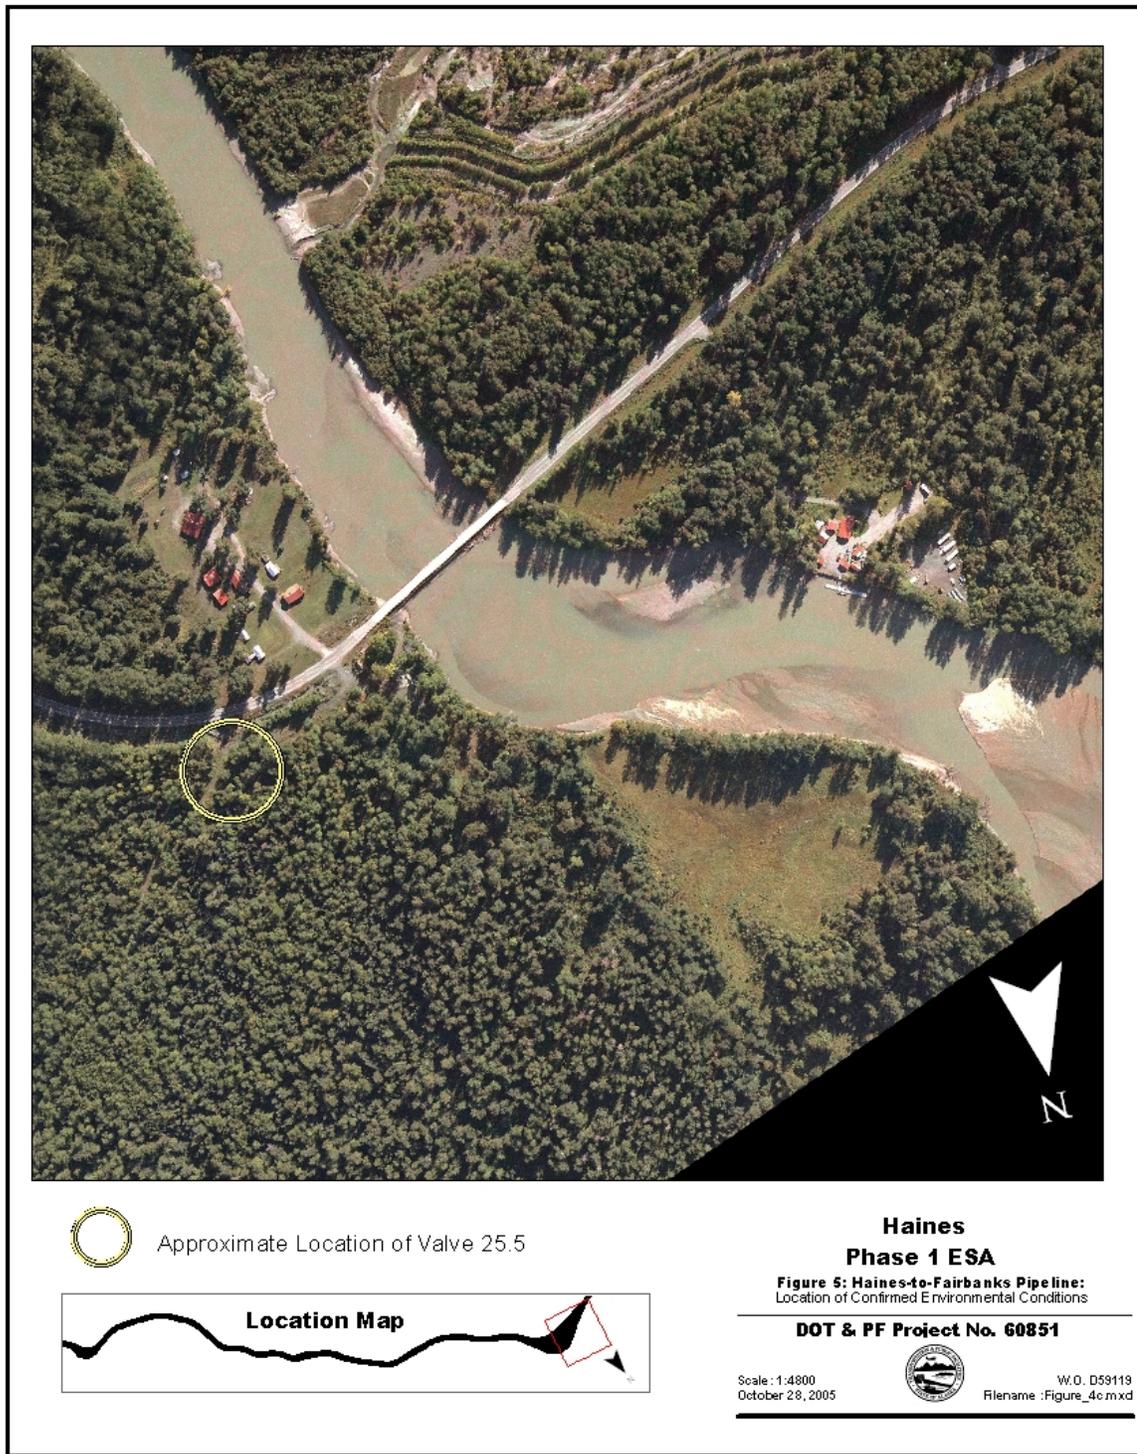
Figure 5: Haines-to-Fairbanks Pipeline: Location of Confirmed Environmental Conditions

Several locations along the highway where the Haines-to-Fairbanks pipeline ran are currently being investigated for the presence of hydrocarbons. The investigation is being operated under the FUDS Program and ADEC will provide oversight. The USACE administers the investigation and performed hydrocarbon sampling in November 2005, which will resume in May or June of 2006 (see Table 2). The November sampling included two locations within the vicinity of the study area, referred to as Release 19.5 and Valve 25.5. During the investigation, hydrocarbon contamination was found at Valve 25.5, near the Wells Bridge (see Figure 5). The second site is located around MP 17.5 and hydrocarbon product was detected, but not at ADEC action levels.

Although the Property contains 14 areas of debris, junked cars, illegal camping areas and other various structures, none of these areas warrant further investigation. However, based on the information obtained during this Phase I ESA, it is DOWL's judgment that past activities on and adjacent to the Property have posed no significant potential for environmental impairment of the Property, with the exception of contaminated soil detected Vault Valve 25.5 described in Section 8.0 and shown in Figure 5. It is recommended that the client continue to monitor the status of the Haines-to-Fairbanks pipeline investigation and coordinate with ADEC, regarding the results of upcoming sampling.

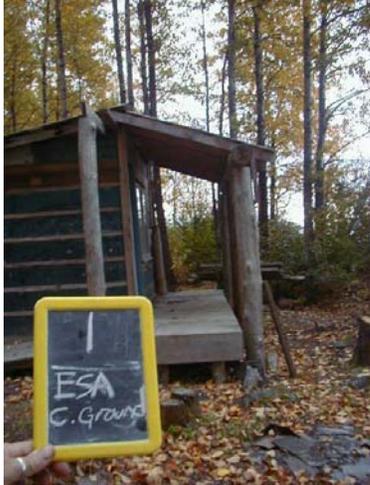
- Site 1: A cabin has been constructed just off the shoulder in a parking area.
- Site 2: Six 55-gallon drums were found between the road and the developed area of the Southeast Roadbuilders property. Five barrels appeared to be old, empty, and were rusted thoroughly without any apparent labeling. One barrel had a fading label and was empty.
- Site 3: A cabin (a potential squatters cabin) has been constructed in a heavily wooded area between the road and the river. Associated debris includes appliances, car parts, and a footpath made of wood.

<p>Photograph No. 1</p> <p>Location: Site 1</p> <p>Direction: Facing southwest</p> <p>Comments: Cabin on Shoulder</p>

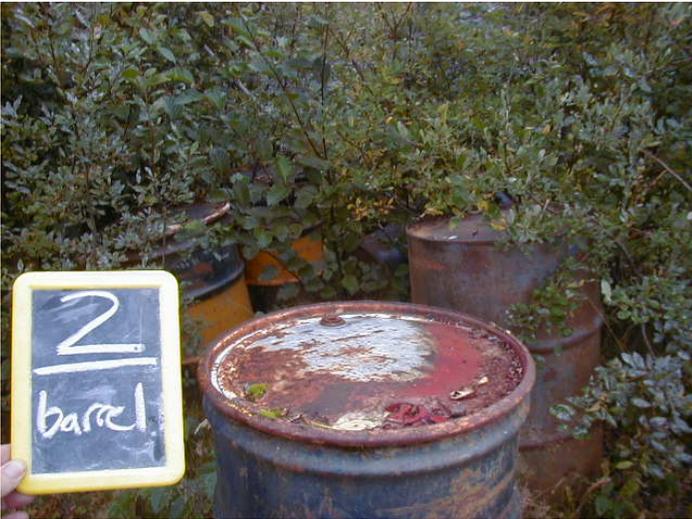
<p>Photograph No. 3</p> <p>Location: Site 2</p> <p>Direction: Facing northeast</p> <p>Comments: Drums</p>

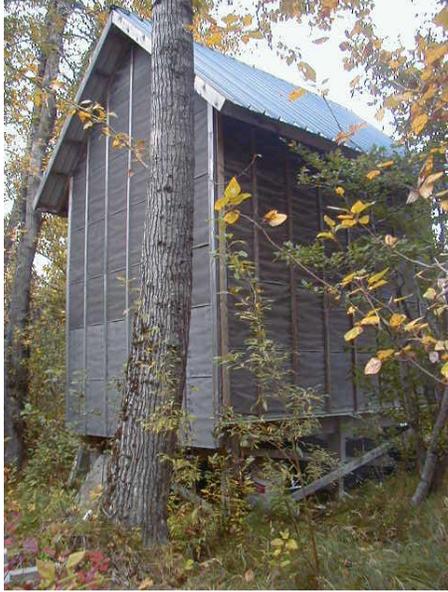
<p>Photograph No. 7</p> <p>Location: Site 3</p> <p>Direction: Facing west</p> <p>Comments: Squatters cabin</p>

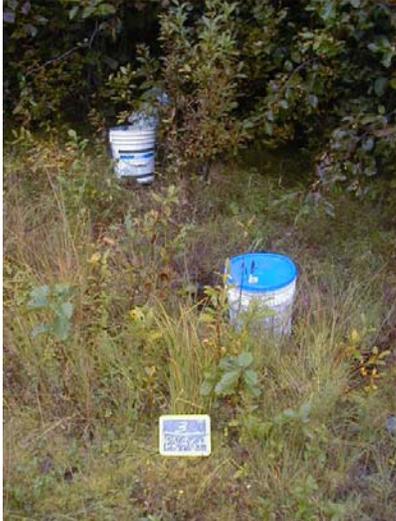
<p>Photograph No. 11</p> <p>Location: Site 4</p> <p>Direction: Facing west</p> <p>Comments: Soap buckets</p>
