FILE No. GEO_HAZ_SUMM.PPT
PROJECT No. 063-5782

GEOLOGIC HAZARD SUMMARY
ARRANGED BY IRP 2006 STATIONING
LYNN CANAL HIGHWAY PHASE I
ZONE 4 GEOTECHNICAL INVESTIGATION

ADOT / LYNN CANAL HWY ZONE 4 / AK

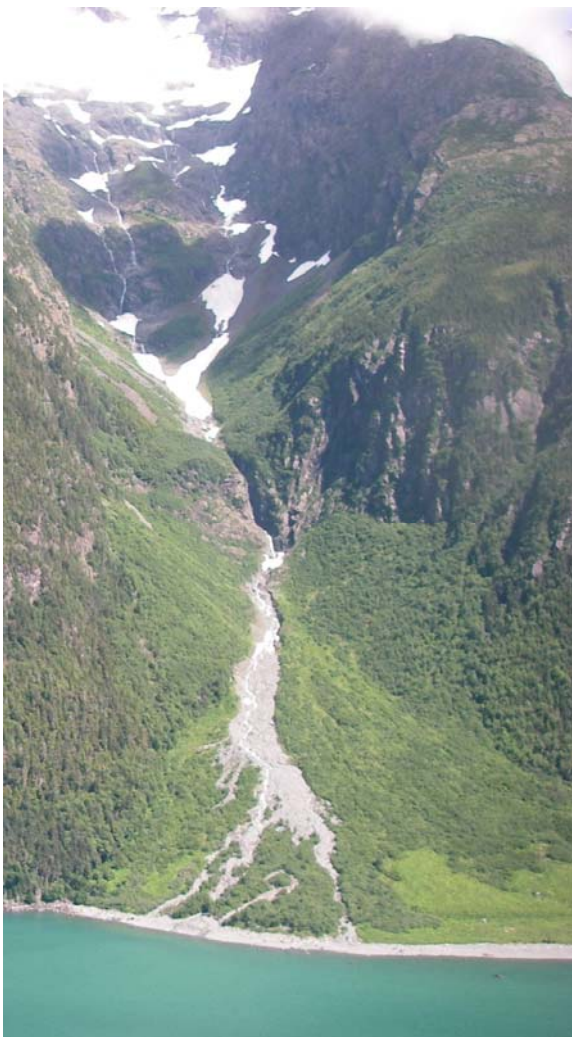
DF01. View east/upslope at alluvial fan with debris flow deposition zone (gray) and avalanche path ELC002.

Hazard ID #:	DF01
Hazard Type:	debris_flow
HIN:	225
Rating:	A
IRP 2006 Location:	1493
Frequency (yrs):	1-5
Predictability:	moderate
Material Volume (CY):	100-1000
Clast Size (ft):	1-2
Source Elev. (ft):	>1000
Centerline Slope:	fan
Alignment Location:	deposition_zone
Impact Alignment:	yes
Alignment Exposure (ft):	500+
Vegetation:	denuded
Deciduous Trees:	yes
IRP 2006 South Margin:	1492+90
IRP 2006 North Margin:	1498+90
Photo #:	4098, 4099, 5146

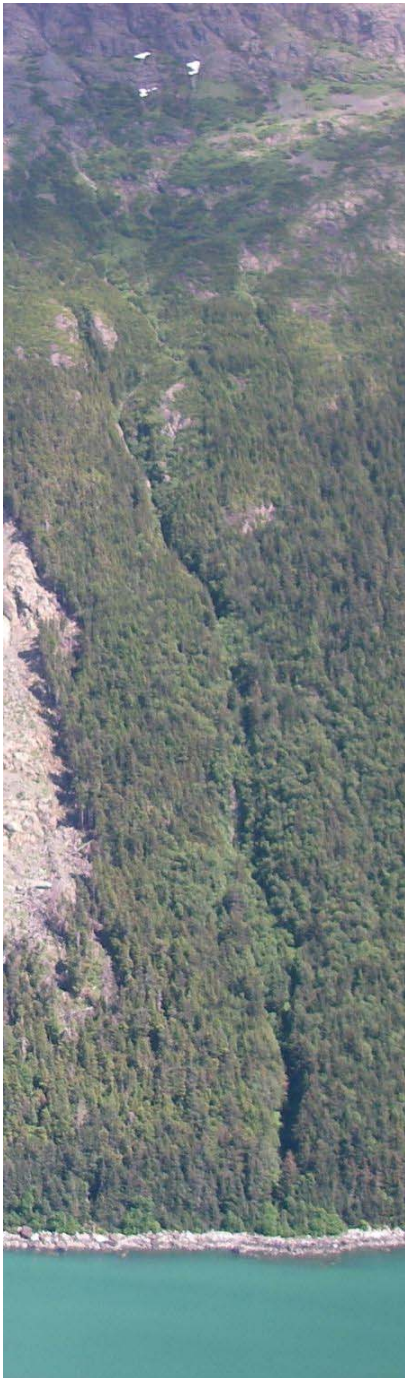
DF03. View east/upslope at debris flow channel.

Hazard ID #:	DF03
Hazard Type:	debris_flow
HIN:	183
Rating:	A
IRP 2006 Location:	1517
Frequency (yrs):	0-1
Predictability:	moderate
Material Volume (CY):	<10
Clast Size (ft):	0-1
Source Elev. (ft):	2000-3000
Centerline Slope:	fan
Alignment Location:	deposition_zone
Impact Alignment:	yes
Alignment Exposure (ft):	50-200
Vegetation:	disturbed
Deciduous Trees:	yes
IRP 2006 South Margin:	1517+00
IRP 2006 North Margin:	1518+20
Photo #:	3893, 5148, 5865, 6256

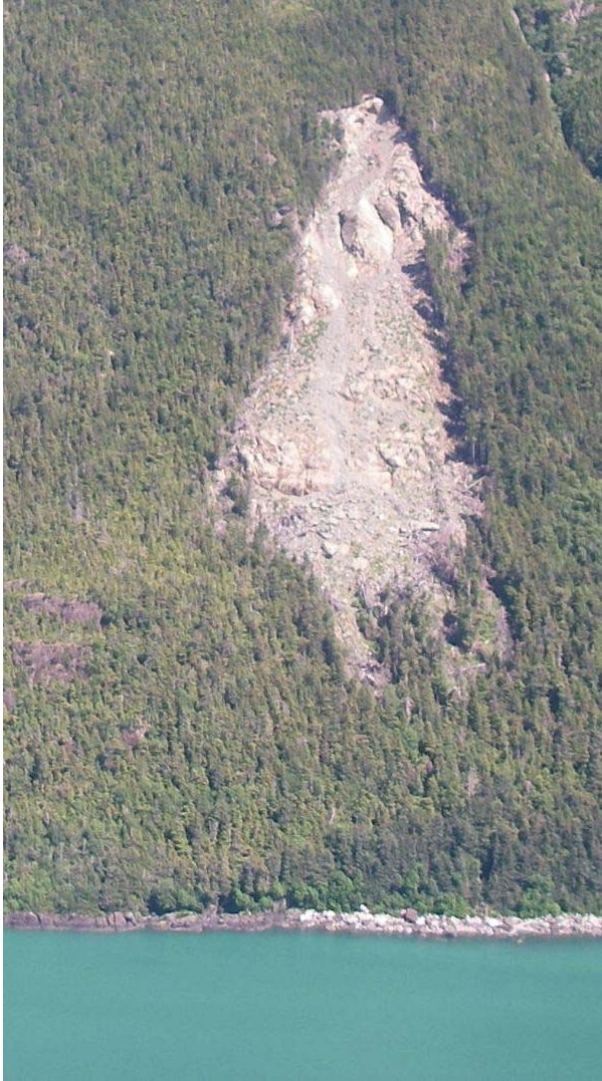
RS01. View east/upslope at 2001 rockslide and avalanche path ELC003-1.

Hazard ID #:	RS01
Hazard Type:	rock_slide
HIN:	219
Rating:	A
IRP 2006 Location:	1522
Frequency (yrs):	unknown(>25?)
Predictability:	unpredictable
Material Volume (CY):	100-1000
Clast Size (ft):	4+
Source Elev. (ft):	>1000
Centerline Slope:	open_bedrock_slope
Alignment Location:	deposition_zone
Impact Alignment:	no
Alignment Exposure (ft):	200-500
Vegetation:	denuded
Deciduous Trees:	no
IRP 2006 South Margin:	1521+80
IRP 2006 North Margin:	1525+50
Photo #:	4123, 4124, 4126, 5148, 5865

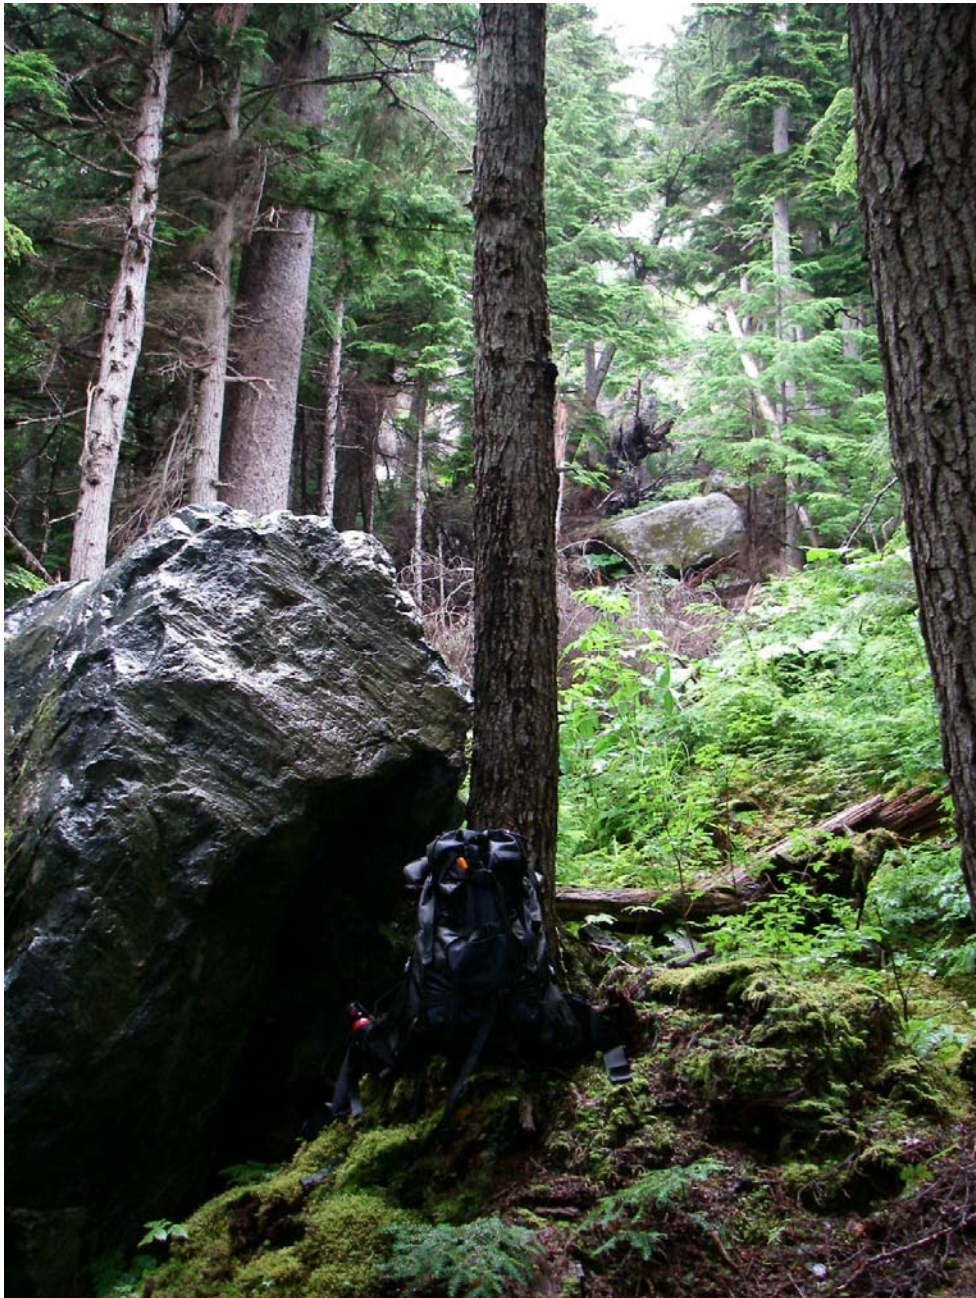
RS01. View east/upslope of fresh rockslide mega-boulder at southwest (downslope and down alignment) corner of rockslide and avalanche path ELC003-1. Photograph taken 360 ft right of IRP 2006 1522+50.

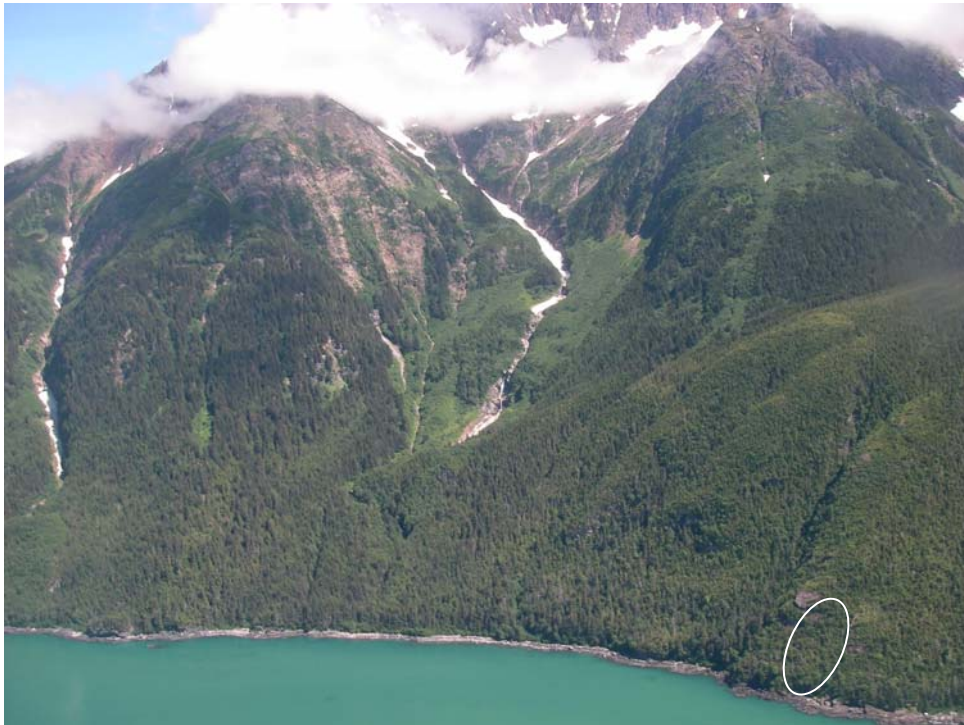
RF05. View east/upslope at rockfall hazard area. Rockfall occurs near beach at base of gully in lower right of photo.

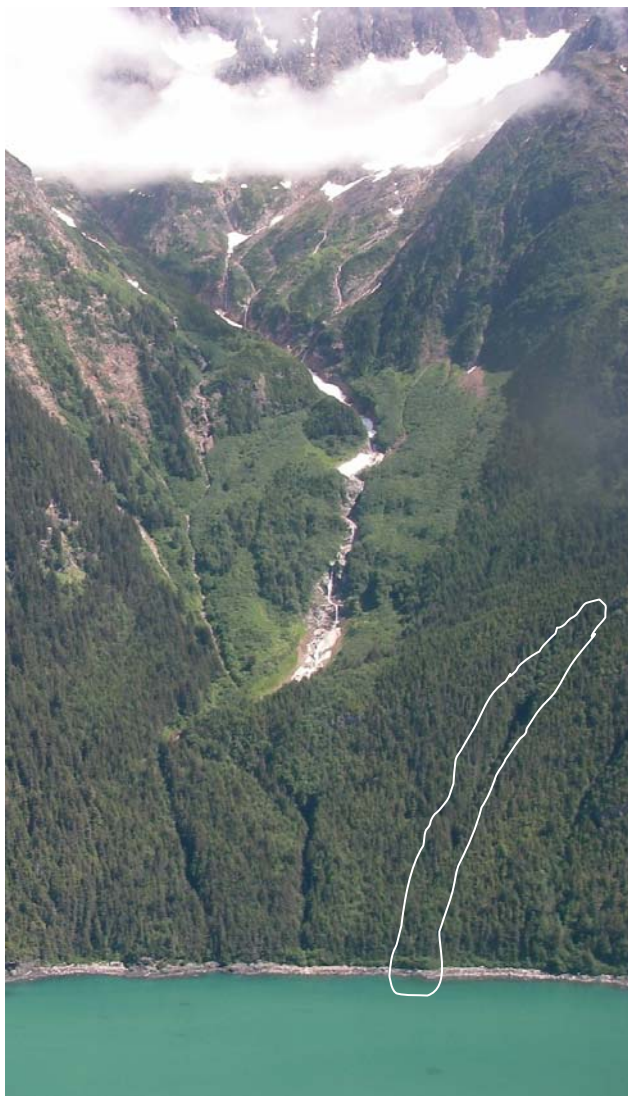
DF04. View east/upslope at debris flow channel, incision visible as gully.

Hazard ID #:	DF04
Hazard Type:	debris_flow
HIN:	117
Rating:	B
IRP 2006 Location:	1670
Frequency (yrs):	5-25
Predictability:	moderate
Material Volume (CY):	10-100
Clast Size (ft):	0-1
Source Elev. (ft):	1000-2000
Centerline Slope:	fan
Alignment Location:	deposition_zone
Impact Alignment:	yes
Alignment Exposure (ft):	50-200
Vegetation:	disturbed
Deciduous Trees:	yes
IRP 2006 South Margin:	1668+50
IRP 2006 North Margin:	1670+50
Photo #:	3875

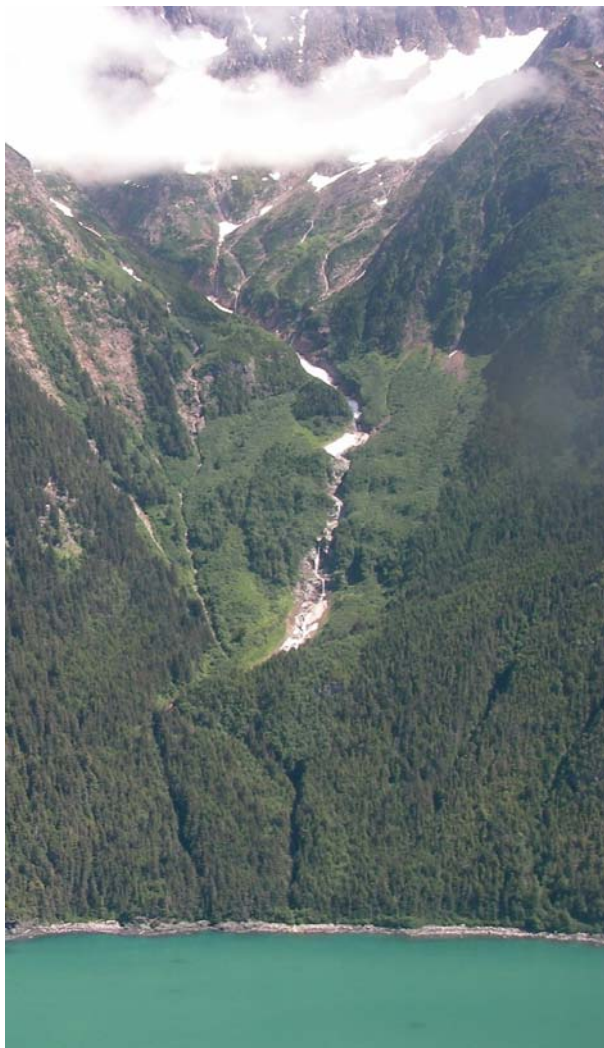
DF05. Debris flow channel visible as incised gully through trees in lower part of photo, left of center.

Hazard ID #:	DF05
Hazard Type:	debris_flow
HIN:	129
Rating:	A
IRP 2006 Location:	1674
Frequency (yrs):	1-5
Predictability:	high
Material Volume (CY):	10-100
Clast Size (ft):	0-1
Source Elev. (ft):	1000-2000
Centerline Slope:	single_channel
Alignment Location:	deposition_zone
Impact Alignment:	yes
Alignment Exposure (ft):	50-200
Vegetation:	denuded
Deciduous Trees:	no
IRP 2006 South Margin:	1673+80
IRP 2006 North Margin:	1675+30
Photo #:	6203, 6204

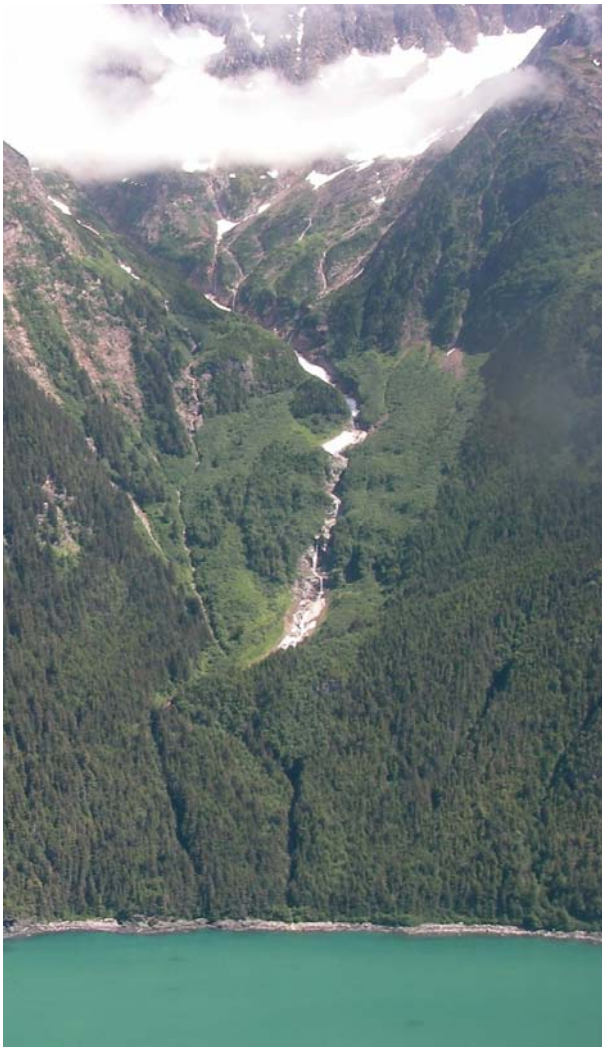
DF06. View east/upslope at debris flow channel and avalanche path ELC005.

Hazard ID #:	DF06
Hazard Type:	debris_flow
HIN:	201
Rating:	A
IRP 2006 Location:	1678
Frequency (yrs):	0-1
Predictability:	high
Material Volume (CY):	10-100
Clast Size (ft):	0-1
Source Elev. (ft):	2000-3000
Centerline Slope:	fan
Alignment Location:	deposition_zone
Impact Alignment:	yes
Alignment Exposure (ft):	200-500
Vegetation:	disturbed
Deciduous Trees:	yes
IRP 2006 South Margin:	1677+00
IRP 2006 North Margin:	1679+00
Photo #:	3876

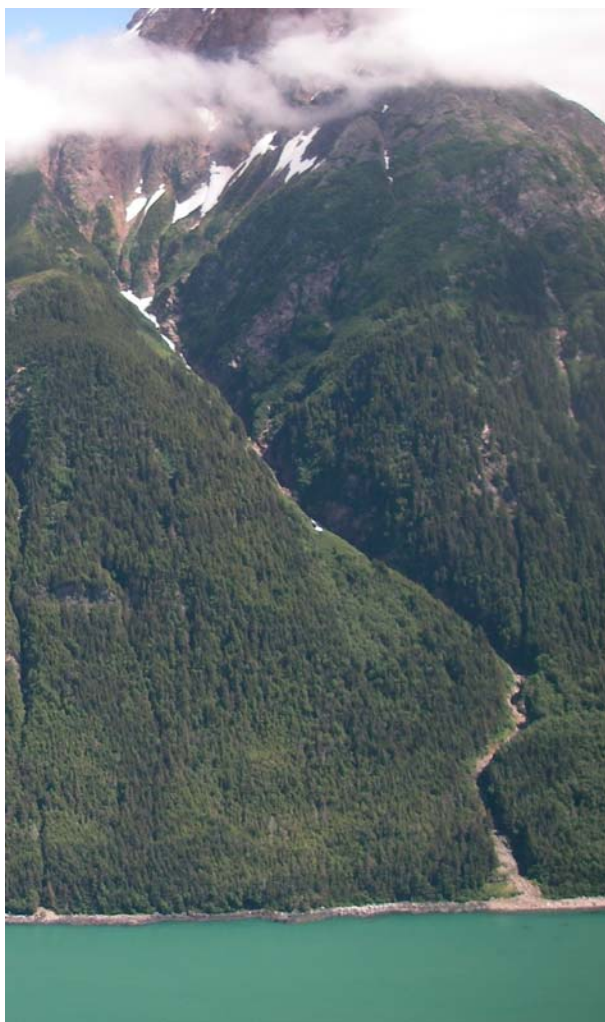
DF07. View east/upslope of debris flow channel and avalanche path ELC006.

Hazard ID #:	DF07
Hazard Type:	debris_flow
HIN:	171
Rating:	A
IRP 2006 Location:	1704
Frequency (yrs):	1-5
Predictability:	moderate
Material Volume (CY):	100-1000
Clast Size (ft):	1-2
Source Elev. (ft):	>1000
Centerline Slope:	multi_channel
Alignment Location:	deposition_zone
Impact Alignment:	yes
Alignment Exposure (ft):	200-500
Vegetation:	denuded
Deciduous Trees:	yes
IRP 2006 South Margin:	1701+50
IRP 2006 North Margin:	1705+50
Photo #:	4366, 5155

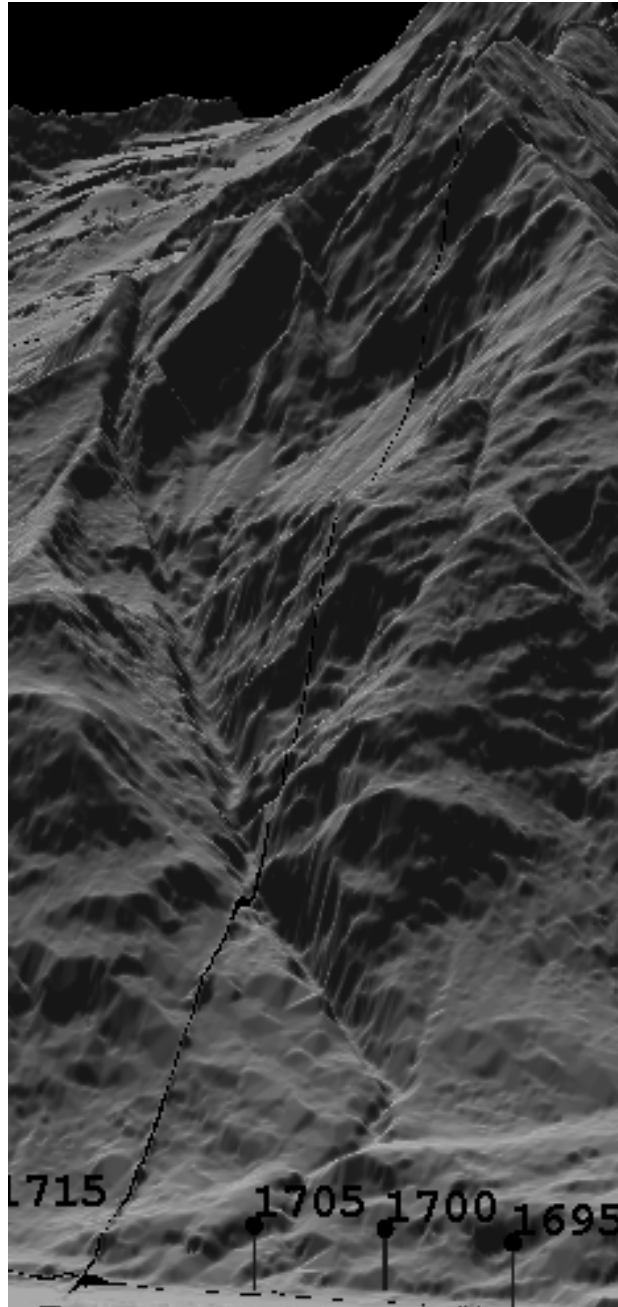
DF07. LIDAR image of debris flow channel and avalanche path ELC006.

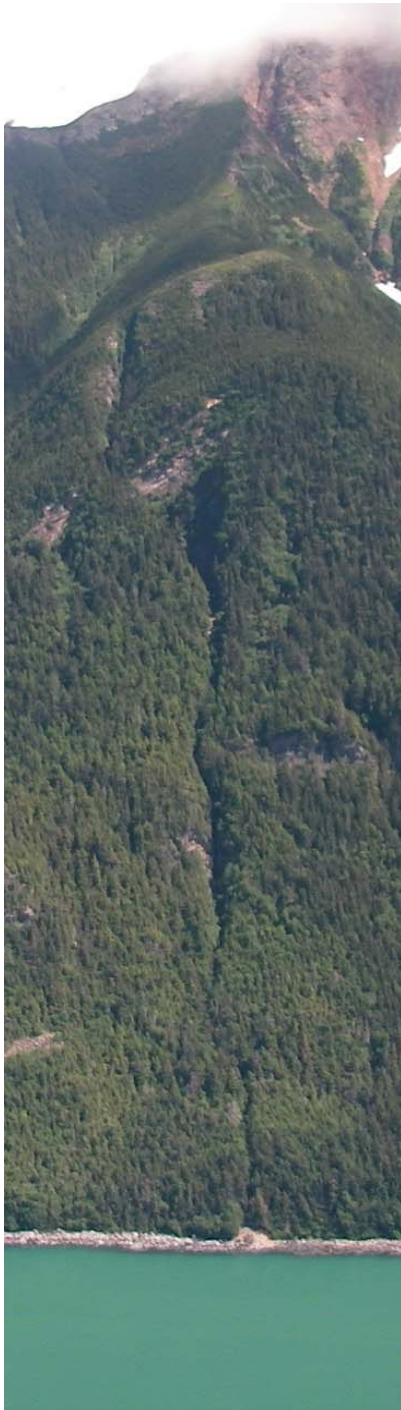
DF08. View east/upslope at debris flow channel and avalanche path ELC007.

Hazard ID #:	DF08
Hazard Type:	debris_flow
HIN:	129
Rating:	A
IRP 2006 Location:	1720
Frequency (yrs):	1-5
Predictability:	high
Material Volume (CY):	10-100
Clast Size (ft):	1-2
Source Elev. (ft):	>1000
Centerline Slope:	fan
Alignment Location:	deposition_zone
Impact Alignment:	yes
Alignment Exposure (ft):	50-200
Vegetation:	denuded
Deciduous Trees:	yes
IRP 2006 South Margin:	1719+90
IRP 2006 North Margin:	1720+80
Photo #:	1126, 5156

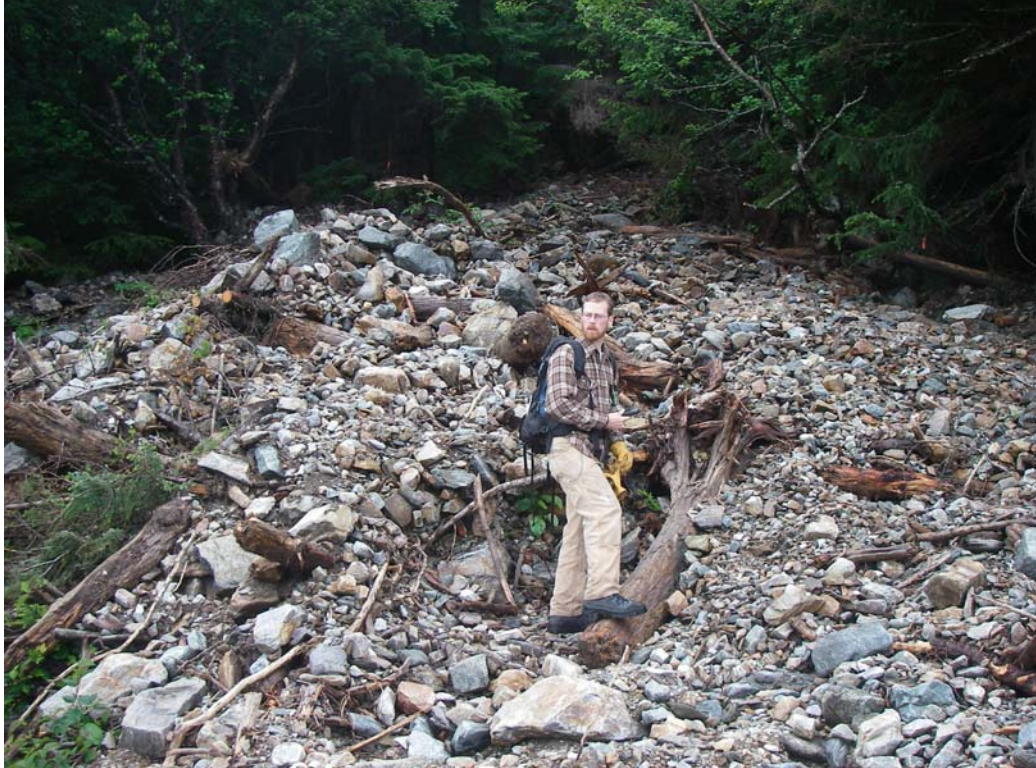
DF08. Debris flow deposition fan and avalanche path ELC007 at centerline at IRP 2006 1720+00.

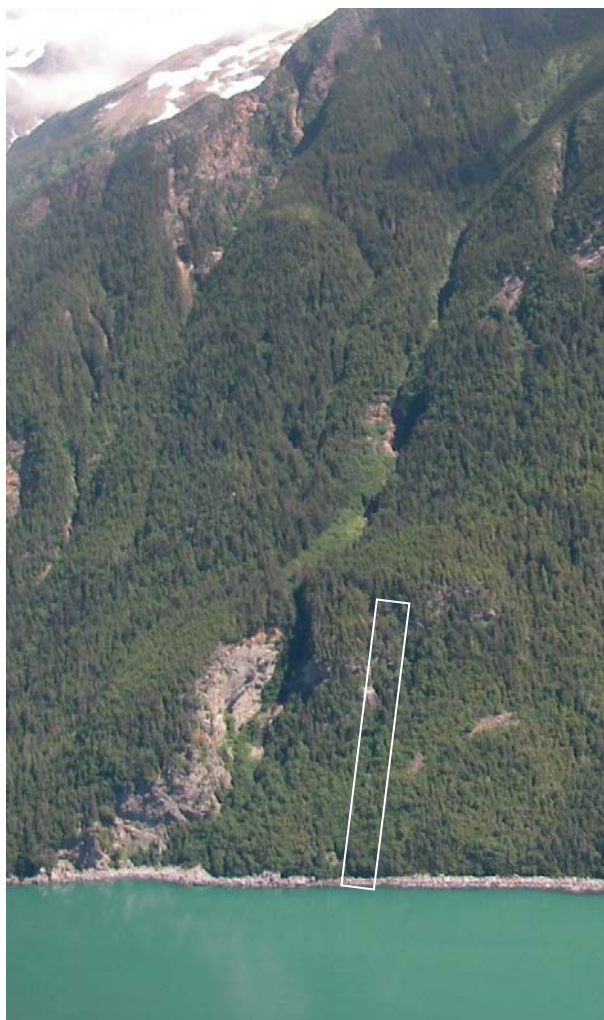
RF06. View east/upslope at rockfall area.

Hazard ID #:	RF06
Hazard Type:	rockfall
HIN:	183
Rating:	A
IRP 2006 Location:	1730
Frequency (yrs):	0-1
Predictability:	unpredictable
Material Volume (CY):	<10
Clast Size (ft):	3-4
Source Elev. (ft):	100-500
Centerline Slope:	open_bedrock_slope
Alignment Location:	deposition_zone
Impact Alignment:	yes
Alignment Exposure (ft):	50-200
Vegetation:	disturbed
Deciduous Trees:	yes
IRP 2006 South Margin:	1729+90
IRP 2006 North Margin:	1730+80
Photo #:	4674, 6206

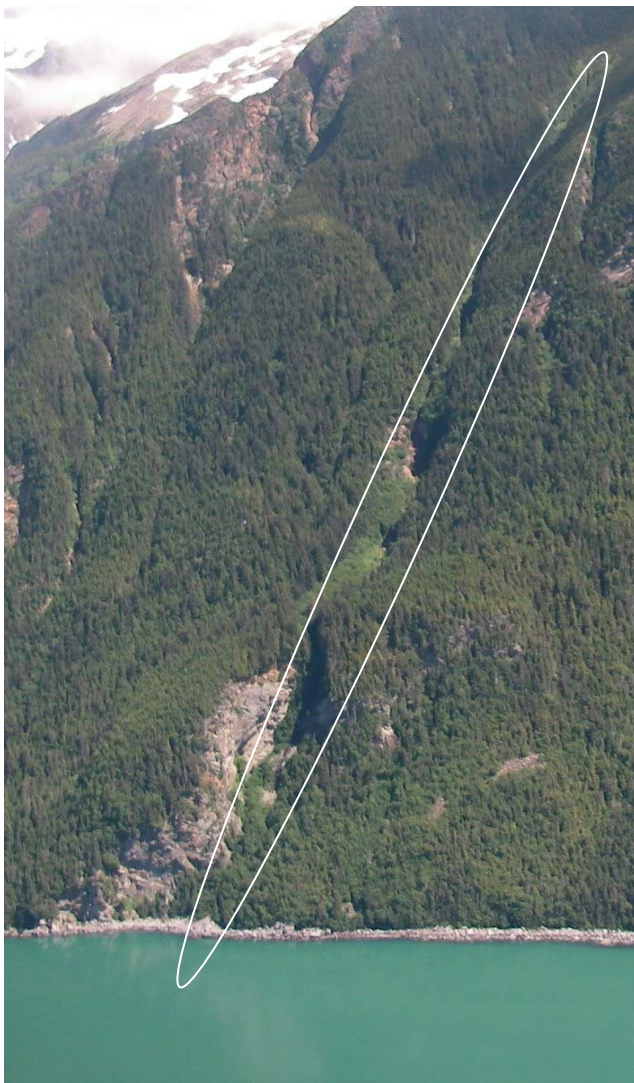
DF09. View east/upslope at debris flow channel and avalanche path ELC008.

Hazard ID #:	DF09
Hazard Type:	debris_flow
HIN:	153
Rating:	A
IRP 2006 Location:	1733
Frequency (yrs):	unknown (1-5?)
Predictability:	low
Material Volume (CY):	10-100
Clast Size (ft):	1-2
Source Elev. (ft):	>1000
Centerline Slope:	single_channel
Alignment Location:	path
Impact Alignment:	yes
Alignment Exposure (ft):	50-200
Vegetation:	disturbed
Deciduous Trees:	yes
IRP 2006 South Margin:	1732+50
IRP 2006 North Margin:	1734+40
Photo #:	3307

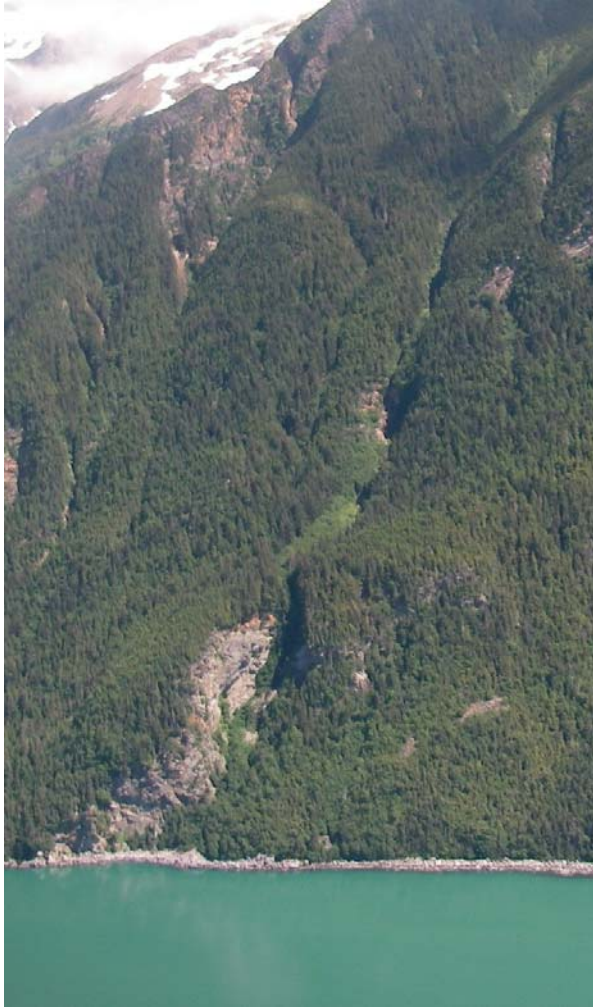
RF07. View east/upslope at rockfall hazard area.

Hazard ID #:	RF07
Hazard Type:	rockfall
HIN:	279
Rating:	A
IRP 2006 Location:	1734
Frequency (yrs):	0-1
Predictability:	unpredictable
Material Volume (CY):	10-100
Clast Size (ft):	4+
Source Elev. (ft):	500-1000
Centerline Slope:	open_bedrock_slope
Alignment Location:	deposition_zone
Impact Alignment:	yes
Alignment Exposure (ft):	500+
Vegetation:	disturbed
Deciduous Trees:	yes
IRP 2006 South Margin:	1724+80
IRP 2006 North Margin:	1739+80
Photo #:	4674

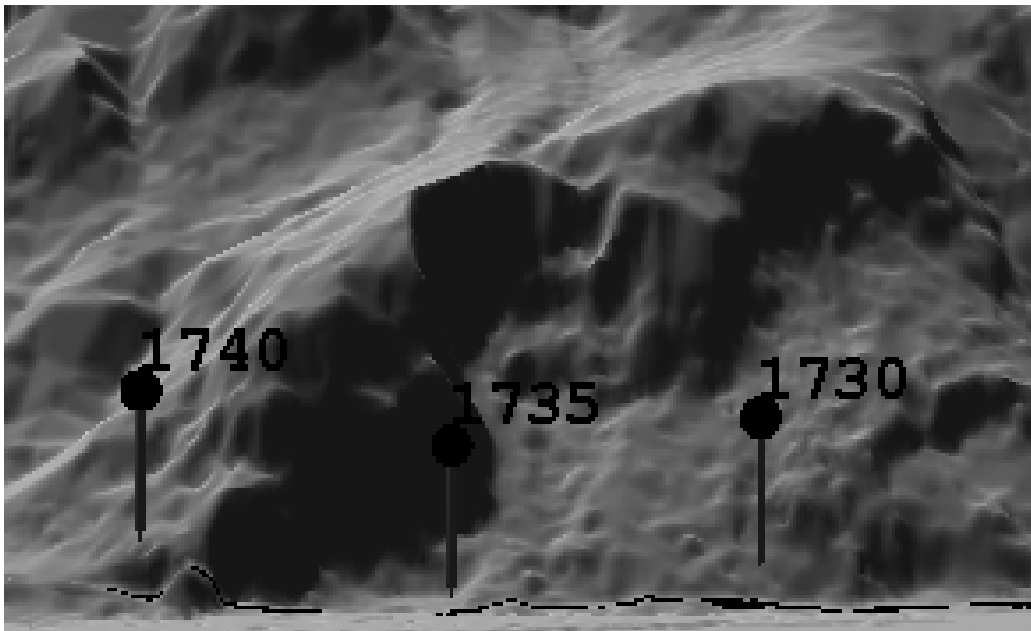
RF07. LIDAR image of rockfall hazard area.

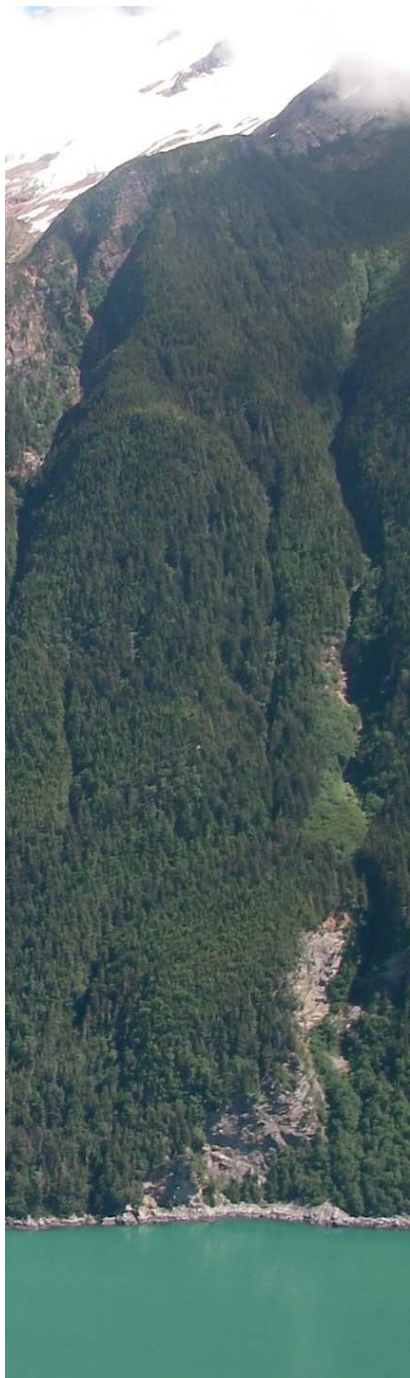
DF10. View east/upslope
at debris flow channel.

Hazard ID #:	DF10
Hazard Type:	debris_flow
HIN:	129
Rating:	A
IRP 2006 Location:	1743
Frequency (yrs):	1-5
Predictability:	high
Material Volume (CY):	10-100
Clast Size (ft):	0-1
Source Elev. (ft):	>1000
Centerline Slope:	multi_channel
Alignment Location:	path
Impact Alignment:	yes
Alignment Exposure (ft):	50-200
Vegetation:	denuded
Deciduous Trees:	no
IRP 2006 South Margin:	1742+50
IRP 2006 North Margin:	1743+40
Photo #:	4745-4748

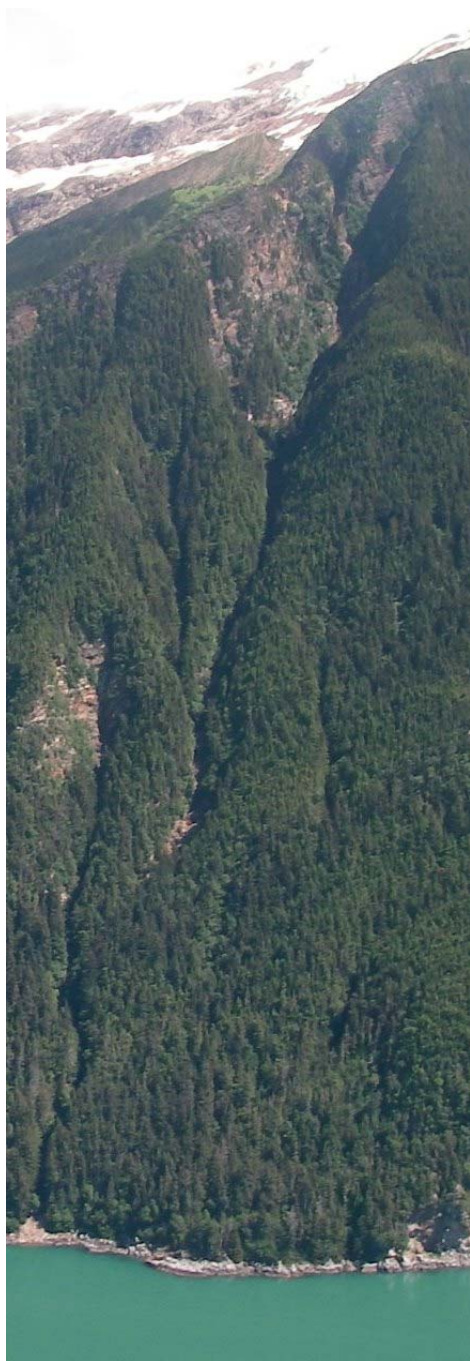
DF11. View east/upslope at debris flow channel and avalanche path ELC009.

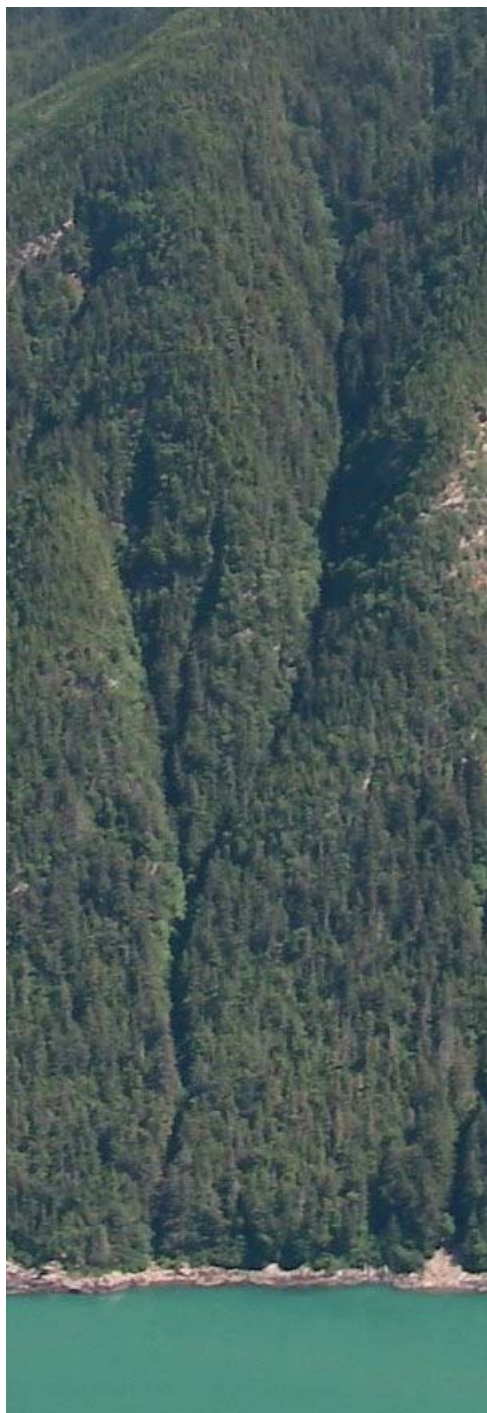
DF12. View east/upslope at debris flow channel and avalanche path ELC010.

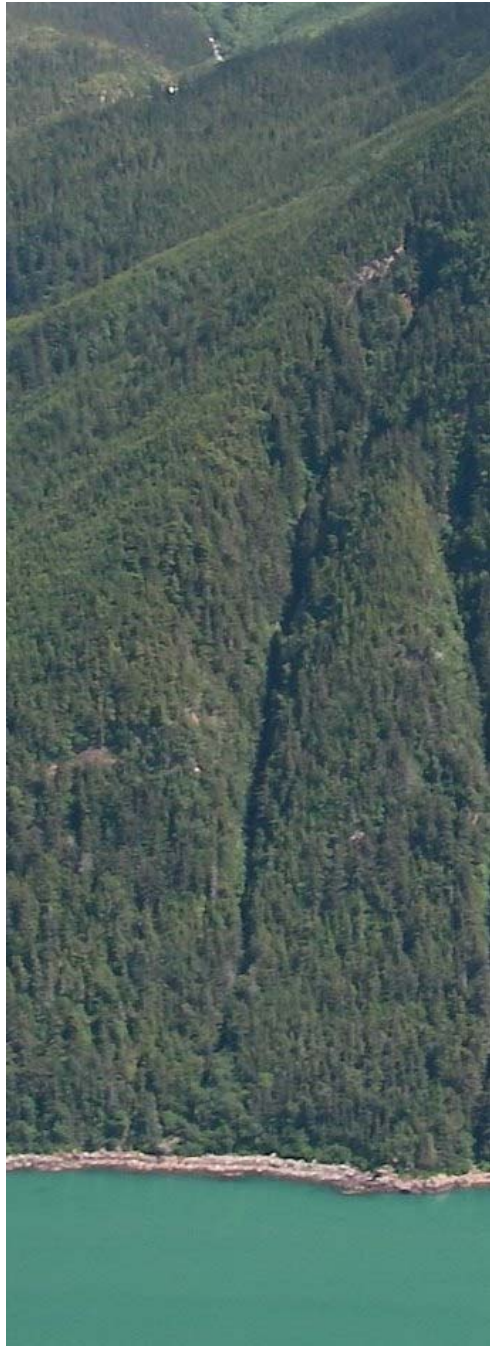
DF13. View east/upslope at debris flow channel and avalanche path ELC011.

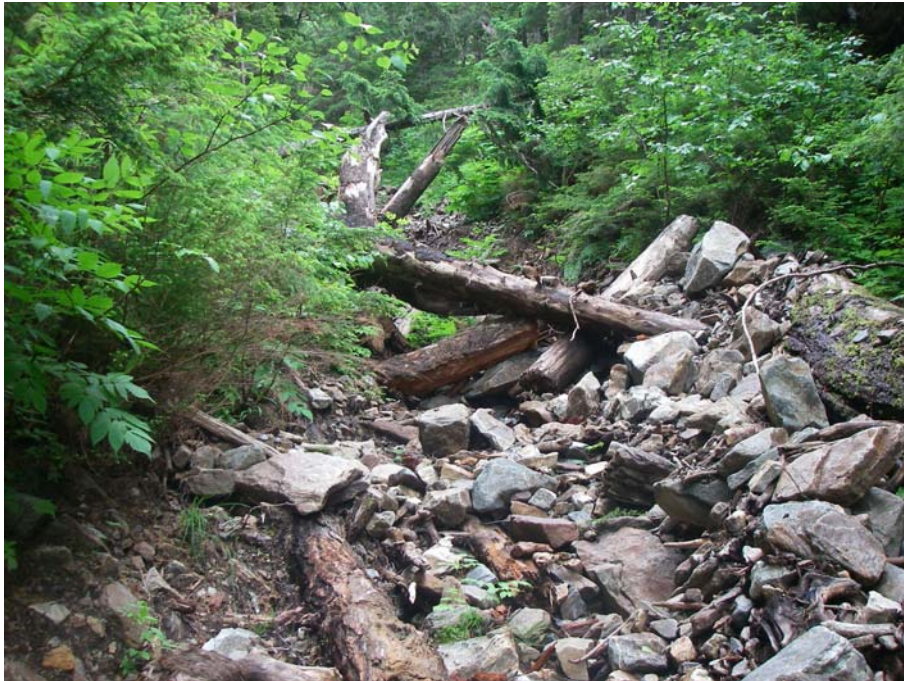
DF13. View east/upslope at debris flow channel and avalanche path ELC011. Photo taken 30 ft right of IRP 2006 1757+00.

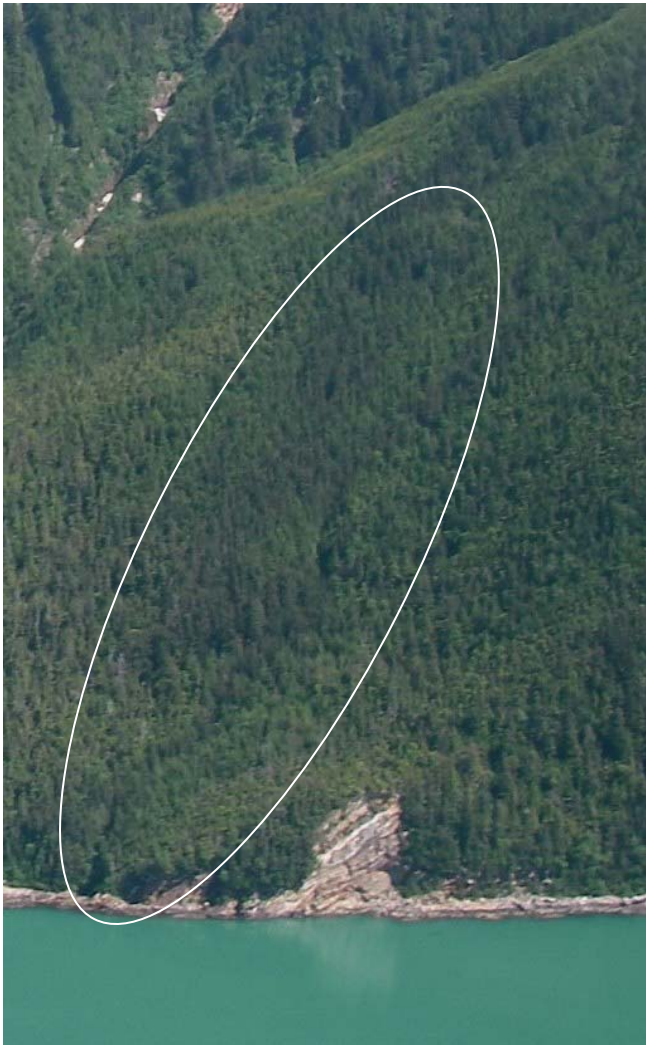
DF14. View east/upslope at debris flow channel.

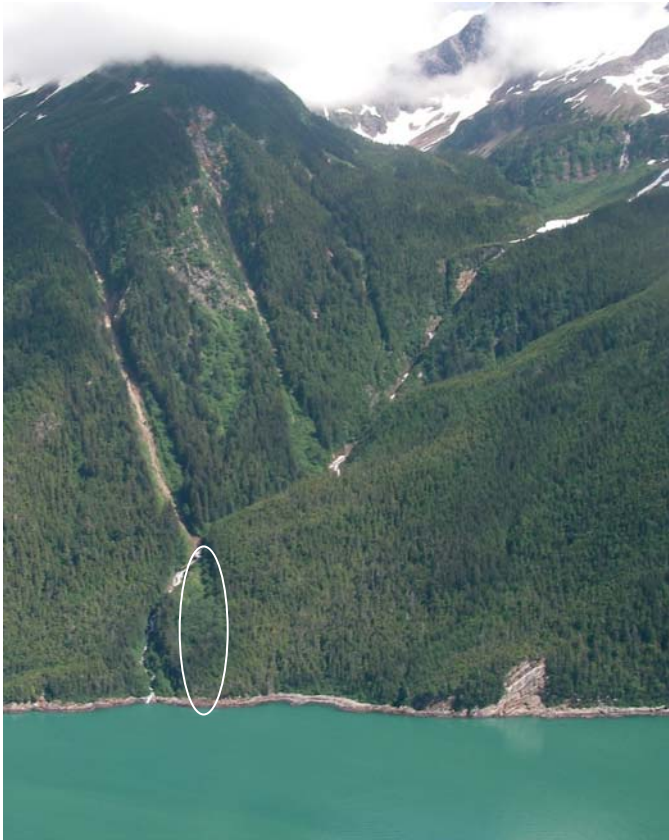
DF15. View east/upslope at debris flow channel and avalanche path ELC012.

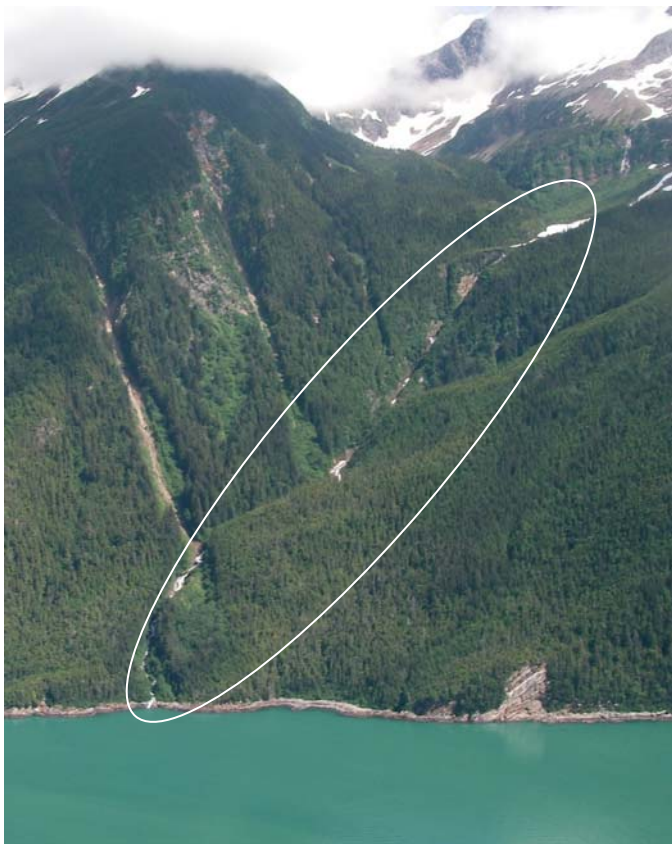
DF16. View east/upslope at debris flow channel and avalanche path ELC012.

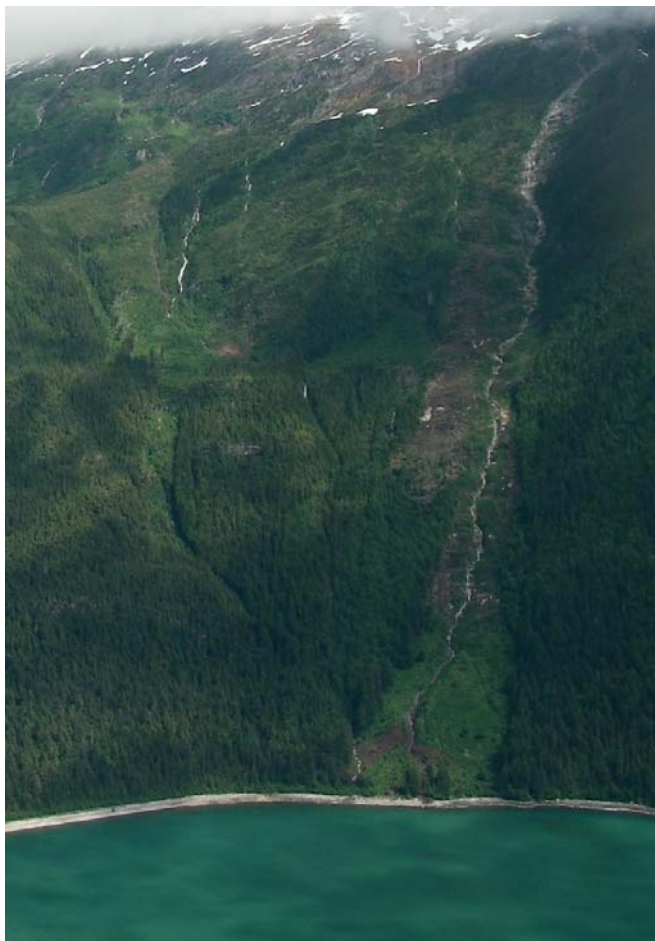
DF19. View east/upslope at debris flow channel and avalanche path ELC014.

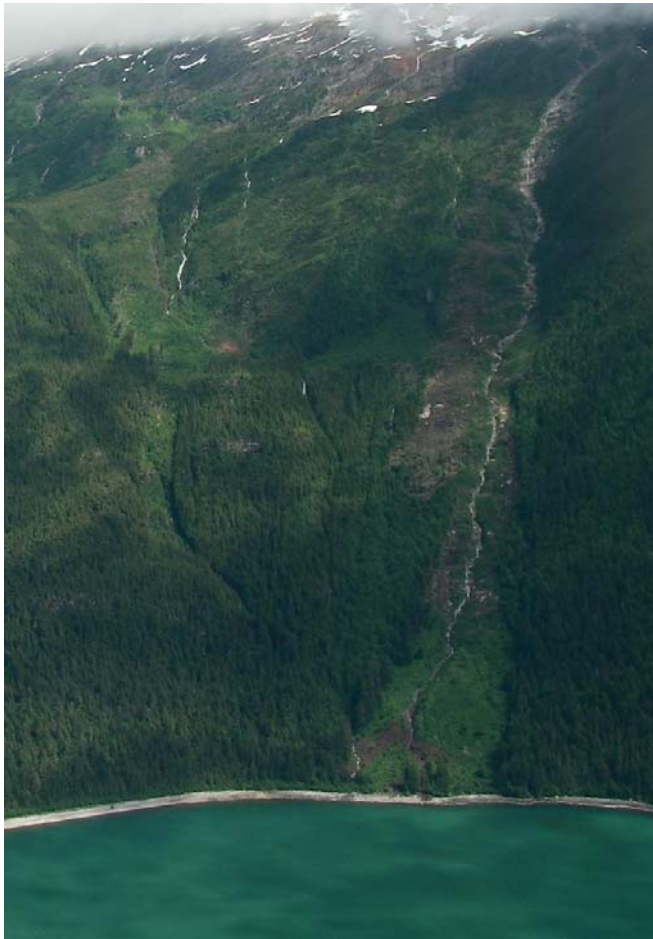
DF20. View east/upslope at debris flow channel.

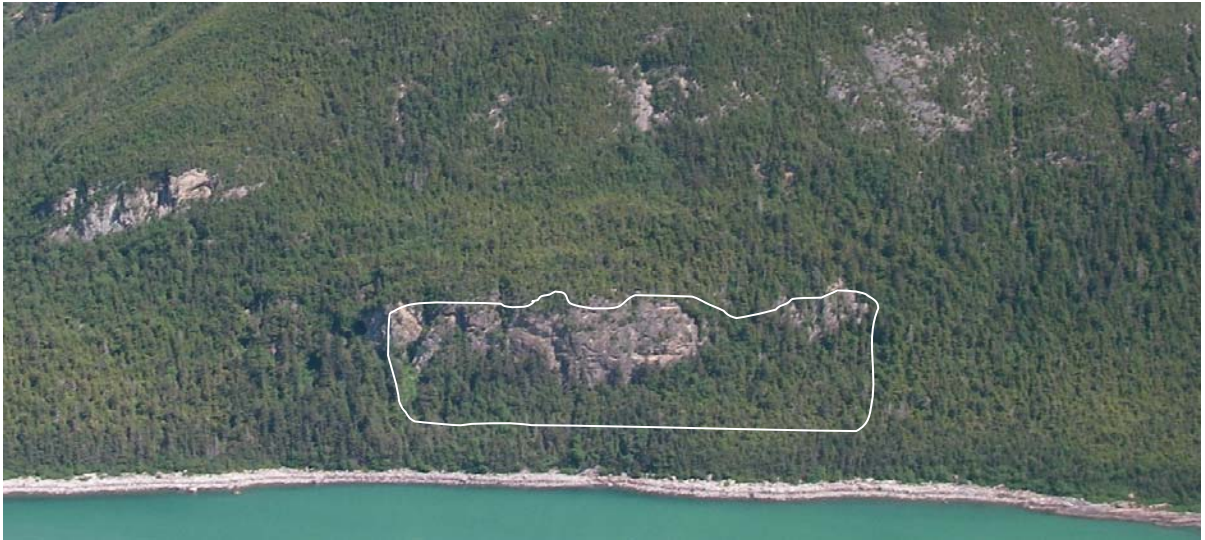
RF14. View east/upslope at moderate rockfall hazard from IRP 2006 1933+00 to 1953+00, below massive gneiss cliffs.

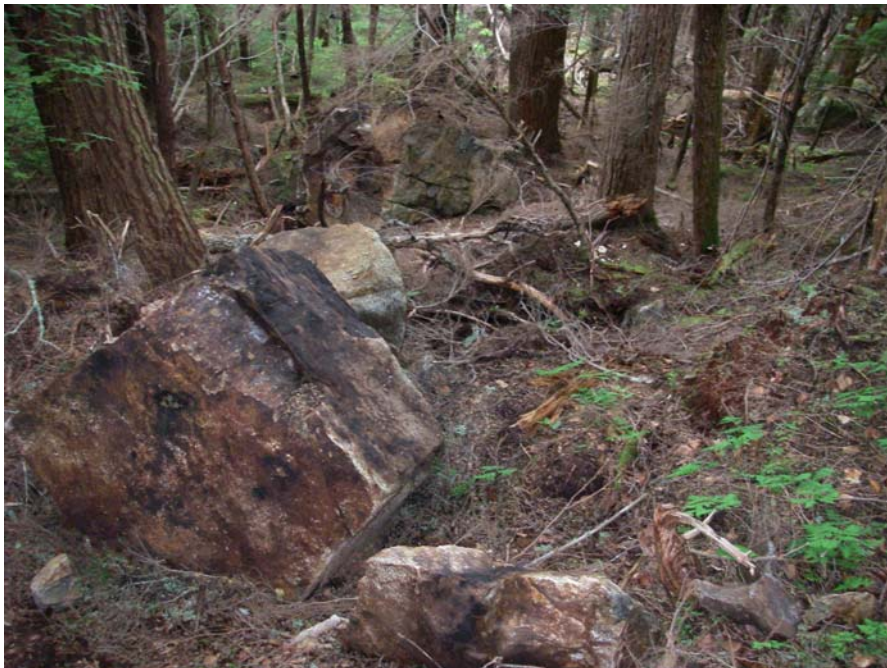
RF14. View west/downslope at fresh rockfall at IRP 2006 1933+00, 3-4 ft diameter boulders.

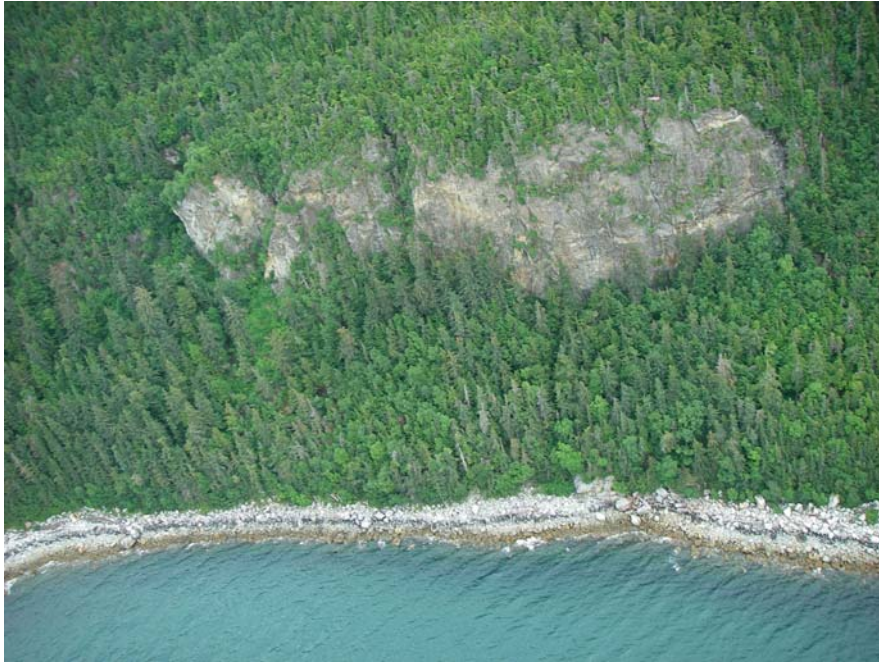
RF15. View east/upslope at rockfall area within rockfall area RF14.

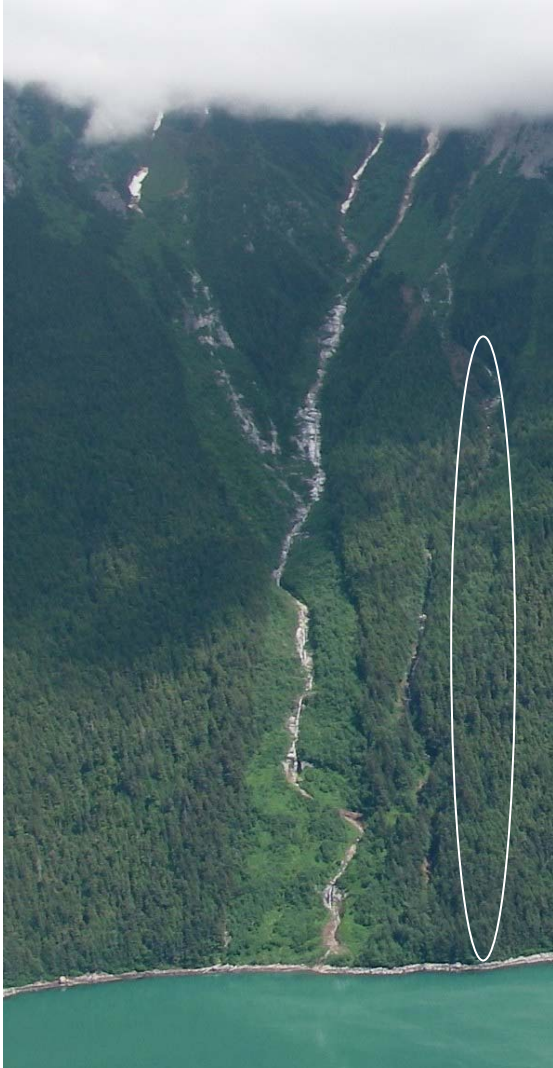
DF24. View east/upslope at debris flow channel and avalanche path ELC018 (circled, right) and avalanche path ELC019 (with major stream, center).

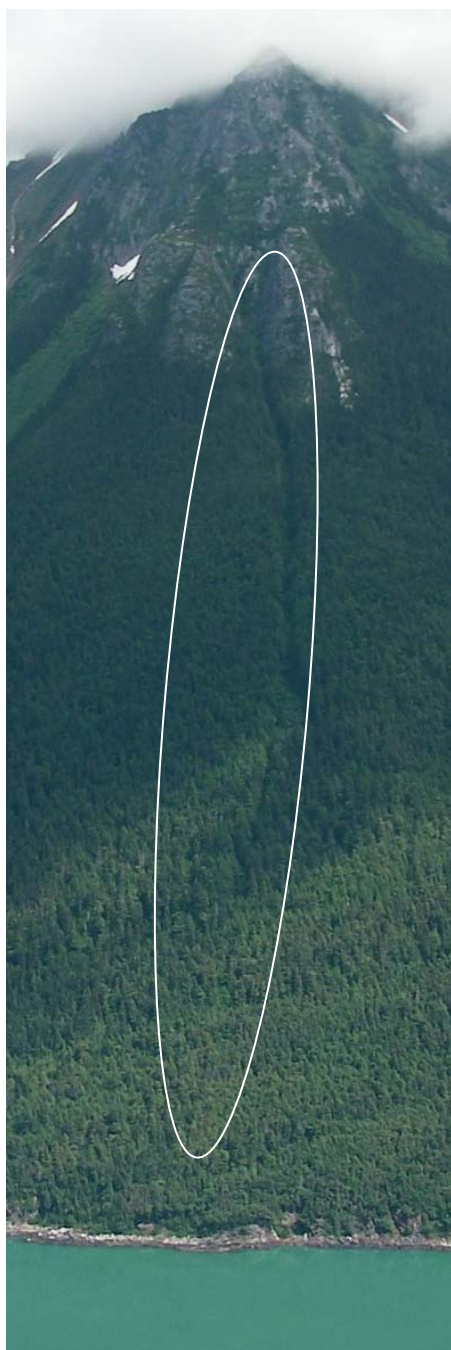
DF27. View east/upslope at debris flow channel and avalanche path ELC019-1.
