FILE No. GEO_HAZ_SUMM.PPT
PROJECT No. 063-5782

GEOLOGIC HAZARD SUMMARY
ARRANGED BY IRP 2006 STATIONING
LYNN CANAL HIGHWAY PHASE I
ZONE 4 GEOTECHNICAL INVESTIGATION

ADOT / LYNN CANAL HWY ZONE 4 / AK

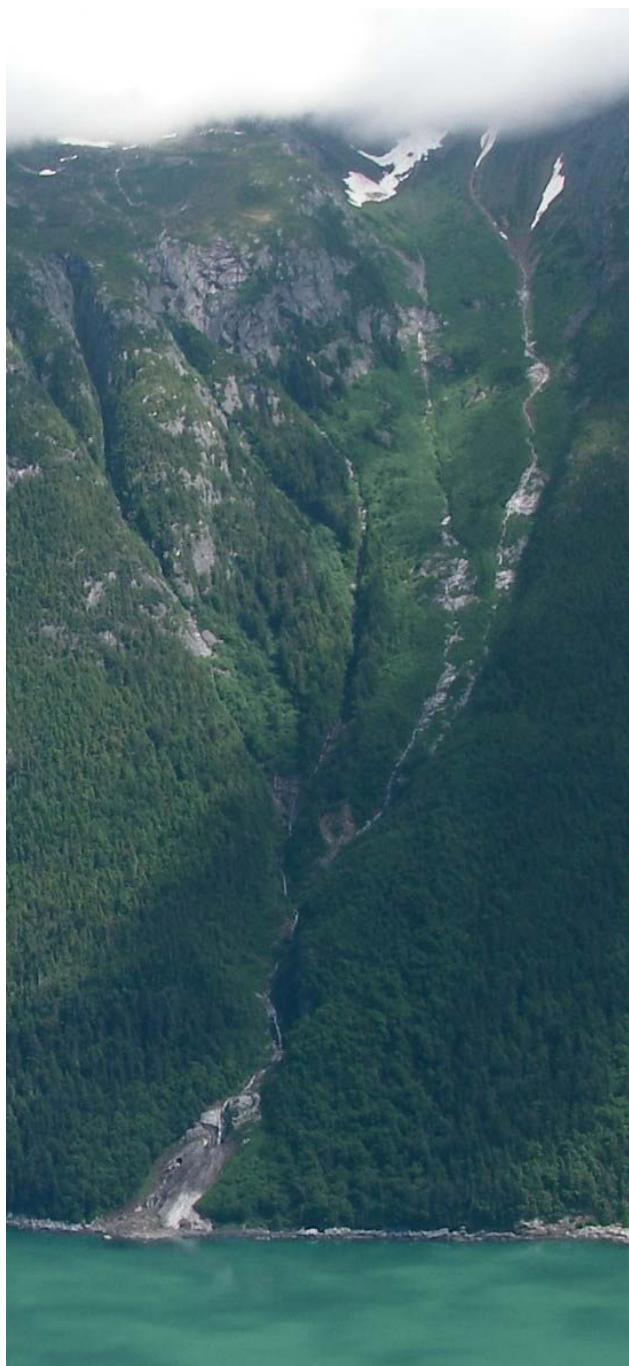
Hazard ID #:	DF29
Hazard Type:	debris_flow
HIN:	153
Rating:	A
IRP 2006 Location:	2114
Frequency (yrs):	1-5
Predictability:	moderate
Material Volume (CY):	10-100
Clast Size (ft):	1-2
Source Elev. (ft):	3000+
Centerline Slope:	fan
Alignment Location:	deposition_zone
Impact Alignment:	yes
Alignment Exposure (ft):	200-500
Vegetation:	denuded
Deciduous Trees:	yes
IRP 2006 South Margin:	2115+00
IRP 2006 North Margin:	2117+40
Photo #:	5125, 5926, 6248

DF29. View east/upslope at debris flow channel and avalanche path ELC020.

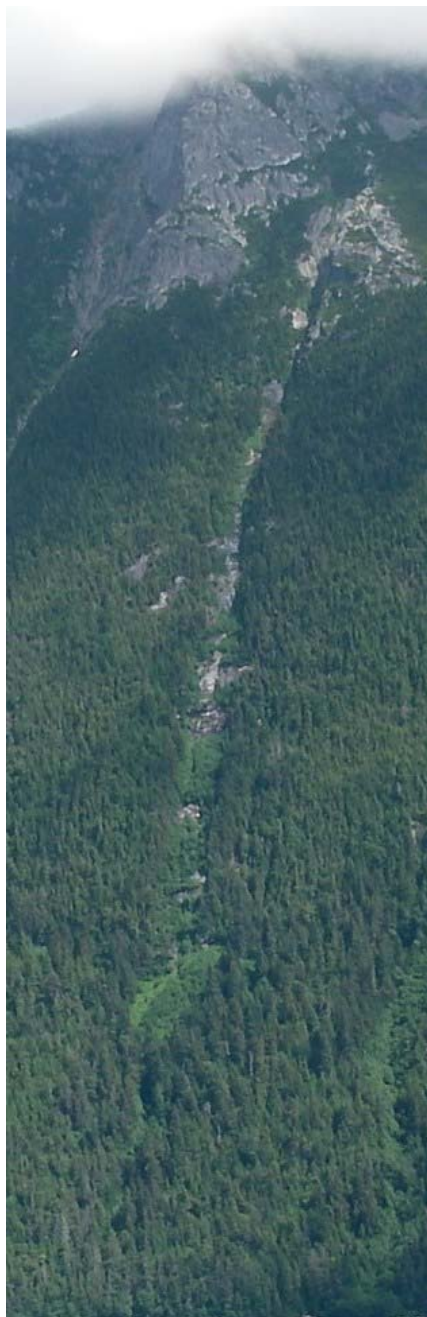
RF17. View east/upslope at rockfall hazard area.

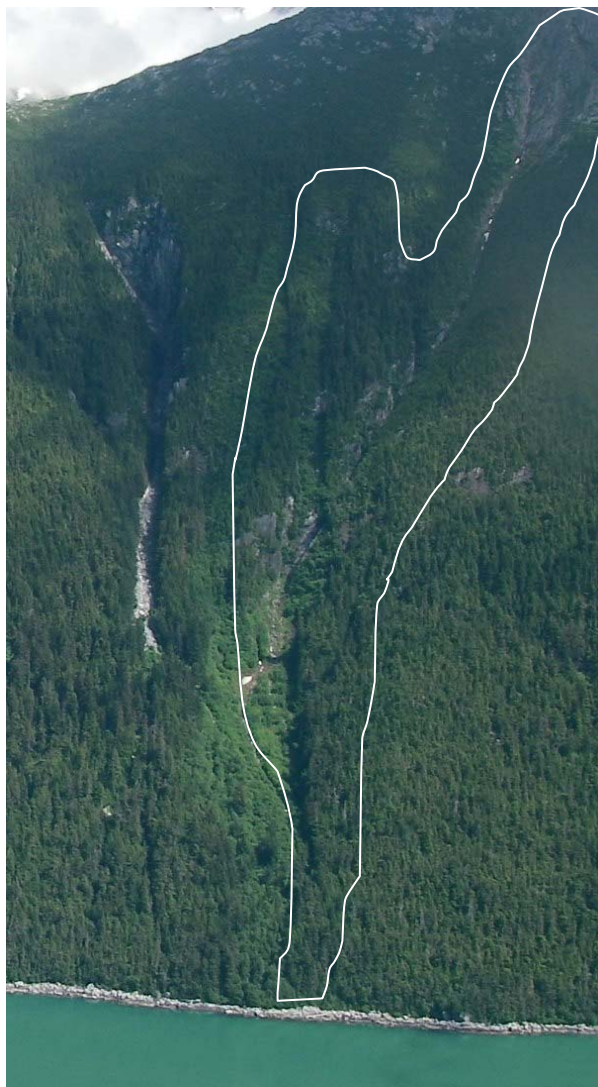
DF31. View east/upslope at debris flow path and base avalanche path ELC021.

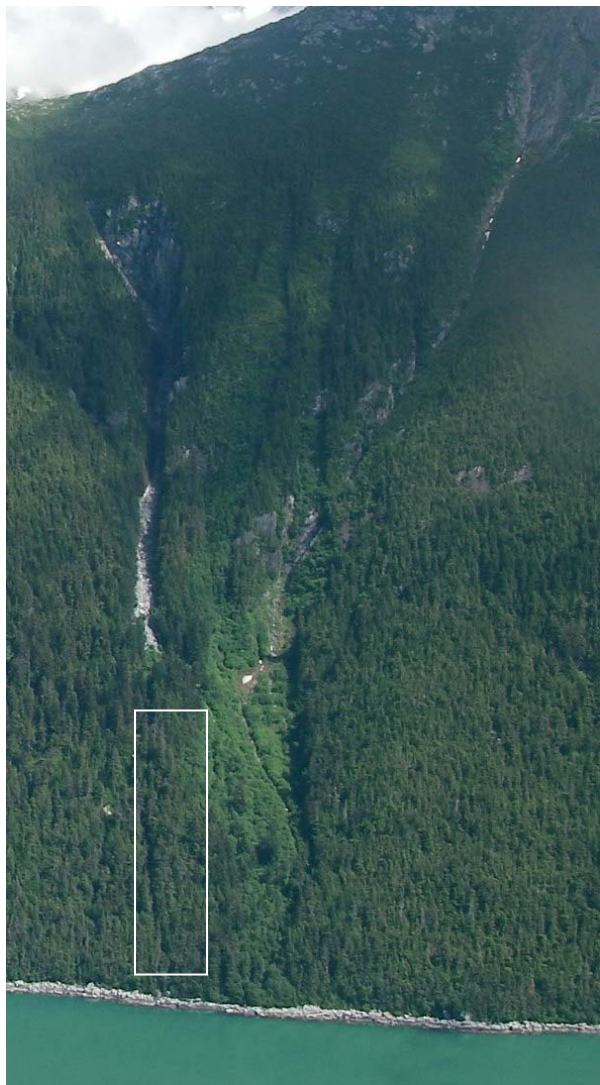
RF20. View east/upslope at rockfall area and avalanche path ELC023.

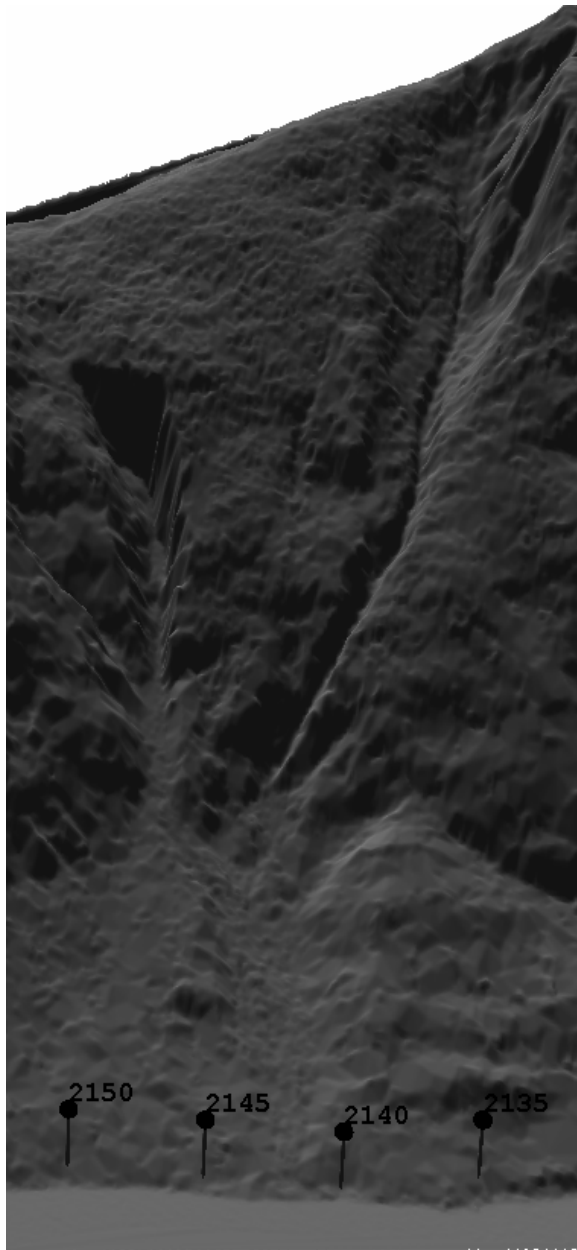
RF20. Bare earth LIDAR image view east/upslope at rockfall hazard area.

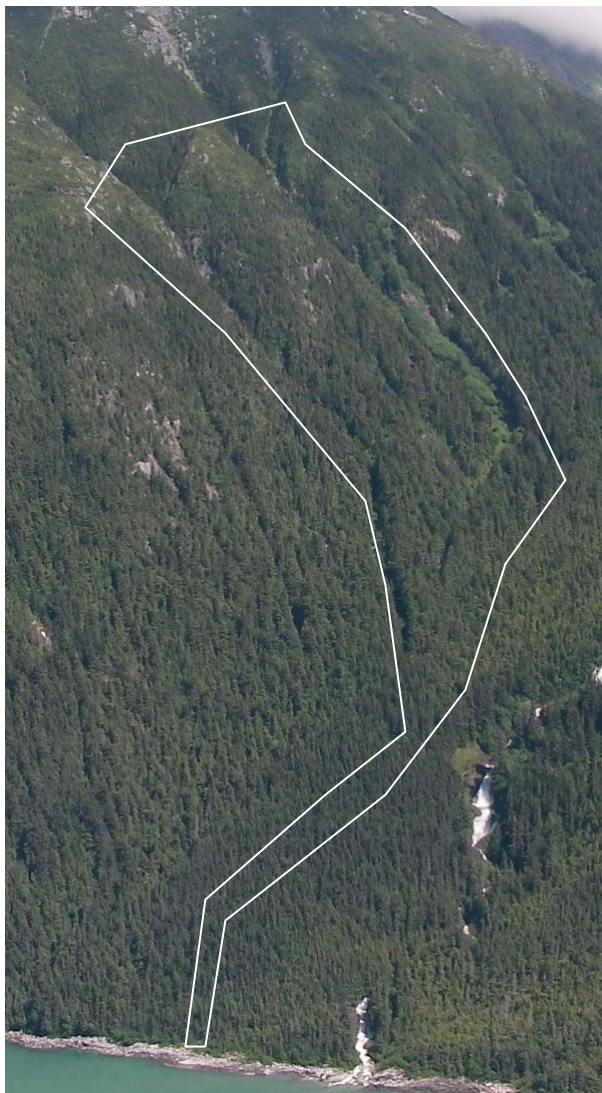
DF33. View east/upslope at debris flow channel.

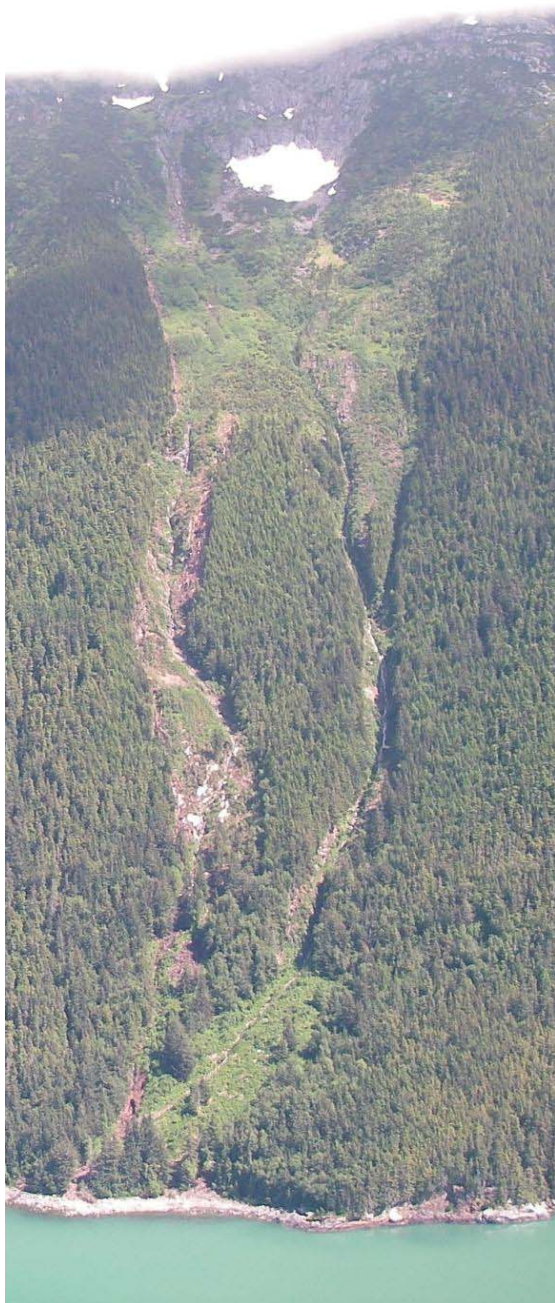
DF 34. View east/upslope at debris flow channel and avalanche path ELC025.

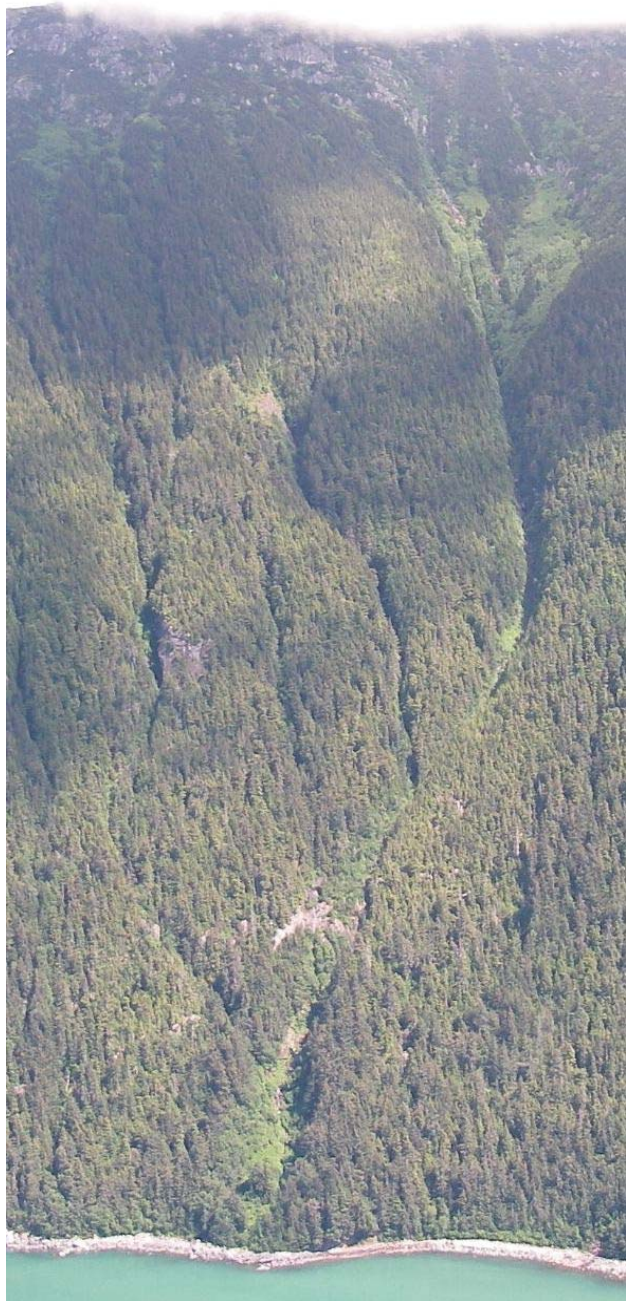
DF35. View east/upslope at debris flow channel and avalanche path ELC026.

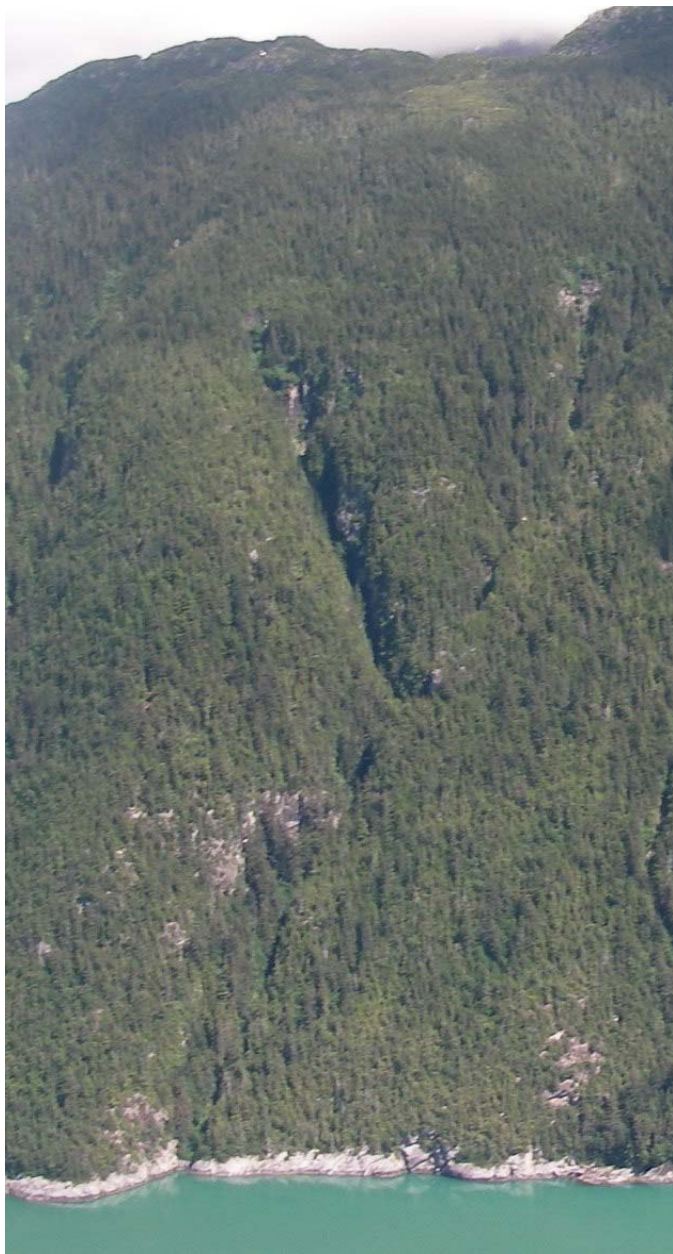
DF37. View east/upslope at debris flow channel and avalanche path ELC028.

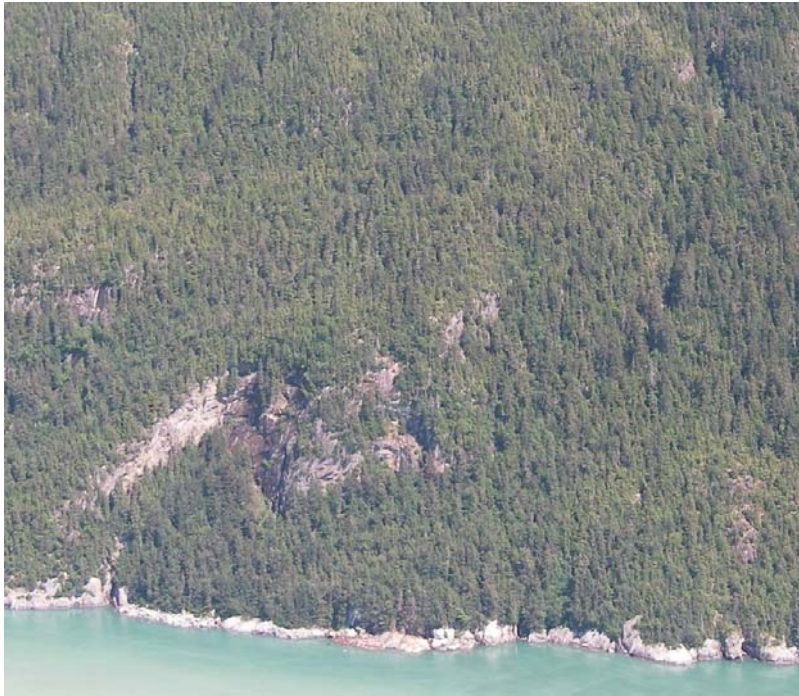
RF32 & RF33. View east/upslope at rockfall hazard from severe cliffs. This photo presents the area for RF32 and RF33.

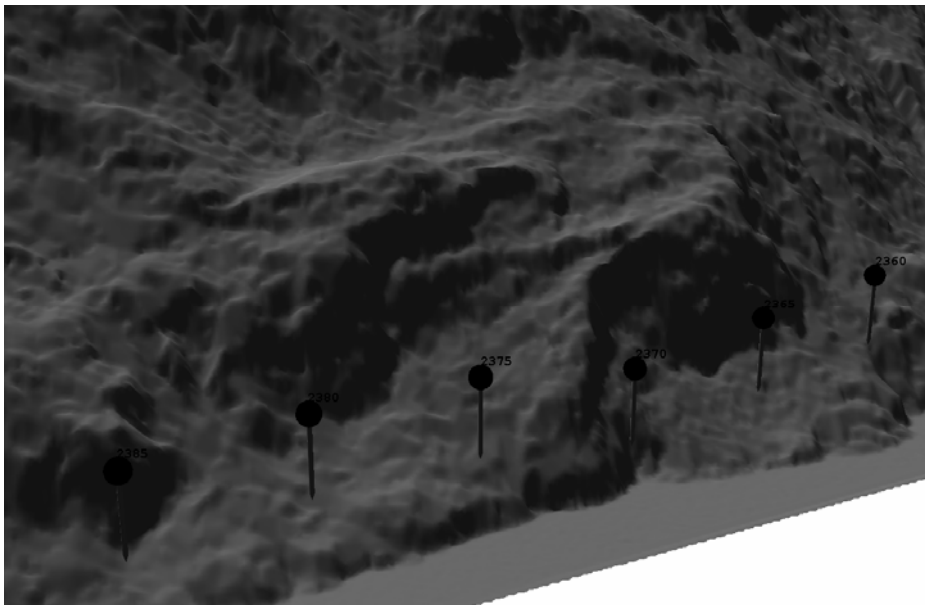
RF32 & RF33. LIDAR image showing topography and cliffs producing rockfall hazards.

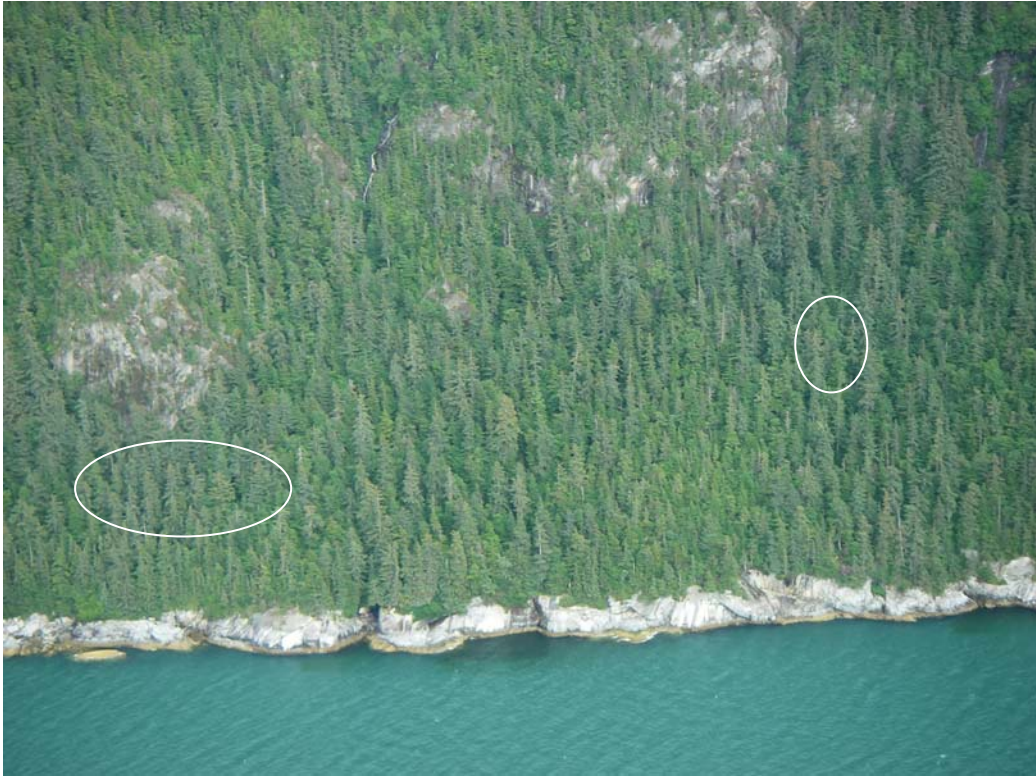
HR01 & HR02. View east/upslope at hazard rocks HR01 (right) and HR02 (left).

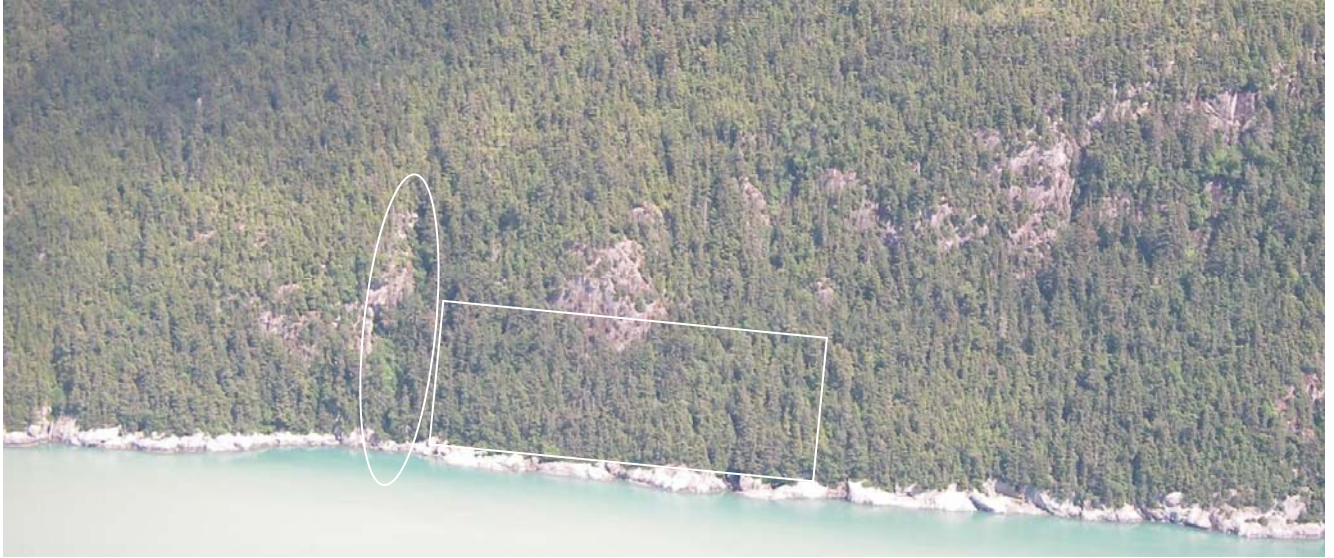
RF34 & RF35. View east/upslope at rockfall hazard from severe cliffs: RF34 (right) and RF 35 (left).

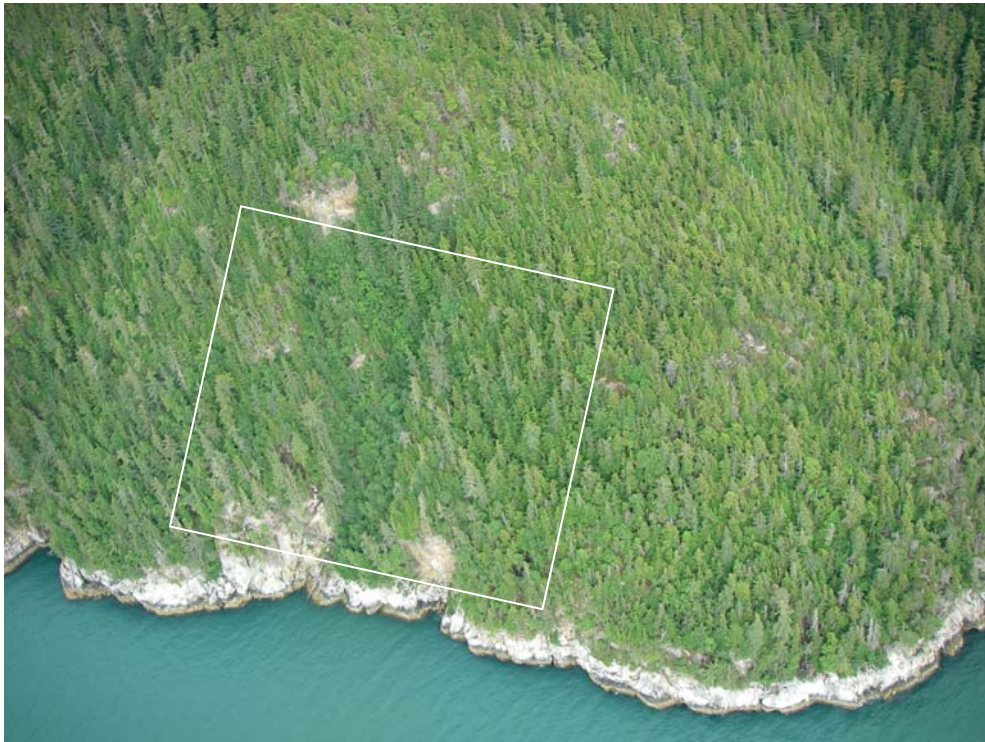
RF37. View east/upslope at rockfall hazard.

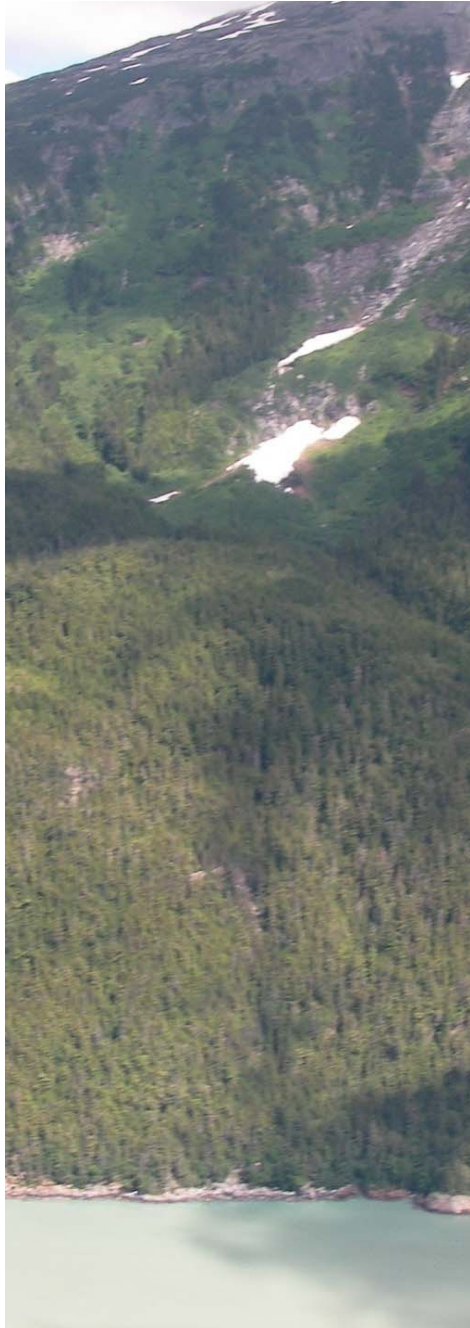
DF42. View east/upslope at debris flow channel.

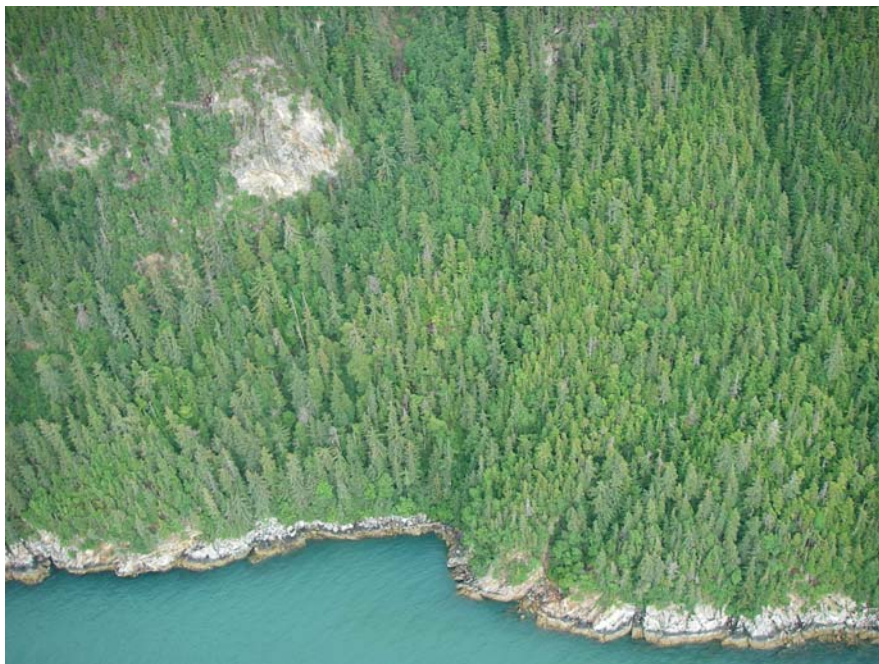
DF42. View east/upslope at debris flow channel.

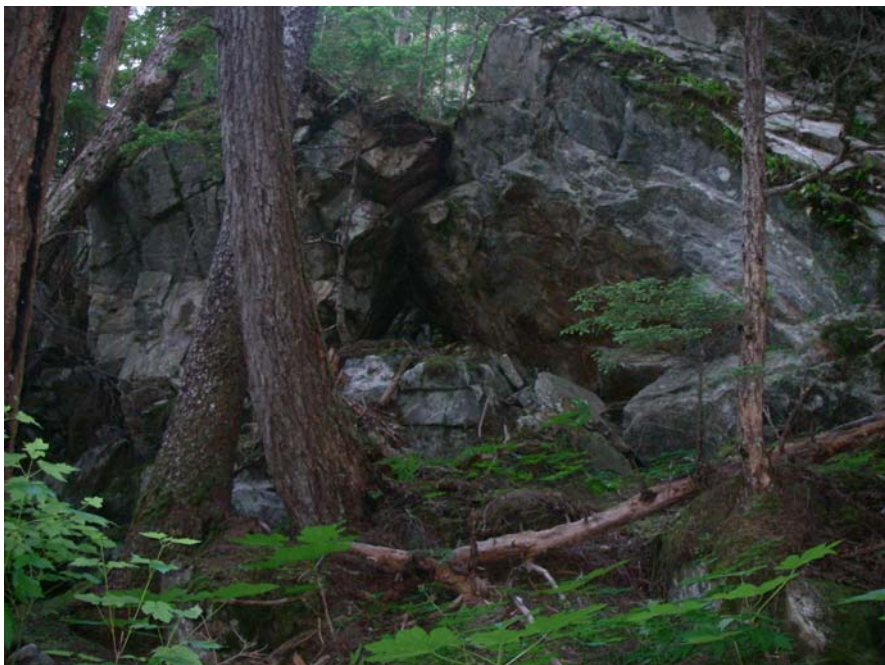
HR03. View east/upslope at hazard rock. Photo taken 75 ft right of IRP 2006 2517+80.

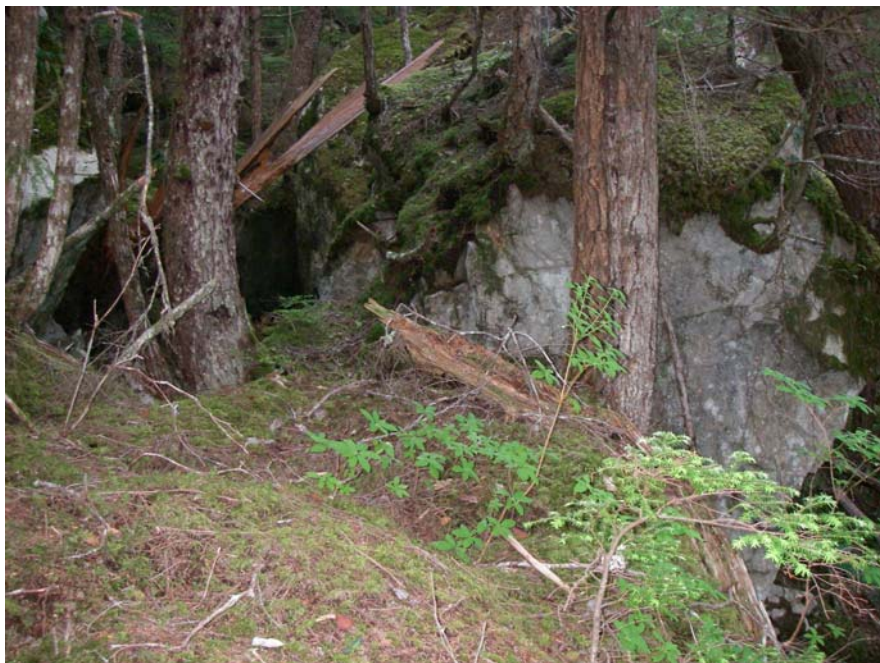
HR04. View south/down alignment at hazard rock. Photo taken 30 ft right of IRP 2006 2526+00.

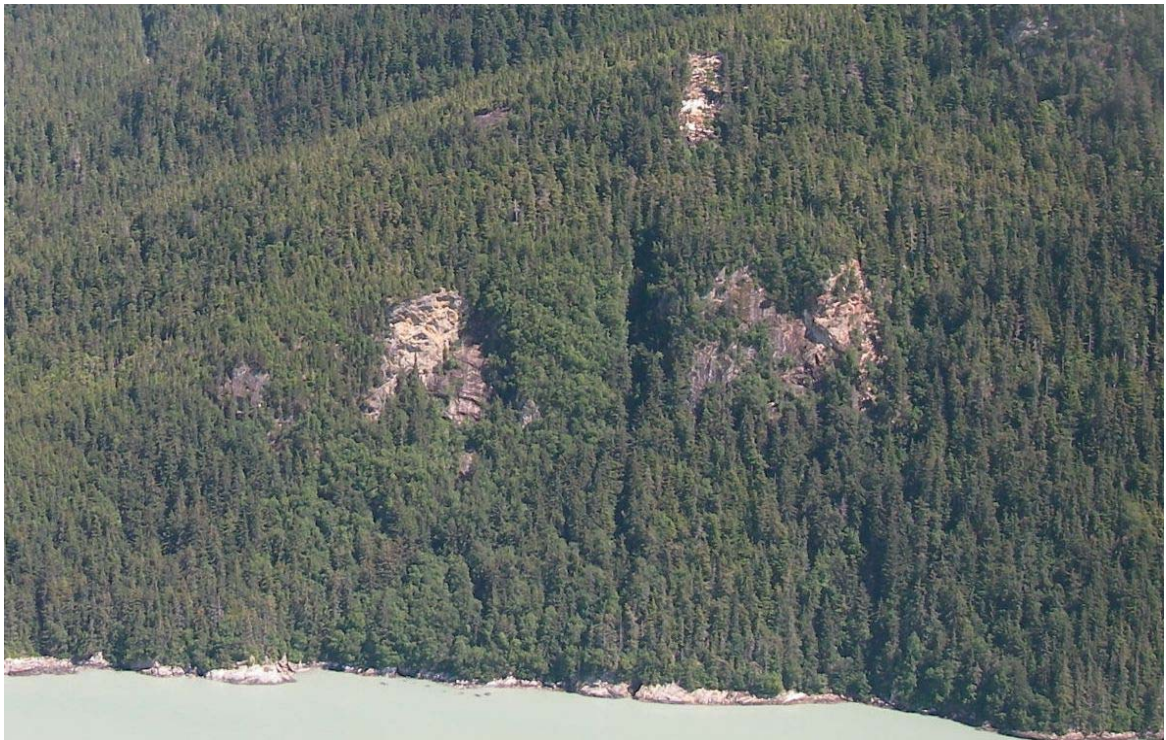
View east/upslope at approximate IRP 2006 range 2550+00 to 2570+00. Regional photo for hazards listed below. Local photos and details for individual hazards follow.

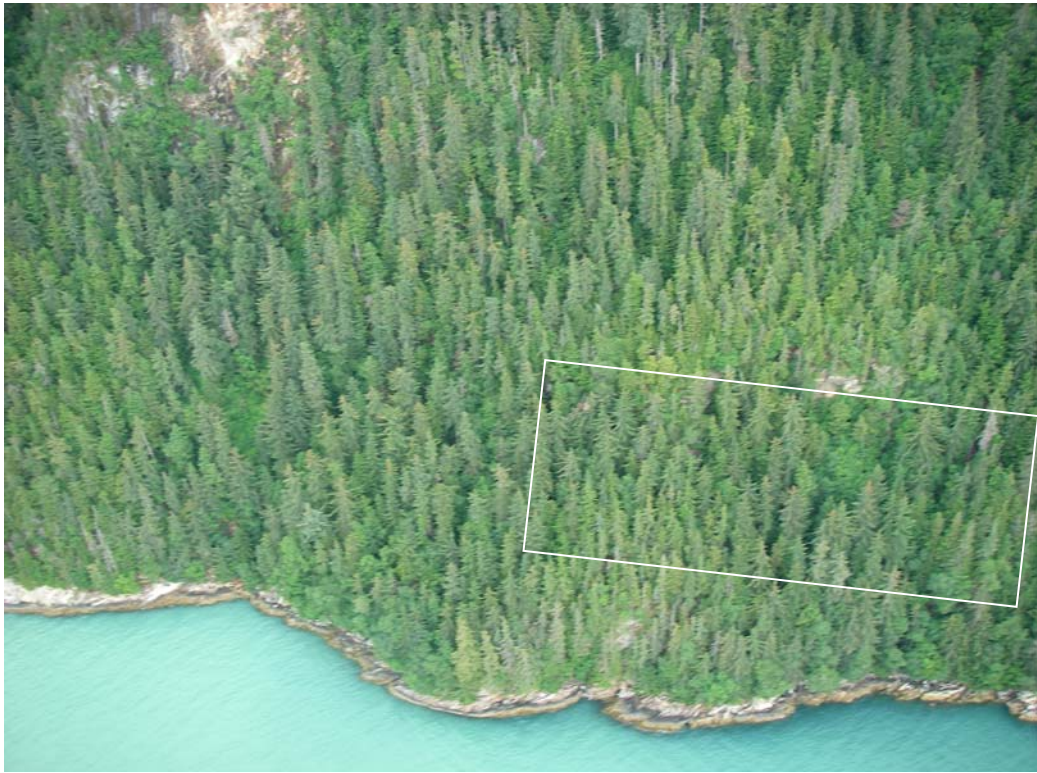
RF47. View east/upslope at rockfall hazard area.

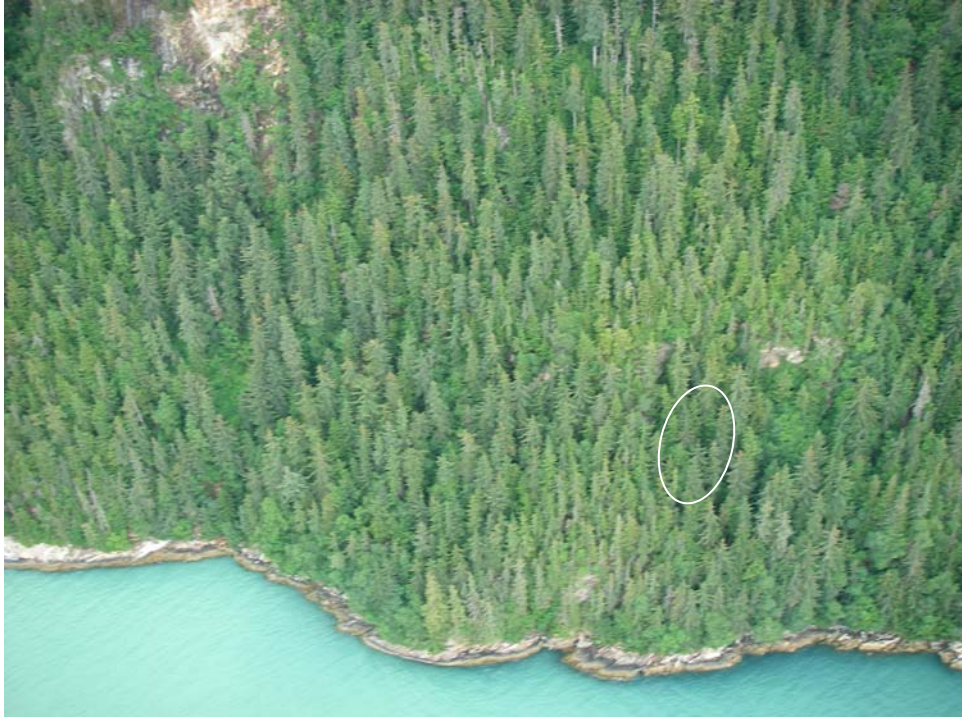
HR05. View east/upslope at hazard rock location. The IRP 2006 alignment range for the aerial photograph is 2550 (right) to 2555 (left).

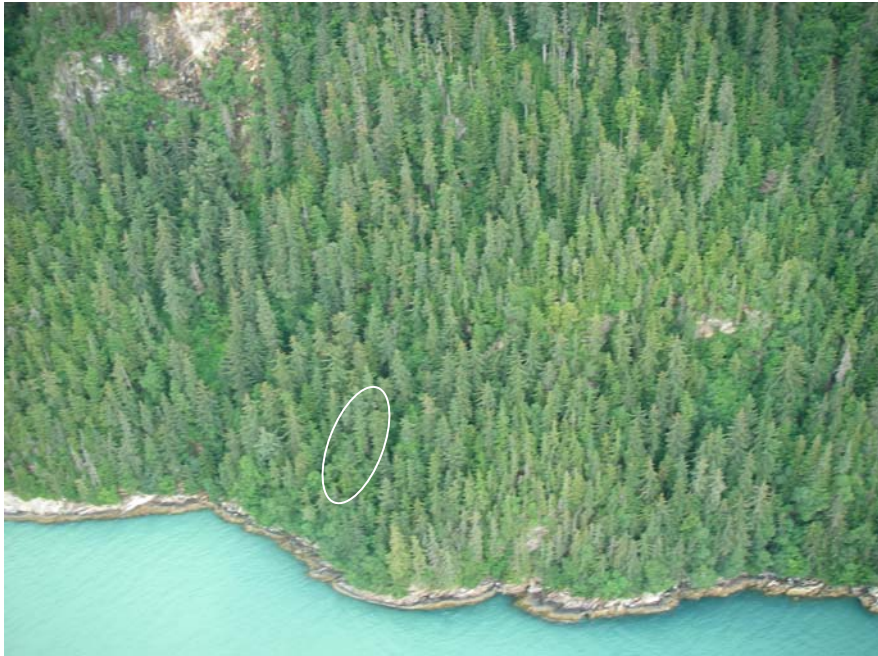
RF50. View east/upslope at rockfall area.

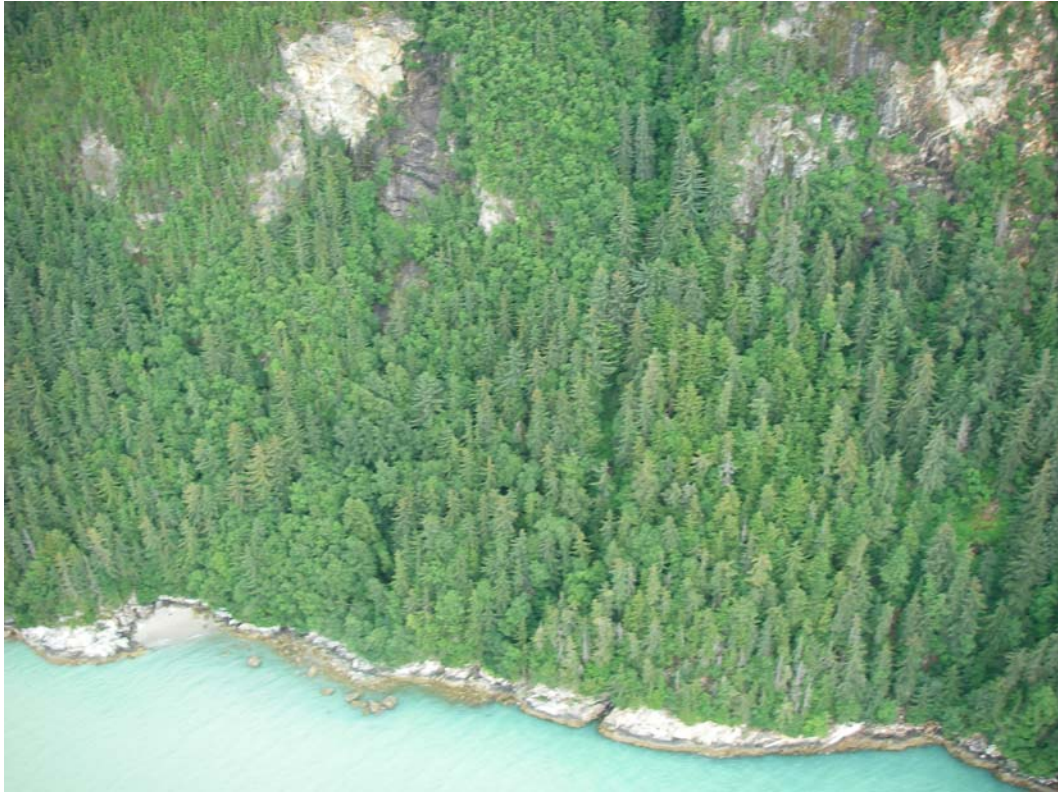
RF51. View east/upslope at rockfall hazard.

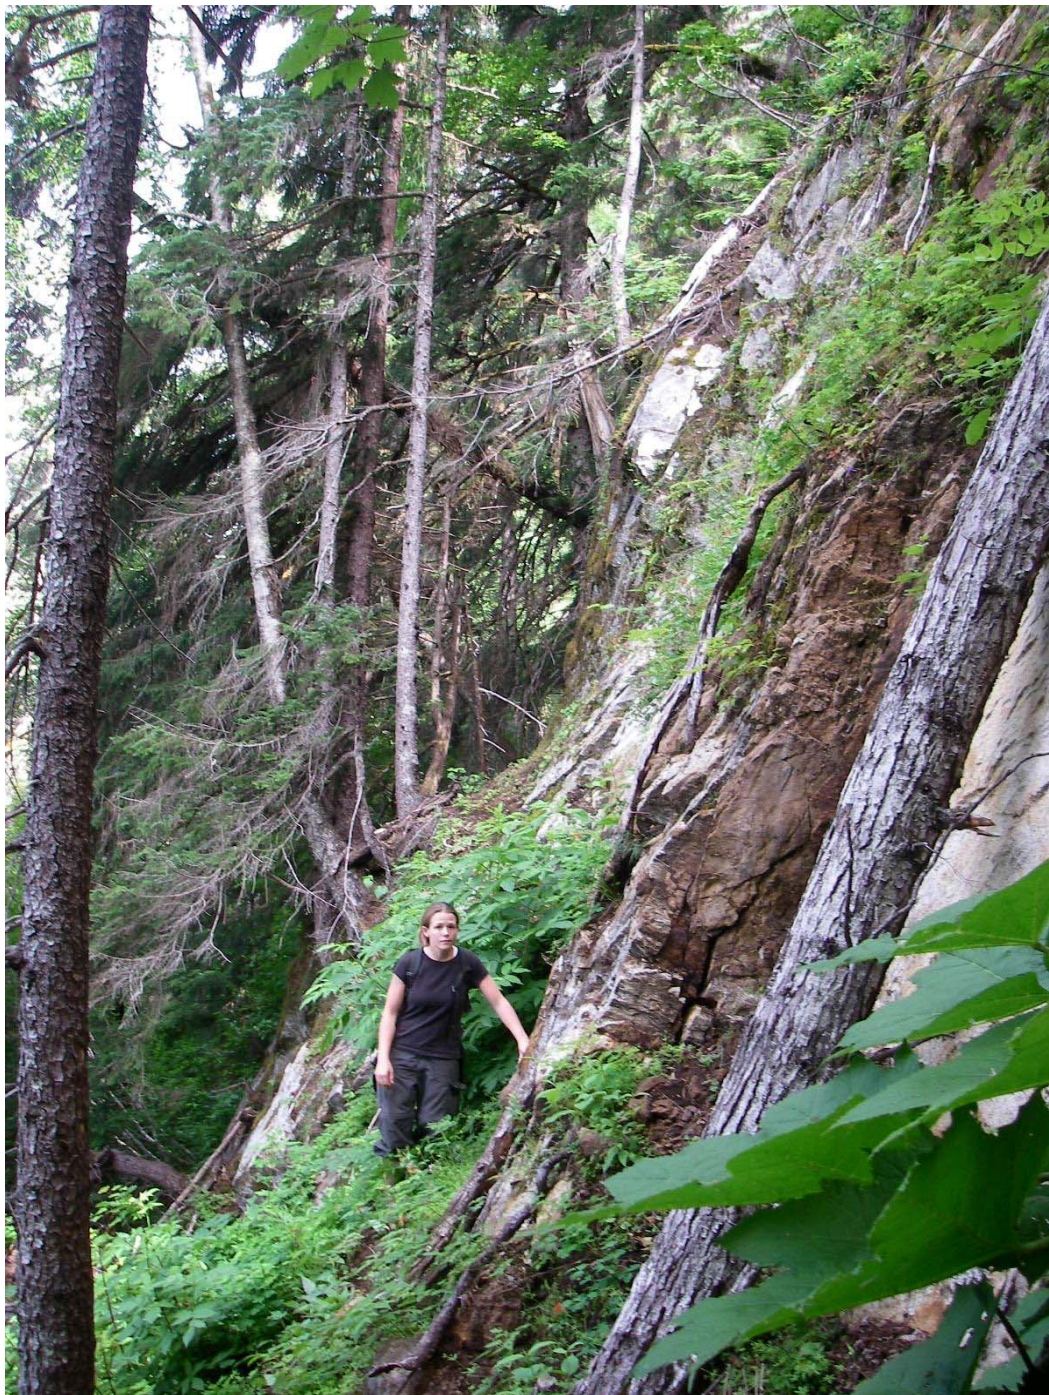
RF51. View north/up alignment across steep face of rockfall hazard.
Photo taken 160 ft right of IRP 2006 2560+50.

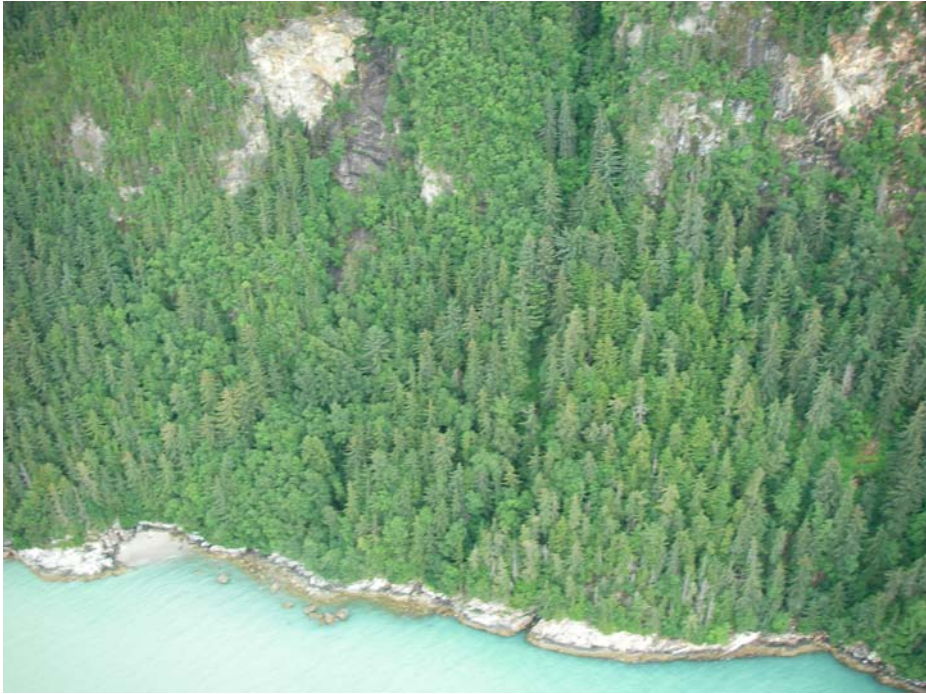
DF43. View east/upslope at debris flow channel.
