Alaska DOT&PF

Pavement Inspection Report Adak Airport

Point of Contact	Phone	Email	Date Inspected	Date Published
Mr. Andrew Pavey, Pavement Management Engineer	(907) 269 6213	andrew.pavey@alaska.gov	May 2023	September 2023

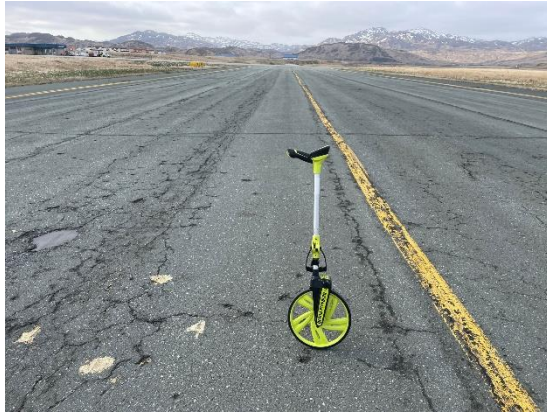
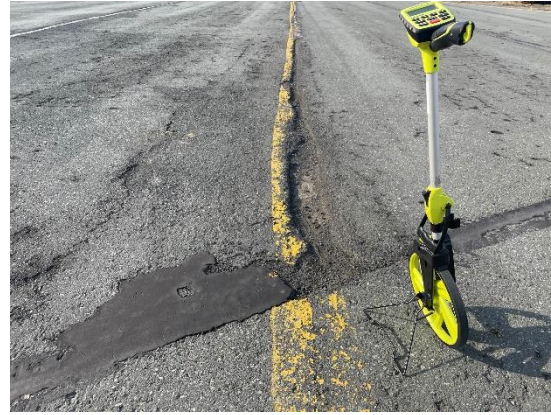
Branch ID	Branch Name	Branch Use	No. of Sections	Area (sf)	Weighted Average PCI
0100	Taxiway A	Taxiway	2	471,761	35

Taxiway A was constructed in 1990 and has not received major work since. Occasional crack seal operations have been performed on the branch. The most common distresses observed are medium to high severity longitudinal and transverse cracking, low to high severity raveling, and low severity alligator cracking. Field observations include further deterioration of the top layer of asphalt which is contributing to higher quantity and severity raveling throughout the branch. Efforts have been made to seal areas of high cracking and raveling, but the sealant is failing.

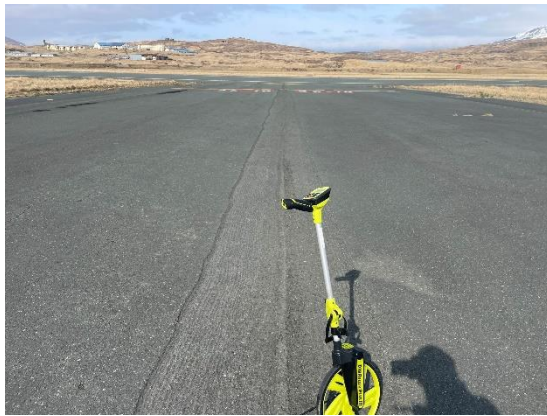
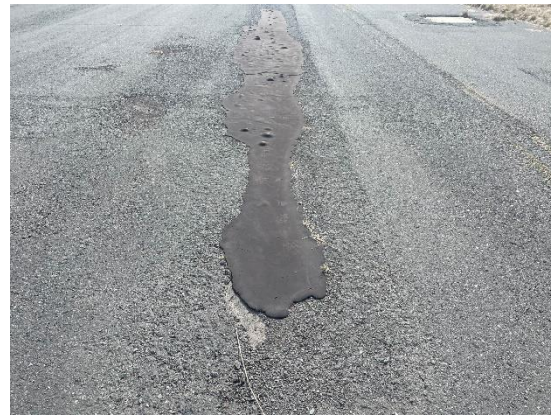
Branch ID	Branch Name	Branch Use	No. of Sections	Area (sf)	Weighted Average PCI
0200	Taxiway B	Inactive	1	32,765	18

Like Taxiway A, Taxiway B was constructed in 1990 and has not received any major work since. At the time of the inspection Taxiway B was designated as inactive. Occasional crack seal operations have been performed on the branch. The most common distresses observed are medium severity longitudinal and transverse cracking, low to high severity raveling, and low severity alligator cracking. Field observations include paint markings having been milled which created large areas of high raveling. Efforts have been made to seal areas of high raveling, but the sealant is failing.

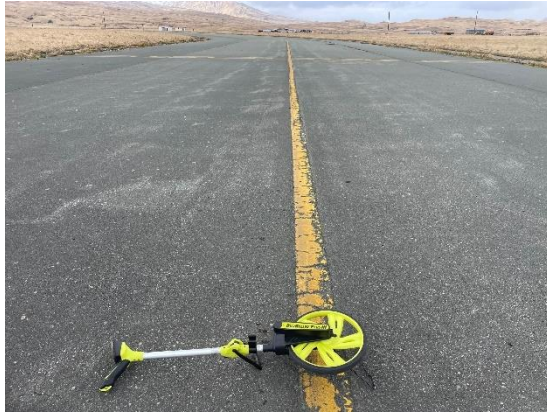
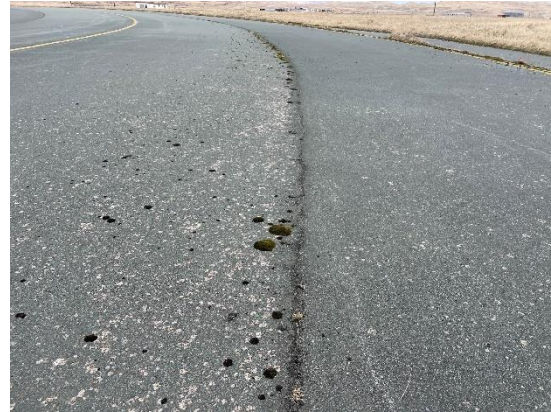
AC Section 0300-01 (71 PCI)

Like Taxiway A and B, Taxiway C was constructed in 1990 and has not received any major work since. Taxiway C is designated as restricted use and consists of two sections, of which one is AC and the other is PCC. The AC section was constructed in 1990. Crack seal operations have not been performed on the branch. The most common distresses observed are low to medium severity longitudinal and transverse cracking and low severity raveling. Field observations include the paving joints continuing to deteriorate and widen leading to higher severity distresses. Vegetation was observed growing in the paving joints.

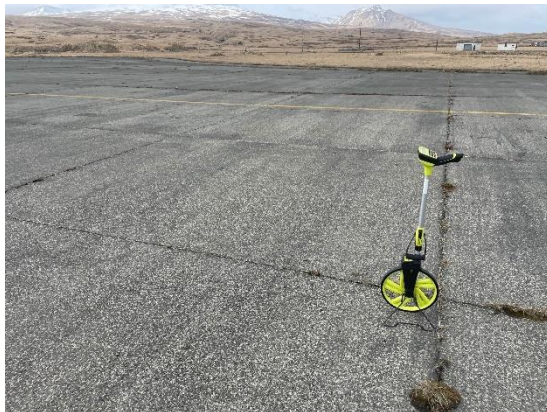
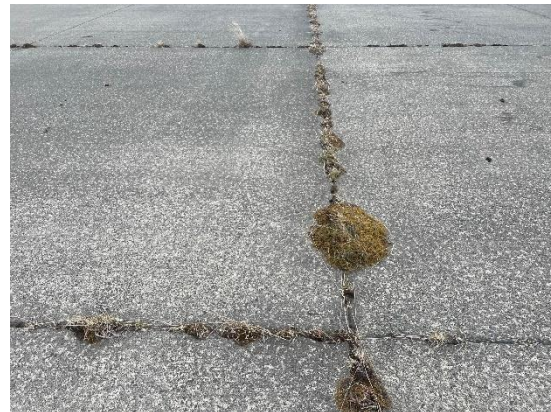
PCC Section 0300-02 (83 PCI)

The PCC section was also constructed in 1990 and has not received any major work since. The most common distresses observed are high severity joint seal damage and low severity scaling. Field observations include wearing of the surface of the concrete leading to the low severity scaling, and vegetation growth in every joint leading to the high severity joint seal damage.

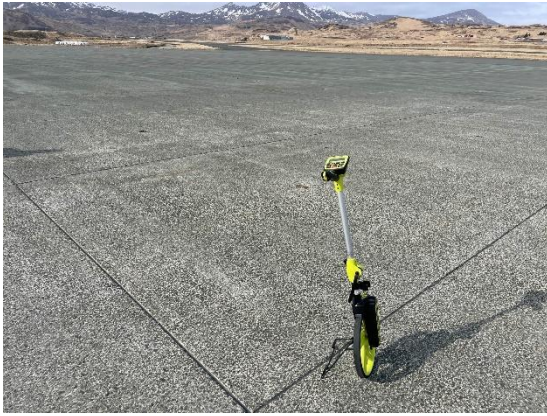
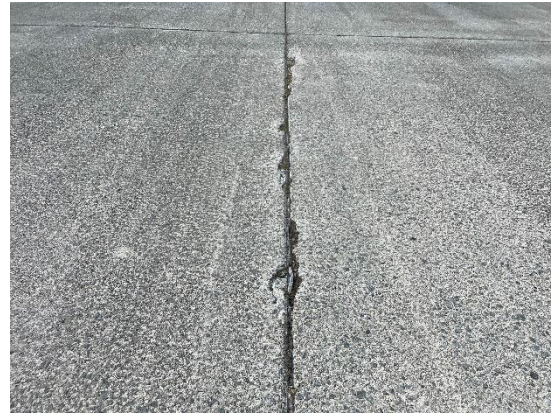
Branch ID	Branch Name	Branch Use	No. of Sections	Area (sf)	Weighted Average PCI
4100	Apron	Apron	1	247,647	89

The apron was constructed in 1990 and has not received any work since. The most common distresses observed are low severity joint seal damage, low severity scaling, and low severity joint and corner spalling. Field observations include wearing of the surface of the concrete leading to the low severity scaling and the occasional joint or corner spall located by the high traffic areas of the apron.
