Alaska DOT&PF

Pavement Inspection Report Akutan Airport

Airport Name	IATA	ICAO	Latitude	Longitude	Elevation (ft)
Akutan Airport	7AK	PAUT	54° 8' 40.6" N	165° 36' 14.79" W	129.3

Point of Contact	Phone	Email	Date Inspected	Date Published
Mr. Andrew Pavey, Pavement Management Engineer	(907) 269 6213	andrew.pavey@alaska.gov	June 2024	June 2025

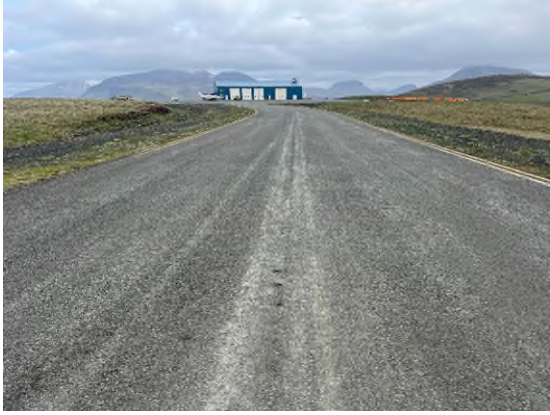
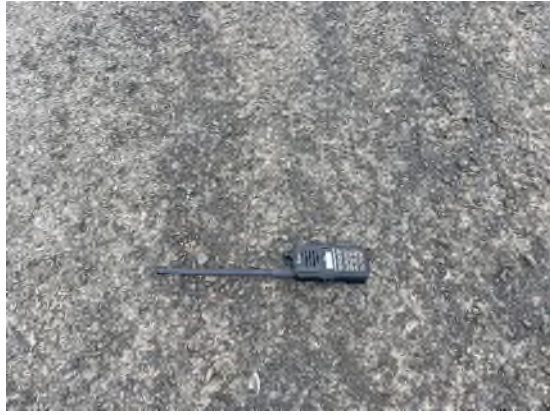
Branch ID	Branch Name	Branch Use	No. of Sections	Area (sf)	Weighted Average PCI
0100	Taxiway	Taxiway	1	25,148	80

The taxiway was initially constructed in 2012 and has not undergone major work since. The most common distresses observed are low to high severity raveling and low severity weathering. Field observations include further deterioration of the top layer of asphalt which is contributing to higher quantity and severity raveling throughout the branch. In contrast, it is noteworthy that no cracking was recorded during the inspection, suggesting that while the surface layer is deteriorating, the underlying structural layers are in relatively good condition.

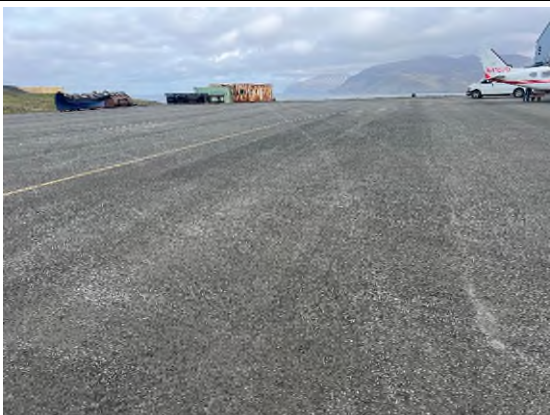
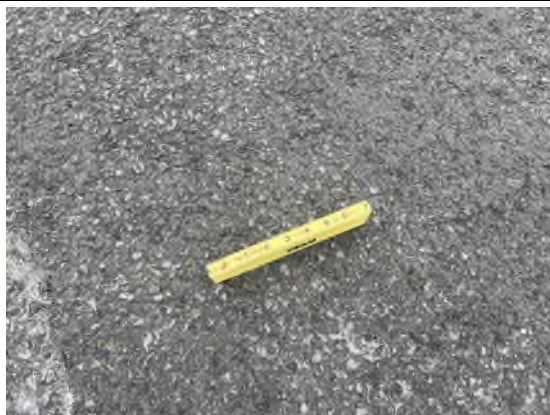
Branch ID	Branch Name	Branch Use	No. of Sections	Area (sf)	Weighted Average PCI
4100	Apron	Apron	1	83,300	82

The apron was initially constructed in 2012 and has not undergone major work since. The most common distresses observed are low severity raveling and low to medium severity weathering. Field observations include further deterioration of the top layer of asphalt which is contributing to higher quantity and severity raveling and weathering throughout the branch. In contrast, it is noteworthy that no cracking was recorded during the inspection, suggesting that while the surface layer is deteriorating, the underlying structural layers are in relatively good condition.
