## Alaska DOT&PF

# Pavement Inspection Report Aniak Airport

Airport Name	IATA	ICAO	Latitude	Longitude	Elevation (ft)
Aniak	ANI	PANI	61° 34' 53.06" N	159° 32' 43.07" W	96.8

Point of Contact	Phone	Email	Date Inspected	Date Published
Mr. Andrew Pavey Pavement Management Engineer	(907) 269 6213	andrew.pavey@alaska.gov	June 2024	December 2024

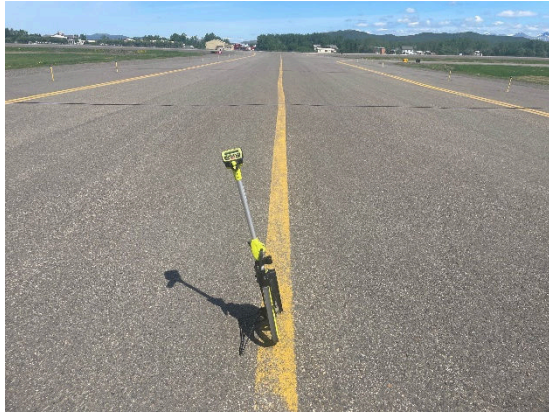
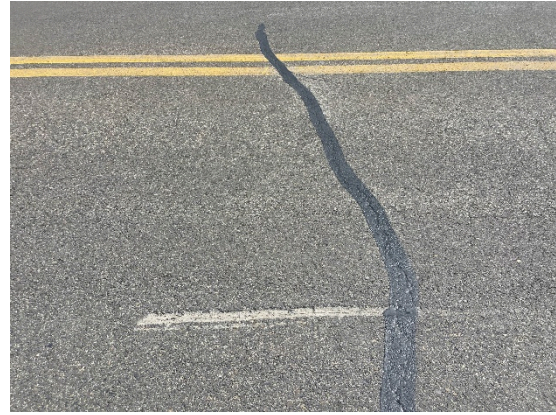
Branch ID	Branch Name	Branch Use	No. of Sections	Area (sf)	Weighted Average PCI
0100	Taxiway F	Taxiway	2	98,717	88

Taxiway F was initially constructed in 1997 and was reconstructed in 2019. Occasional crack seal operations have been performed on the branch. The most common distresses observed are low severity longitudinal and transverse cracking, low severity raveling, and low severity weathering. Field observations include sealed cracks, the pavements surface beginning to weather, and localized areas of raveling.

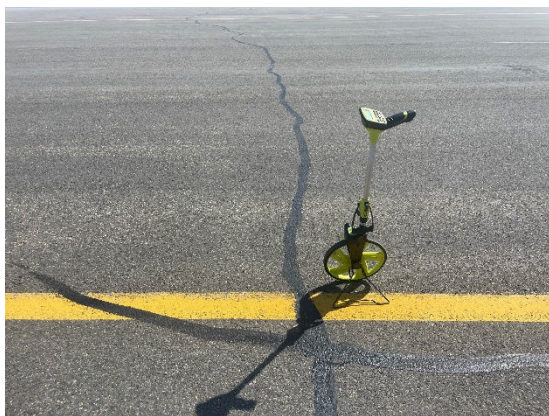
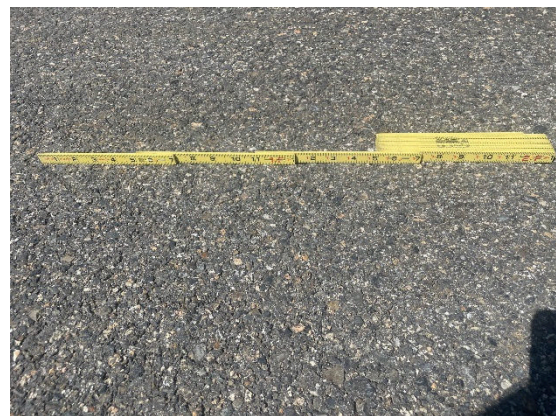
Branch ID	Branch Name	Branch Use	No. of Sections	Area (sf)	Weighted Average PCI
0200	Taxiway G	Taxiway	1	55,938	91

Taxiway G was initially constructed in 2019 during the runway shift project. Occasional crack seal operations have been performed on the branch. The most common distresses observed are low severity longitudinal and transverse cracking, low severity raveling, and low severity weathering. Field observations include sealed cracks, the pavements surface beginning to weather, and localized areas of raveling.

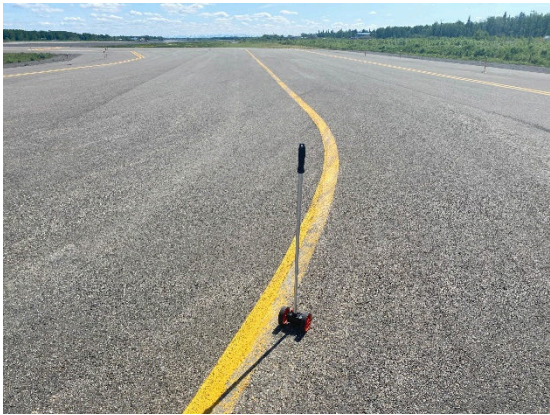
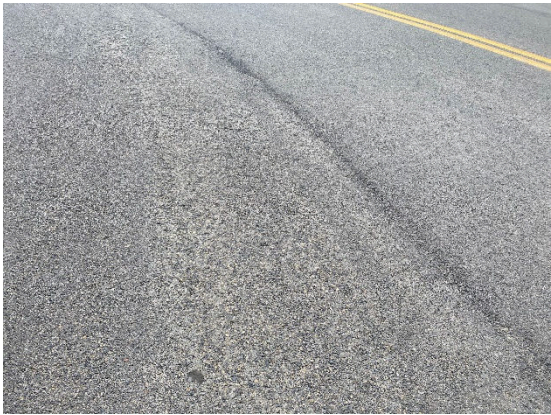
Branch ID	Branch Name	Branch Use	No. of Sections	Area (sf)	Weighted Average PCI
0300	Turnaround	Taxiway	1	53,659	93

The turnaround taxiway was newly constructed in 2019 as a part of the runway shift project. Occasional crack seal operations have been performed on the branch. The most common distresses observed are low severity longitudinal and transverse cracking, low severity raveling, and low severity weathering. Field observations include the pavements surface beginning to weather and localized areas of raveling.

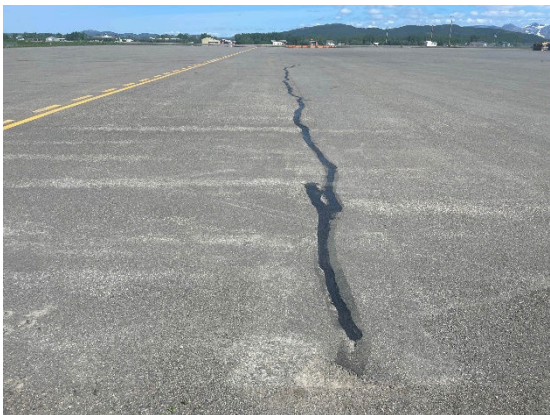
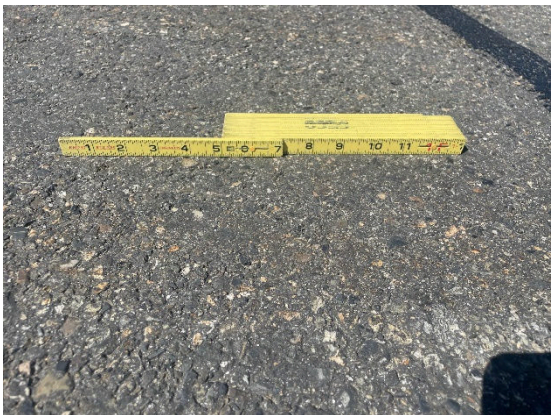
Branch ID	Branch Name	Branch Use	No. of Sections	Area (sf)	Weighted Average PCI
4100	Apron	Apron	1	215,089	90

The apron was initially constructed in 1997 and was reconstructed in 2019. The most common distresses observed are low severity longitudinal and transverse cracking and low severity weathering. Field observations include sealed cracks and the pavements surface beginning to weather. Unsealed medium severity longitudinal and transverse cracks exist on the apron near the hangars.

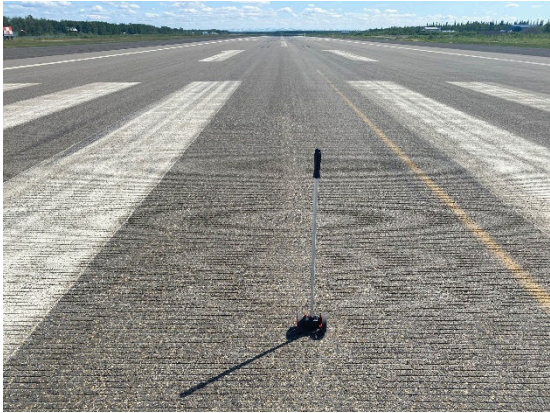
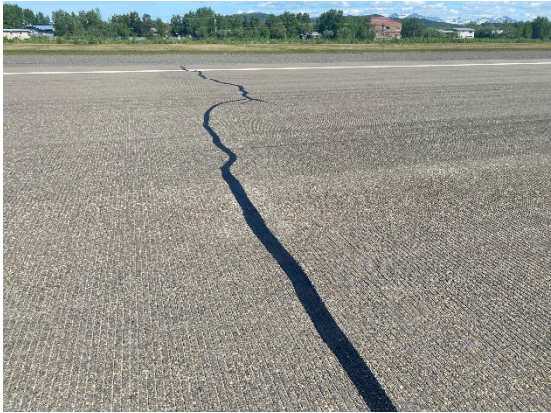
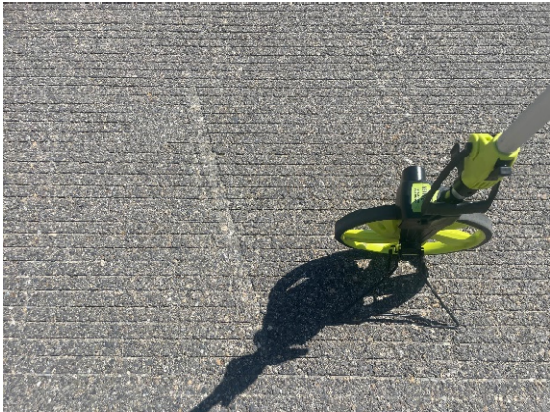
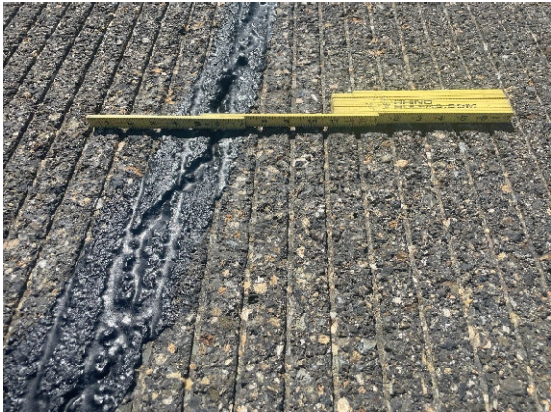
Branch ID	Branch Name	Branch Use	No. of Sections	Area (sf)	Weighted Average PCI
6100	Runway 11/29	Runway	5	676,000	88

Runway 11/29 was newly constructed in 2019 as a runway shift project. Periodic crack seal operations have been performed on the branch since construction. The most common distresses observed are low severity longitudinal and transverse cracking, low severity raveling, and low severity weathering. Field observations include sealed cracks, the pavements surface beginning to weather, and localized areas of raveling.
