Alaska DOT&PF

Pavement Inspection Report Atka Airport

Airport Name	IATA	ICAO	Latitude	Longitude	Elevation (ft)
Atka Airport	AKA	PAAK	52° 13' 14.1" N	174° 12' 22.3" W	55.2

Point of Contact	Phone	Email	Date Inspected	Date Published
Mr. Andrew Pavey, Pavement Management Engineer	(907) 269 6213	andrew.pavey@alaska.gov	May 2023	September 2023

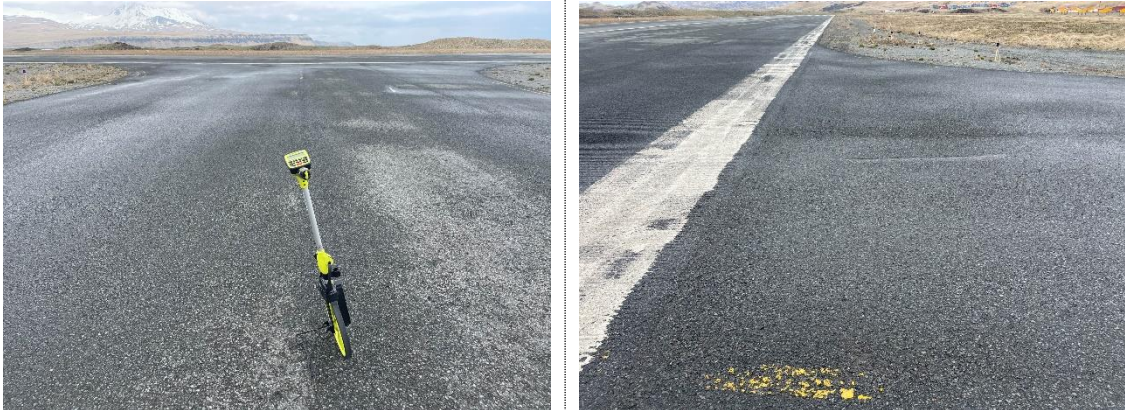
Branch ID	Branch Name	Branch Use	No. of Sections	Area (sf)	Weighted Average PCI
0100	Taxiway A	Taxiway	1	20,000	82

Taxiway A was initially constructed in 1982 and was reconstructed in 2009. No crack seal operations have been performed on the branch. The most common distresses observed are low to medium severity raveling and low severity weathering. Field observations include isolated areas of low raveling and snowplow drags attributed to the higher severity raveling.

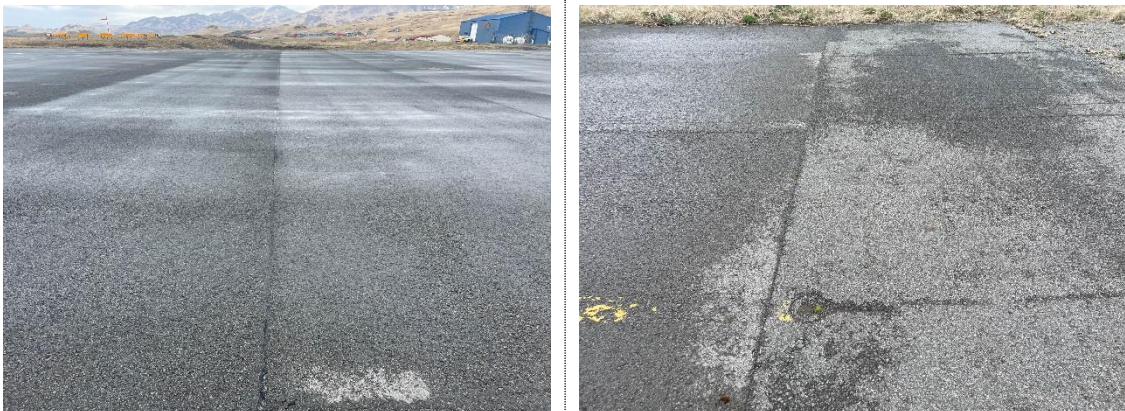
Branch ID	Branch Name	Branch Use	No. of Sections	Area (sf)	Weighted Average PCI
4100	Apron	Apron	1	90,000	82

Like Taxiway A, the Apron was initially constructed in 1982 and was reconstructed in 2009. No crack seal operations have been performed on the branch. The most common distresses observed are low severity longitudinal and transverse cracking, low to medium severity raveling, and low severity weathering. Field observations include development of new unfilled cracks and the deterioration of the paving joints creating additional cracks and raveling throughout the apron.
