Alaska DOT&PF

Pavement Inspection Report Barrow Airport

Airport Name	IATA	ICAO	Latitude	Longitude	Elevation (ft)
Wiley Post-Will Rogers Airport	BRW	PABR	71° 17' 5.5" N	156° 46' 6.9" W	48.6

Point of Contact	Phone	Email	Date Inspected	Date Published
Mr. Andrew Pavey, Pavement Management Engineer	(907) 269 6213	andrew.pavey@alaska.gov	June 2024	August 2025

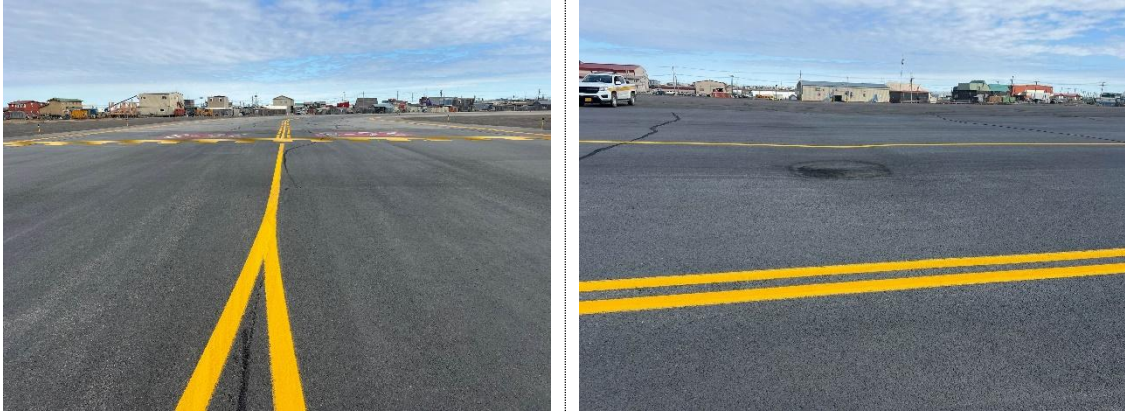
Branch ID	Branch Name	Branch Use	No. of Sections	Area (sf)	Weighted Average PCI
0100	Taxiway A	Taxiway	3	395,415	82

Taxiway A was initially constructed in 1975, and the most recent major work was a two-inch overlay from 2021 to 2022. Periodic crack seal operations have been performed on the branch. The most common distresses observed are low severity longitudinal and transverse cracking, low severity raveling, and low severity weathering. Field observations indicate a significant depression near the edge of the Apron, between Taxiway B and Taxiway C. This depression, measuring approximately 500 square feet, has a depth ranging from 1 inch to over 2 inches, resulting in medium- to high-severity distresses for taxiways and aprons.

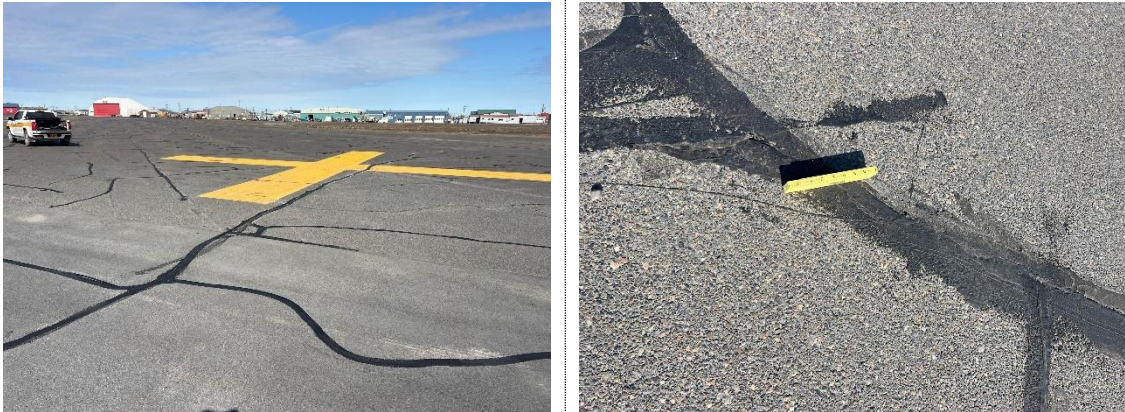
Branch ID	Branch Name	Branch Use	No. of Sections	Area (sf)	Weighted Average PCI
0200	Taxiway B	Taxiway	2	99,821	51

Taxiway B was constructed in 1977 and reconstructed in 2011 in correlation with the runway realignment. Periodic crack seal operations have been performed on the branch. The most common distresses observed are low severity block cracking, low severity depressions, low severity longitudinal and transverse cracking, low severity raveling, and low weathering. Field observations note the taxiway being closed during the inspection but still received a recent crack seal application.

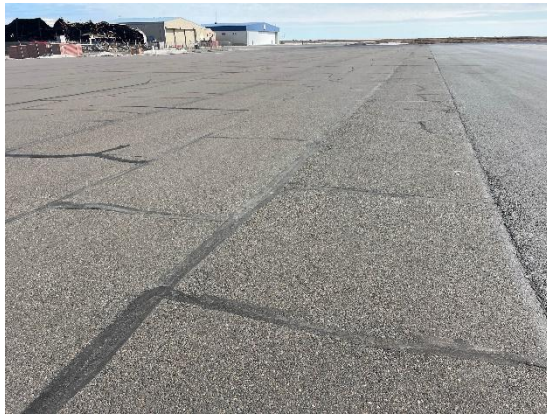
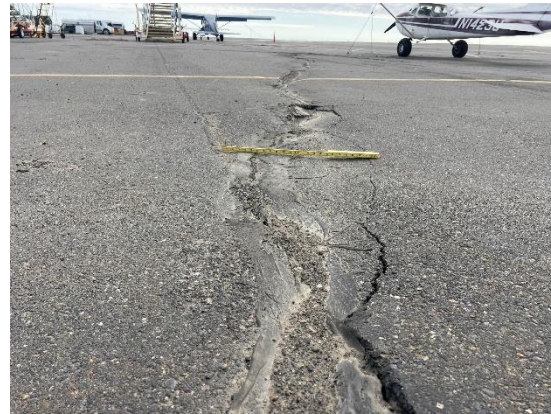
AC Section 4100-01 (55 PCI), 4100-02 (54 PCI)

The West Apron consists of three sections, of which two are AC and the other is PCC. AC Section 4100-01 was initially constructed in 1977, in 2003 section 4100-02 was added doubling the size of the apron. Both sections had major work conducted from 2010 to 2011. Periodic crack sealing has been performed on the branch. The most common distresses are low severity block cracking, low to high severity depressions, low to high severity longitudinal and transverse cracking, low to high severity raveling, and low severity weathering. Pavement inspectors observed several large depressions holding water on the apron. In addition, high-severity cracks appear to be allowing water to infiltrate the AC pavement section, further compromising pavement integrity.

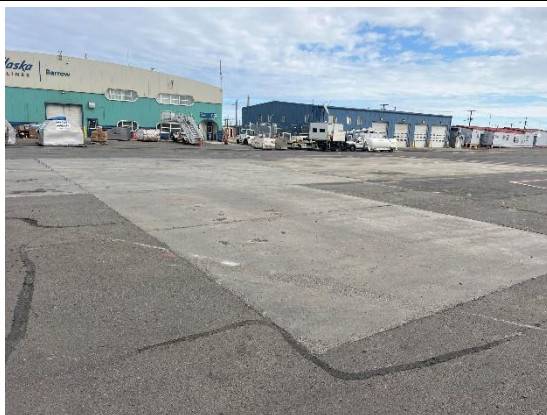
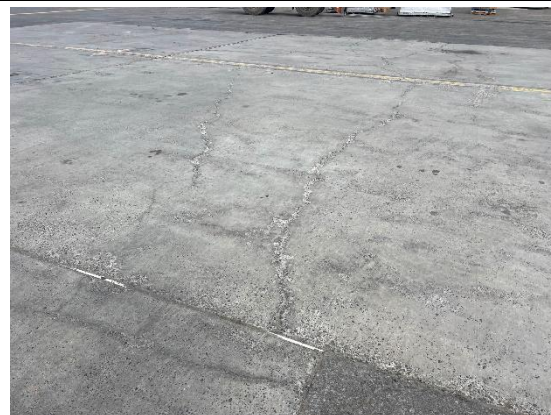
PCC Section 4100-03 (42 PCI)

PCC Section 4100-03 was constructed in 2014 and has not received any major work since. The most common distresses observed are low to medium linear cracking, high severity joint seal damage, and low to high severity joint spalling. Field observations note the high severity joint seal damage compromises the pavement's ability to prevent water infiltration. This infiltration can exacerbate existing distresses and lead to further deterioration of the pavement structure.

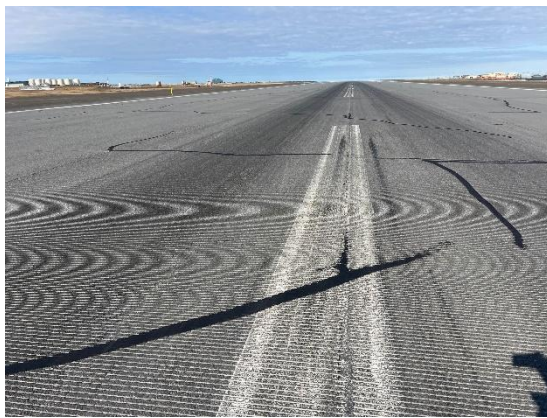
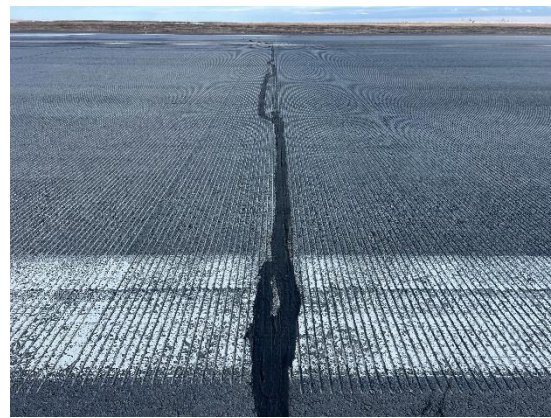
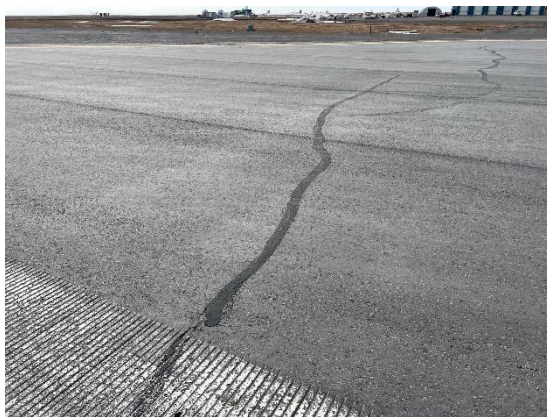
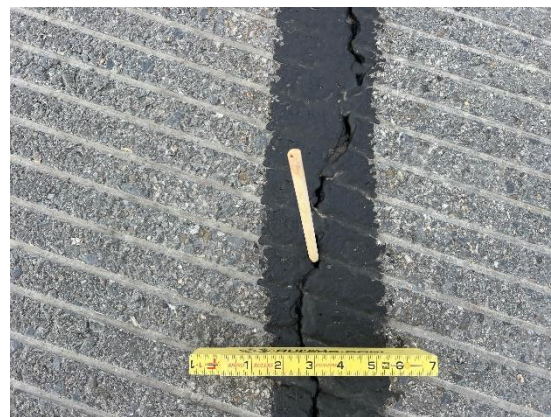
Branch ID	Branch Name	Branch Use	No. of Sections	Area (sf)	Weighted Average PCI
6100	Runway 08/26	Runway	9	1,197,870	88

Runway 08/26 underwent realignment and construction from 2009 to 2010. In 2022, the runway received a two-inch overlay. Periodic crack seal operations have been performed on the branch. The most common distresses observed are low to medium severity longitudinal and transverse cracking and low severity weathering. Field observations have highlighted the development of new cracks beginning to reflect through the top asphalt layer. This phenomenon, known as reflective cracking, occurs when cracks in the underlying pavement layers propagate upwards through the new overlay. It indicates the need for continued monitoring and maintenance to address these issues and ensure the runway's long-term performance.
