Alaska DOT&PF

Pavement Inspection Report Bethel Airport

Bethel Airport

Airport Code: BET
Site Number: 50061.1*A

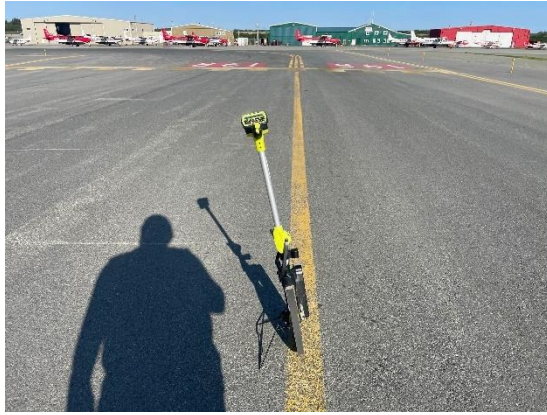
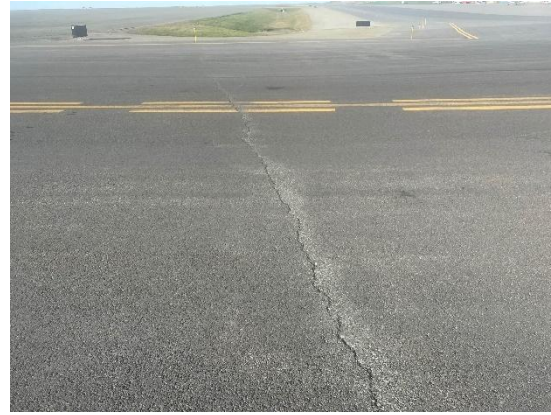
Taxiway A was initially constructed in 1985 then received a 2-inch mill and overlay in 2012 and another mill and overlay in 2022. The most common distresses observed are low severity longitudinal and transverse cracking. Field observations include localized spots of raveling, plus cracks developing on the new pavement that should be crack sealed.

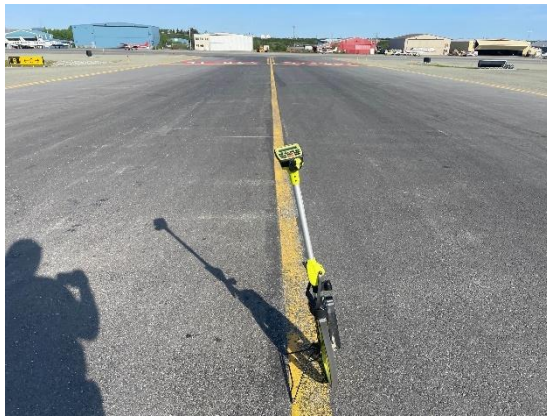
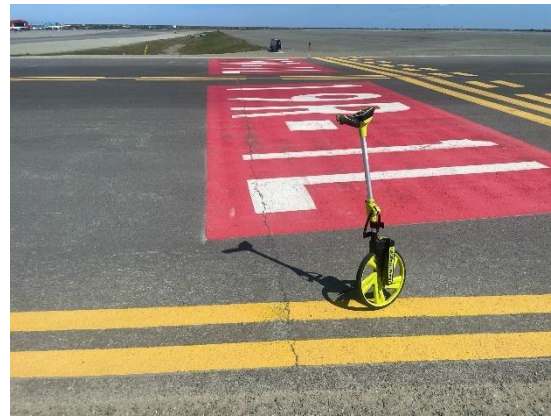
Like Taxiway A, Taxiway B was initially constructed in 1985 then received a 2-inch mill and overlay in 2012 and another mill and overlay in 2022. The most common distresses observed are low severity longitudinal and transverse cracking. Field observations include localized spots of raveling, plus cracks developing on the new pavement that should be crack sealed.

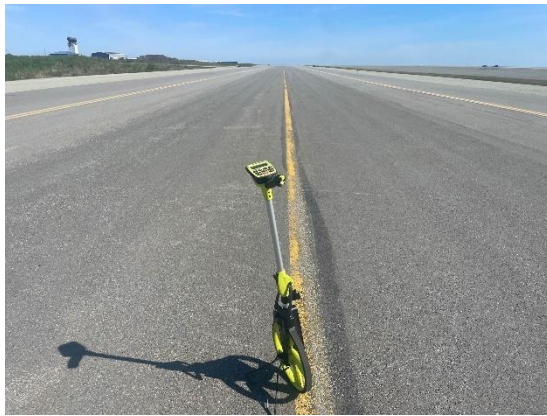
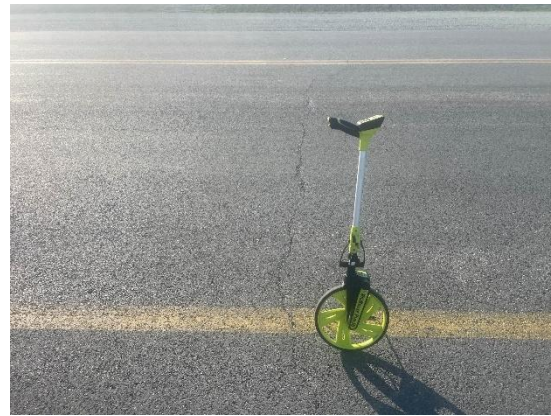
Like Taxiway A and Taxiway B, Taxiway C Section 0300-01 was initially constructed in 1985 then received a 2-inch mill and overlay in 2012 and another mill and overlay in 2022. Taxiway C Sections 0300-02 through 0300-04 were initially constructed in 1998 and 1999 then all received a mill and overlay 2022. The most common distresses observed are low severity longitudinal and transverse cracking. Field observations include localized spots of raveling, plus cracks developing on the new pavement that should be crack sealed.

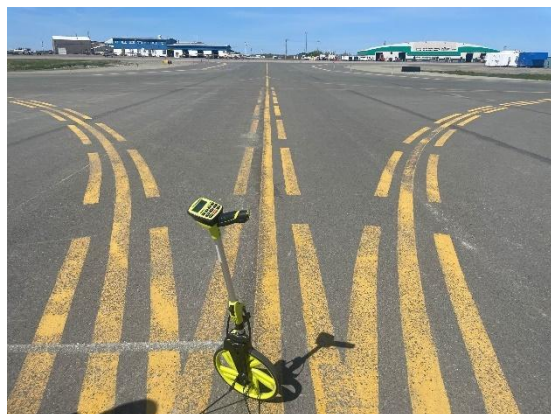
Section 0400-01 (94 PCI), 0400-02 (93 PCI)

Taxiway D Section 0400-01 was initially constructed in 1989 then received a 2-inch mill and overlay in 2012 and another mill and overlay in 2022. Section 0400-02 was initially constructed in 2009 then received a mill and overlay in 2022. The most common distresses observed are low severity longitudinal and transverse cracking. Field observations include localized spots of raveling, plus cracks developing on the new pavement that should be crack sealed.

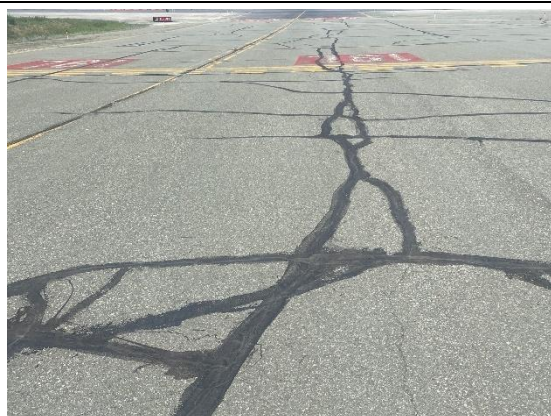
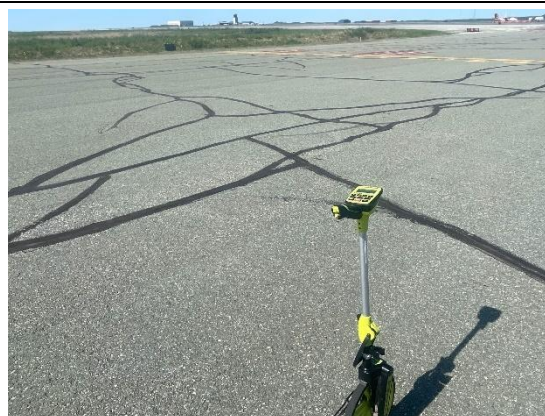
Section 0400-03 (67 PCI)

Taxiway D Section 0400-03 was initially constructed in 2009 and has not received any major work since. Occasional crack seal operations have been performed on the section. The most common distresses observed are low severity longitudinal and transverse cracking, low severity raveling, and low severity weathering. Field observations include a large amount of cracking, all of which are sealed, plus localized spots of medium to high severity raveling.

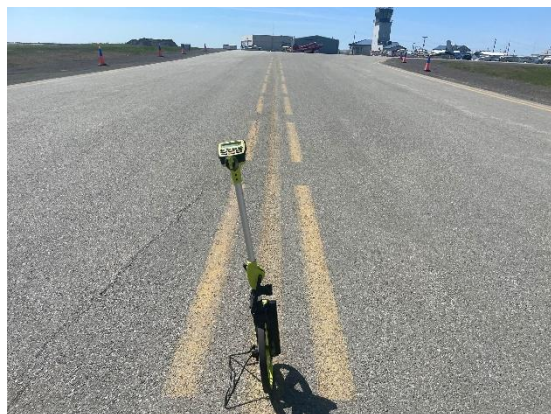
Section 0500-01 (84 PCI), 0500-03 (78 PCI)

Taxiway E Section 0500-01 was initially constructed in 1988 and received a 2-inch overlay in 2018. Section 0500-03 was initially constructed in 1985 and received a complete reconstruction in 2012. Crack seal operations have been performed on Section 0500-03 but not on Section 0500-01. The most common distresses observed are low to medium severity longitudinal and transverse cracking, low severity raveling, and low severity weathering. Field observations include unsealed cracks on the larger Section 0500-01 (20,315 Sq Ft), but cracks are sealed on the smaller Section 0500-03 (5,368 Sq Ft).

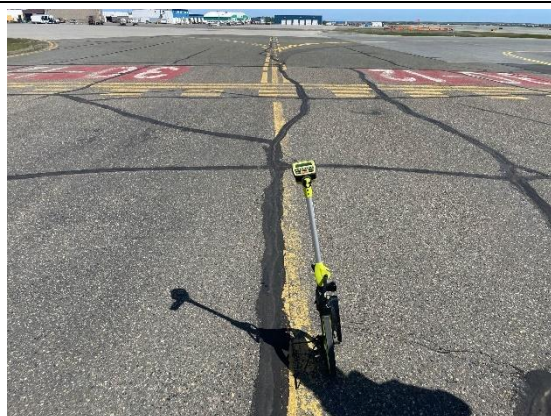
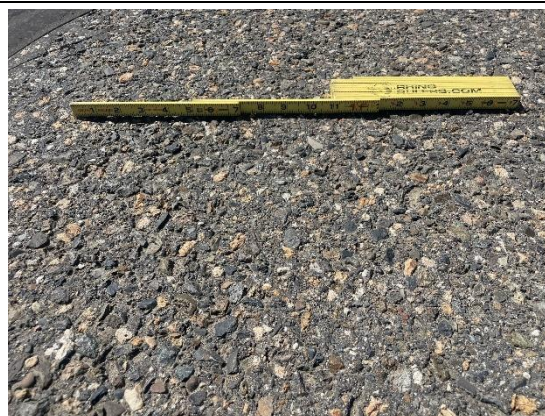
Section 0500-02 (56 PCI)

Taxiway E Section 0500-02 was constructed in 1985 and has not received any major work since. Occasional crack seal operations have been performed on the section. The most common distresses observed are low to medium severity longitudinal and transverse cracking, low severity raveling, and medium severity weathering. Field observations include wearing of the surface leading to the medium severity weathering, and sealed cracks that should be touched up with additional sealant.

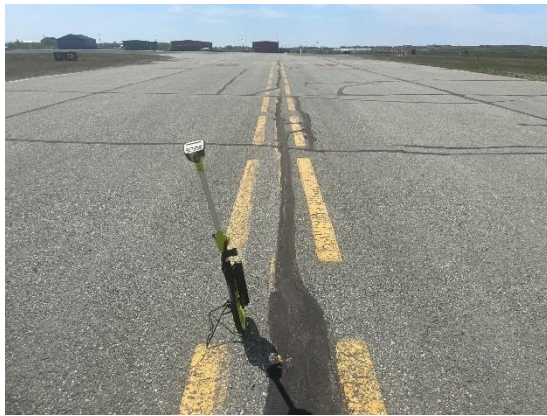
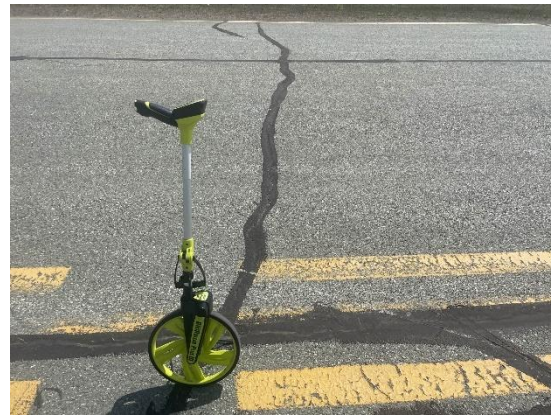
Taxiway F was constructed in 2007 and has not received any major work since. Occasional crack seal operations have been performed on the branch. The most common distresses observed are low severity longitudinal and transverse cracking, low severity raveling, and low severity weathering. Field observations include sealed cracks that should be touched up with additional sealant.

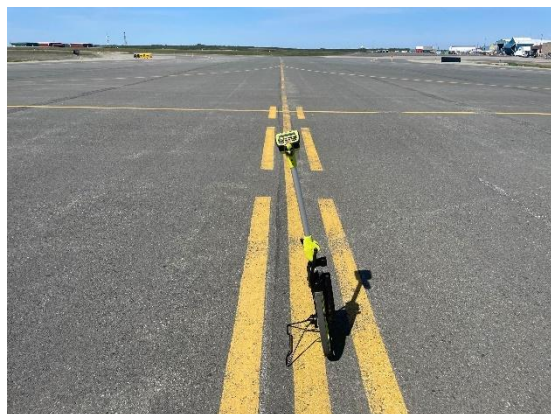
Section 0700-01 (95 PCI), 0700-05 (95 PCI)

Taxiway G Sections 0700-01 and 0700-05 were initially constructed in 1996 and 2009, respectively, then both received a mill and overlay in 2022. Crack seal operations have not been performed on these sections. The most common distresses observed are low severity longitudinal and transverse cracking. Field observations include localized spots of raveling, plus cracks developing on the new pavement that should be crack sealed.

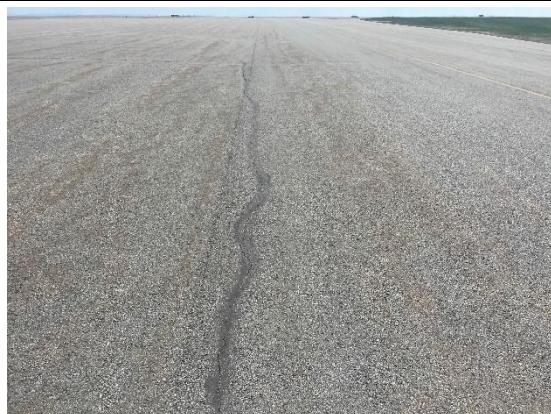
Section 0700-02 (73 PCI)

Section 0700-02 was initially constructed in 1985 then received a surface reconstruction in 2001 and a 2-inch overlay in 2017. Occasional crack seal operations have been performed on the section. The most common distresses observed are low to medium severity longitudinal and transverse cracking and low severity weathering. Field observations include sealed cracks, some of which have progressed into medium severity, that should be touched up with additional sealant.

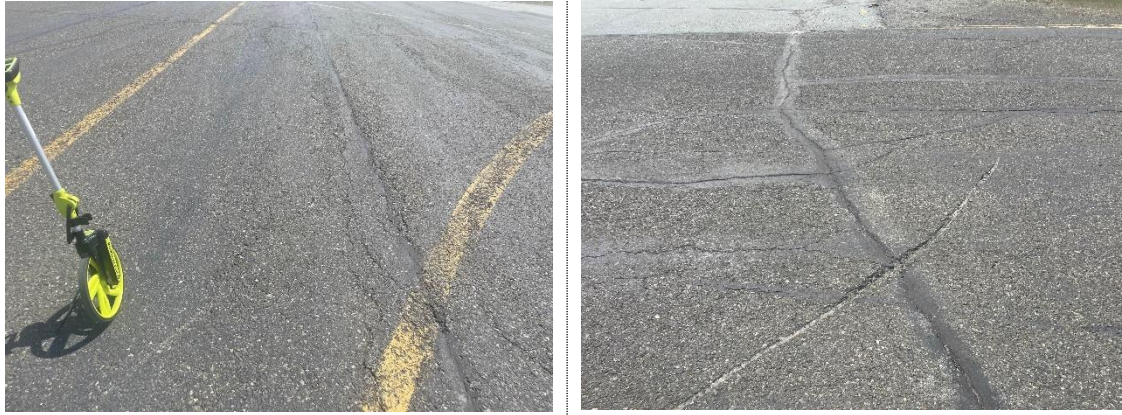
Section 0700-03 (48 PCI)

Taxiway G Section 0700-03 was initially constructed in 1985 and received a surface reconstruction in 2001. Occasional crack seal operations have been performed on the section. The most common distresses observed are low to medium severity longitudinal and transverse cracking, low severity raveling, and medium severity weathering. Field observations include wearing of the surface leading to the medium severity weathering, and sealed cracks where the sealant is failing in areas.

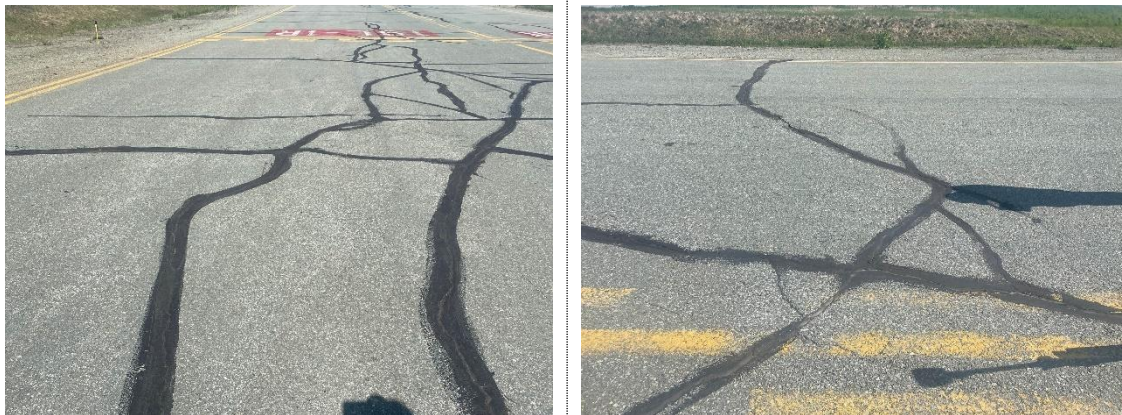
Section 0700-04 (66 PCI)

Section 0700-04 was constructed in 2009 and has not received any major work since. Occasional crack seal operations have been performed on the section. The most common distresses observed are low severity longitudinal and transverse cracking, low severity raveling, and low severity weathering. Field observations include a large amount of cracking that is adequately sealed.

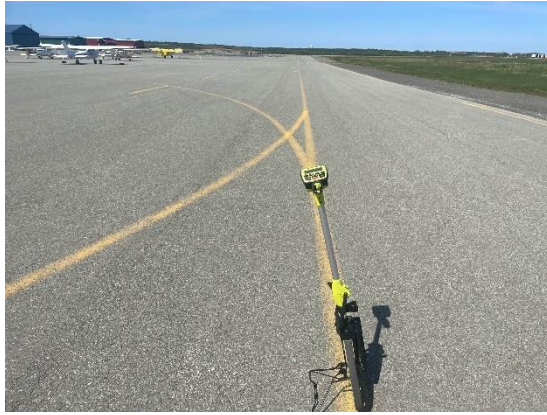
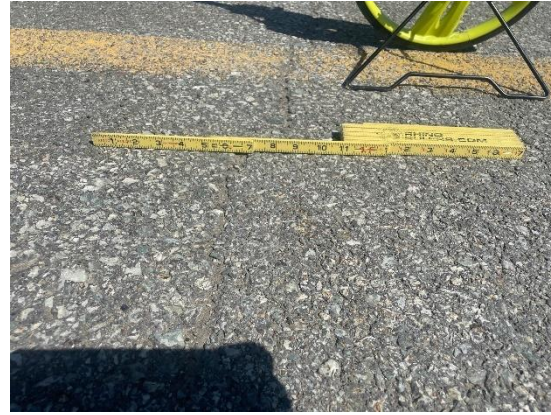
Section 1000-01 (80 PCI)

Taxiway J Section 1000-01 was initially constructed in 1988 and received a mill and overlay in 2018. Crack seal operations have not been performed on the section. The most common distresses observed are low to medium severity longitudinal and transverse cracking and low severity weathering. Field observations include localized spots of low to high severity raveling, plus the development of cracks that should be crack sealed.

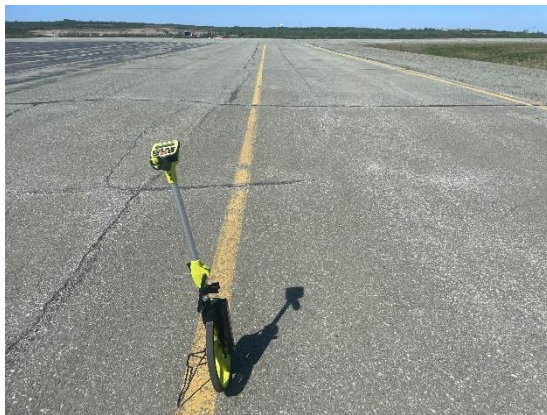
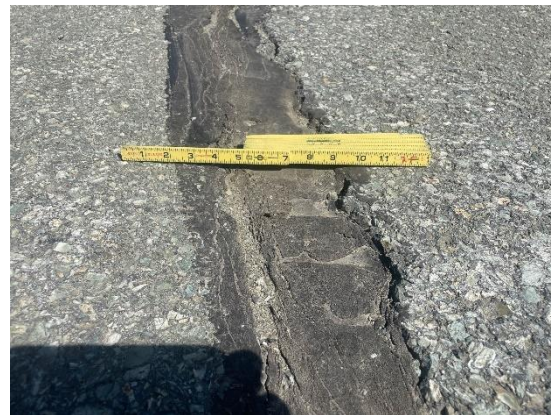
Section 1000-02 (59 PCI)

Section 1000-02 was constructed in 2007 and has not received any major work since. Occasional crack seal operations have been performed on the section. The most common distresses observed are low to medium severity longitudinal and transverse cracking, low severity raveling, and low severity weathering. Field observations include sealed cracks where the sealant is failing in areas.

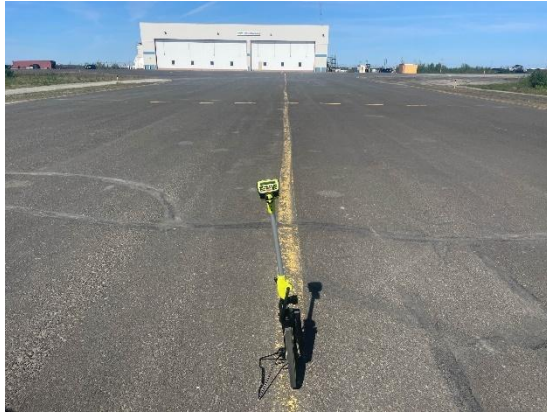
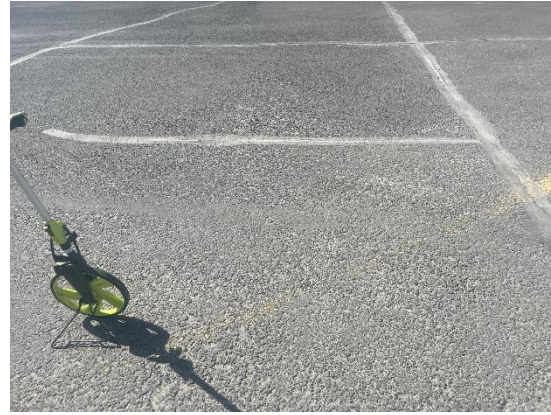
Section 1300-01 (71 PCI)

Taxiway M Section 1300-01 was constructed in 1999 and has not received any major work since. Occasional crack seal operations have been performed on the section. The most common distresses observed are low severity longitudinal and transverse cracking and low severity raveling. Field observations include localized spots of medium to high severity raveling, plus cracks that are adequately sealed.

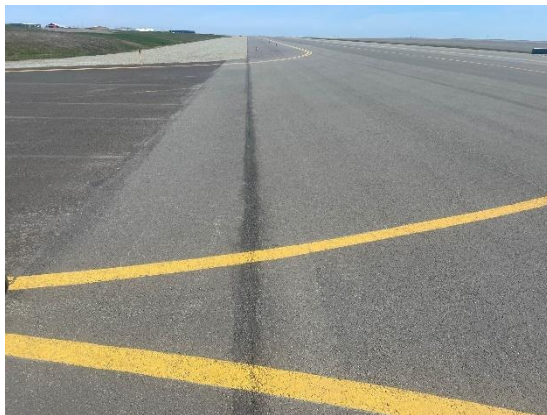
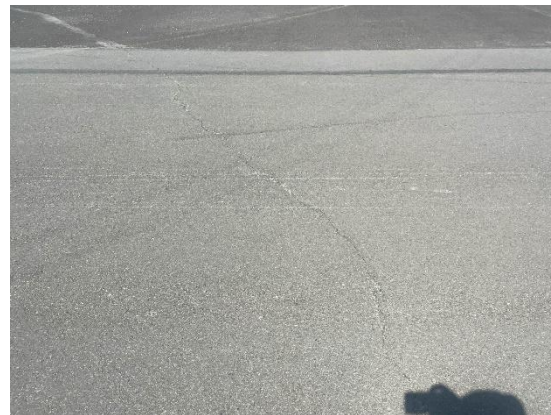
Section 1300-02 (96 PCI)

Section 1300-02 was initially constructed in 1999 and received a mill and overlay in 2022. Crack seal operations have not been performed on the section. The most common distresses observed are low severity longitudinal and transverse cracking. Field observations include cracks developing on the new pavement that should be crack sealed.

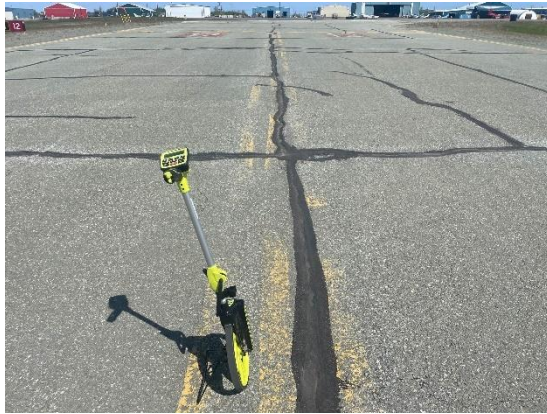
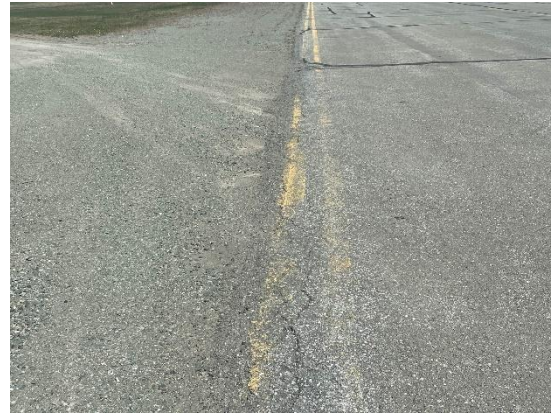
Taxiway N was constructed in 2007 and has not received any major work since. Occasional crack seal operations have been performed on the branch. The most common distresses observed are low severity longitudinal and transverse cracking, low severity raveling, and low severity weathering. Field observations include sealed cracks that should be touched up with additional sealant, as some are progressing into medium severity cracks.

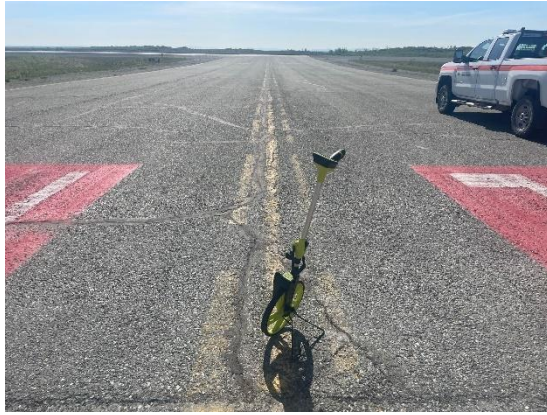
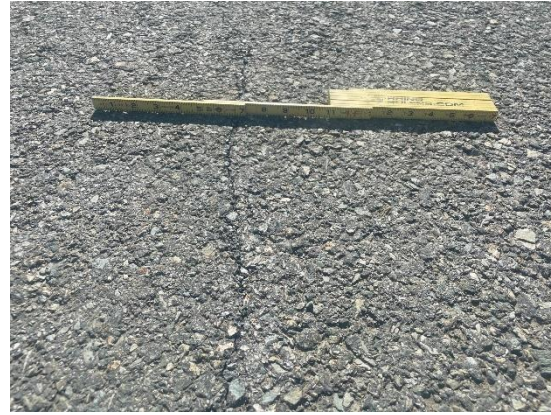
Section 1500-01 (74 PCI)

Taxiway O Section 1500-01 was constructed in 2009 and has not received any major work since. Occasional crack seal operations have been performed on the section. The most common distresses observed are low severity longitudinal and transverse cracking and low to medium severity weathering. Field observations include sealed cracks and further wearing of the pavement surface leading to the medium severity weathering.

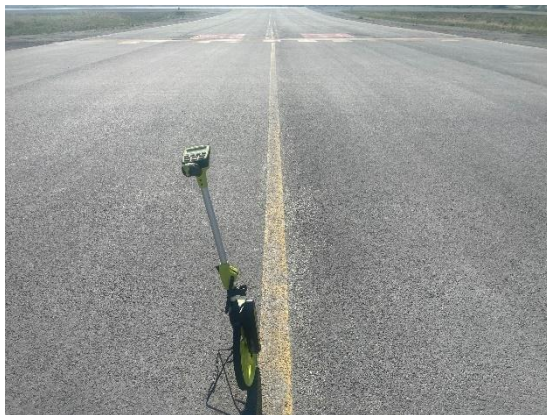
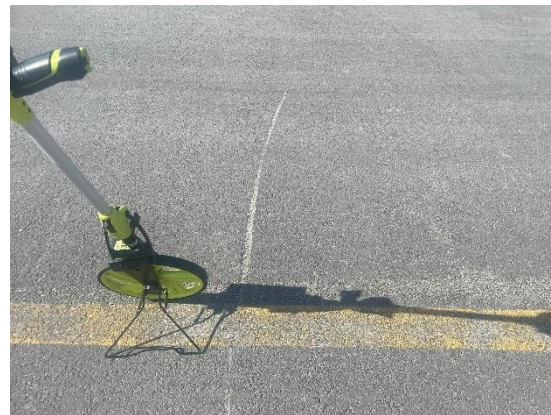
Section 1500-02 (94 PCI)

Section 1500-02 was also constructed in 2009, but then received a mill and overlay in 2022. The most common distresses observed are low severity longitudinal and transverse cracking. Field observations include localized spots of raveling and weathering, plus cracks developing on the new pavement that should be crack sealed.

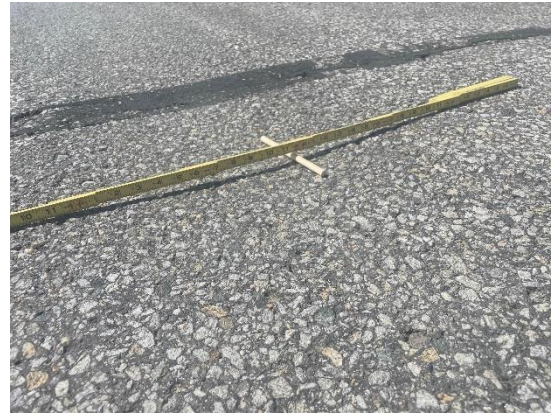
Section 4100-01 (71 PCI)

The main terminal apron consists of 4 sections with varying work history, conditions, and surface types. Section 4100-01 was initially constructed in 1989 then received a 2-inch mill and overlay in 2001 and a 2-inch overlay in 2017. Occasional crack seal operations have been performed on the section. The most common distresses observed are low to medium severity longitudinal and transverse cracking and low severity weathering. Field observations include localized spots of raveling, and low severity rutting developing near the concrete hardstand.

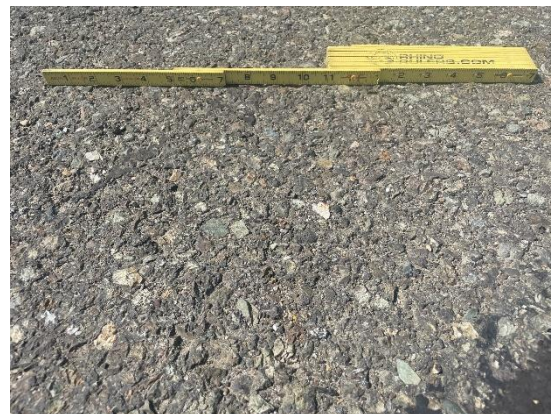
Section 4100-02 (57 PCI)

Section 4100-02 was initially constructed in 1973 then received a surface reconstruction in 2001. Occasional crack seal operations have been performed on the section. The most common distresses observed are low severity longitudinal and transverse cracking, low severity raveling, and medium severity weathering. Field observations include wearing of the surface leading to the medium severity weathering, and sealed cracks that should be touched up with additional sealant.

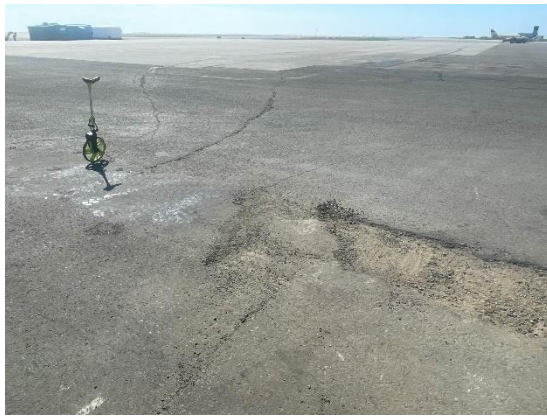
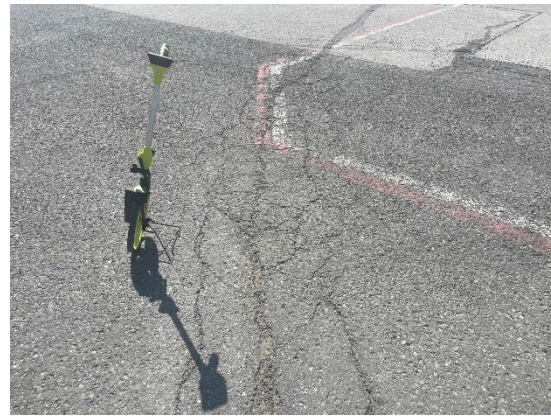
Section 4100-03 (44 PCI)

Section 4100-03 was constructed in 2001 and has not received any major work since. Occasional crack seal operations have been performed on the section, but the sealant is failing in areas. The most common distresses observed are low to medium severity longitudinal and transverse cracking, low severity raveling, and medium severity weathering. Field observations include localized spots of medium severity alligator cracking and high severity longitudinal and transverse cracking. This section functions primarily for the DOT maintenance shop trucks and does not handle much aircraft traffic.

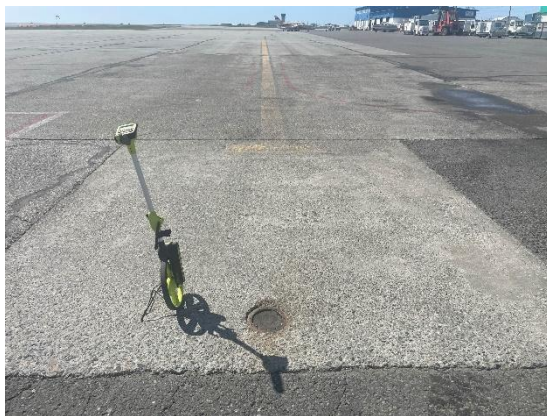
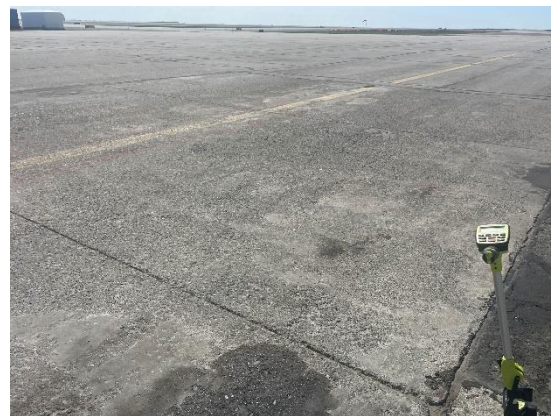
PCC Section 4100-04 (42 PCI)

The PCC section 4100-04 was constructed in 2017 and has not received any major work since. The most common distresses observed are high severity joint seal damage, medium severity scaling, and medium severity joint and corner spalling. Field observations include wearing of the surface of the concrete leading to the medium severity scaling.

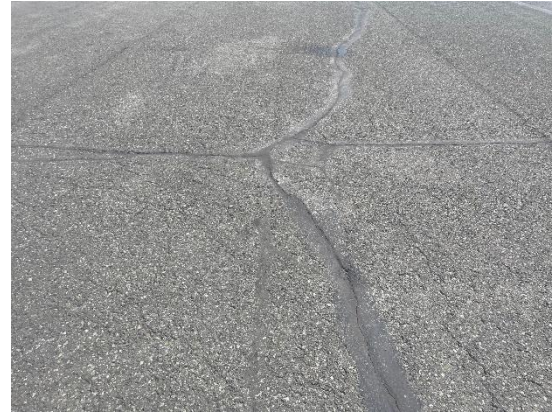
Section 4200-01 (53 PCI)

The west apron Section 4200-01 was initially constructed in 1985 and received a surface reconstruction in 2001. Occasional crack seal operations have been performed on the branch. The most common distresses observed are low to medium severity longitudinal and transverse cracking, low severity raveling, and medium severity weathering. Field observations include wearing of the surface leading to the medium severity weathering, and sealed cracks where the sealant is failing in areas.

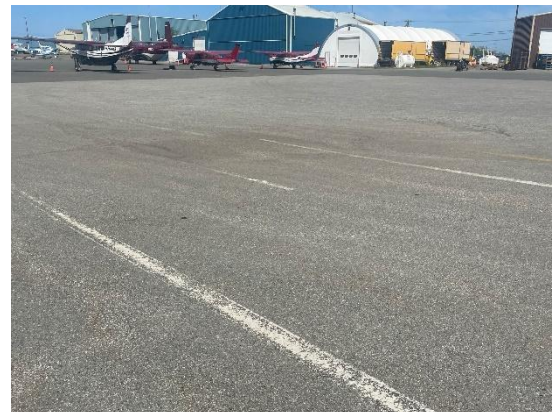
Section 4200-02 (73 PCI)

Section 4200-02 was also initially constructed in 1985 and received a surface reconstruction in 2001, but then also received a 2-inch overlay in 2017. Occasional crack seal operations have been performed on the branch. The most common distresses observed are low to medium severity longitudinal and transverse cracking and low severity weathering. Field observations include sealed cracks that should be touched up with additional sealant, plus two additional sample units that contain low and medium severity depressions.

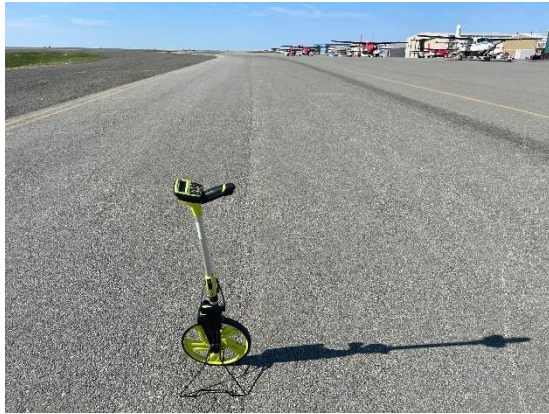
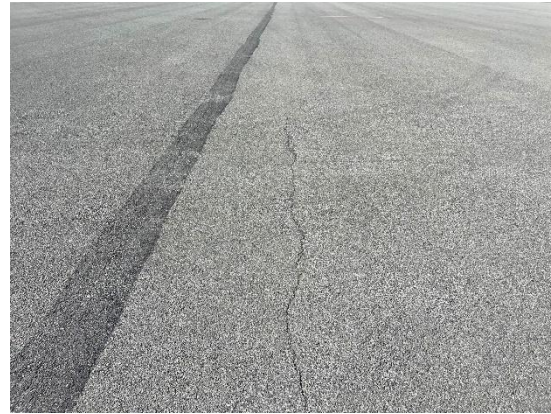
Section 4300-01 (86 PCI), 4300-02 (84 PCI), 4300-04 (86 PCI)

The north GA apron consists of 5 sections with varying work history and conditions. Section 4300-01 was initially constructed in 1985 and received a 2-inch overlay in 2018. Section 4300-02 was initially constructed in 1999 and received a 2-inch overlay in 2018. Section 4300-04 was constructed in 2018 and has not received any major work since. Crack seal operations have not been performed on these sections. The most common distresses observed are low to medium severity longitudinal and transverse cracking and low severity weathering. Field observations include the development of low and medium severity cracking that should be crack sealed.

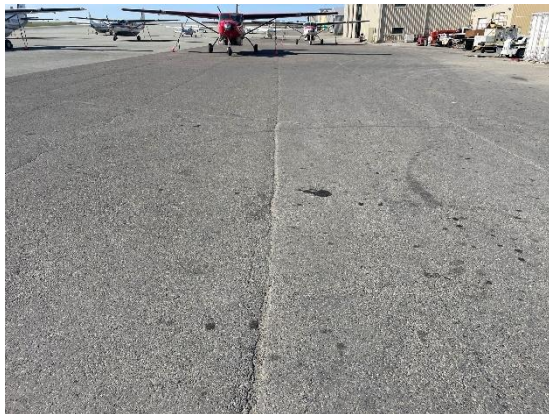
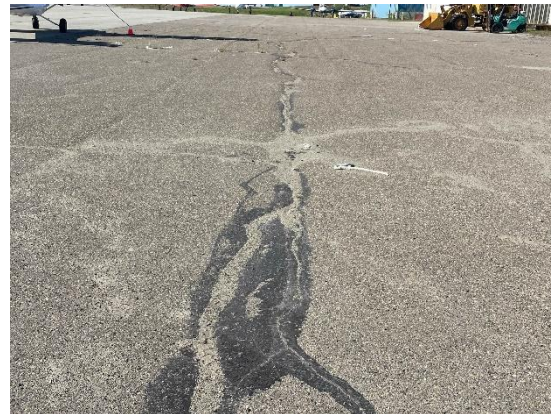
Section 4300-03 (44 PCI)

Section 4300-03 was constructed in 1999 and has not received any major work since. Occasional crack seal operations have been performed on the section, but the sealant is failing in areas. The most common distresses observed are low to medium severity longitudinal and transverse cracking, low severity raveling, and low severity weathering. Field observations include localized spots of low to medium severity alligator cracking, low to medium severity block cracking, and high severity longitudinal and transverse cracking.

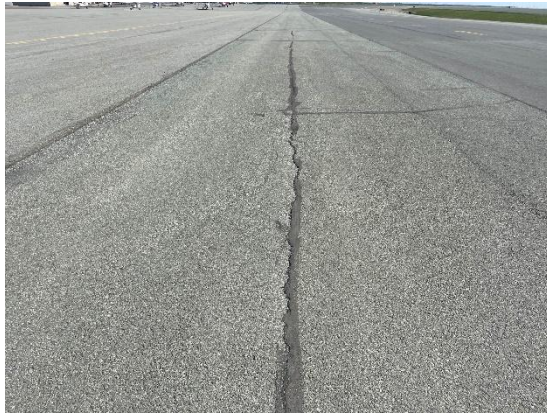
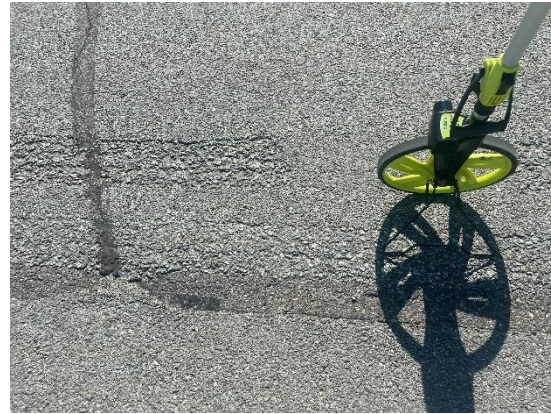
Section 4300-05 (69 PCI)

Section 4300-05 was initially constructed in 1985 and received a 2-inch overlay in 2012. Occasional crack seal operations have been performed on the section. The most common distresses observed are low to medium severity longitudinal and transverse cracking and low severity weathering. Field observations include localized spots of low to high severity raveling.

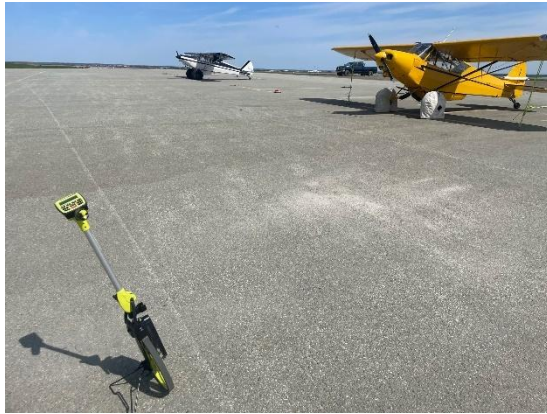
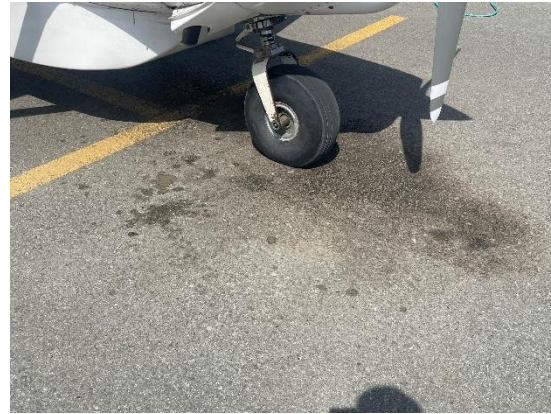
Section 4400-01 (87 PCI)

The south GA apron Section 4400-01 was initially constructed in 1988 and received a 2-inch mill and overlay in 2018. Crack seal operations have not been performed on the section. The most common distresses observed are low severity longitudinal and transverse cracking, oil spillage, and low severity weathering. Field observations include numerous locations of oil spillage from the GA aircrafts, and the development of low severity cracking that should be crack sealed.

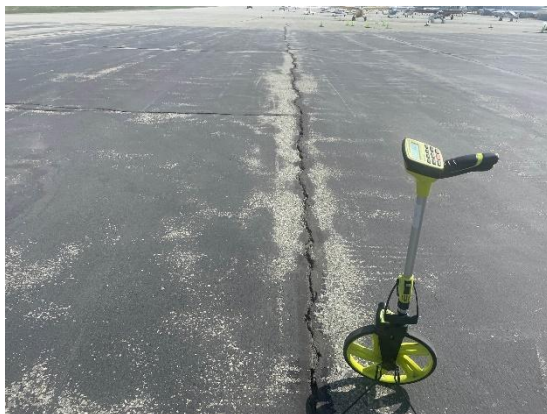
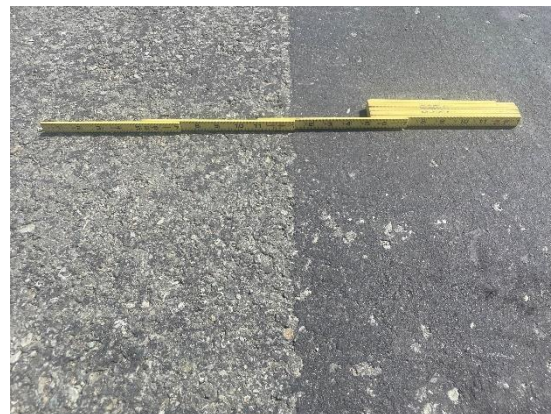
Section 4400-02 (64 PCI)

Section 4400-02 was constructed in 2007 and has not received any major work since. Occasional crack seal operations have been performed on the section, but the sealant is failing in areas. The most common distresses observed are low to medium severity longitudinal and transverse cracking and low severity weathering. Field observations include further development of low and medium severity cracking, plus a large portion of the section that appears to have received a surface treatment.

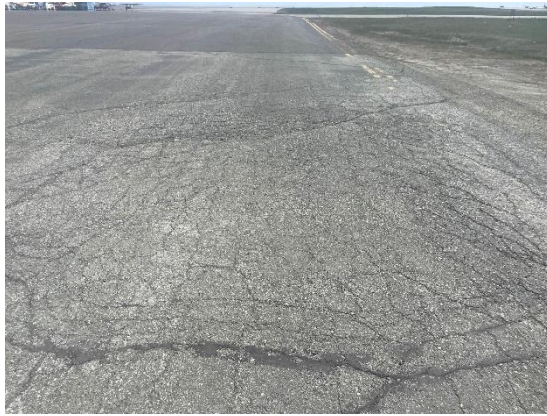
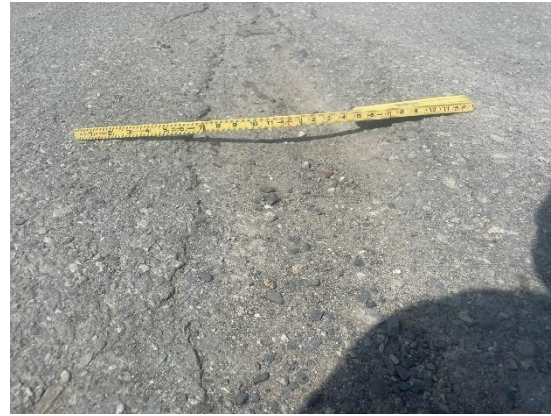
The west air taxi apron was constructed in 2007 and has not received any major work since. Occasional crack seal operations have been performed on the branch, but the current condition is beyond repairing with crack sealant. The most common distresses observed are low to medium severity alligator cracking, low to high severity longitudinal and transverse cracking, low severity raveling, and low severity weathering. Field observations include a highly degraded pavement with localized spots of low severity depression, low severity rutting, and medium to high severity raveling.

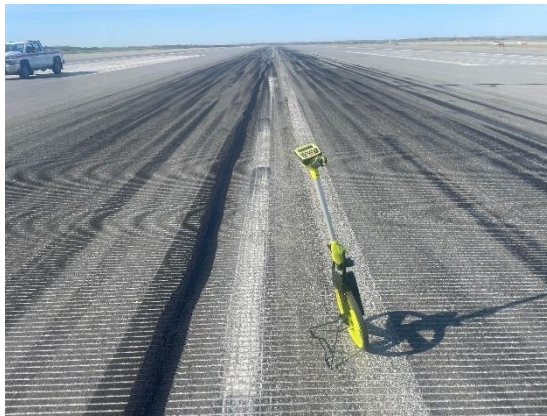
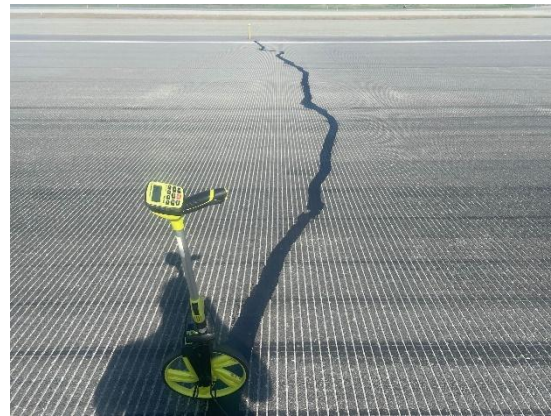
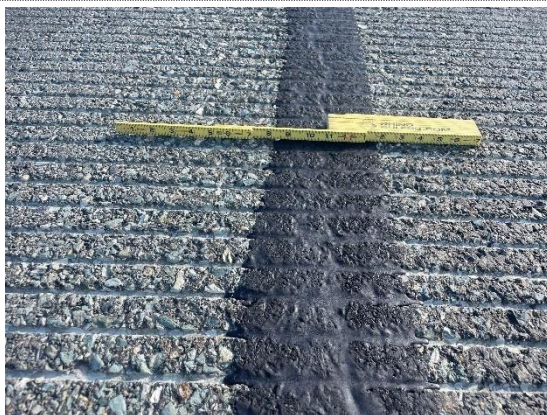
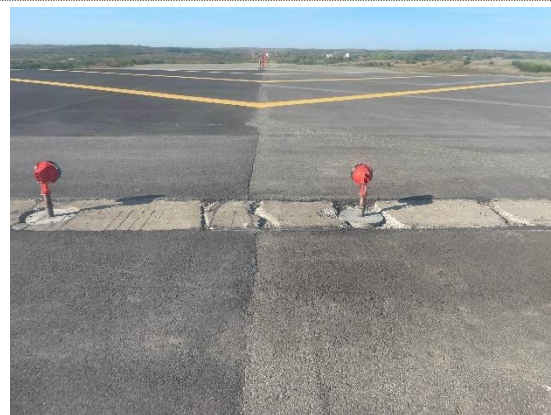
Runway 01L/19R consists of 18 sections with varied construction history, but the entire branch received a cold mill and overlay in 2023. Much of the runway pavement was initially constructed in 1989 and received a 2-inch cold mill and overlay in 2012 before receiving the 2023 work. Crack seal operations have been performed on the branch since construction. The most common distresses observed are low severity longitudinal and transverse cracking. Field observations include localized spots of raveling and weathering, plus cracks already developing on the 1-year-old pavement that should continue to be crack sealed.

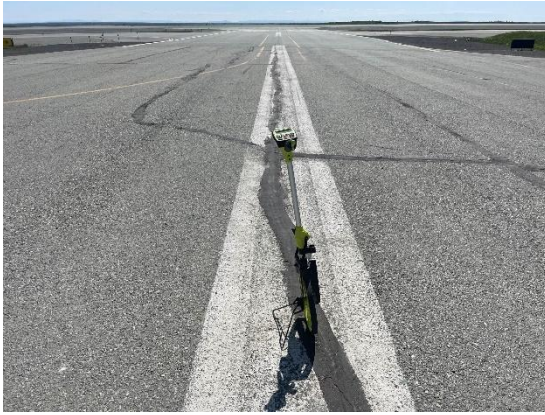
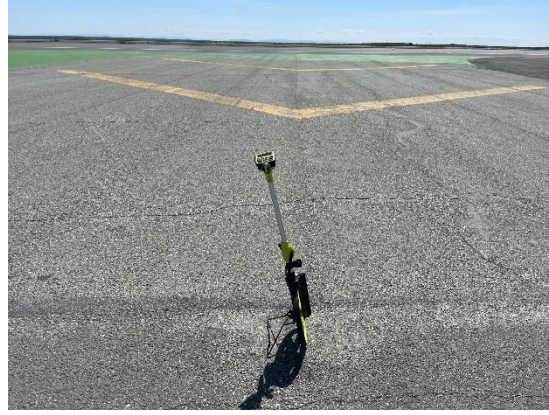
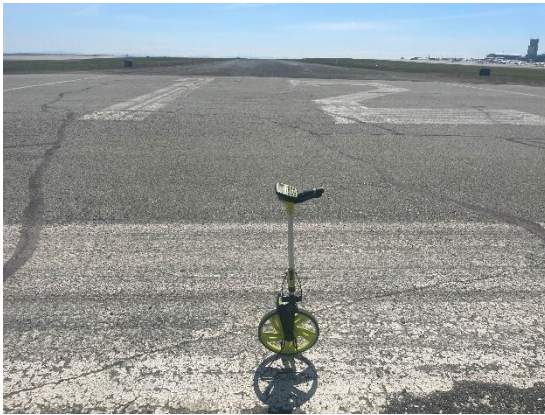
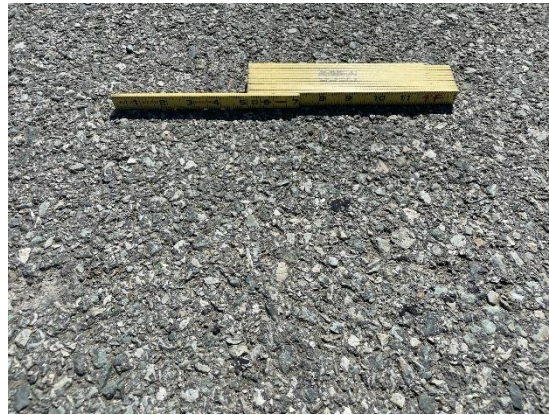
Section 6200-01 (70 PCI), 6200-03 (75 PCI), 6200-04 (64 PCI),

Runway 12/30 Sections 6200-01 and 6200-03 were initially constructed in 1985 and received a complete reconstruction in 2012. Section 6200-04 was initially constructed in 2007 and has not received any major work since. Occasional crack seal operations have been performed on the branch. The most common distresses observed are low to medium severity longitudinal and transverse cracking and low severity weathering. Field observations include localized spots of raveling and sealed cracks that should be touched up with additional sealant.

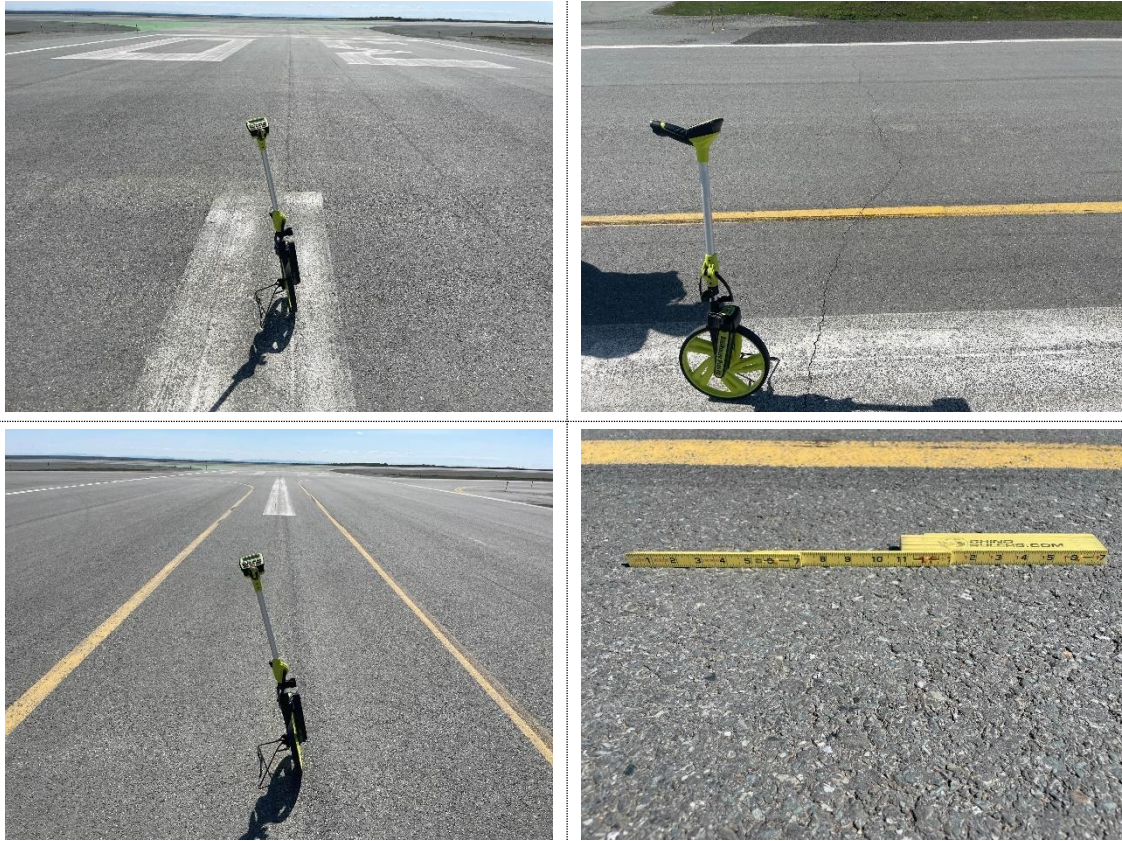
Section 6200-02 (97 PCI)

Section 6200-02 was also initially constructed in 1985 and received a complete reconstruction in 2012, but then received a mill and overlay in 2023. The most common distresses observed are low severity longitudinal and transverse cracking. Field observations include localized spots of weathering, plus cracks developing on the new pavement that should be crack sealed.

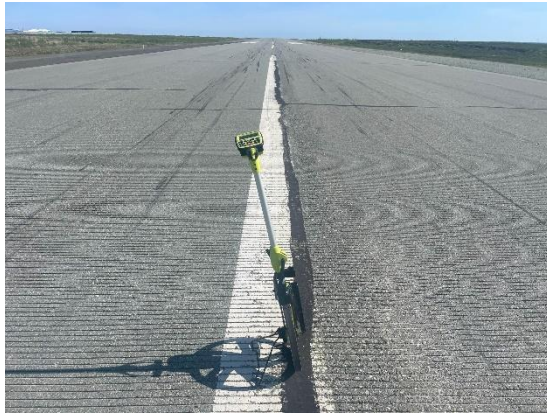
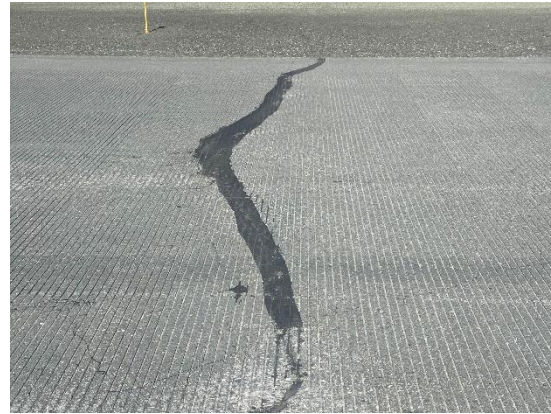
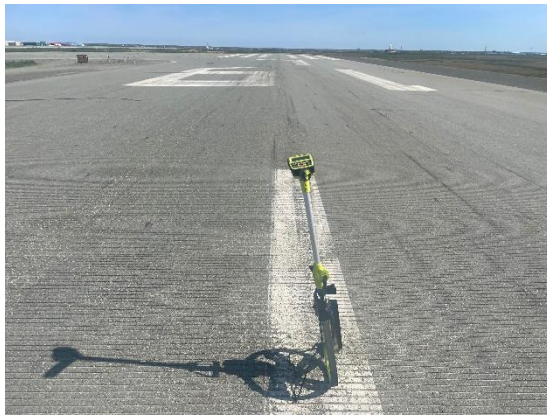
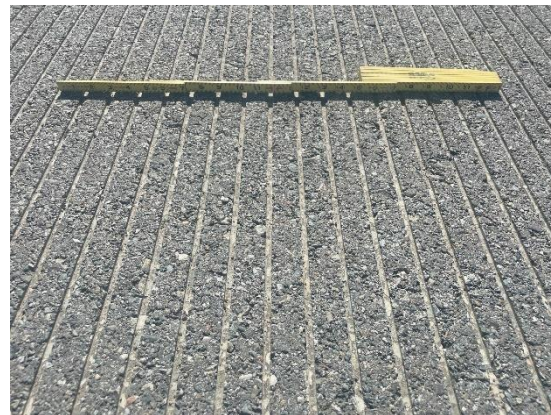
Section 6300-01 (95 PCI), 6300-03 (90 PCI)

Runway 01R/19L Sections 6300-01 and 6300-03 were initially constructed in 2009 and received a 2-inch overlay in 2021. Occasional crack seal operations have been performed on the branch. The most common distresses observed are low severity longitudinal and transverse cracking. Field observations include localized spots of weathering and sealed cracks that should continue to be crack sealed.

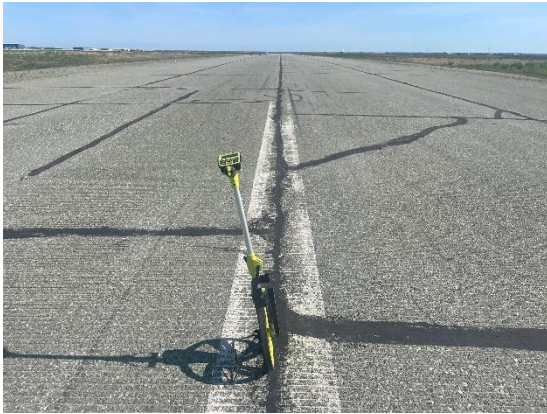
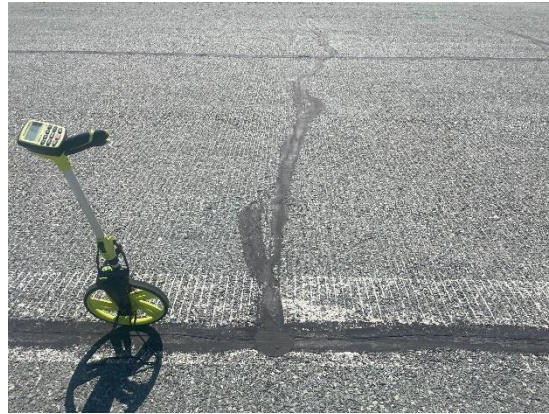
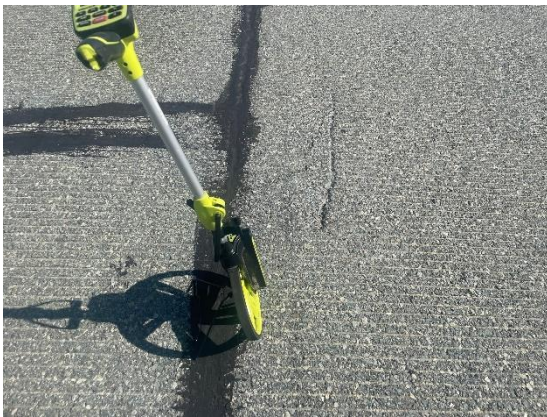
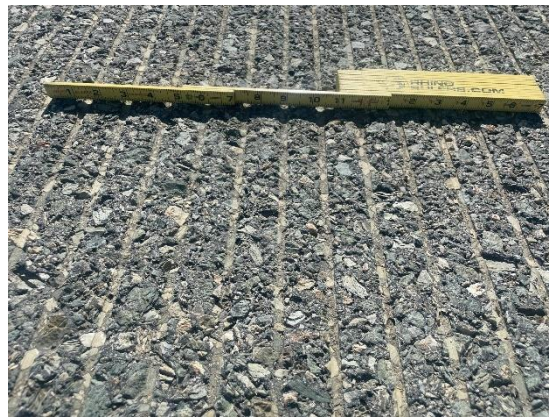
Section 6300-02 (62 PCI)

Section 6300-02 was constructed in 2009 and has not received any major work since. Occasional crack seal operations have been performed on the branch. The most common distresses observed are low severity longitudinal and transverse cracking, low severity raveling, and low severity weathering. Field observations include sealed cracks that should continue to be crack sealed.
