# Pavement Inspection Report Birchwood Airport

Airport Name	IATA	ICAO	Latitude	Longitude	Elevation (ft)
Birchwood Airport	BCV	PABV	62° 24' 58" N	149° 30' 30" W	83

Point of Contact	Phone	Email	Date Inspected	Date Published
Mr. Andrew Pavey, Pavement Management Engineer	(907) 269 6213	andrew.pavey@alaska.gov	August 2024	January 2025

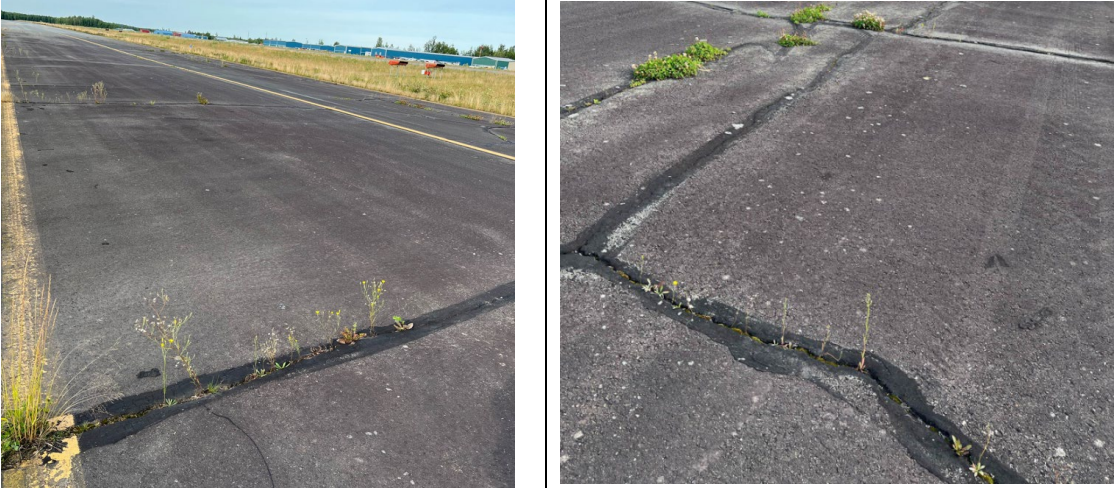
Branch ID	Branch Name	Branch Use	No. of Sections	Area (sf)	Weight Average PCI
0100	Taxiway A	Taxiway	1	26,400	26

Taxiway A was originally constructed in 1978 and has not been resurfaced. Common distresses on the taxiway are moderate to high severity block cracking, alligator cracking, low to moderate severity weathering and medium severity raveling.

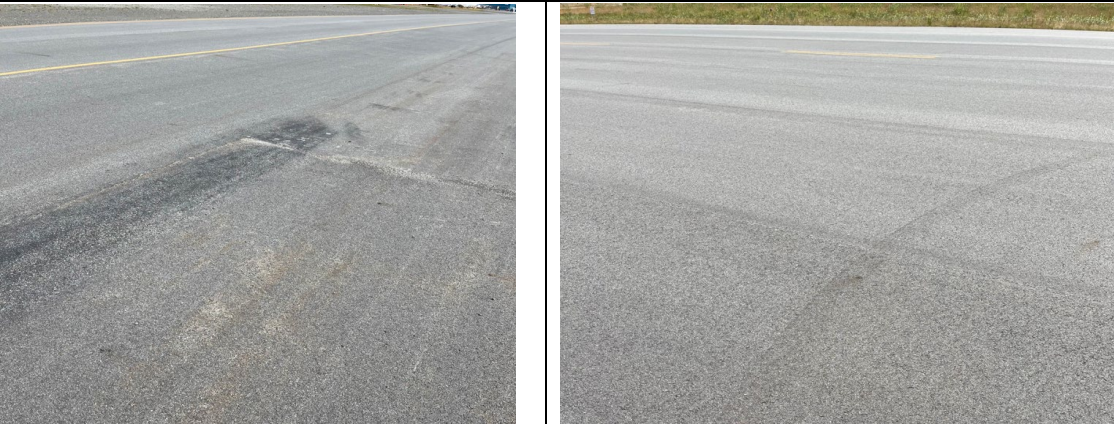
Branch ID	Branch Name	Branch Use	No. of Sections	Area (sf)	Weight Average PCI
0200	Taxiway B	Taxiway	1	361,930	92

Taxiway B was constructed in 1978 and resurfaced in 2018. Observed distresses are low severity longitudinal and transverse cracking, low to medium severity weathering and isolated areas of low to medium severity raveling.

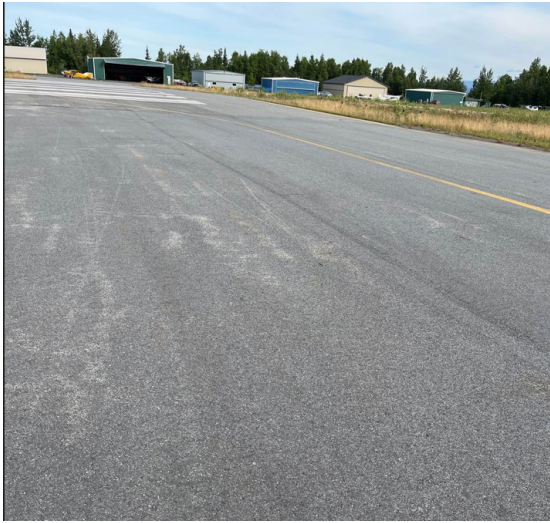
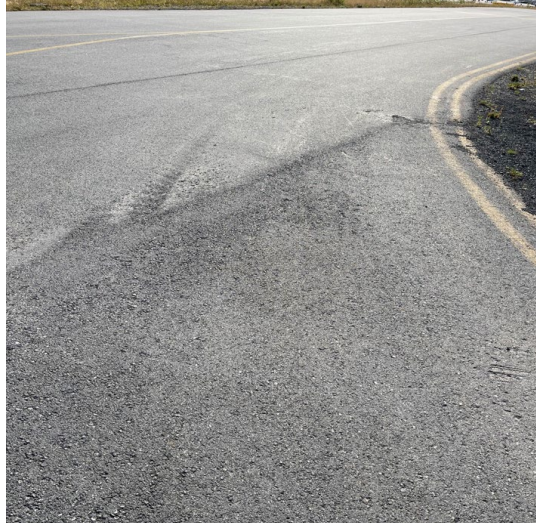
Branch ID	Branch Name	Branch Use	No. of Sections	Area (sf)	Weight Average PCI
0300	Taxiway C	Taxiway	2	23,945	87

Taxiway C was constructed in 1978 and was resurfaced in 2018. Distresses are low severity longitudinal and transverse cracking, low severity weathering and isolated moderate severity weathering and raveling.

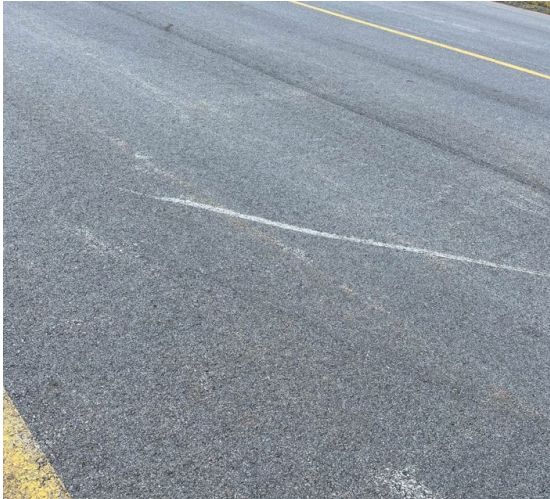
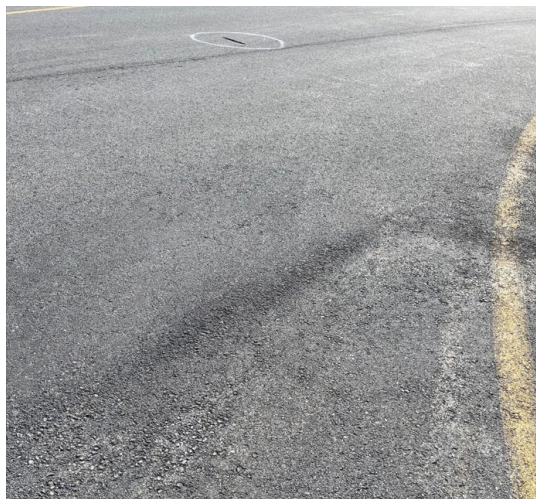
Branch ID	Branch Name	Branch Use	No. of Sections	Area (sf)	Weight Average PCI
0400	Taxiway D	Taxiway	2	20,890	91

Taxiway D was constructed in 1978 and was resurfaced in 2018. Common distresses are low severity longitudinal and transverse cracking, low severity weathering and small amounts of low severity raveling.

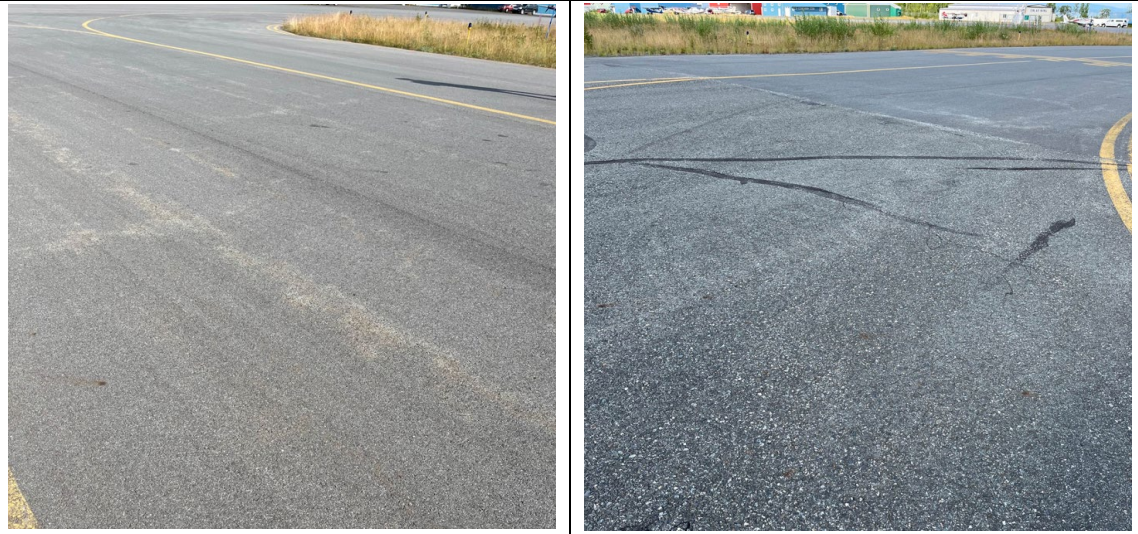
Branch ID	Branch Name	Branch Use	No. of Sections	Area (sf)	Weight Average PCI
0500	Taxiway E	Taxiway	1	12,905	89

Taxiway E was constructed in 1978 and was resurfaced in 2018. The distresses on the taxiway are low to moderate severity longitudinal and transverse cracking and low severity weathering.

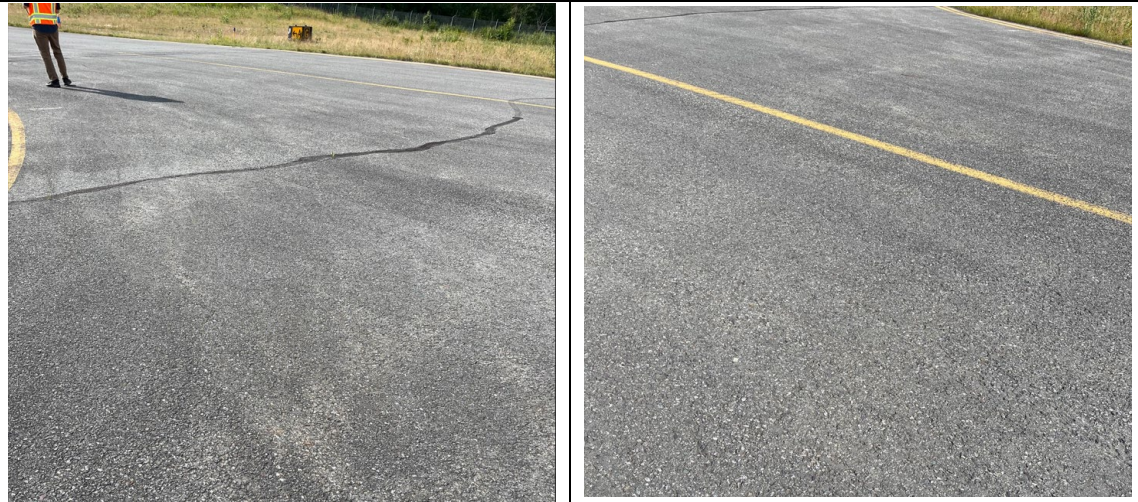
Branch ID	Branch Name	Branch Use	No. of Sections	Area (sf)	Weight Average PCI
0700	Taxiway G	Taxiway	1	3,290	77

Taxiway G was constructed in 1978 and was resurfaced in 2012. The primary distresses are low severity longitudinal and transverse cracking and low to moderate severity weathering.

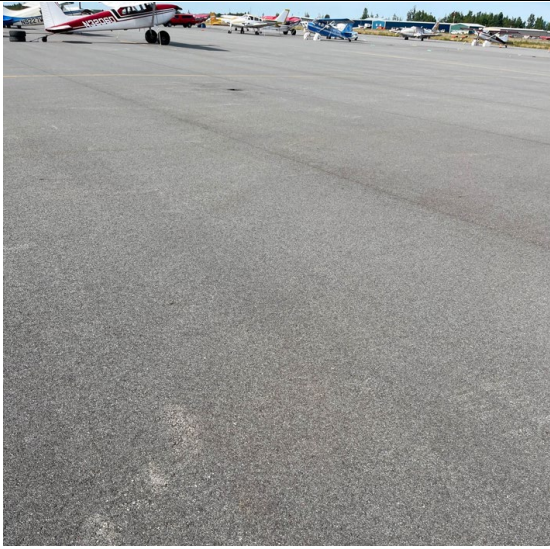
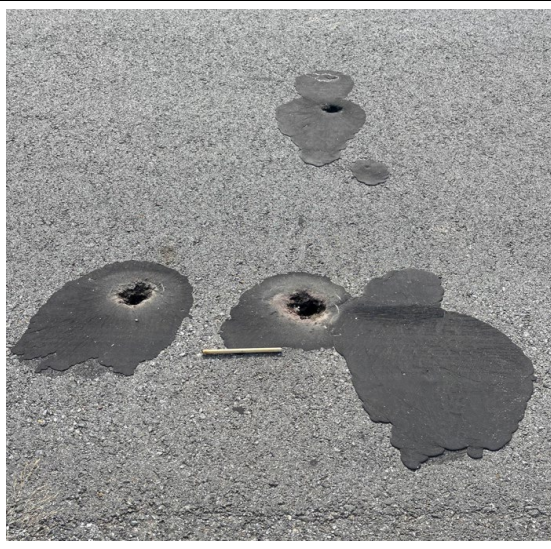
Branch ID	Branch Name	Branch Use	No. of Sections	Area (sf)	Weight Average PCI
4200	Northeast Apron	Apron	2	383,880	96

The 4200-01 portion of the Northeast Apron was constructed in 1987 and reconstructed in 2018. Section 4200-02 was constructed in 1978 and reconstructed in 2018. Predominant distresses are low severity weathering and scattered low severity longitudinal and transverse cracking. Along the northwestern edge of the apron there is an area with medium severity longitudinal and transverse cracking and small voids in the hot mix asphalt that had been previously filled with crack seal.

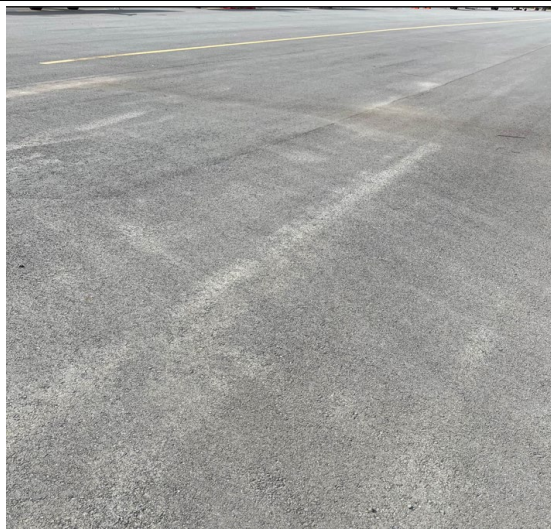
Branch ID	Branch Name	Branch Use	No. of Sections	Area (sf)	Weight Average PCI
4300	Southeast Apron	Apron	1	187,595	97

The Southeast Apron was constructed in 1987 and reconstructed in 2018. Commonly observed distresses are low severity weathering and small amounts of oil spillage.

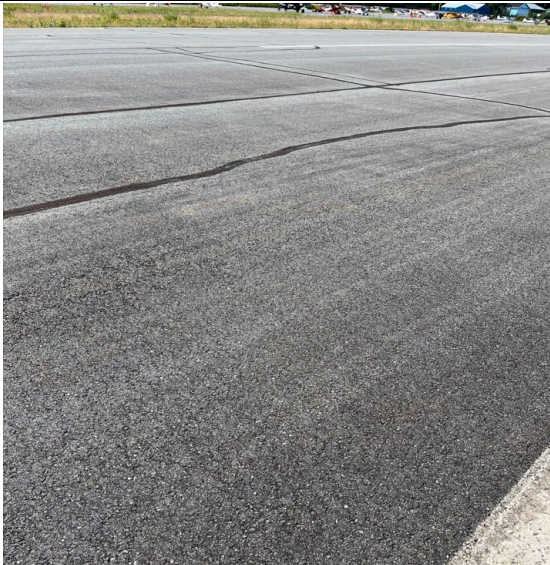
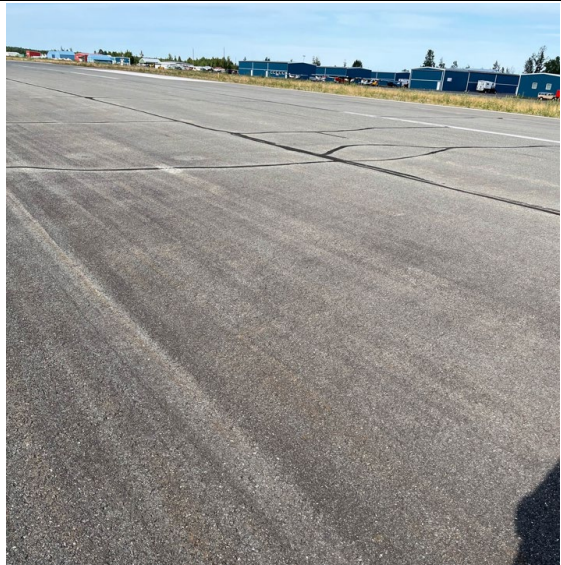
Branch ID	Branch Name	Branch Use	No. of Sections	Area (sf)	Weight Average PCI
6100	02L/20R	Runway	1	400,000	77

Runway 02L/20R was constructed in 1978 and received surface reconstruction in 2012. Observed distresses are low severity longitudinal and transverse cracking and low severity weathering.

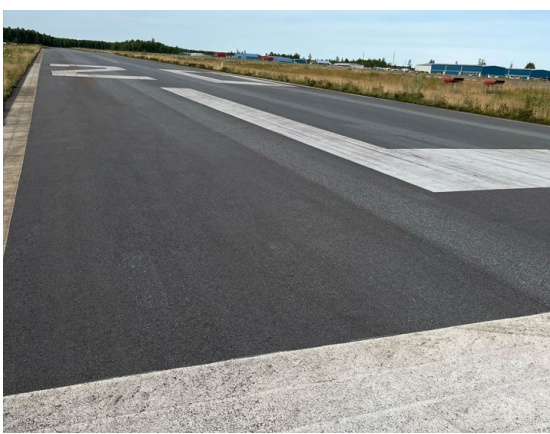
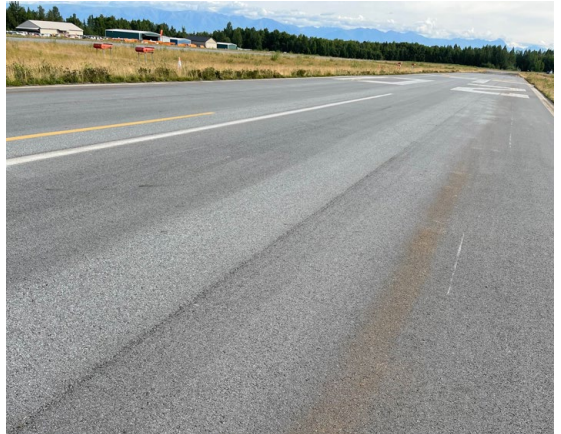
Branch ID	Branch Name	Branch Use	No. of Sections	Area (sf)	Weight Average PCI
6200	02R/20L	Runway	1	41,750	97

Runway 02R/20L was constructed in 1978 and reconstructed in 2018. The predominant distress is low severity weathering. This is the paved portion of a predominantly gravel runway.
