Alaska DOT&PF

Pavement Inspection Report Clear Airport

Airport Name	IATA	ICAO	Latitude	Longitude	Elevation (ft)
Clear Airport	-	PACL	64° 18' 04" N	149° 07' 13" W	552

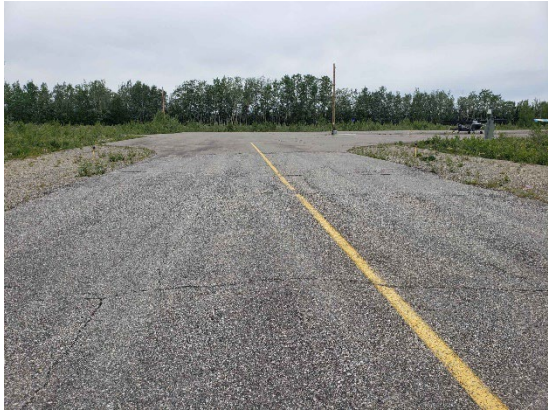
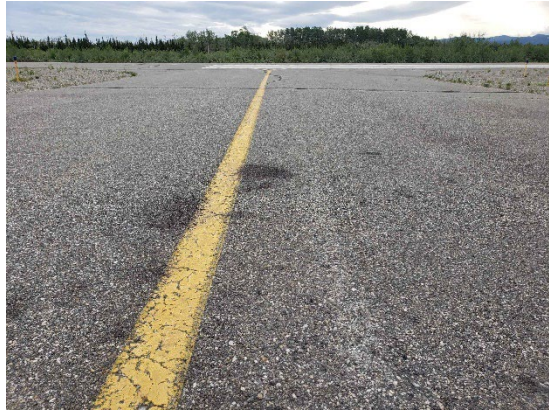
Branch ID	Branch Name	Branch Use	No. of Sections	Area (sf)	Weight Average PCI
0100	Taxiway A	Taxiway	1	13,616	46

Taxiway A was originally constructed in 1996 and has had no work since. Common distresses on the taxiway are low to medium severity weathering, low to medium severity longitudinal and transverse cracking, low severity depression, and a large medium severity patch adjacent to the apron.

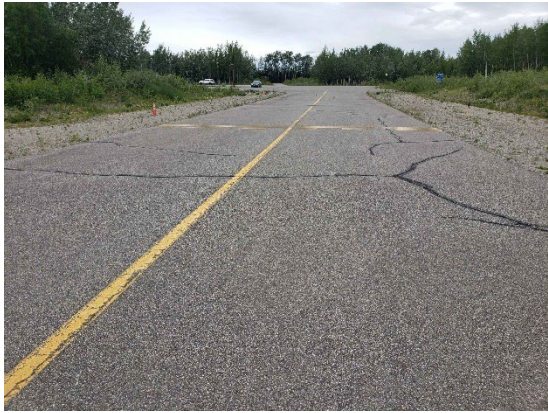
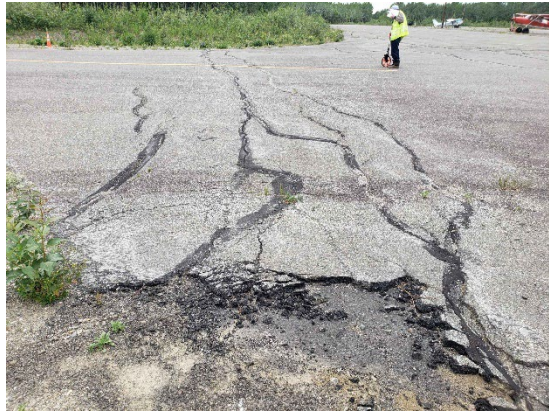
Branch ID	Branch Name	Branch Use	No. of Sections	Area (sf)	Weight Average PCI
0200	Taxiway B	Taxiway	1	13,631	56

Taxiway B was constructed in 1996 and has had no work since. Typical distresses are low severity longitudinal and transverse cracking, low severity patching and low severity weathering. Adjacent to the apron is an area of severe distress with low, medium and high severity longitudinal and transverse cracking and raveling and low severity alligator cracking. The edge of pavement is being damaged by snowplows and crumbling.

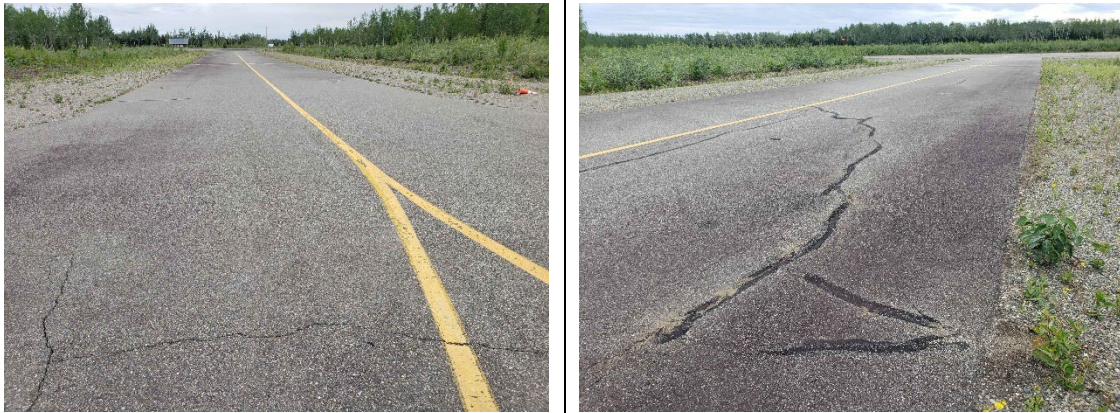
Branch ID	Branch Name	Branch Use	No. of Sections	Area (sf)	Weight Average PCI
0300	Taxiway C	Taxiway	1	17,766	74

Taxiway C was constructed in 1997 and received no work since. Distresses are low severity weathering, low to medium severity longitudinal and transverse cracking and a low severity depression.

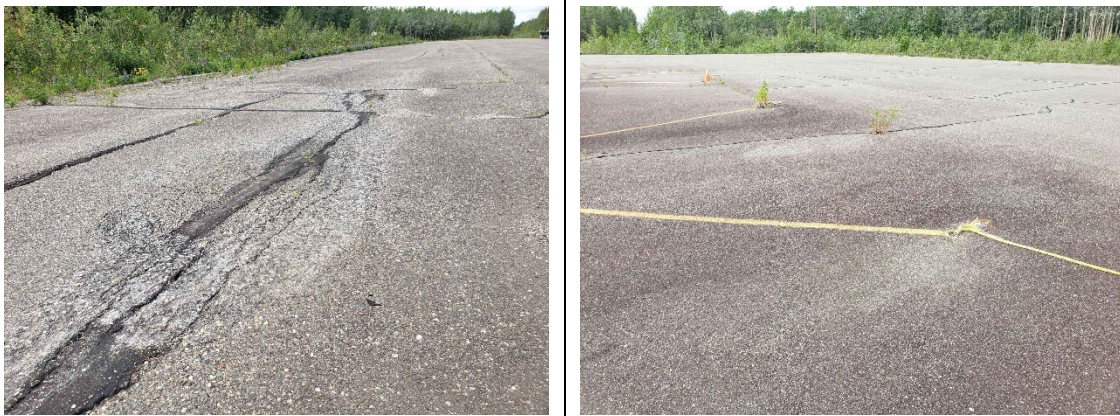
Branch ID	Branch Name	Branch Use	No. of Sections	Area (sf)	Weight Average PCI
4100	South Apron	Parking Apron	1	130,000	43

The South Apron was constructed in 1996 and has received no work since. Commonly distresses are low to medium severity longitudinal and transverse cracking, low severity weathering and low severity raveling. Areas near the edge of the apron have more severe distresses that include low to medium severity alligator cracking, medium severity raveling, medium severity swelling and a high severity depression.

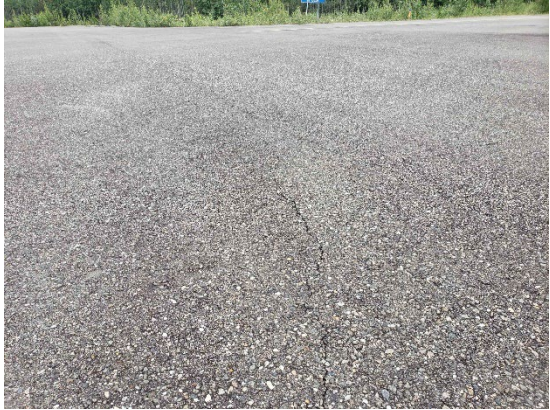
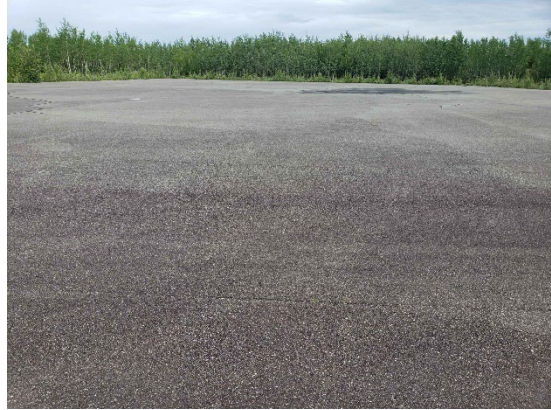
Branch ID	Branch Name	Branch Use	No. of Sections	Area (sf)	Weight Average PCI
4200	North Apron	Parking Apron	1	60,000	68

The North Apron was constructed in 1997 and has received no work since. Observed distresses are low severity longitudinal and transverse cracking and low severity weathering. There are scattered areas of high severity raveling across the apron, as well as isolated areas of severe edge cracking at the sides of the apron.

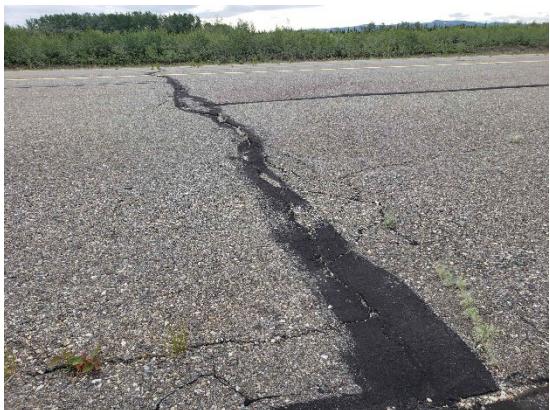
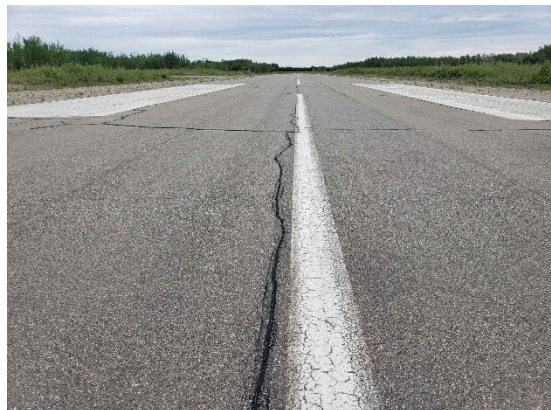
Branch ID	Branch Name	Branch Use	No. of Sections	Area (sf)	Weight Average PCI
6100	Runway 01-19	Runway	1	400,000	53

Runway 15-33 was constructed in 1996 and has received no work since. Common distresses are low to medium to high severity longitudinal and transverse cracking, low severity raveling, low to medium severity weathering, and isolated low severity alligator cracking.
