Alaska DOT&PF

Pavement Inspection Report Cold Bay Airport

Airport Name	IATA	ICAO	Latitude	Longitude	Elevation (ft)
Cold Bay Airport	CDB	PACD	55° 12' 21.3" N	162° 43' 34.5" W	99.5

Point of Contact	Phone	Email	Date Inspected	Date Published
Mr. Andrew Pavey, Pavement Management Engineer	(907) 269 6213	andrew.pavey@alaska.gov	May 2023	September 2023

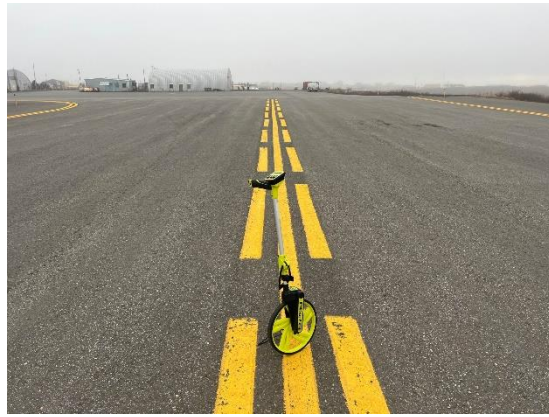
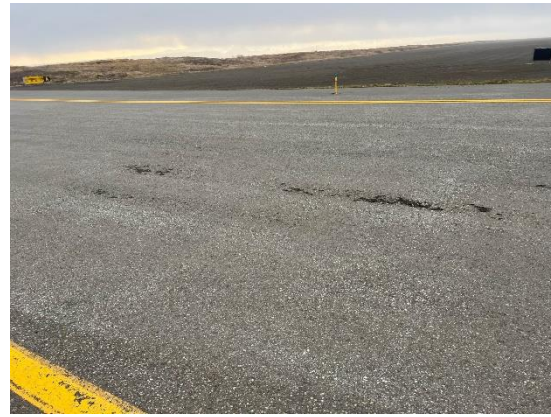
Branch ID	Branch Name	Branch Use	No. of Sections	Area (sf)	Weighted Average PCI
0100	Taxiway A	Taxiway	1	26,675	82

Taxiway A was initially constructed in 1942 and the most recent major work was a surface course in 2005. Crack seal operations have not been performed on the branch. The most common distresses observed are low severity longitudinal and transverse cracking, low to medium severity raveling, and low to medium severity weathering. Field observations include wearing of the pavement surface due to climate and traffic and the creation of new unfilled cracks.

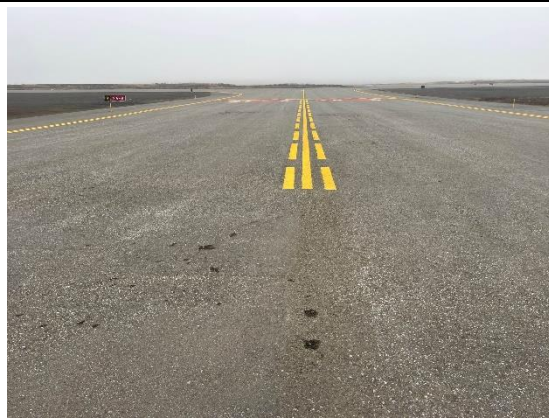
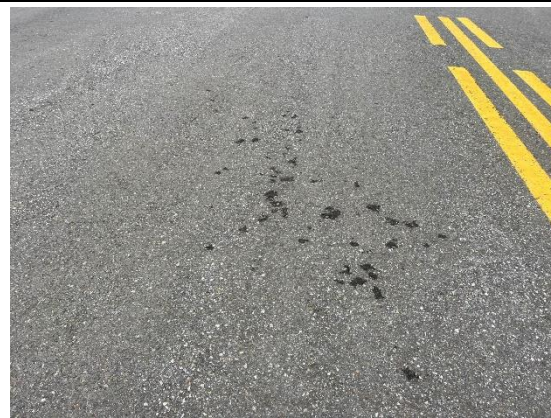
Branch ID	Branch Name	Branch Use	No. of Sections	Area (sf)	Weighted Average PCI
0200	Taxiway B	Inactive	1	29,000	86

Like Taxiway A, Taxiway B was initially constructed in 1942 and the most recent major work was a surface course in 2005. Crack seal operations have not been performed on the branch. The most common distresses observed are low to medium severity raveling and low to medium severity weathering. Field observations include wearing of the pavement surface due to climate and traffic.

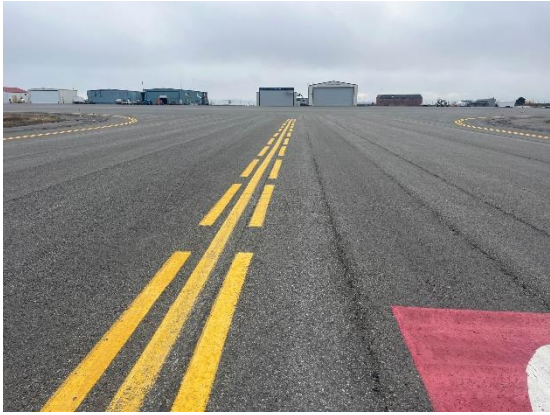
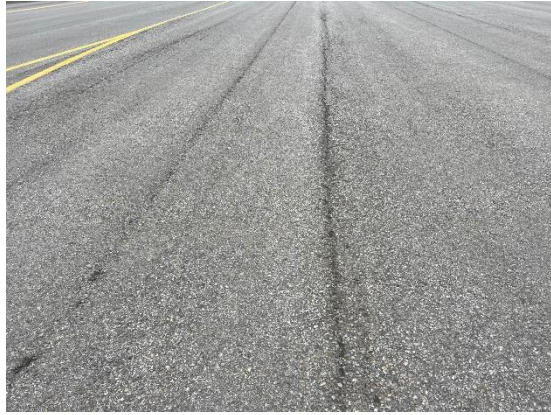
Branch ID	Branch Name	Branch Use	No. of Sections	Area (sf)	Weighted Average PCI
0300	Taxiway C	Taxiway	1	48,735	80

Taxiway C was initially constructed in 1972 and underwent surface reconstruction in 2012. Crack seal operations have not been performed on the branch. The most common distresses observed are low severity longitudinal and transverse cracking, low to medium severity raveling, and low severity weathering. Field observations include expedited wearing of the paving joints compared to Taxiway A and B, causing an increased quantity and severity of distress.

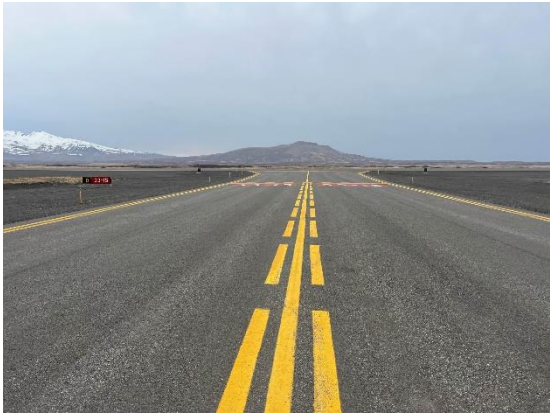
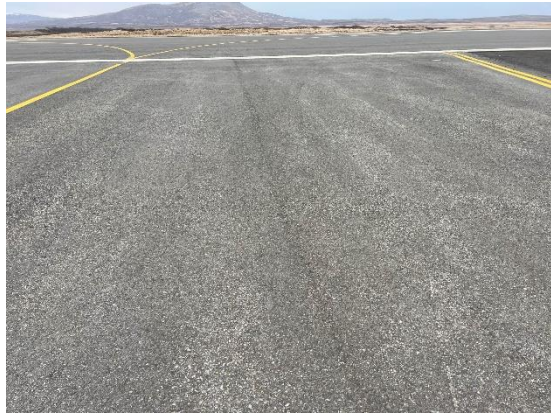
Branch ID	Branch Name	Branch Use	No. of Sections	Area (sf)	Weighted Average PCI
0400	Taxiway D	Taxiway	1	46,225	93

Taxiway D was constructed in 2018 and had not received any major work since. Crack seal operations have not been performed on the branch. The most common distresses observed are low severity raveling and low severity weathering. Field observations include initial wearing of the pavement surface and paving joints.

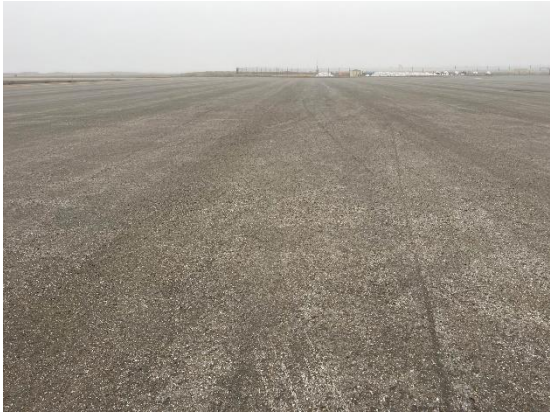
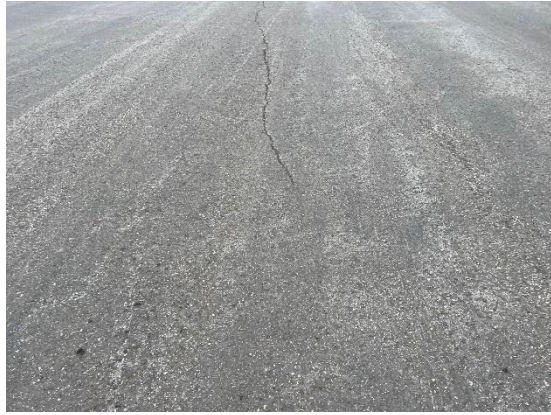
Branch ID	Branch Name	Branch Use	No. of Sections	Area (sf)	Weighted Average PCI
4100	South Apron	Apron	1	149,175	77

The South Apron, connected to Taxiways A and B, was first built in 1942, and the most recent major work was a surface course in 2005. Crack seal operations have not been performed on the branch. The most common distresses observed are low severity depressions, low severity longitudinal and transverse cracking, low to medium severity raveling, and low severity weathering. Field observations include wearing of the pavement surface due to climate and traffic, the creation of new unfilled cracks, and standing water in localized areas across the apron.

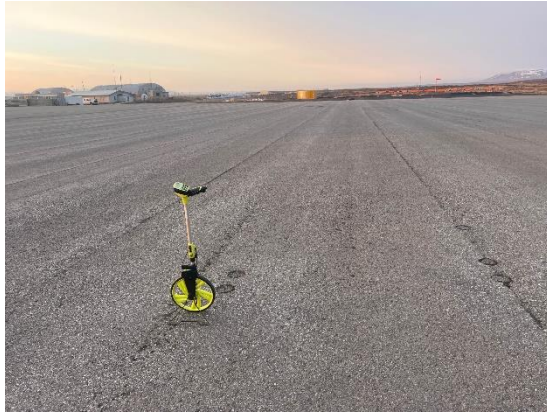
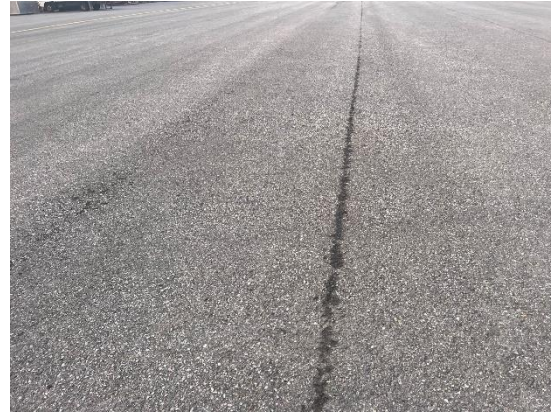
AC Section 4200-01 (86 PCI)

The larger section (301,000 Sq Ft) of the North Ramp, connected to Taxiway C, was first built in 1972 and underwent surface reconstruction in 2012. Crack seal operations have not been performed on the branch. The most common distresses observed are low severity longitudinal and transverse cracking, low severity raveling, and low severity weathering. Field observations include expedited wearing of the paving joints causing an increased quantity and severity of distresses.

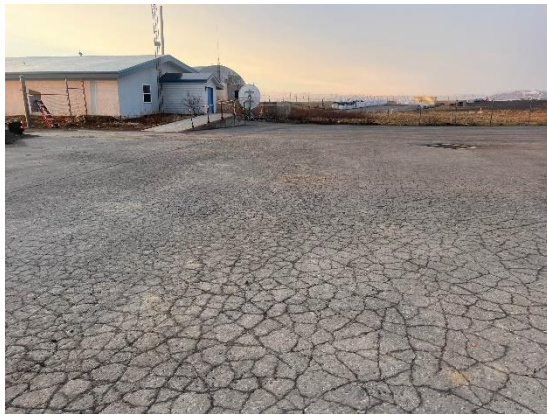
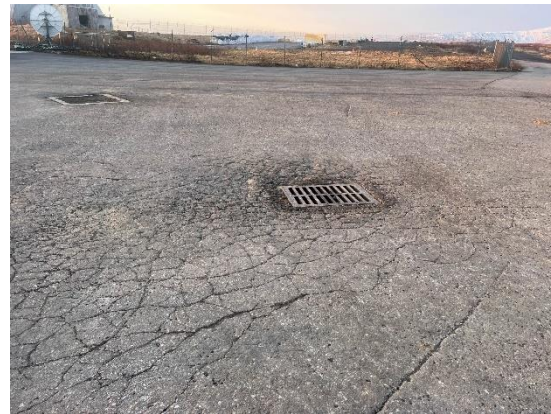
AC Section 4200-05 (14 PCI)

The smaller section (27,340 Sq Ft) of the North Ramp was constructed in 1970 and has not received any major work since. Crack seal operations have not been performed on the branch. The most common distresses observed are low to high severity alligator cracking, low to medium severity longitudinal and transverse cracking, low to high severity raveling, and low severity weathering.

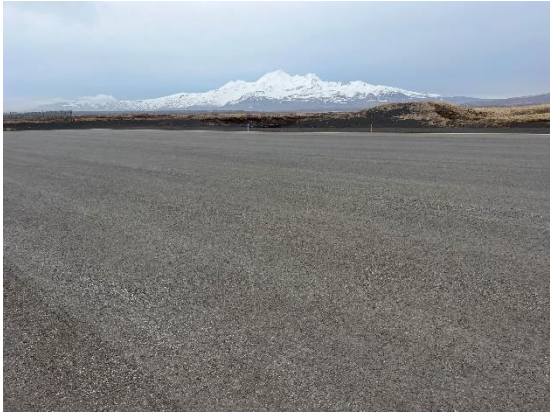
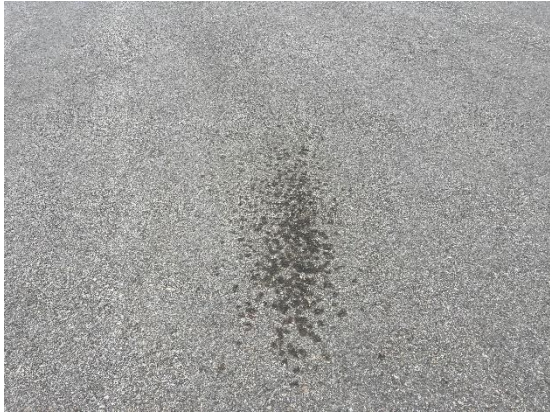
Branch ID	Branch Name	Branch Use	No. of Sections	Area (sf)	Weighted Average PCI
4300	Apron	Apron	1	116,500	94

The Apron, which is connected to Taxiway D, was constructed in 2018 and has not received any major work since. Crack seal operations have not been performed on the branch. The most common distresses observed are low severity raveling and low severity weathering. Field observations include initial wearing of the pavement surface and paving joints.

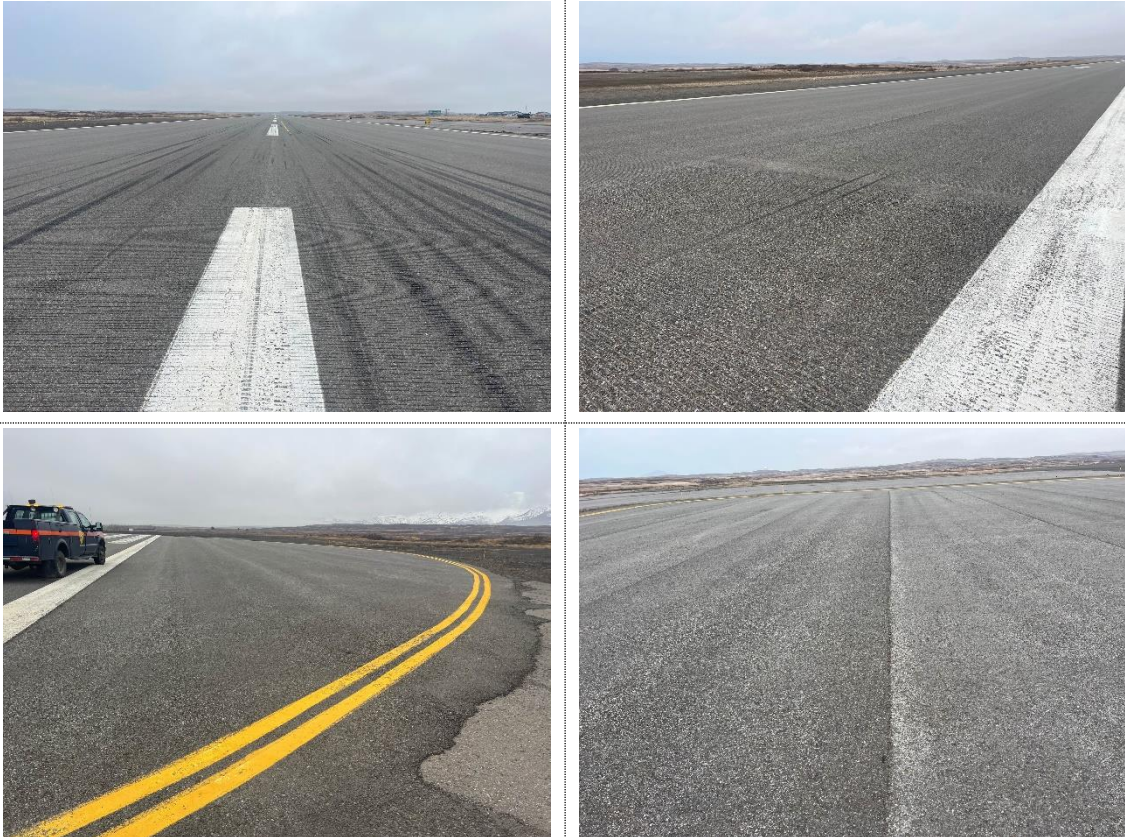
Branch ID	Branch Name	Branch Use	No. of Sections	Area (sf)	Weighted Average PCI
6100	Runway 15/33	Runway	6	1,638,540	94

Runway 15/33 was initially constructed in 1942 and the most recent major work was a 4-inch overlay in 2018. Crack seal operations have not been performed on the section. The most common distresses observed are low severity raveling and low severity weathering. Field observations include initial wearing of the pavement surface and paving joints.
