Pavement Inspection Report Cordova Airport

Airport Name	IATA	ICAO	Latitude	Longitude	Elevation (ft)
Merle K (Mudhole) Smith Airport	CDV	PACV	60° 29' 29.9" N	145° 28' 39.21" W	43

Point of Contact	Phone	Email	Date Inspected	Date Published
Mr. Andrew Pavey, Pavement Management Engineer	(907) 269 6213	andrew.pavey@alaska.gov	September 2024	June 2025

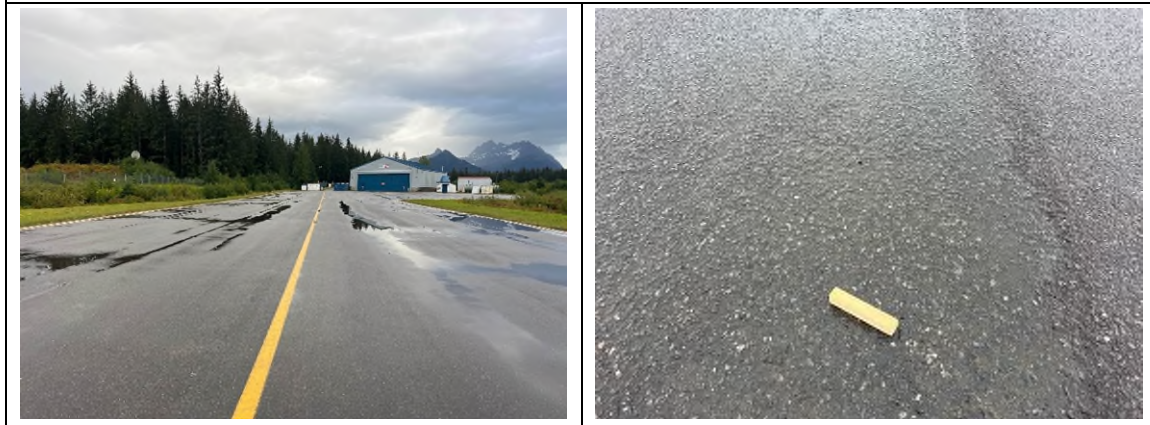
AC Section 0200-01 (67 PCI)

Taxiway B consists of two sections, of which Section 0200-01 is asphalt concrete (AC) and Section 0200-02 is portland cement concrete (PCC). Section 0200-01 was constructed in 1995 and has not received any major work since. Periodic crack seal operations have been performed on the branch. The most common distresses observed are low to medium severity depressions, low to medium severity longitudinal and transverse cracking, low severity raveling, and low to medium severity weathering. Field observations include isolated areas of alligator cracking and slippage cracking located in the aircraft turning motions.

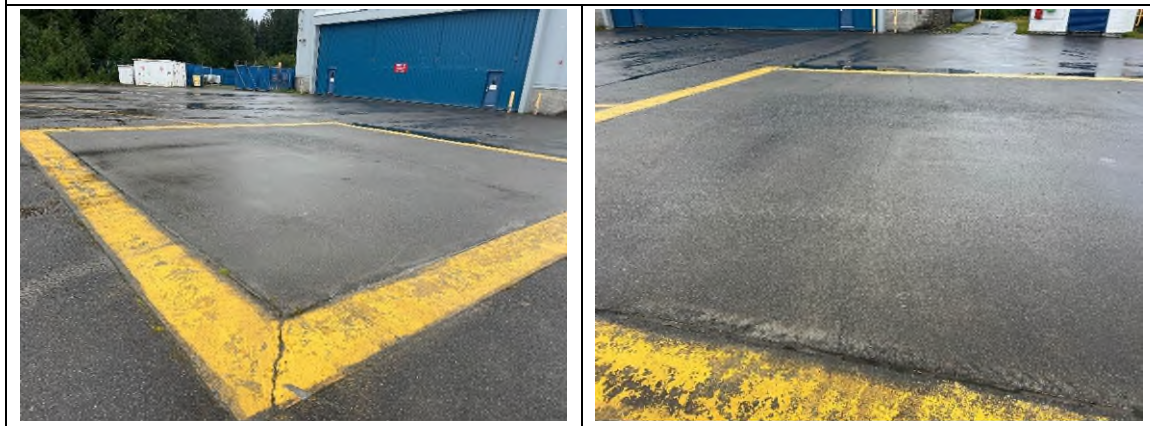
PCC Section 0200-02 (80 PCI)

Taxiway B Section 0200-02 was constructed in 1995 and has not received any major work since. The only distress observed was low severity linear cracking. No additional field observations were made during the inspection.

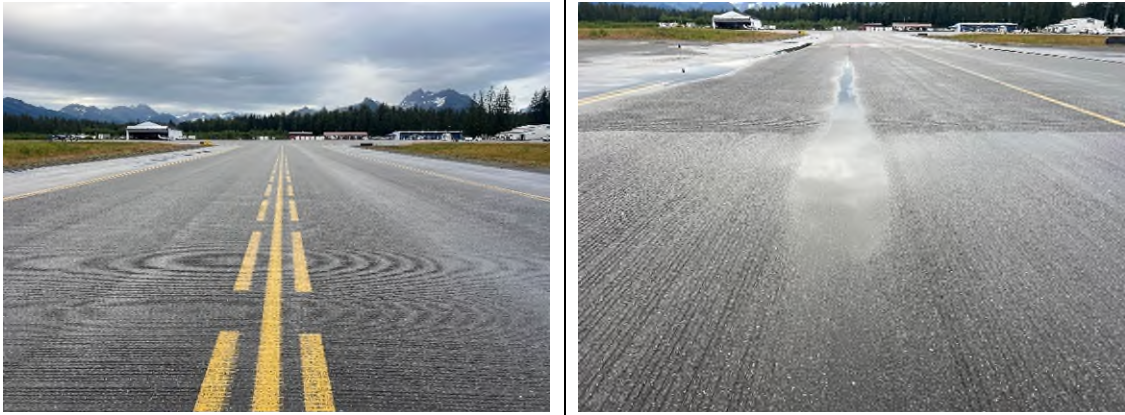
Branch ID	Branch Name	Branch Use	No. of Sections	Area (sf)	Weighted Average PCI
0300	Taxiway C	Taxiway	1	38,335	88

Taxiway C was initially constructed in 1967. The most recent major work, a complete reconstruction, was carried out in 2017. This included 16" of subbase, 6" of asphalt treated base, and 4" of asphalt top layer. Crack seal operations have not been performed on the branch. The most common distresses observed are low severity depressions, low severity raveling, and low severity weathering. Field observations indicate early signs of paving joint deterioration, resulting in isolated areas of raveling. Additionally, depressions along the joints are causing water to pool, further accelerating the deterioration.

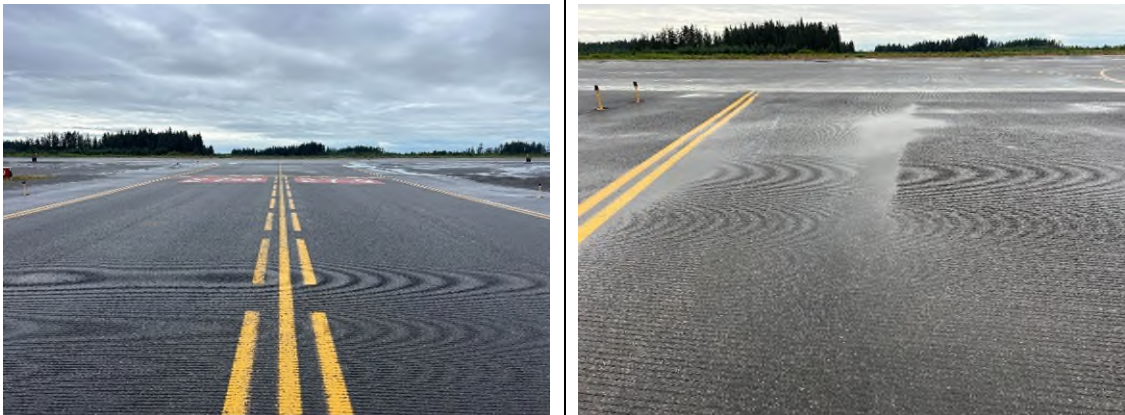
Branch ID	Branch Name	Branch Use	No. of Sections	Area (sf)	Weighted Average PCI
0400	Taxiway D	Taxiway	2	34,724	89

Taxiway D was initially constructed in 1967. The most recent major work, a complete reconstruction, was carried out in 2017. This included 26" of subbase, 6" of asphalt treated base, and 4" of asphalt top layer. Crack seal operations have not been performed on the branch. The most common distresses observed are low severity depressions, low severity raveling, and low severity weathering. Field observations indicate early signs of paving joint deterioration, resulting in isolated areas of raveling. Additionally, depressions along the joints are causing water to pool, further accelerating the deterioration.

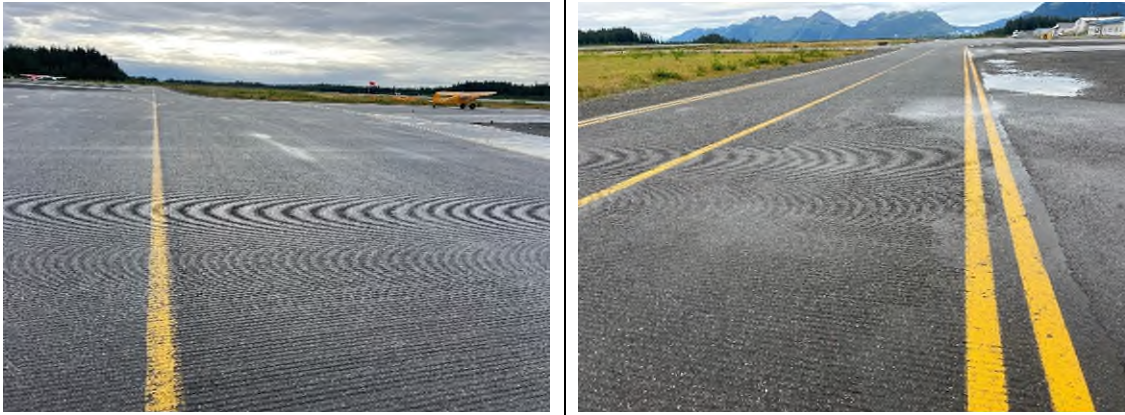
Branch ID	Branch Name	Branch Use	No. of Sections	Area (sf)	Weighted Average PCI
0500	Taxilane L	Taxiway	2	73,856	85

Taxilane L was initially constructed in 1967. The most recent major work, a complete reconstruction, was carried out in 2016. This included 18" of subbase, 6" of asphalt treated base, and 4" of asphalt top layer. Crack seal operations have not been performed on the branch. The most common distresses observed are low severity longitudinal and transverse cracking, low severity raveling, and low severity weathering. Field observations indicate initial development of cracking across the branch.

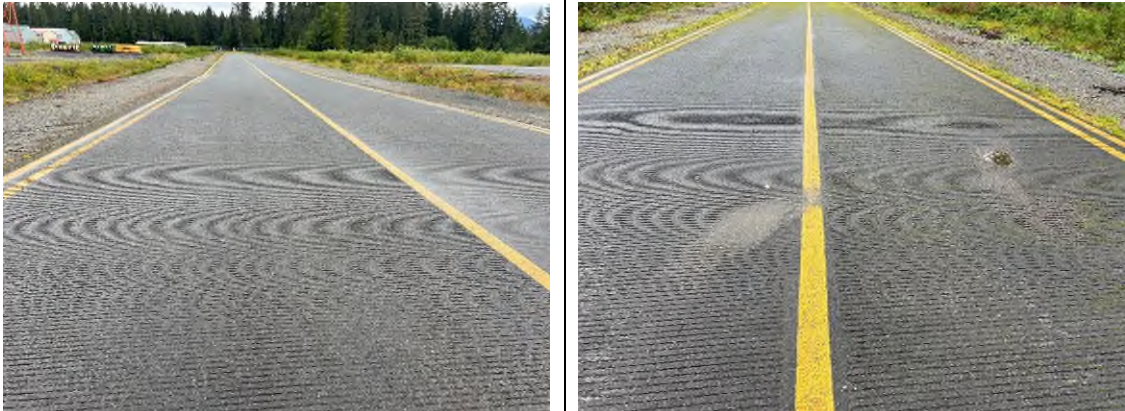
Branch ID	Branch Name	Branch Use	No. of Sections	Area (sf)	Weighted Average PCI
0600	Taxiway K	Taxiway	1	21,785	86

Taxiway K was initially constructed in 2016 and has not received any major work since. Crack seal operations have not been performed on the branch. The most common distresses observed are low to medium severity raveling and low severity weathering. Field observations indicate initial deterioration of the paving joints, resulting in isolated areas of raveling.

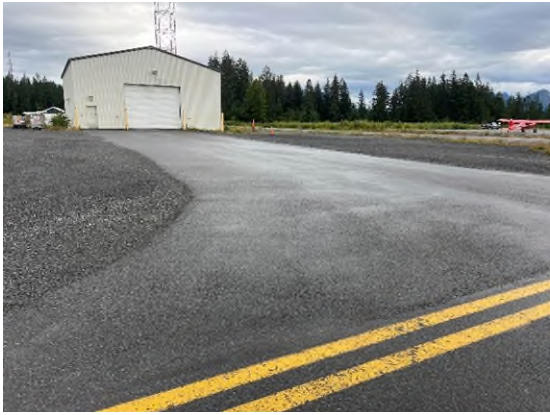
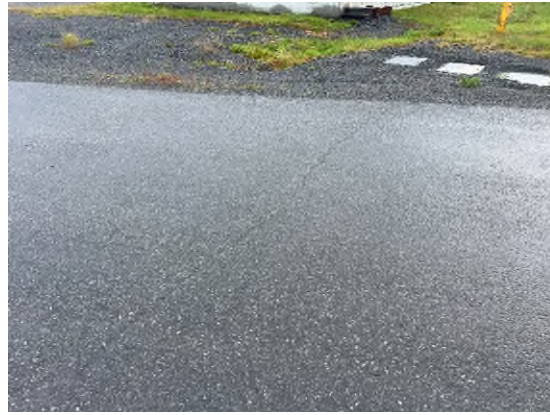
Branch ID	Branch Name	Branch Use	No. of Sections	Area (sf)	Weighted Average PCI
0700	Access Roads	Taxiway	2	13,615	89

The access roads that break off from Taxilane K were constructed in 2016 and have not received any major work since. Crack seal operations have not been performed on the branch. The most common distresses observed are low severity longitudinal and transverse cracking, low severity raveling, and low severity weathering. Field observations indicate initial development of cracking across the branch.

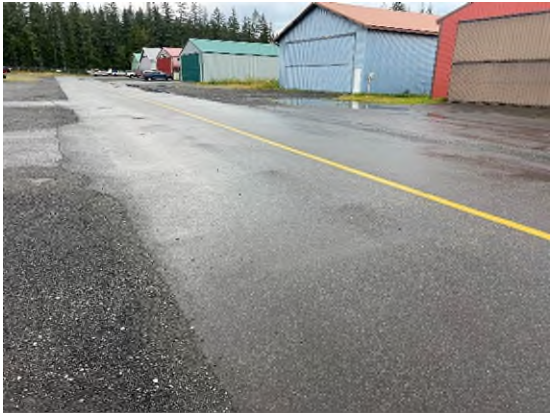
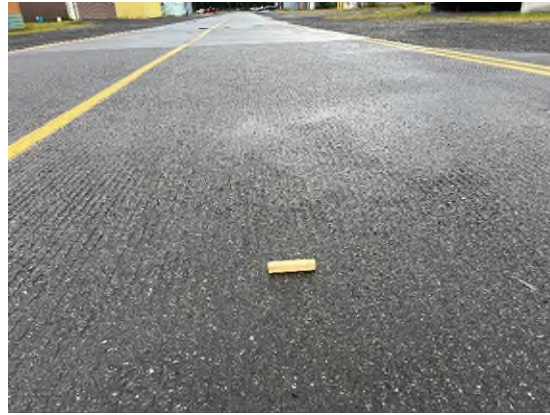
Branch ID	Branch Name	Branch Use	No. of Sections	Area (sf)	Weighted Average PCI
0800	Hangar TW	Taxiway	2	25,901	84

The Hangar Taxiway consists of two sections, of which section 0800-01 was initially constructed in 1975 while section 0800-02 was added on in 1995. Both sections underwent a 2" overlay in 2017. Crack seal operations have not been performed on the branch. The most common distresses observed are low severity longitudinal and transverse cracking, low severity raveling, and low to medium severity weathering. Field observations indicate initial deterioration of the paving joints, resulting in isolated areas of raveling.

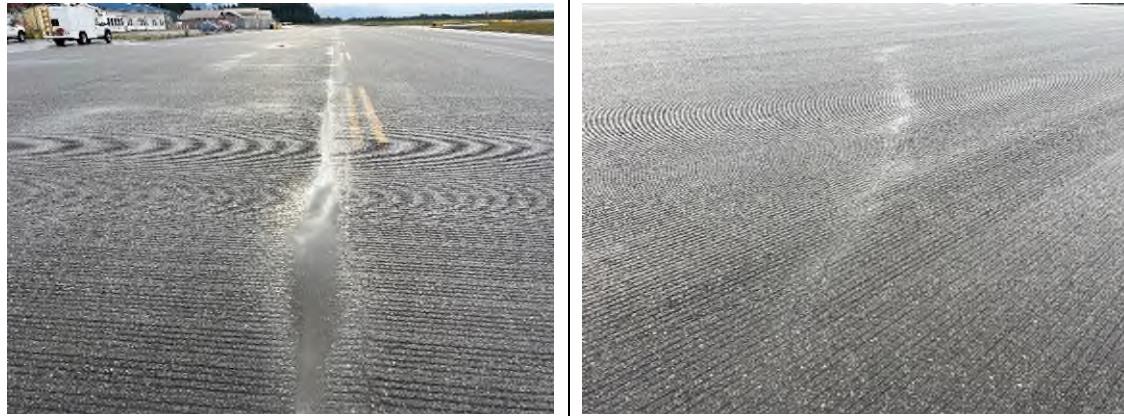
AC Section 4100-01 (88 PCI), 4100-02 (88 PCI), 4100-03 (86 PCI)

The Paved Apron consists of four sections, of which Sections 4100-01, 4100-02, and 4100-03 are asphalt concrete (AC) while Section 4100-04 is portland cement concrete (PCC). Section 4100-01 was initially constructed in 1995 and received a 2" overlay in 2017. Sections 4100-02 and 4100-03 were initially constructed in 1967 and both received a 2" mill and overlay in 2017. Crack seal operations have not been performed on the branch. The most common distresses observed are low severity depressions, low severity longitudinal and transverse cracking, low severity raveling, and low severity weathering. Field observations indicate early signs of paving joint deterioration, resulting in isolated areas of raveling. Additionally, depressions along the joints are causing water to pool, further accelerating the deterioration.

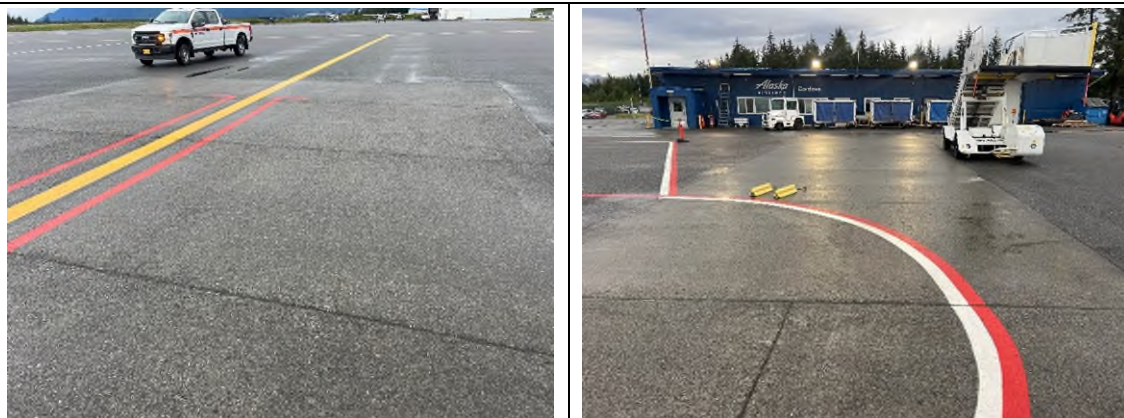
PCC Section 4100-04 (95 PCI)

The Paved Apron Section 4100-04 was initially constructed in 2010 and has not received any major work since. The most common distresses observed are low severity joint seal damage and low severity scaling. Field observations include wearing of the surface of the concrete leading to the low severity scaling, and initial deterioration of the joint sealant causing low severity joint seal damage.

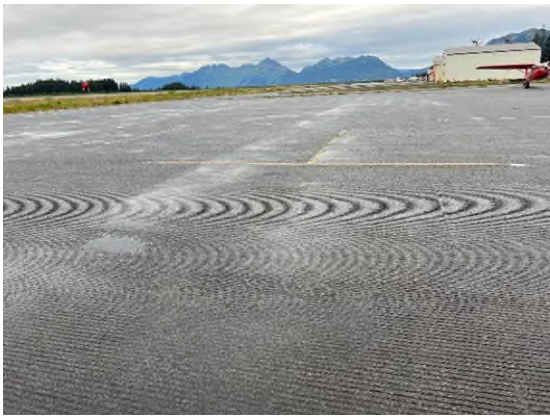
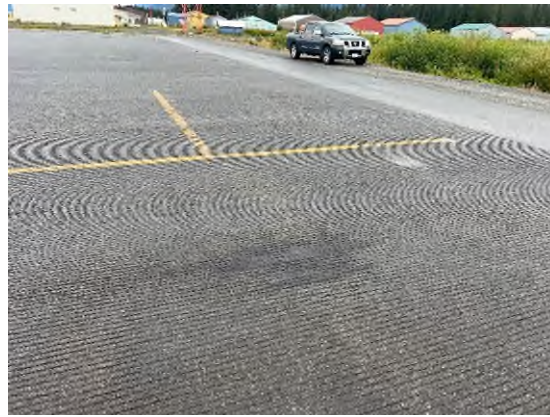
ranch ID	Branch Name	Branch Use	No. of Sections	Area (sf)	Weighted Average PCI
4200	General Aviation Apron	Apron	1	69,600	80

The General Aviation Apron was initially constructed in 2016 and has not received any major work since. Crack seal operations have not been performed on the branch. The most common distresses observed are oil spillage, low severity raveling, and low to medium severity weathering. Field observations indicate initial deterioration of the paving joints, resulting in isolated areas of raveling as well as localized areas of oil spillage across the branch.

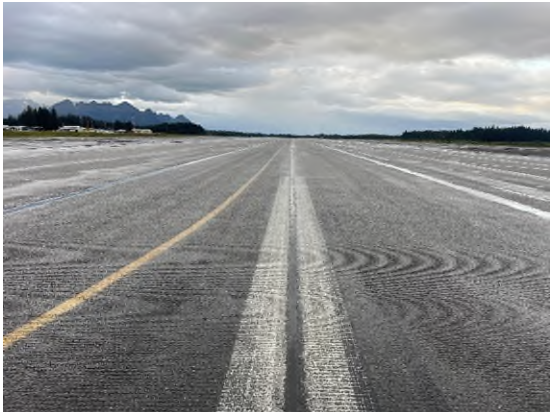
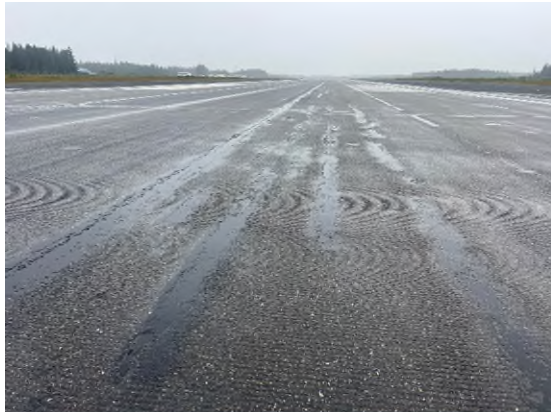
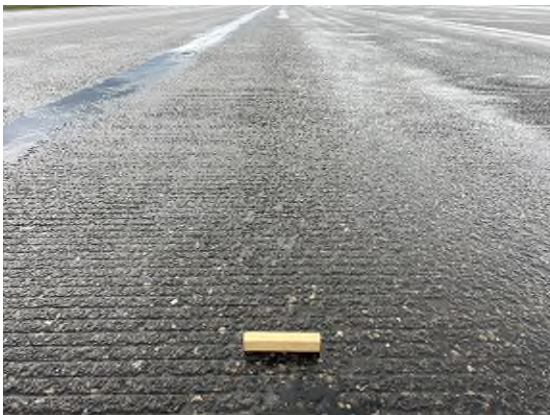
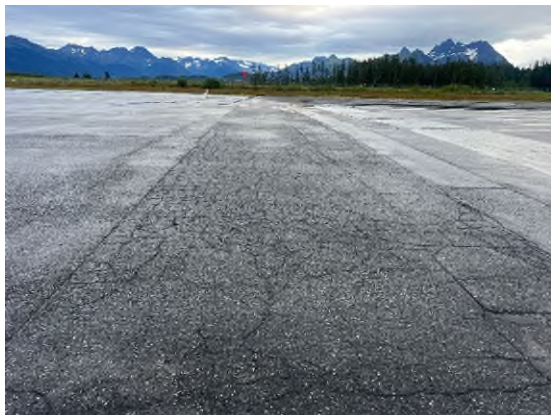
Branch ID	Branch Name	Branch Use	No. of Sections	Area (sf)	Weighted Average PCI
6100	Runway 09/27	Runway	7	1,303,827	66

Runway 09/27 was initially constructed in 1967 and received major work in 1998. Periodic crack seal operations have been performed on the branch. The most common distresses observed are low severity alligator cracking, low to medium severity longitudinal and transverse cracking, low severity depressions, low to high severity raveling, and low to medium severity weathering. Field observations include further deterioration of the top layer of asphalt, contributing to higher quantity and severity raveling and weathering throughout the branch.
