Alaska DOT&PF

Pavement Inspection Report Deadhorse Airport

Deadhorse Airport

Airport Code: SCC
Site Number: 50140.7*A

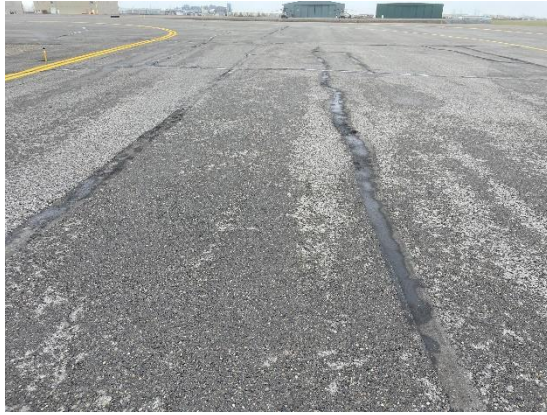
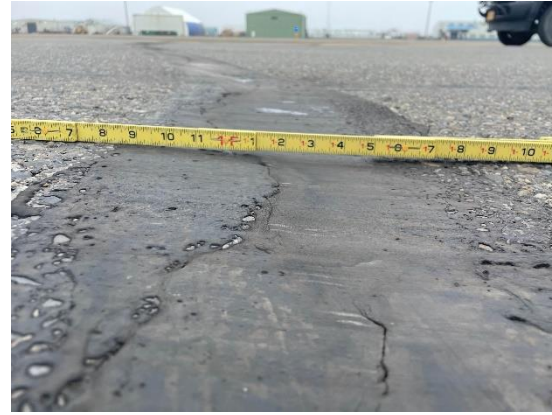
Branch ID	Branch Name	Branch Use	No. of Sections	Area (sf)	Weighted Average PCI
0100	Taxiway A	Taxiway	3	775,810	78

Taxiway A was constructed in 1998 and had surface reconstruction in 2012. Annual crack seal operations have been performed on the branch. The most common distresses observed are low severity depression, low severity longitudinal and transverse cracking, low severity raveling, and low severity weathering. Field observations include deterioration of the paving joints resulting in the need for them to be sealed. Also, there are a few transverse cracks that are starting to sag creating a depression and a ride quality issue.

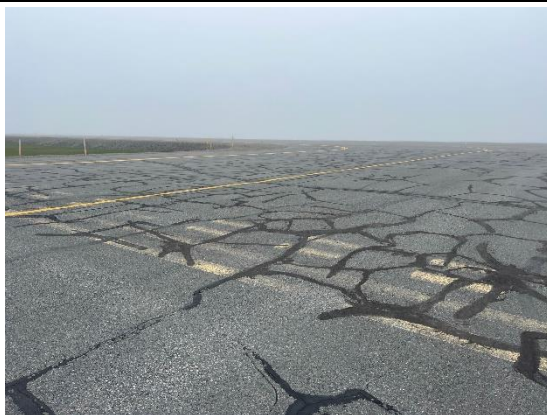
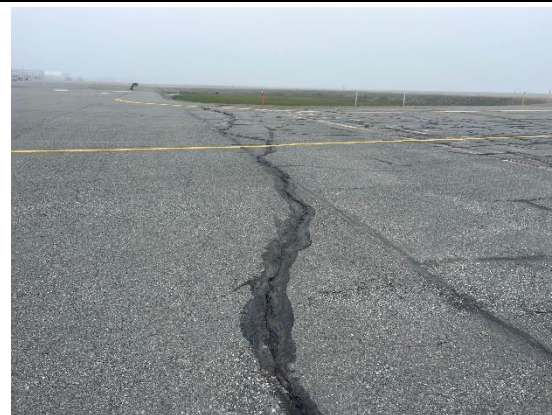
Branch ID	Branch Name	Branch Use	No. of Sections	Area (sf)	Weighted Average PCI
0110	Taxiway Deadhorse Aviation Center	Taxiway	1	25,078	67

Taxiway for the Alaska Airlines Leased Apron was constructed in 2008 and has not received any major work since. Annual crack seal operations have been performed on the branch. The most common distresses observed are low severity block cracking, low severity depression, low to medium severity longitudinal and transverse cracking, low severity raveling, and low severity weathering. Field observations include most of the area is experiencing block cracking with the addition of a few medium severity cracks spanning the width of the taxiway.

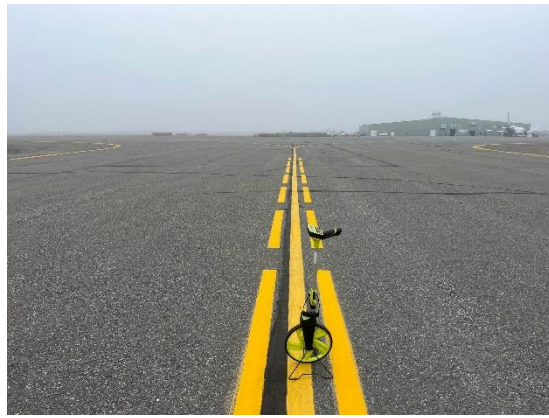
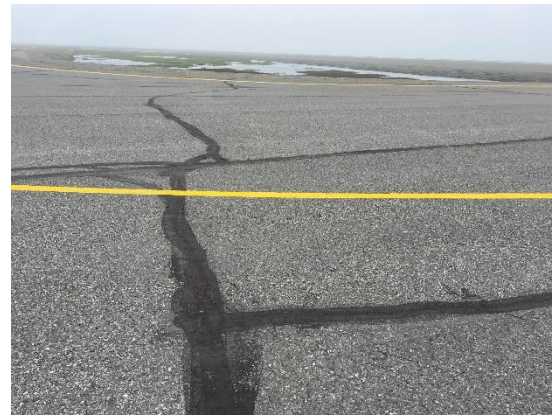
Branch ID	Branch Name	Branch Use	No. of Sections	Area (sf)	Weighted Average PCI
0200	Taxiway B	Taxiway	1	66,000	79

Like Taxiway A, Taxiway B was constructed in 1998 and had surface reconstruction in 2012. Annual crack seal operations have been performed on the branch. The most common distresses observed are low severity longitudinal and transverse cracking, low severity raveling, and low severity weathering. Field observations include deterioration of the paving joints and the initial signs of wearing of the pavements surface defined by loss of the fine aggregate matrix.

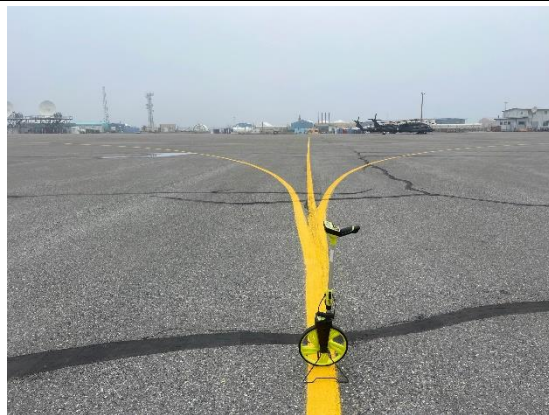
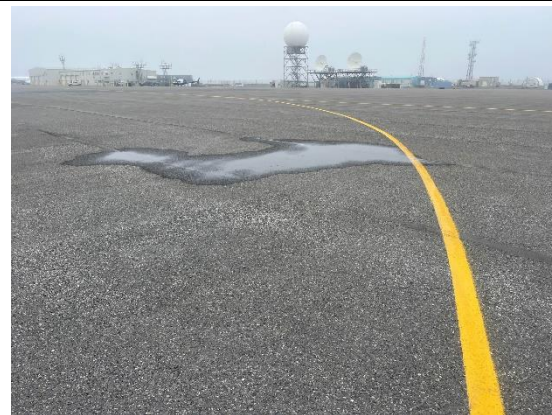
Branch ID	Branch Name	Branch Use	No. of Sections	Area (sf)	Weighted Average PCI
0300	Taxiway C	Taxiway	2	107,900	82

Like Taxiway A and B, Taxiway C was constructed in 1998 and had surface reconstruction in 2012. Annual crack seal operations have been performed on the branch. The most common distresses observed are low severity depression, low severity longitudinal and transverse cracking, low severity raveling, and low severity weathering. Field observations include areas of standing water along the length of the taxiway.

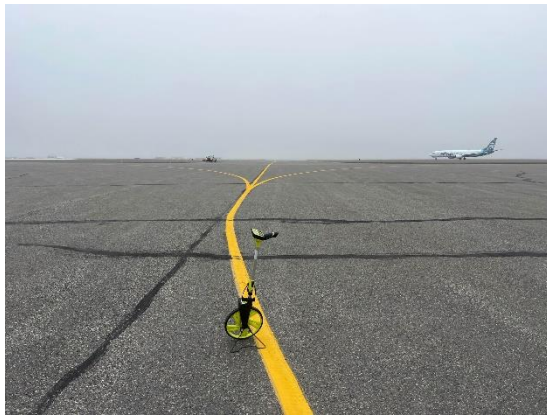
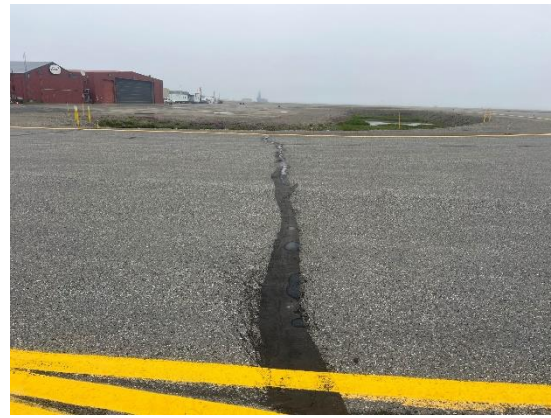
Branch ID	Branch Name	Branch Use	No. of Sections	Area (sf)	Weighted Average PCI
0400	Taxiway D	Taxiway	2	103,600	80

Like Taxiway A, B, and C, Taxiway D was constructed in 1998 and had surface reconstruction in 2012. Annual crack seal operations have been performed on the branch. The most common distresses observed are low severity longitudinal and transverse cracking, low severity raveling, and low severity weathering. Field observations include deterioration of the paving joints resulting in the need for them to be sealed.

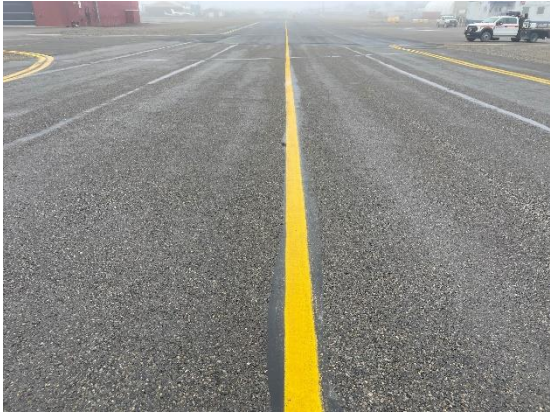
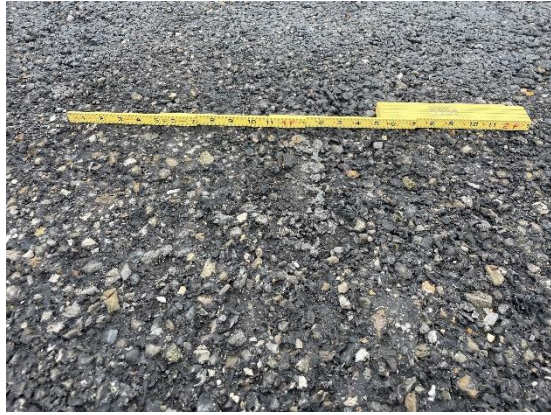
Branch ID	Branch Name	Branch Use	No. of Sections	Area (sf)	Weighted Average PCI
0500	Taxiway E	Taxiway	1	43,525	84

Taxiway E was constructed in 1996 and had surface reconstruction in 2013. Taxiway E is for general aviation aircraft and leads to various lease lots. Annual crack seal operations have been performed on the branch. The most common distresses observed are low severity depression, low severity longitudinal and transverse cracking, low severity raveling, and low severity weathering. Field observations include deterioration of the paving joints and isolated areas of coarse aggregate loss across the section.

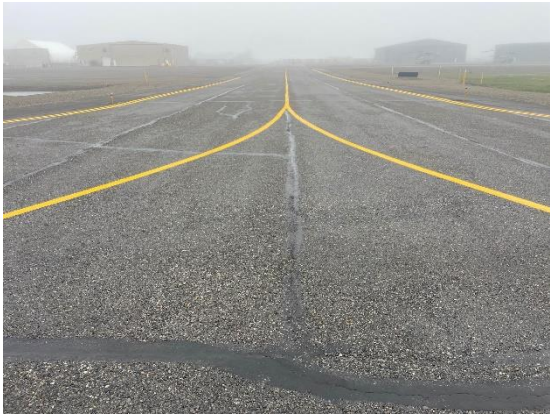
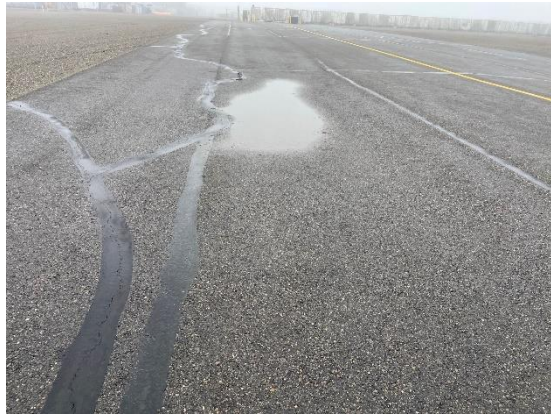
Branch ID	Branch Name	Branch Use	No. of Sections	Area (sf)	Weighted Average PCI
0600	Taxiway F	Taxiway	1	52,000	71

Like Taxiway E, Taxiway F was constructed in 1996 and had surface reconstruction in 2013. Taxiway F is also for general aviation aircraft and leads to various lease lots. Annual crack seal operations have been performed on the branch. The most common distresses observed are low severity depression, low severity longitudinal and transverse cracking, low severity raveling, and low severity weathering. Field observations include deterioration of the paving joints and areas of standing water along the length of the section.

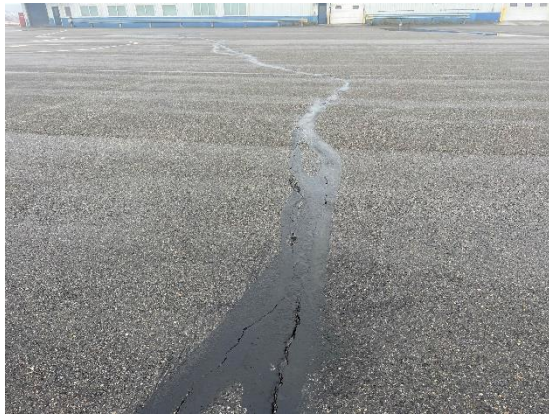
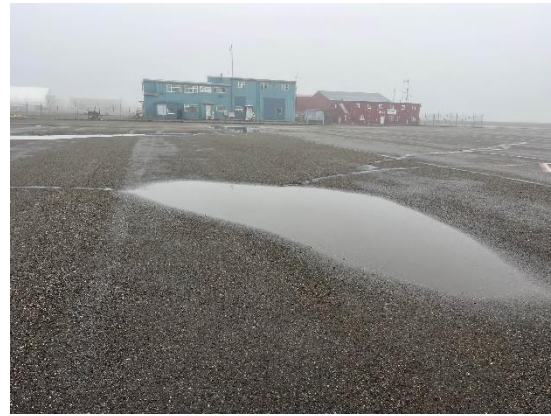
Branch ID	Branch Name	Branch Use	No. of Sections	Area (sf)	Weighted Average PCI
4100	Terminal Apron	Apron	1	752,700	72

The Terminal Apron was initially constructed in 1979 and underwent surface reconstruction in 2013. The most common distresses observed are low to medium severity depression, low to medium severity longitudinal and transverse cracking, low severity raveling, and low severity weathering. Field observations include the further deterioration of existing cracks showing the need for annual crack seal operations to continue and large isolated areas of standing water.

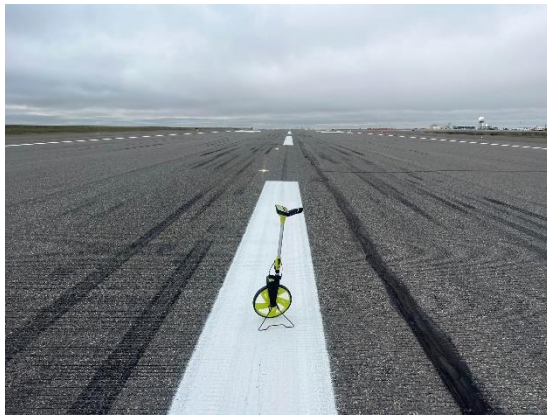
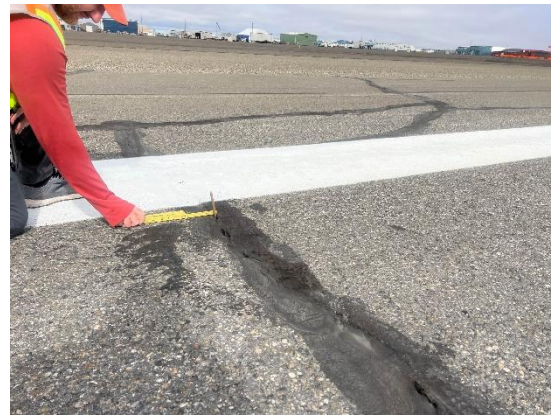
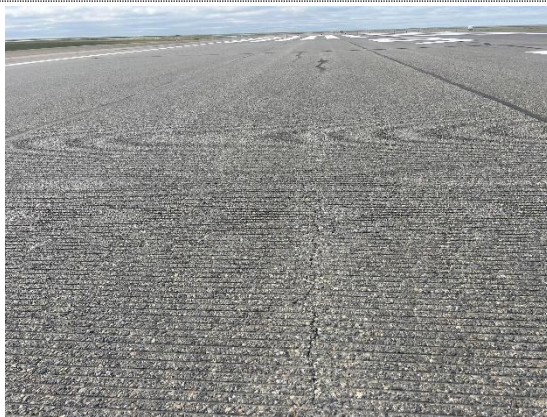
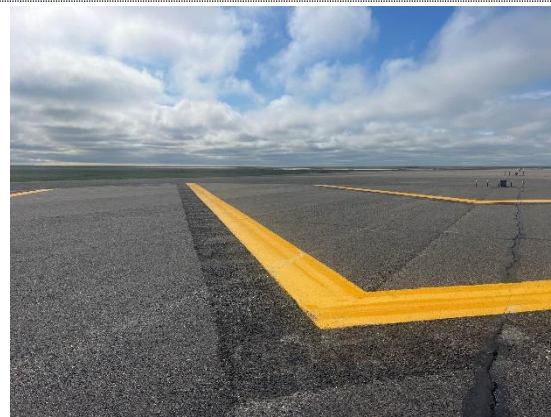
Branch ID	Branch Name	Branch Use	No. of Sections	Area (sf)	Weighted Average PCI
6100	Runway 06/24	Runway	5	1,055,000	74

Runway 06/24 was constructed in 1998 and underwent surface reconstruction in 2012. Annual crack seal operations have been performed on the branch since construction. The most common distresses observed are low to medium severity longitudinal and transverse cracking, low to medium severity raveling, and low severity weathering. Field observations include further deterioration of the top layer of asphalt, contributing to weathering being called during this inspection. Crack seal operations have been conducted, but some areas are starting to have the cracks open back up. When the initial paint was laid down on the blast pads it was in the wrong location, so it had to be grinded off and repainted, this has led to large quantities of raveling.
