## Alaska DOT&PF

# Pavement Inspection Report Dillingham Airport

Airport Name	IATA	ICAO	Latitude	Longitude	Elevation (ft)
Dillingham Airport	DLG	PADL	59° 2' 40.8" N	158° 30' 19.8" W	82

Point of Contact	Phone	Email	Date Inspected	Date Published
Mr. Andrew Pavey, Pavement Management Engineer	(907) 269 6213	andrew.pavey@alaska.gov	May 2023	September 2023

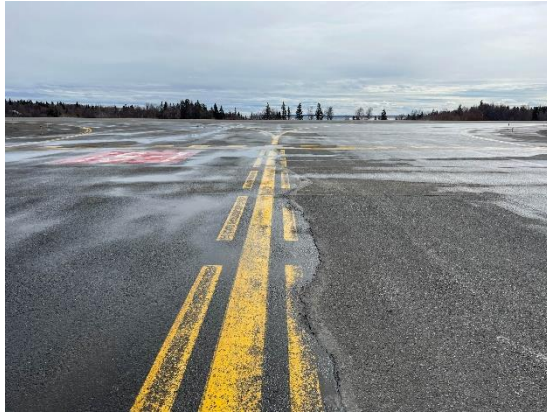
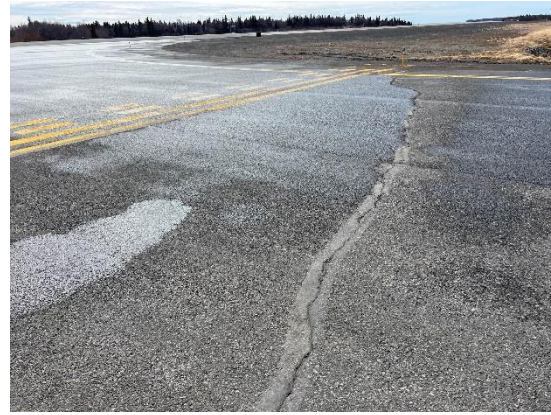
Branch ID	Branch Name	Branch Use	No. of Sections	Area (sf)	Weighted Average PCI
0100	Taxiway A	Taxiway	2	54,464	85

Taxiway A was initially constructed in 1987 and had surface reconstruction in 2011. Additionally, the taxiway had a partial reconstruction when the runway underwent a surface reconstruction in 2018. Annual crack seal operations have been performed on the branch. The most common distresses observed are low to medium severity longitudinal and transverse cracking and low severity weathering. Field observations include wearing surface course, development of new unfilled cracks, and widening of previously filled cracks.

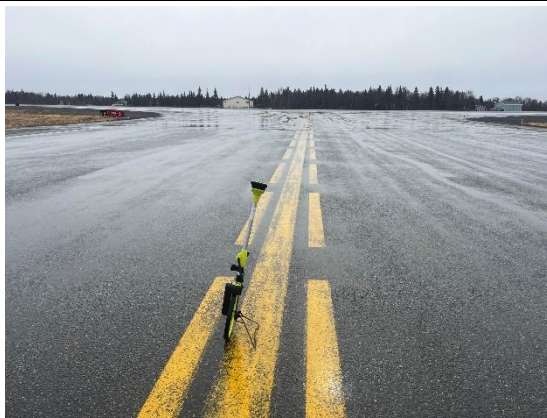
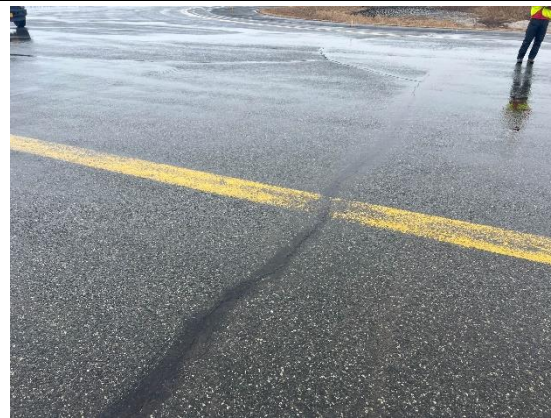
Branch ID	Branch Name	Branch Use	No. of Sections	Area (sf)	Weighted Average PCI
0200	Taxiway B	Taxiway	2	61,516	85

Like Taxiway A, Taxiway B was initially constructed in 1987 and had surface reconstruction in 2011. Additionally, the taxiway had a partial reconstruction when the runway underwent a surface reconstruction in 2018. Annual crack seal operations have been performed on the branch. The most common distresses observed are low to medium severity longitudinal and transverse cracking and low severity weathering. Field observations include wearing surface course, development of new unfilled cracks, and widening of previously filled cracks.

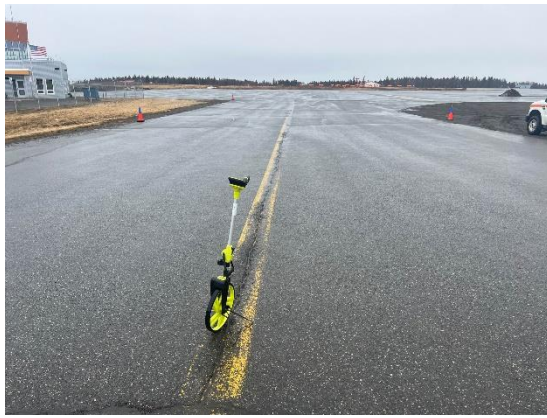
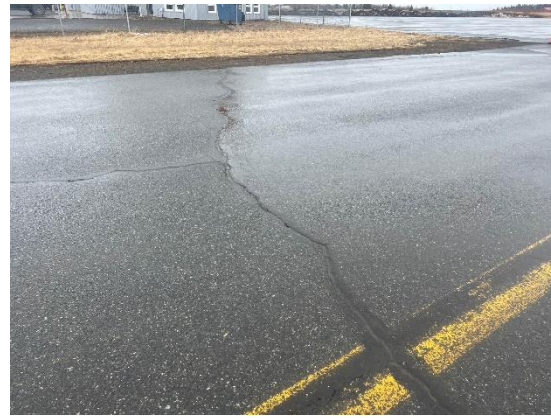
Branch ID	Branch Name	Branch Use	No. of Sections	Area (sf)	Weighted Average PCI
0300	Taxiway C	Taxiway	1	28,420	75

Taxiway C, which connects the general aviation gravel apron to the main paved apron, was originally constructed in 1987 and was reconstructed in 2011 together with Taxiways A and B. Annual crack seal operations have been performed on the branch. The most common distresses observed are low to medium severity longitudinal and transverse cracking, low severity raveling, and low severity weathering. Field observations include the creation of new unfilled cracks along the paving joints and the widening of previously filled cracks.

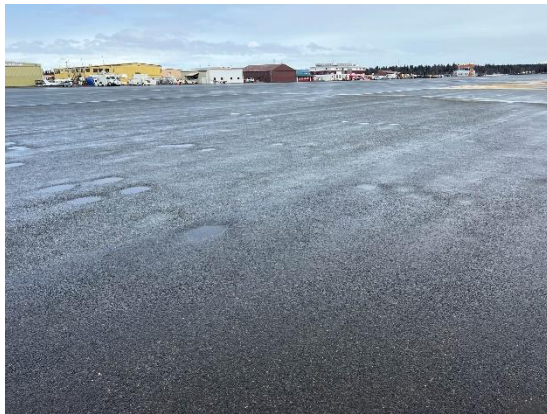
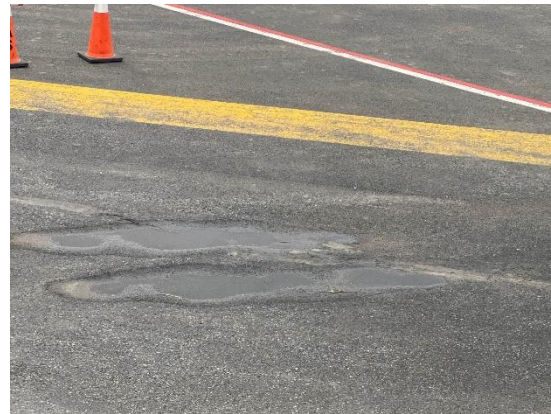
Branch ID	Branch Name	Branch Use	No. of Sections	Area (sf)	Weighted Average PCI
4100	Main Apron	Apron	1	790,500	80

The Main Apron was initially constructed in 1987 and underwent a surface reconstruction in 2011. Annual crack seal operations have been performed on the branch. The most common distresses observed are low severity depression, low to medium severity longitudinal and transverse cracking, low severity raveling, and low severity weathering. Field observations include dimpling across the apron creating areas of standing water, the development of new unfilled cracks, and the widening of previously filled cracks. Also, some low to medium rutting has formed where the commercial aviation loading and unloading operations are performed.

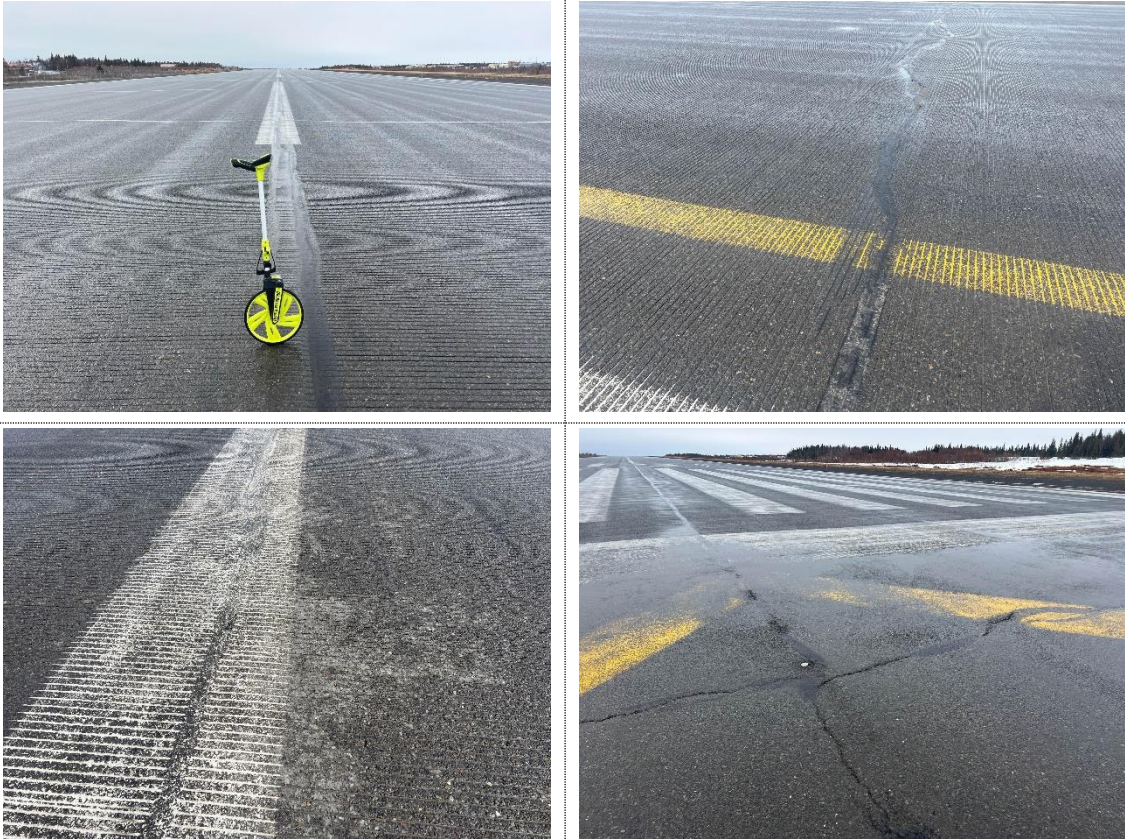
Branch ID	Branch Name	Branch Use	No. of Sections	Area (sf)	Weighted Average PCI
6100	Runway 01/19	Runway	5	1,032,000	86

Runway 01/19 was first built in 1987 and underwent surface reconstruction in 2018, including 4 inches of asphalt and 6 inches of foam stabilized base course. The most common distresses observed are low to medium severity longitudinal and transverse cracking, low severity raveling, and low severity weathering. Field pavement observations include development of new unfilled cracks, widening of previously filled cracks, and localized areas of raveling.
