# Alaska DOT&PF

## Pavement Inspection Report Fairbanks Airport

Airport Name	IATA	ICAO	Latitude	Longitude	Elevation (ft)
Fairbanks International Airport	FAI	PAFA	64° 48' 55.28" N	147° 51' 24.00" W	438.9

Point of Contact	Phone	Email	Date Inspected	Date Published
Mr. Andrew Pavey, Pavement Management Engineer	(907) 269 6213	andrew.pavey@alaska.gov	June 2024	August 2025

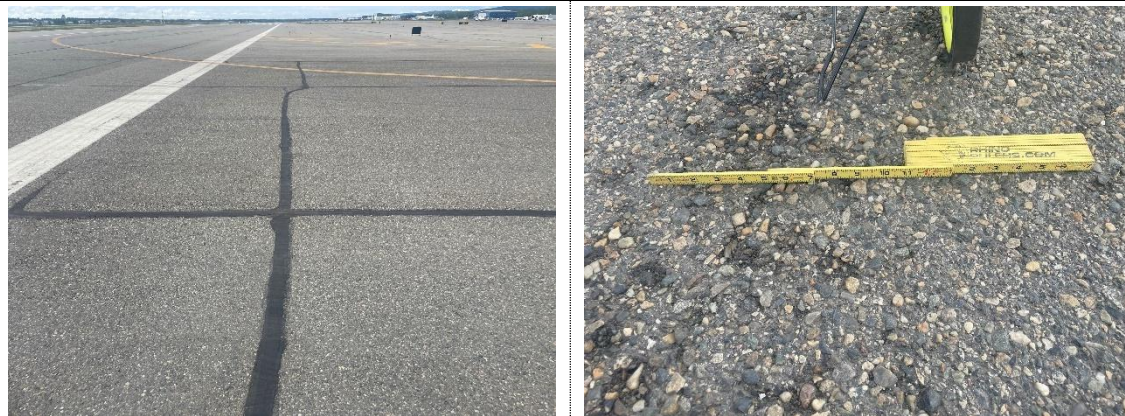
### Section 0100-00 (68 PCI), 0100-06 (68 PCI)

Taxiway A consists of seven sections, Sections 0100-00 through Section 0100-06. Sections 0100-00 and 0100-06 were constructed in 1996 and 1997 and were reconstructed in 2008. Routine crack seal operations have been performed on these sections. The most common distresses are low severity longitudinal and transverse cracking, low to medium severity raveling, and medium severity weathering. The pavement surface is developing new unfilled cracks outside the planned relief cuts. In addition, raveling of the coarse aggregate particles is progressing.

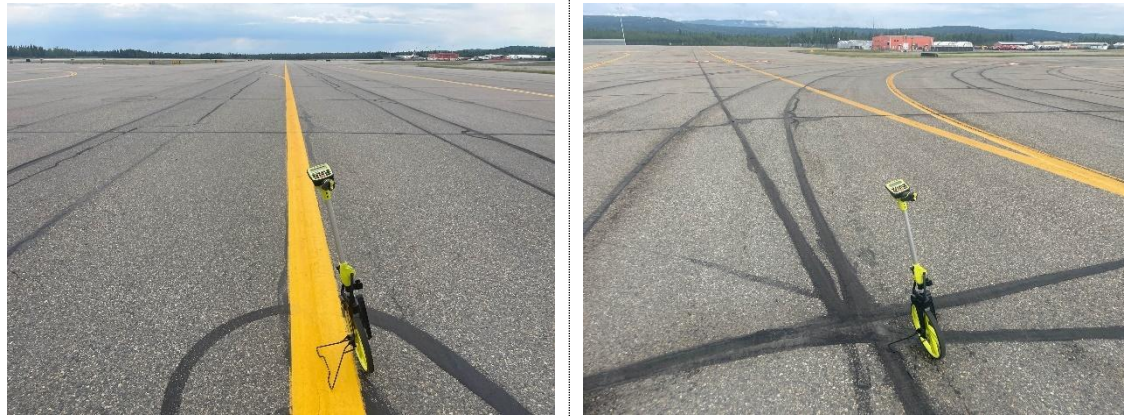
**Section 0100-01 (61 PCI), 0100-02 (61 PCI), 0100-04 (62 PCI)**

Sections 0100-01, 0100-02, and 0100-04 were most recently reconstructed in 2005. Routine crack seal operations have been performed on these sections. The most common distresses are low severity fatigue cracking, bleeding, low severity longitudinal and transverse cracking, low to medium severity raveling, and medium severity weathering. The pavement surface is developing new unfilled cracks outside the planned relief cuts. In addition, fatigue cracking is developing in high-traffic areas across these taxiway sections.

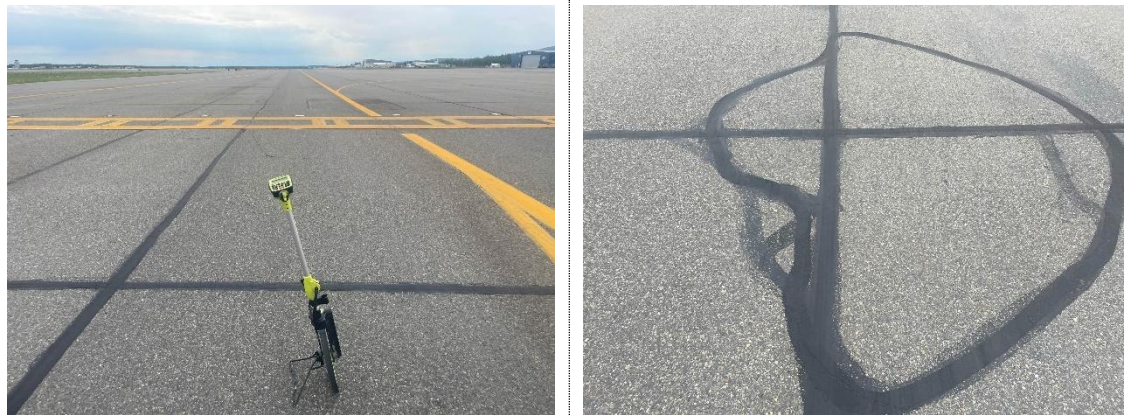
**Section 0100-03 (71 PCI)**

Section 0100-03 was originally constructed in 1961 and was most recently reconstructed in 2012. Routine crack seal operations have been performed on the section. The most common distresses are low severity longitudinal and transverse cracking, low severity raveling, and medium severity weathering. The pavement surface is developing new unfilled cracks outside the planned relief cuts. Pavement inspectors note the development of fatigue cracking in high-traffic areas across the section.

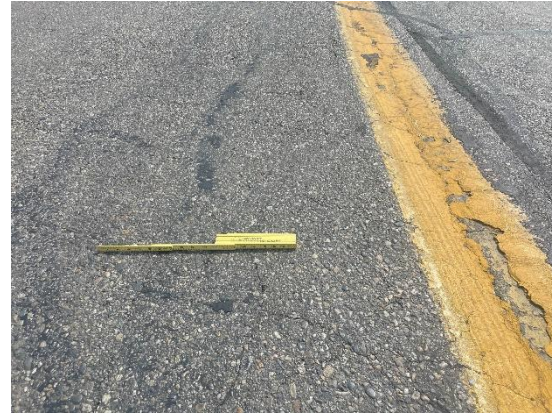
**Section 0100-05 (56 PCI)**

Section 0100-05 was constructed in 1996 and has not undergone any major work since. Routine crack seal operations have been performed on the section. The most common distresses are low severity fatigue cracking, low severity longitudinal and transverse cracking, low to medium severity raveling, and medium severity weathering. The pavement surface is developing new unfilled cracks outside the planned relief cuts. Also noted is the development of fatigue cracking in high-traffic areas across the section.

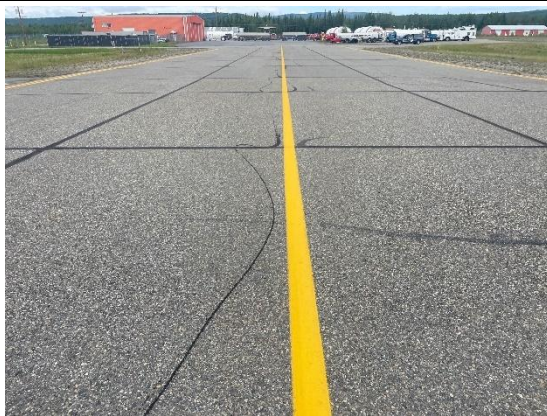
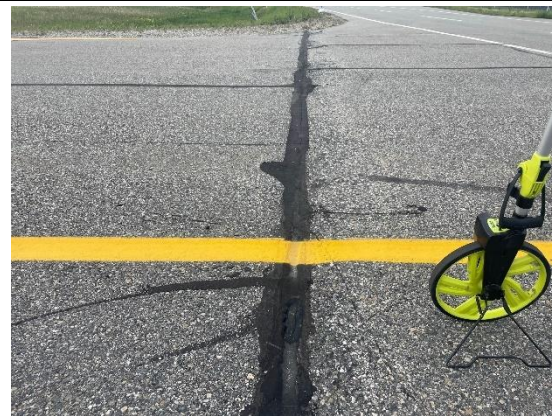
Taxiway South Elephant Ear was constructed in 1961 and consists of two sections, Section 0110-01 and Section 0110-02. Section 0110-01 was reconstructed in 2005, and Section 0110-02 received an AC overlay in 2012. Routine crack seal operations have been performed on the branch. The most common distresses are low severity longitudinal and transverse cracking, low to medium severity raveling, and low to medium severity weathering. Field observations include further deterioration of the AC surface and the commensurate increase in the quantity and severity of raveling and weathering across the branch.

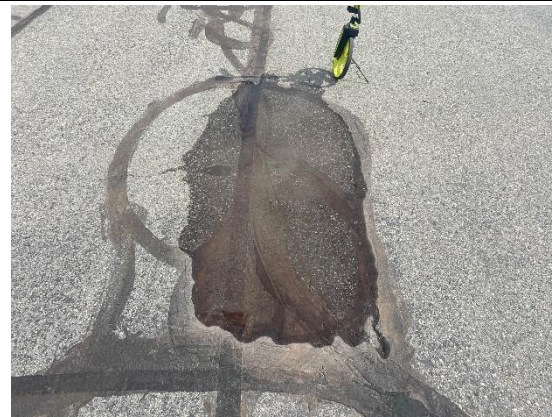
**AC Section 0120-01 (65 PCI)**

Taxiway Air Industrial Park consists of two sections, AC Section 0120-01 and portland cement concrete (PCC) Section 0120-02. AC Section 0120-01 was constructed in 1987 and was subsequently realigned and reconstructed in 2004. Routine crack seal operations have been performed on the section. The most common distresses are low to medium severity longitudinal and transverse cracking and low severity raveling. Pavement inspectors observed an increase in the amount of both longitudinal and fatigue cracking along the wheel paths on either side of the PCC hard stand.

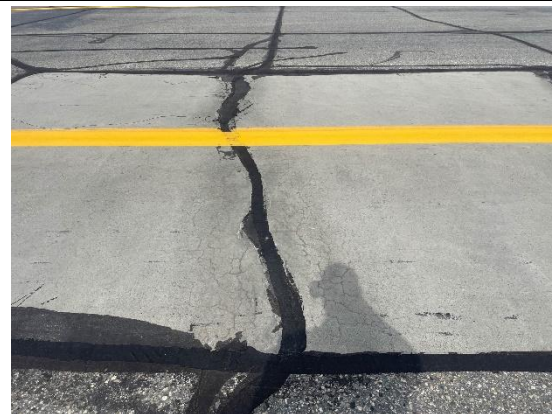
**PCC Section 0120-HS (63 PCI)**

PCC Section 0120-HS was initially constructed in 2004 and has not received any major work since. Routine crack and joint seal operations have been performed on the section. The most common distresses are low severity linear cracking, low severity durability cracking, low severity scaling, and medium severity corner spalling. Durability cracking has initiated along the panel joints as well as along linear cracks in the panels. Durability cracking indicates the PCC mixture, specifically the coarse aggregate, is incapable of holding up to expansive and contractive stresses during freezing and thawing. This distress will eventually lead to disintegration of the PCC hardstand and the likely generation of a FOD hazard to aircraft operations.

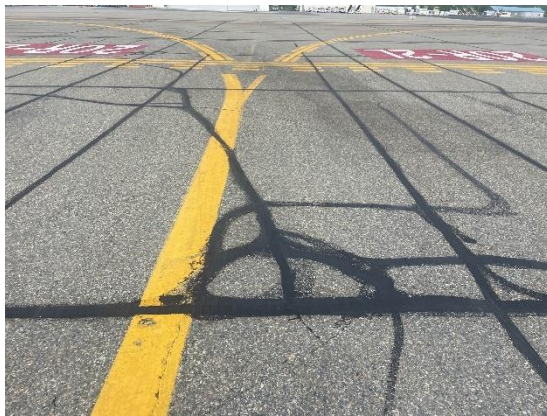
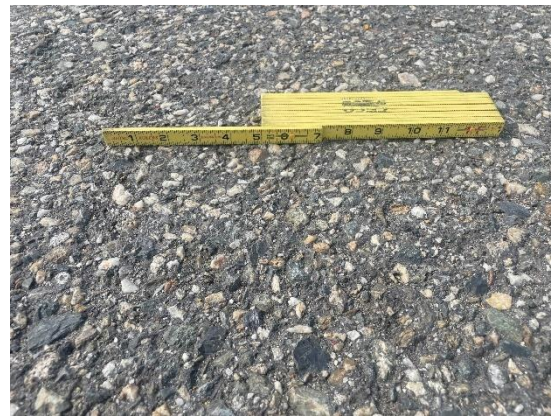
Taxiway South Mark Air was constructed in 1988 and consists of two sections, Section 0130-01 and Section 0130-02. Section 0130-01 was reconstructed in 2005 and Section 0130-02 received an AC overlay in 2012. Routine crack seal operations have been performed on the branch. The most common distresses are low severity longitudinal and transverse cracking, low to medium severity raveling, and low to medium severity weathering. The AC surface continues to deteriorate as evidenced by the higher quantity and severity of raveling and weathering across the branch.

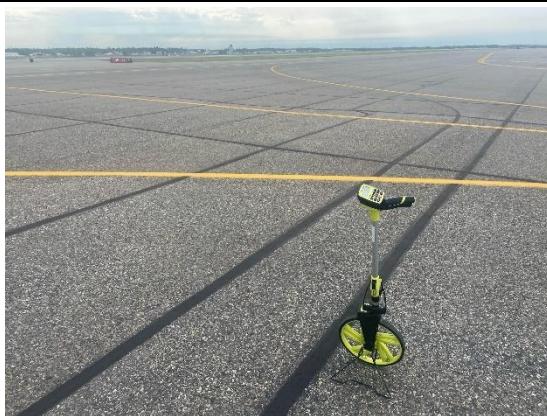
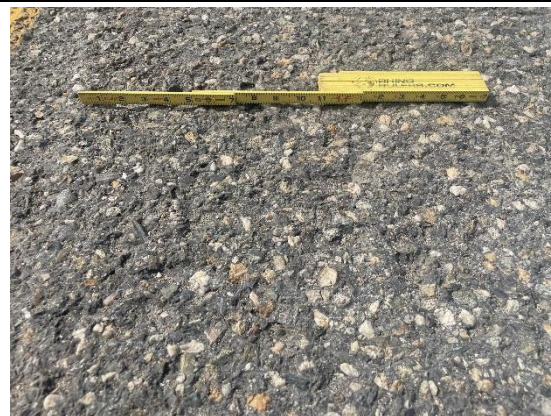
Taxiway North Old Mark Air was constructed in 1988 and consists of two sections, Section 0140-01 and Section 0140-02. Section 0140-01 was reconstructed in 2005 and Section 0140-02 received an AC overlay in 2012. Routine crack seal operations have been performed on the branch. The most common distresses are low severity longitudinal and transverse cracking, low to medium severity raveling, and low to medium severity weathering. The AC surface continues to deteriorate as evidenced by the higher quantity and severity of raveling and weathering across the branch.

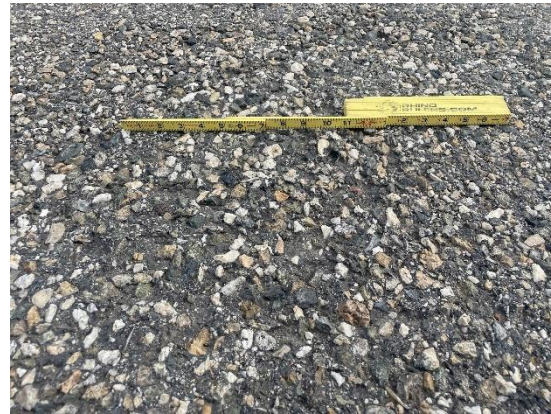
Taxiway Frontier Air was constructed in 1988 and consists of two sections, Section 0150-01 and Section 0150-02. Both sections were reconstructed in 2005. Routine crack seal operations have been performed on the branch. The most common distresses are low severity longitudinal and transverse cracking, low to medium severity raveling, and medium severity weathering. The AC surface continues to deteriorate as evidenced by the higher quantity and severity of raveling and weathering across the branch.

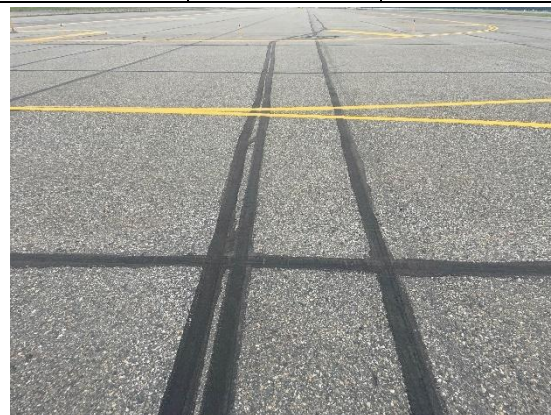
Taxiway T1 was constructed in 1991 and in 2005 was subsequently realigned and reconstructed. Routine crack seal operations have been performed on the branch. The most common distresses are low severity longitudinal and transverse cracking, low to medium severity raveling, and medium severity weathering. The AC surface continues to deteriorate as evidenced by the higher quantity and severity of raveling and weathering across the branch.

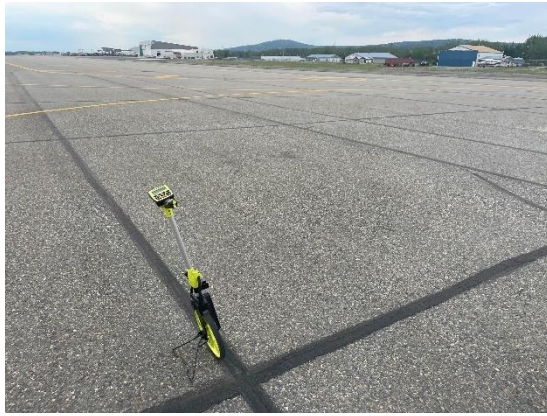
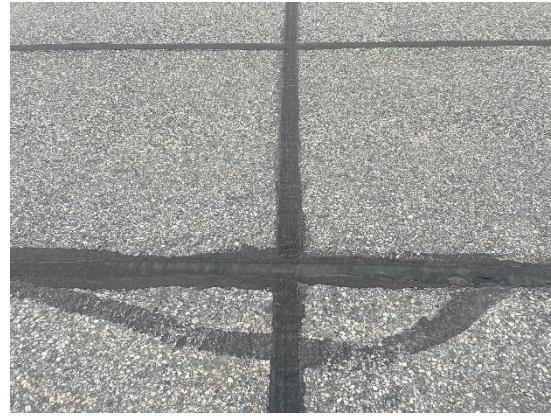
Taxiway T2 was constructed in 2005 and has not received any major work since. Routine crack seal operations have been performed on the branch. The most common distresses are low severity longitudinal and transverse cracking, low severity raveling, and medium severity weathering. The AC surface continues to deteriorate and the amount and severity of raveling and weathering continues to increase across the branch.

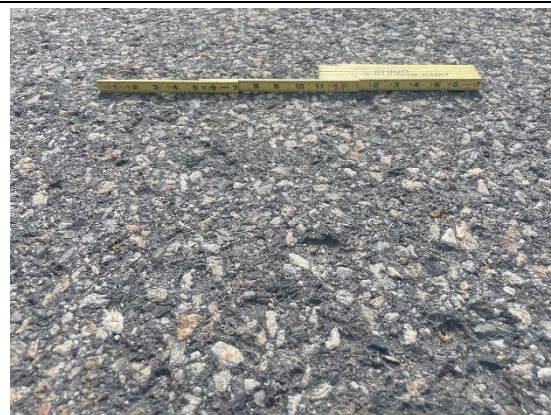
**Section 0200-02 (67 PCI), 0200-03 (63 PCI)**

Taxiway B connects the West Ramp to the East Ramp and consists of eight sections, Sections 0200-01 through 0200-08. Section 0200-02 and Section 0200-03 were both originally constructed in 1950 and received overlays in 1987. Section 0200-03 was reconstructed in 2005 and Section 0200-02 was reconstructed in 2008. Routine crack seal operations have been performed on these sections. The most common distresses are low severity longitudinal and transverse cracking, low to medium severity raveling, and medium severity weathering. The pavement surface is developing new unfilled cracks outside the planned relief cuts. In addition, raveling of the coarse aggregate particles is progressing.

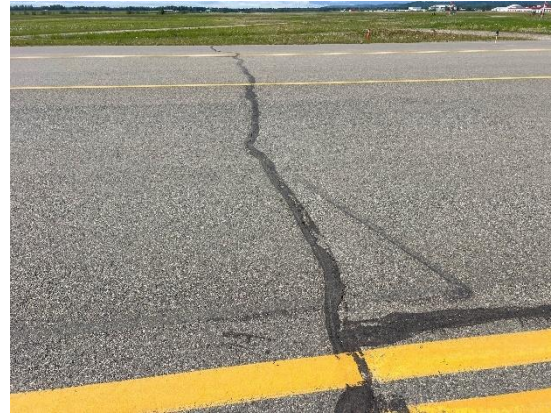
**Section 0200-01 (84 PCI), 0200-04 (86 PCI), 0200-06 (79 PCI)**

Originally constructed in 1975, Taxiway B Sections 0200-01, 0200-04, and 0200-06 were reconstructed in 2018. Routine crack seal operations have been performed on these sections. The most common distresses are low severity longitudinal and transverse cracking, low severity raveling, and low to medium severity weathering. Transverse cracks are developing across the width of the taxiway.

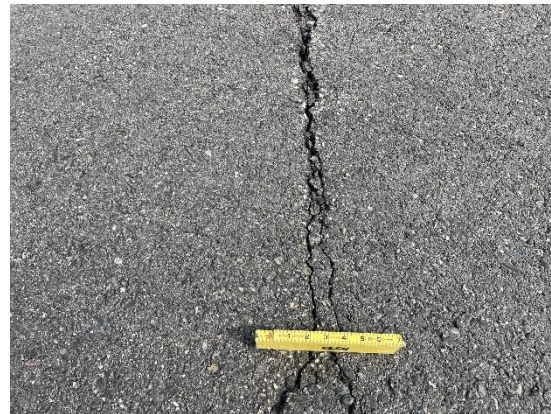
**Section 0200-05 (91 PCI), 0200-08 (82 PCI)**

Taxiway B Section 0200-05 was constructed in 1975 and was reconstructed in 2022. Section 0200-08 was constructed as part of the 2008 project. Crack seal operations have yet to be performed on these sections. The most common distresses are low severity longitudinal and transverse cracking, low severity raveling, and low to medium severity weathering. Transverse cracks are developing across the width of the taxiway.

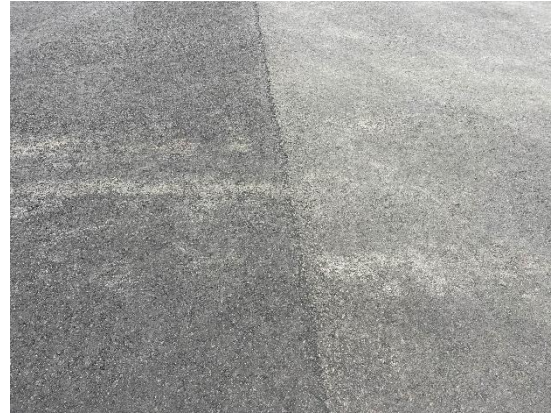
**Section 0200-07 (100 PCI)**

Taxiway B Section 0200-07 was constructed in 1970 and reconstructed through a process of full depth reclamation in 2023. Pavement inspectors observed no distresses during the inspection.

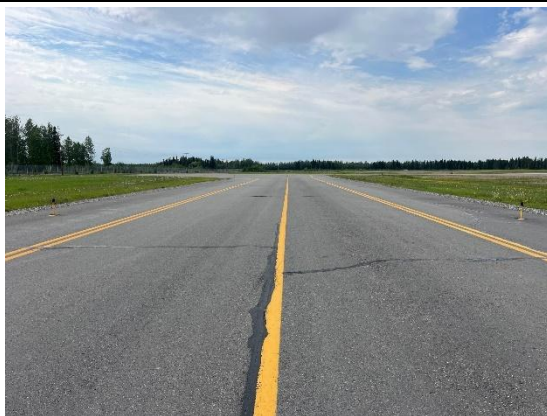
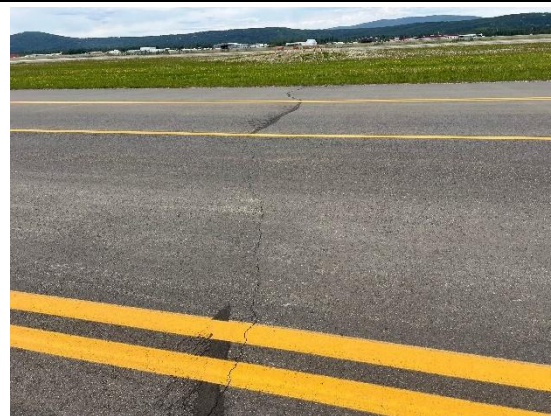
**Section 0300-01 (86 PCI), 0300-06 (80 PCI)**

Taxiway C includes five sections, Section 0300-01 through 0300-04 and Section 0300-06. Sections 0300-01 were originally constructed in 1985. In 2002 Section 0300-01 was reconstructed and Section 0300-06 was initially constructed. Both sections received an AC overlay in 2022. Routine crack seal operations have been performed on these sections. The most common distresses are low severity longitudinal and transverse cracking, low severity raveling, and low severity weathering. Transverse cracks are developing across the width of the taxiway.

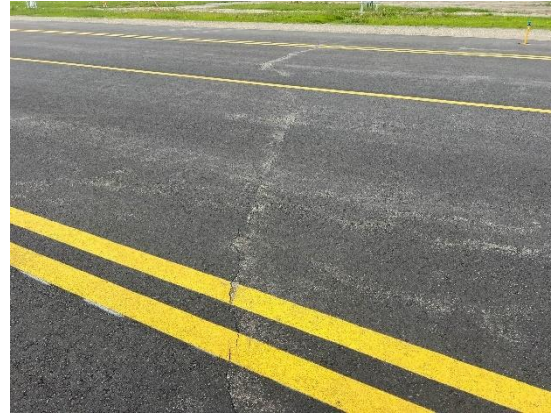
**Section 0300-02 (98 PCI), 0300-03 (100 PCI), 0300-04 (100PCI)**

Taxiway C Sections 0300-02, 0300-03, and 0300-04 were reconstructed through a process of full depth reclamation in 2023. Crack seal operations have yet to be performed on these sections. The most common distress is low severity longitudinal and transverse cracking. Transverse cracks are developing across the width of the taxiway.

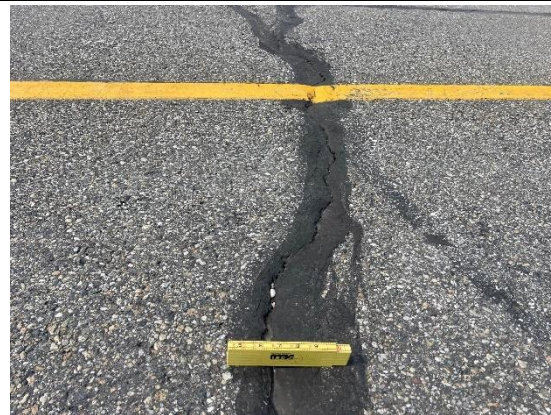
The Fish and Wildlife Services (FWS) Taxiway was initially constructed in 1985 and has not received any major work since. Routine crack seal operations have been performed on the branch. The most common distresses are low severity block cracking, low to medium severity longitudinal and transverse cracking, low severity raveling, and low to medium severity weathering. The pavement surface is developing new unfilled cracks and raveling of the coarse aggregate particles is progressing.

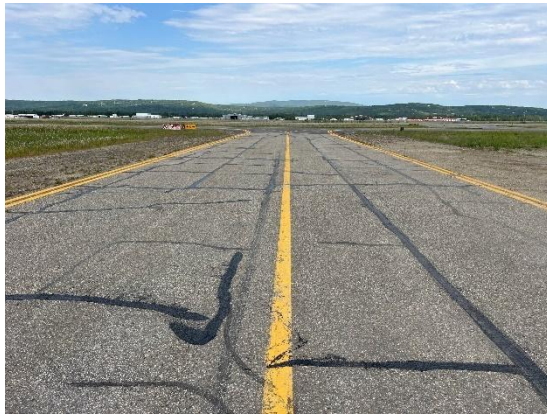
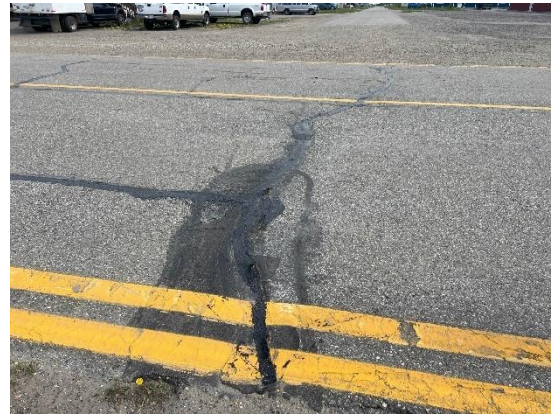
The Old Smith Air Service Taxiway was constructed in 1985 and has not received any major work since. Routine crack seal operations have been performed on the branch. The most common distresses are low severity block cracking, low to medium severity longitudinal and transverse cracking, low to medium severity raveling, and low severity weathering. The pavement surface is developing new unfilled cracks outside the planned relief cuts. In addition, raveling of the coarse aggregate particles is progressing.

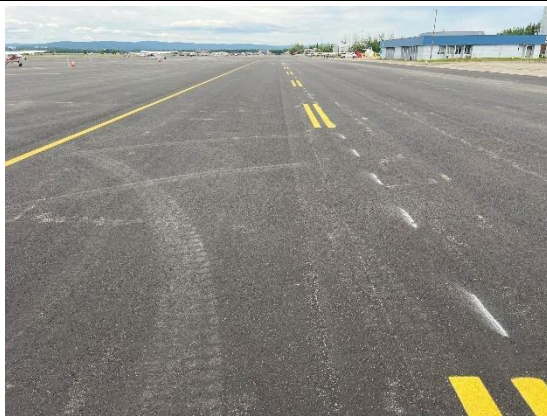
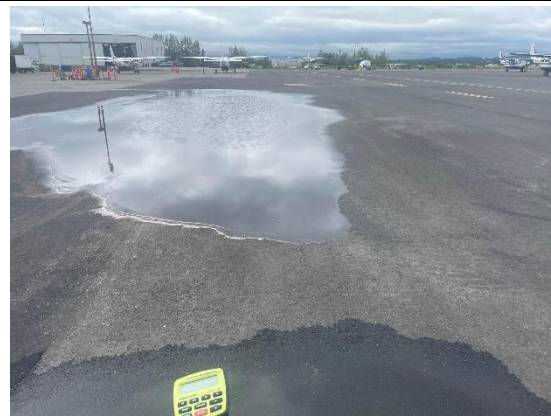
Taxiway D consists of three sections, Sections 0400-01 through 0400-03. Originally constructed during the period 1970 to 1998, TW D was reconstructed in 2023 through a process of full depth reclamation. Crack seal operations have yet to be performed on the branch. The most common distress is a number of low to medium severity depressions. A large depression was observed with standing water at the edge of TW D near the Wright Air Services lot.

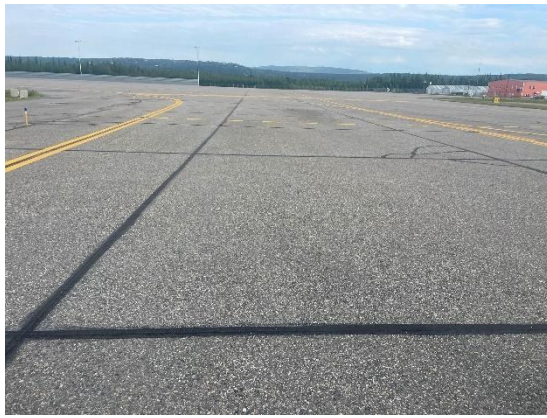
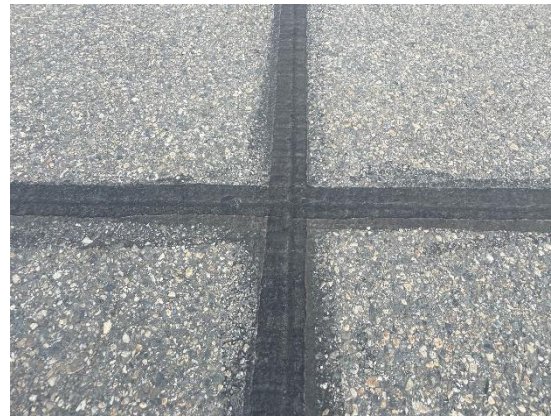
Taxiway E was constructed in 2007 and has not received any major work since. Routine crack seal operations have been performed on the branch. The most common distresses are low severity depressions, low severity longitudinal and transverse cracking, and low to medium severity weathering. The pavement surface is developing new unfilled cracks outside the planned relief cuts.

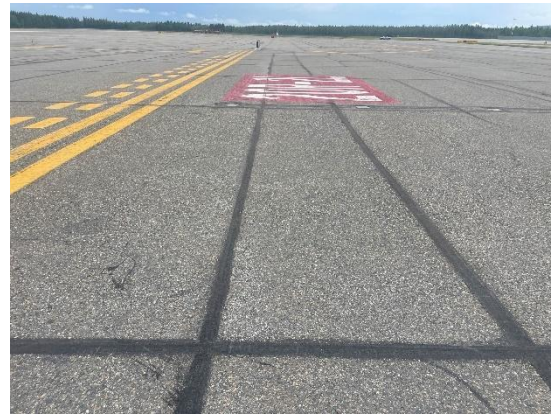
Taxiway F is made up of two sections, Section 0600-01 and Section 0600-02. Both sections were constructed in 1997. Section 0600-02 was constructed in 2005 and Section 0600-01 was reconstructed in 2008. Routine crack seal operations have been performed on the branch. The most common distresses observed are low severity block cracking, low severity longitudinal and transverse cracking, low severity raveling, and medium severity weathering. The pavement surface is developing new unfilled cracks outside the planned relief cuts. In addition, raveling of the coarse aggregate particles is progressing.

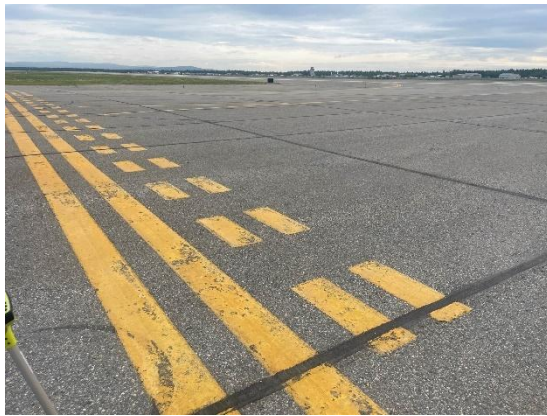
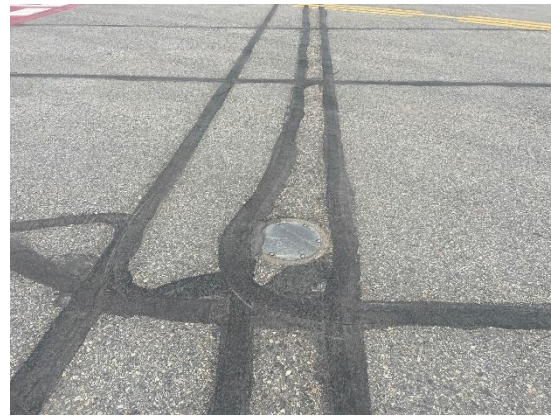
Taxiway G consists of two sections, Section 0700-01 and Section 0700-02, which were both originally constructed in 1987. Section 0700-02 was reconstructed in 2005 and Section 0700-01 was reconstructed in 2008. Routine crack seal operations have been performed on the branch. The most common distresses are low severity longitudinal and transverse cracking, low to medium severity raveling, and medium severity weathering. The pavement surface is developing new unfilled cracks outside the planned relief cuts. In addition, raveling of the coarse aggregate particles is progressing.

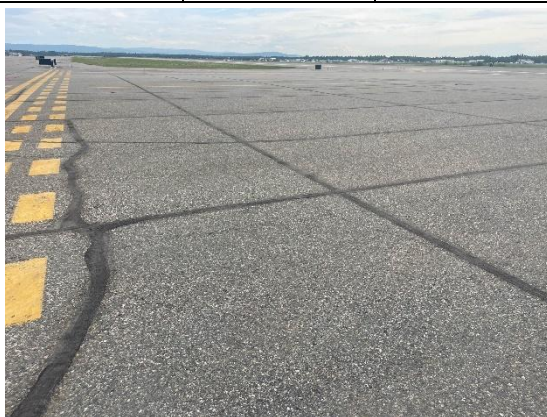
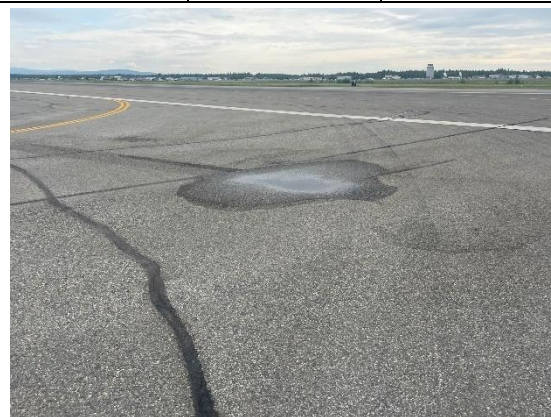
Taxiway H includes two sections, Section 0800-01 and Section 0800-02 which were both originally constructed in 1987. Section 0800-02 was reconstructed in 2005, and Section 0800-01 was reconstructed in 2008. Routine crack seal operations have been performed on the branch. The most common distresses are low to medium severity depressions, low severity longitudinal and transverse cracking, low severity raveling, and medium severity weathering. The pavement surface is developing new unfilled cracks outside the planned relief cuts. In addition, raveling of the coarse aggregate particles is progressing. Furthermore, several depressions with standing water were observed along the taxiway.

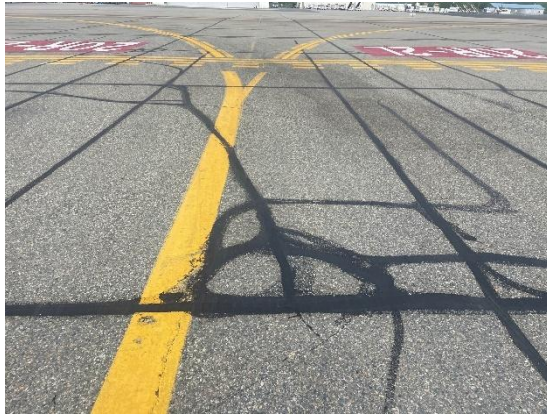
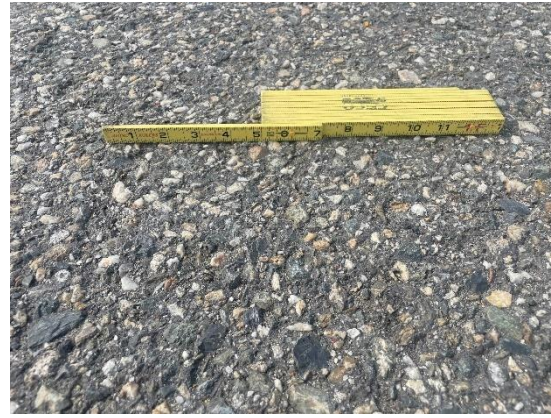
Taxiway M consists of two sections, Section 1300-01 and Section 1300-02, which were both constructed originally in 1987. Section 1300-02 was reconstructed in 2005, and Section 1300-01 was reconstructed in 2008. Routine crack seal operations have been performed on the branch. The most common distresses are low severity depression, low severity longitudinal and transverse cracking, low to medium severity raveling, and medium severity weathering. The pavement surface is developing new unfilled cracks outside the planned relief cuts. In addition, raveling of the coarse aggregate particles is progressing.

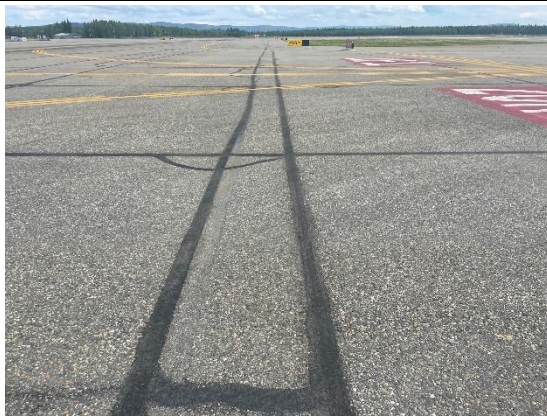
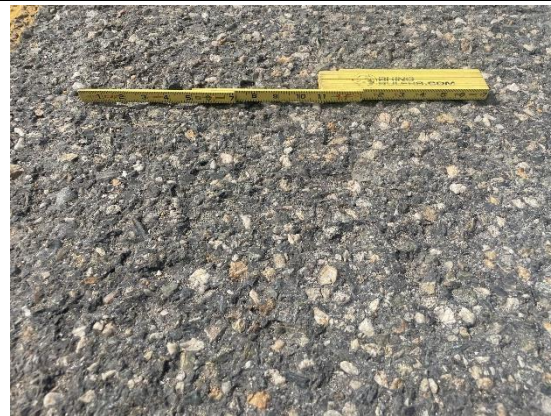
Taxiway N is made up of three sections, Section 1400-01 through Section 1400-03. Sections 1400-01 and 1400-02 were originally constructed in 1987 and Section 1400-03 was added in 1991. Sections 1400-02 and 1400-03 were reconstructed in 2005 and Section 1400-01 was reconstructed in 2008. Routine crack seal operations have been performed on the branch. The most common distresses observed are low severity depression, low severity longitudinal and transverse cracking, low to medium severity raveling, and medium severity weathering. The pavement surface is developing new unfilled cracks outside the planned relief cuts. In addition, raveling of the coarse aggregate particles is progressing.

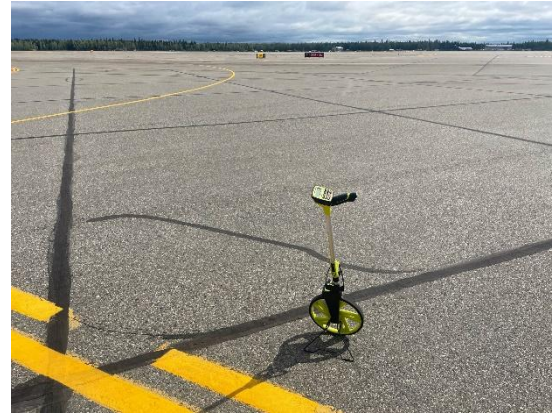
**AC Section 1600-01 (70 PCI), 1600-02 (65 PCI), 1600-03 (62 PCI), 1600-04 (73 PCI)**

Taxiway P consists of five sections, AC Sections 1600-01 to 1600-04 and PCC Section 1600-HS. Sections 1600-01 and 1600-02 were originally constructed in 1987, 1600-03 in 2004 and 1600-04 in 2012. Section 1600-02 and 1600-01 were reconstructed in 2005 and 2008, respectively. Sections 1600-03 and 1600-04 have not received any major work yet. Routine crack seal operations have been performed on these sections. The most common distresses are low severity fatigue cracking, low severity block cracking, low severity longitudinal and transverse cracking, low to medium severity raveling, and low to medium severity weathering. Pavement inspectors noted the increase in the amount of both longitudinal cracking and fatigue cracking along the wheel paths on either side of the PCC hard stand.

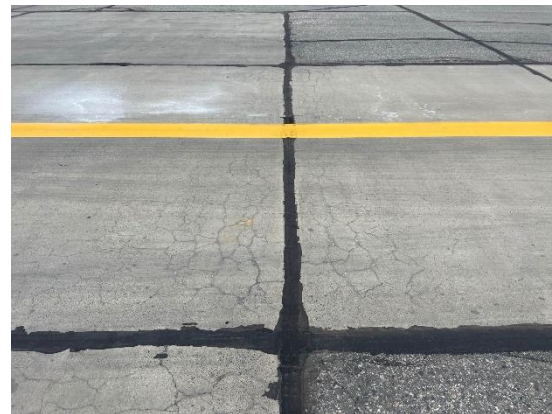
**PCC Section 1600-HS (75 PCI)**

PCC Section 1600-HS was originally constructed in 2004 and has not received any major work since. Routine crack and joint seal operations have been performed on the section. The most common distresses are low severity linear cracking, low severity durability cracking, and shrinkage cracking. Durability cracking has initiated along the panel joints as well as along linear cracks in the panels. This distress will eventually lead to deterioration of the PCC hardstand and the likely generation of a FOD hazard to aircraft operations.

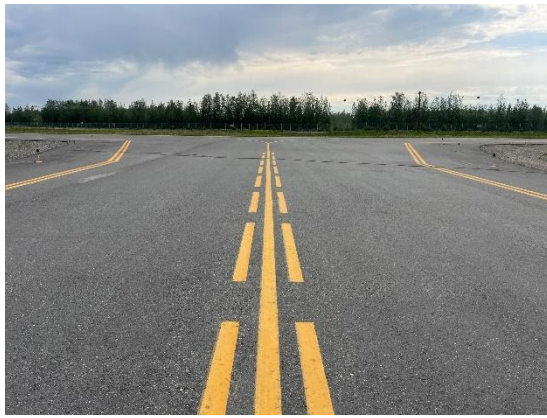
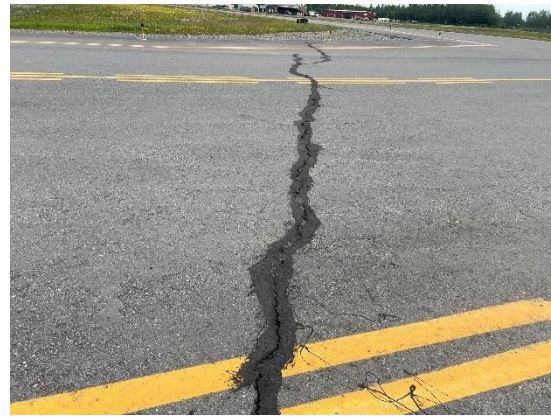
Taxiway Q was constructed in 2002 and in 2022 received 4 inches of full depth reclamation (FDR) followed by a 3-inch thick AC overlay (this was a surface rehabilitation strategy applied to a number of taxiway branches in 2022). Routine crack seal operations have been performed on the branch. The most common distresses are low severity longitudinal and transverse cracking and low severity weathering. Transverse cracks are developing across the width of the taxiway.

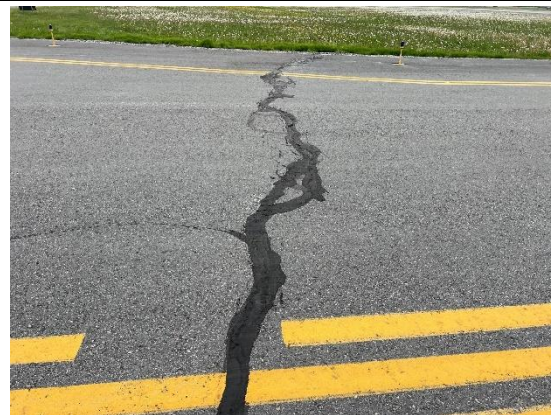
Taxiway R was originally constructed in 1985, reconstructed in 2002 and subsequently received an AC resurfacing in 2022 consisting of 4 inches of FDR and a 3-inch thick AC overlay. Routine crack seal operations have been performed on the branch. The most common distresses are low severity longitudinal and transverse cracking and low severity weathering. Transverse cracks are developing across the width of the taxiway.

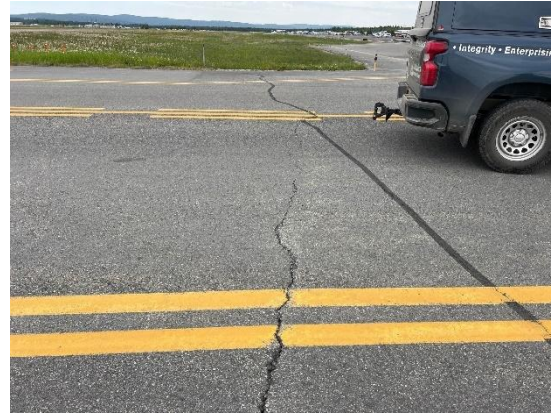
#### Section 1900-01 (89 PCI)

Taxiway S consists of two sections, Section 1900-01 and Section 1900-02. Section 1900-01 was originally constructed in 2002 and was resurfaced in 2022 (4 inches FDR followed by a 3-inch thick AC overlay). Routine crack seal operations have been performed on the section. The most common distresses are low severity longitudinal and transverse cracking and low severity weathering. Transverse cracks are developing across the width of the taxiway.

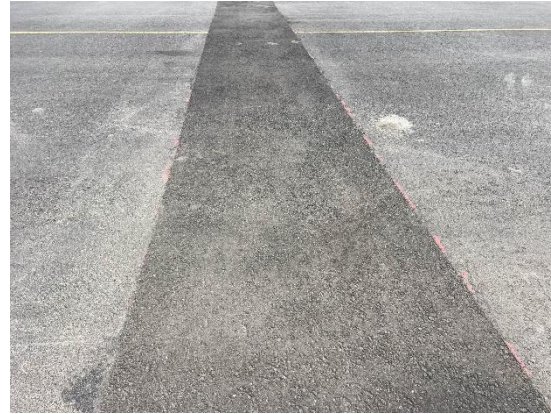
#### Section 2000-01 (90 PCI)

Taxiway T is composed of two sections, Section 2000-01 and Section 2000-02. Section 2000-01 was originally constructed in 2002 and in 2022 received AC resurfacing (4 inches of FDR following by a 3-inch thick AC overlay). Routine crack seal operations have been performed on the section. The most common distresses are low severity patching and low severity weathering. A utility patch spans the width of the taxiway.

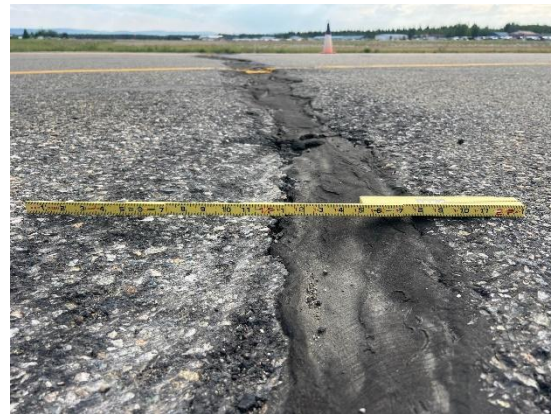
#### Section 2000-02 (52 PCI)

Taxiway T Section 2000-02 was initially constructed in 2002 and has not received any major work since. Routine crack sealing has been performed on the section. The most common distresses are low severity block cracking, low severity patching, low severity raveling, and medium severity weathering. Pavement inspectors observed that a high severity sealed transverse crack extends across the width of the taxiway. The pavement adjacent to the crack is fragmented and is raveling. Inspectors also noted that a utility patch spans the width of the taxiway.

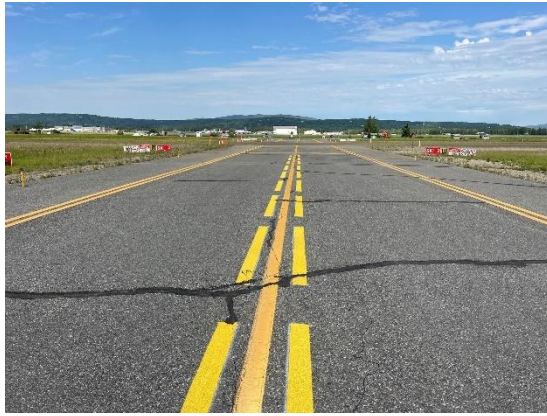
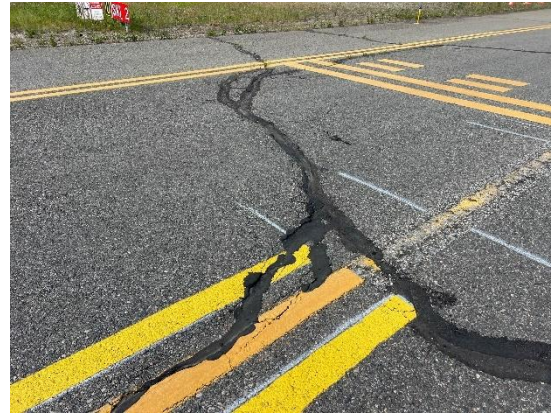
Taxiway U was initially constructed in 2005 and has not received any major work since. Routine crack seal operations have been performed on the branch. The most common distresses are low to medium severity longitudinal and transverse cracking, low severity patching, low severity raveling, and low to medium severity weathering. Pavement inspectors noted several transverse cracks and a utility patch that span the width of the taxiway.

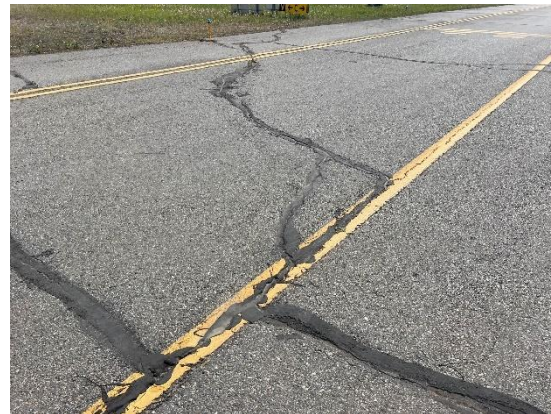
Taxiway V was initially constructed in 2002 and has not received any major work since. Routine crack seal operations have been performed on the branch. The most common distresses are low to medium severity longitudinal and transverse cracking, low severity patching, low severity raveling, and low to medium severity weathering. Pavement inspectors noted several transverse cracks and a utility patch that span the width of the taxiway.

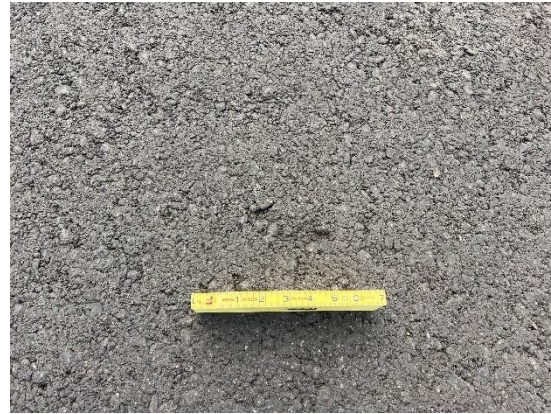
**Section 2300-01 (100 PCI), 2300-02 (100 PCI)**

Taxiway W is composed of three sections, Sections 2300-01 through 2300-03. Sections 2300-01 and 2300-02 were constructed in 2002 and were reconstructed using a full-depth reclamation process in 2023. Crack seal operations have yet to be performed on these sections. No distresses were observed during the inspection.

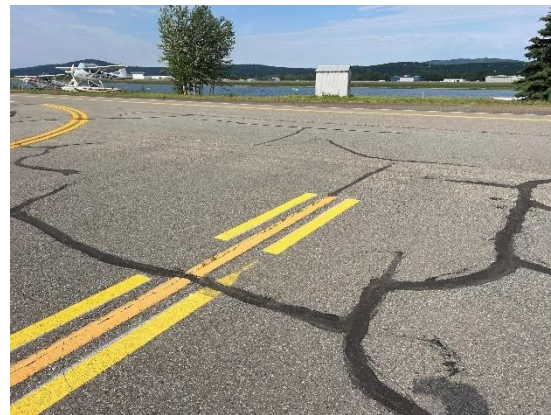
**Section 2300-03 (72 PCI)**

Taxiway W Section 2300-03 was constructed in 2002 and has not received any major work since. Crack seal operations have yet to be performed on the section. The most common distresses are low to medium severity longitudinal and transverse cracking, low severity patching, low severity raveling, and low severity weathering. Pavement inspectors noted several transverse cracks and a utility patch that span the width of the taxiway.

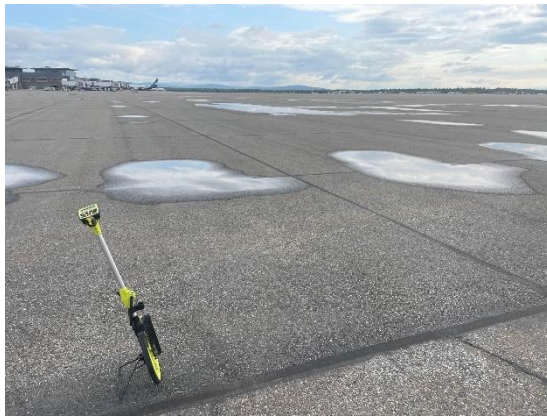
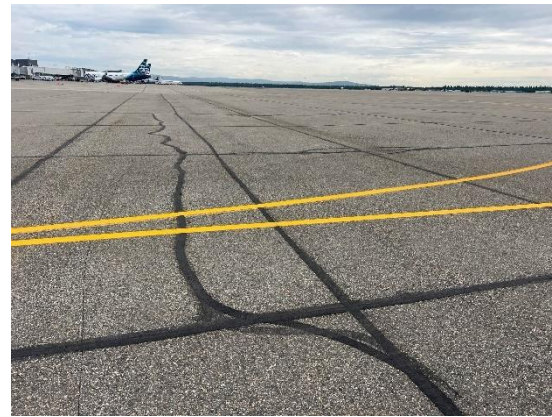
**AC Sections 4100-01 (66 PCI), 4100-02 (64 PCI), 4100-03 (64 PCI), 4100-04 (63 PCI), 4100-05 (73 PCI), 4100-06 (63 PCI), 4100-07 (67 PCI), 4100-08 (71 PCI)**

The West Ramp consists of 14 sections including eight AC Sections and six PCC sections. AC Sections 4100-01 through 4100-08 were most recently constructed or reconstructed during the period 2006 to 2012. Routine crack seal operations have been performed on these sections. The most common distresses observed are low severity block cracking, low to medium severity depressions, low severity longitudinal and transverse cracking, oil spillage, low to medium severity raveling, and low to medium severity weathering. The pavement surface is developing new unfilled cracks outside the planned relief cuts. In addition, raveling of the coarse aggregate particles is progressing. Furthermore, several depressions with standing water were observed along the taxiway.

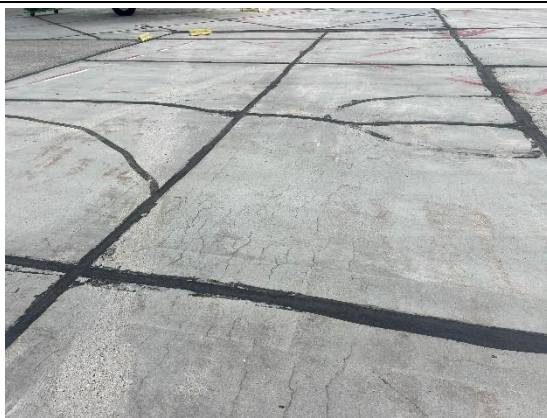
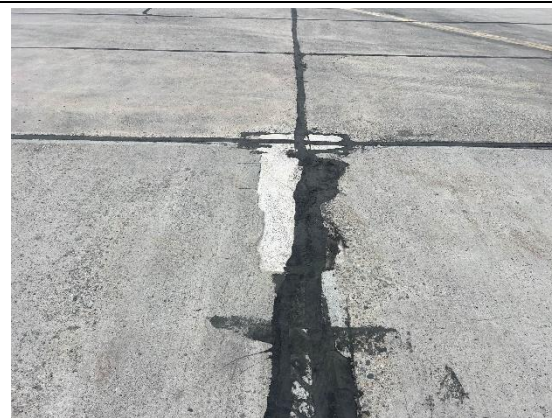
**PCC Section 4100-C1 (72 PCI), 4100-C2 (78 PCI), 4100-C3 (68 PCI)**

West Ramp PCC Sections 4100-C1, 4100-C2, 4100-C3 were constructed in 1960 and were subsequently reconstructed in 1990. Localized patching and slab replacements as well as routine crack and joint sealing has been performed on these sections. The most common distresses are low to medium severity linear cracking, low severity durability cracking, low severity small and large patching, low to medium severity scaling, low severity shattered slab, low to medium joint and corner spalling, and low severity alkali silica reaction (ASR). Inspectors noted the presence of durability cracking and ASR along the joints and linear cracks. These distresses can eventually lead to the disintegration of the PCC and generation of FOD.

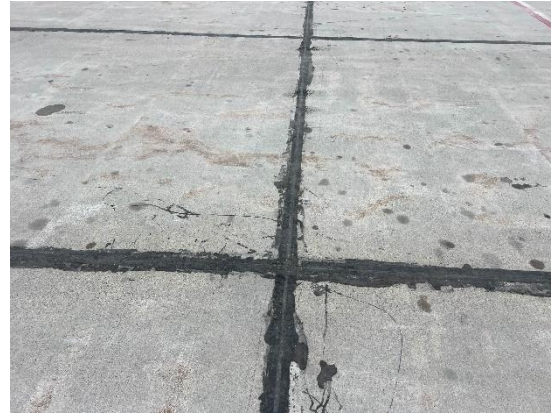
**PCC Section 4100-C4 (92 PCI), 4100-C5 (92 PCI)**

West Ramp PCC Sections 4100-C4 and 4100-C5 were constructed in 2007 and have not received any major work since. Routine crack and joint seal operations have been performed on these sections. The most common distresses observed are low severity scaling and low severity joint spalling. Pavement inspectors observed low severity scaling, which manifests as delamination of the slab surface.

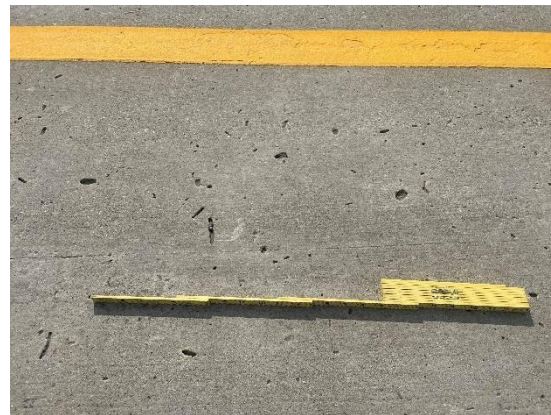
The West Ramp PCC Section 4100-HS was originally constructed in 1964 and was reconstructed in 2012. Routine crack and joint seal operations have been performed on the section. The most common distresses are low severity linear cracks, low severity popouts, and low severity scaling. Pavement inspectors noted that several slabs exhibited popouts, which are small pieces of aggregate that break loose from the pavement surface due to freeze-thaw action, potentially in combination with expansive aggregates.

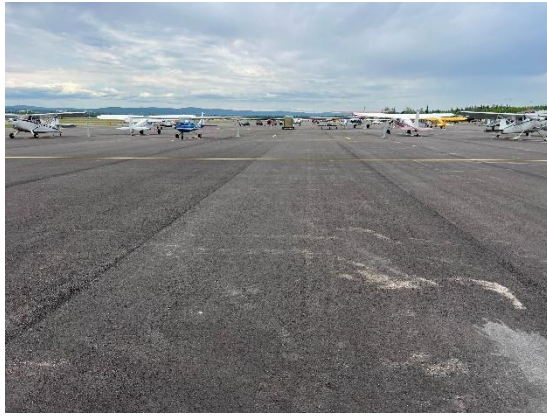
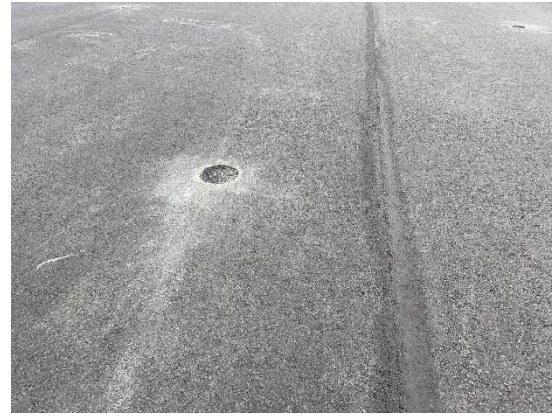
The East Ramp is made up of three sections, Section 4200-01 through 4200-03. Original construction of the East Ramp dates back to 1970. In 2023, the branch was reconstructed using the process of full depth reclamation. Crack seal operations have yet to be performed on the branch. Pavement inspectors observed no distresses other than a few core hole patches.

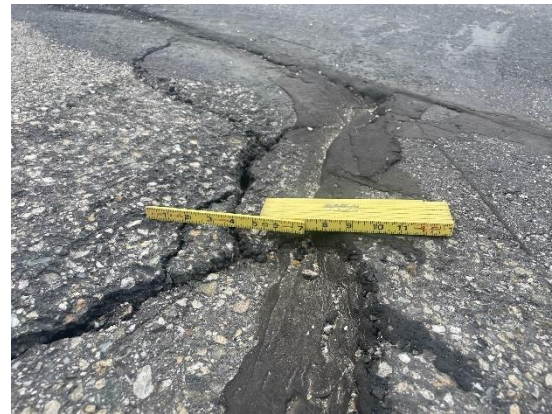
The North West Ramp has not received any major work since its initial construction in 2012. Routine crack seal operations have been performed on the branch. The most common distresses are low severity longitudinal and transverse cracking, low to medium severity raveling, and low severity weathering. The pavement surface is developing new unfilled cracks outside the planned relief cuts. In addition, raveling of the coarse aggregate particles is progressing. Pavement inspectors observed a high severity sealed crack in which the pavement adjacent to the crack is fragmented and is raveling.

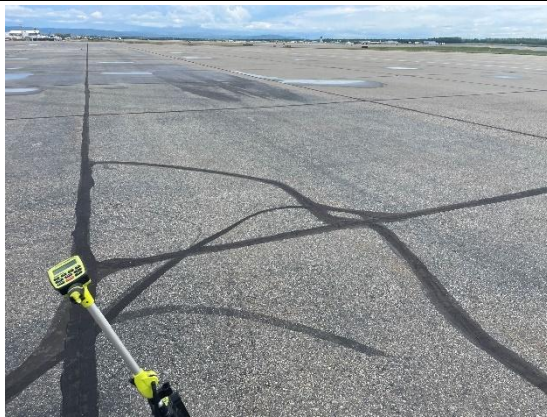
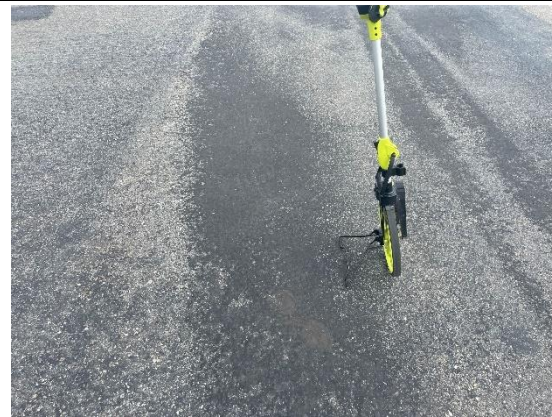
The Heavy Aircraft Cargo Apron consists of two sections, AC Section 4400-01 and PCC Section 4400-HS. AC Section 4400-01 was constructed in 2007 and has not received any major work since. Routine crack seal operations have been performed on the section. The most common distresses are bleeding, low severity depressions, low severity longitudinal and transverse cracking, and low severity weathering. Large areas on the parking apron exhibit bleeding, which occurs when the AC mix has less than optimal air voids and the asphalt binder expands to the surface of the pavement, especially during warmer temperatures.

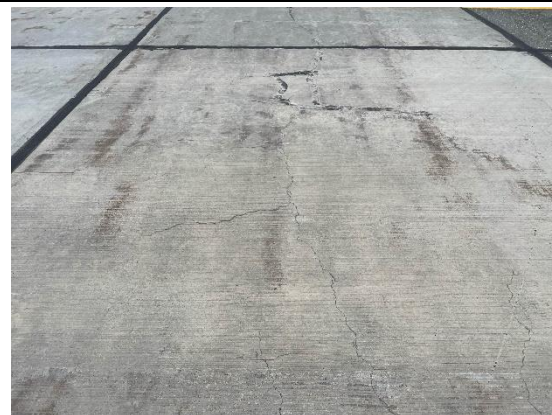
The PCC hardstands, Section 4400-HS, were constructed in 2007 and have not received any major work since. Routine crack and joint seal operations have been performed on the section. The most common distresses are low severity linear cracking, low severity scaling, and shrinkage cracking. Nearly every slab exhibits signs of shrinkage cracking, though this type of cracking typically does not extend through the full depth of the slab.
