# Alaska DOT&PF

## Pavement Inspection Report Fairbanks Airport

Airport Name	IATA	ICAO	Latitude	Longitude	Elevation (ft)
Fairbanks International Airport	FAI	PAFA	64° 48' 55.28" N	147° 51' 24.00" W	438.9

Point of Contact	Phone	Email	Date Inspected	Date Published
Mr. Andrew Pavey, Pavement Management Engineer	(907) 269 6213	andrew.pavey@alaska.gov	June 2024	August 2025

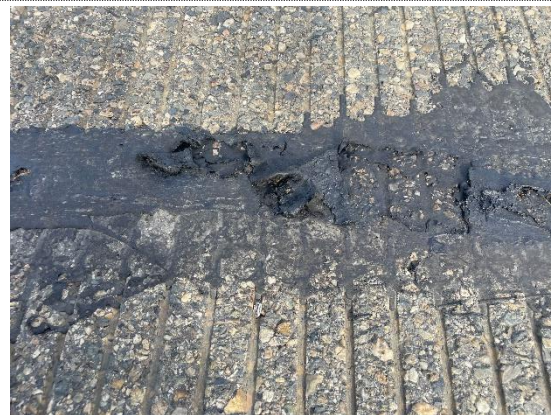
Runway 02L/20R consists of five sections, Sections 6100-01, 6100-03, and 6100-05 to 6100-07. The runway was constructed in 1987 and most recently reconstructed in 2008. Periodic crack seal operations have been performed on the branch. The most common distresses are low severity longitudinal and transverse cracking, low severity raveling, and medium severity weathering. Pavement inspectors observed the continued deterioration of the AC pavement surface, particularly the impact of the weathering on the pavement. The weather (loss of the fine aggregate) makes the pavement susceptible to future raveling and abrasion. In addition, inspectors noted the pavement surface is developing new unfilled cracks outside the planned relief cuts.

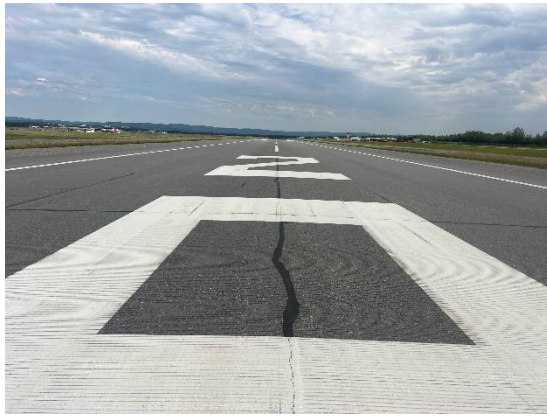
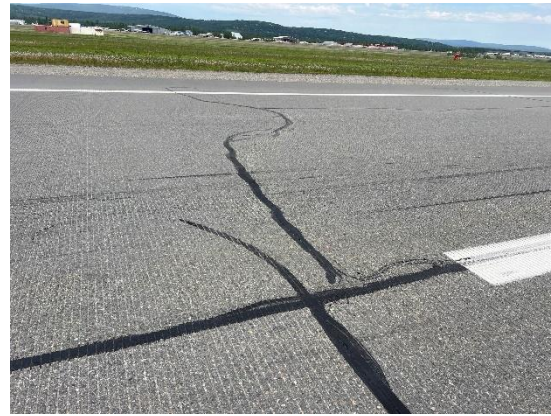
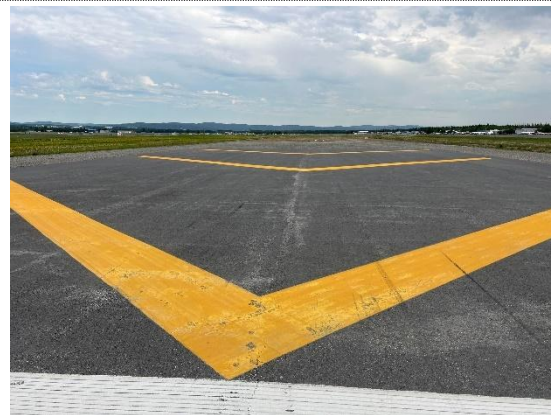
Runway 02R/20L is made up of three sections, Sections 6200-01 to 6200-03. Constructed in 2002, the runway was rehabilitated in 2022 by conducting 4 inches FDR followed by a 3-inch AC overlay. Periodic crack seal operations have been performed on the branch. The most common distresses are low severity longitudinal and transverse cracking and low severity weathering. Pavement inspectors observed the initiation of transverse cracking extending across the width of the runway, along with the gradual opening of paving joints.
