Alaska DOT&PF

Pavement Management and Preservation

Pavement Inspection Report Galena Airport

Airport Name	IATA	ICAO	Latitude	Longitude	Elevation (ft)
Edward G Pitka Sr Airport	GAL	PAGA	64° 44' 10.28" N	156° 56' 04.4" W	153.7

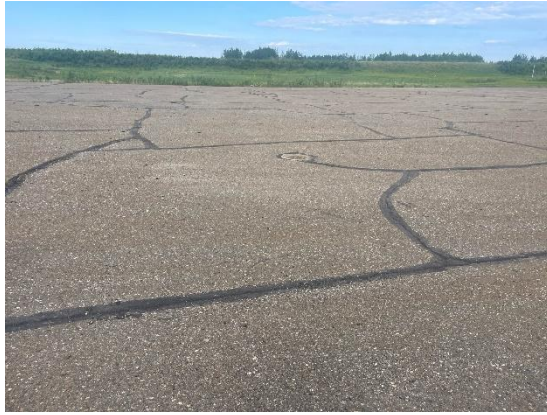
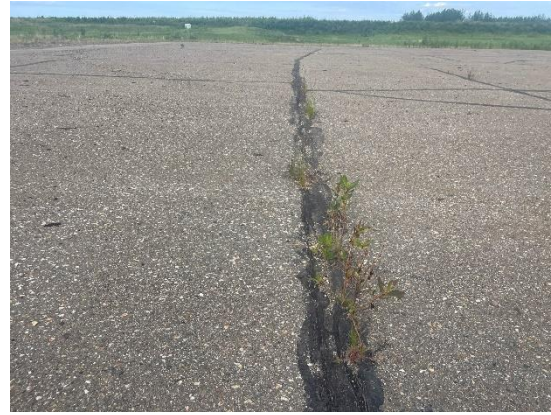
Branch ID	Branch Name	Branch Use	No. of Sections	Area (sf)	Weighted Average PCI
0100	Taxiway A	Taxiway	1	31,805	52

Taxiway A was constructed in 1987 and has not received major work since. Occasional crack seal operations have been performed on the branch. The most common distresses are low to high severity longitudinal and transverse cracking, low severity raveling, and low severity weathering. Pavement inspectors note that since 2018 the taxiway no longer connects to the runway due to a project that shortened the total length of the runway, making Taxiways B and D the primary connectors. As a result, Taxiway A is not regularly used and vegetation has begun to grow in the cracks, causing high severity longitudinal and transverse cracking to form.

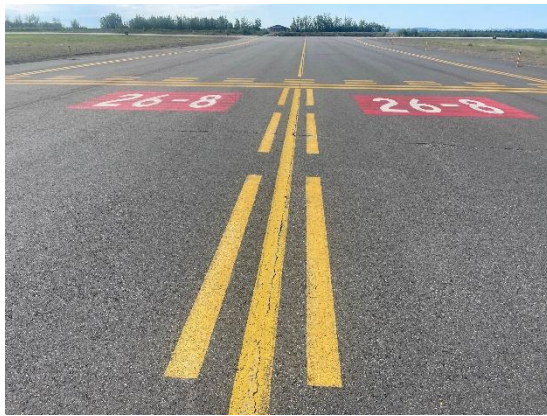
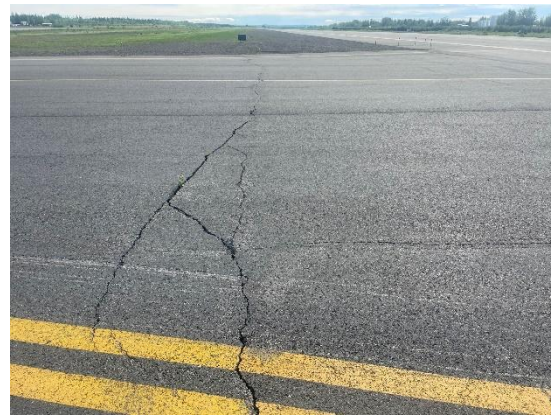
Branch ID	Branch Name	Branch Use	No. of Sections	Area (sf)	Weighted Average PCI
0200	Taxiway B	Taxiway	1	35,515	79

Taxiway B was constructed in 1987 and reconstructed in 2018. Crack seal operations have not been performed on the branch. The most common distresses are low to medium severity longitudinal and transverse cracking and low severity weathering. The pavement inspection team noted a significant increase in the quantity and severity of cracks developing across the taxiway. Crack sealing is recommended to slow the rate of pavement deterioration.

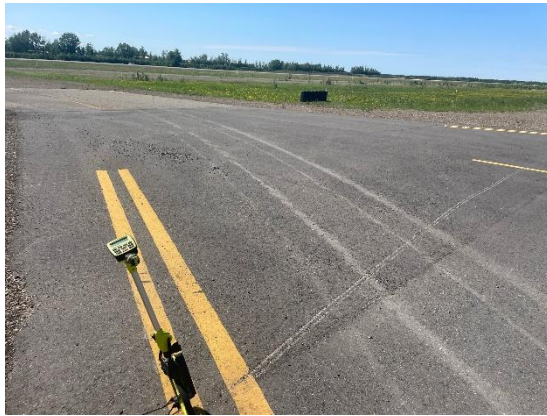
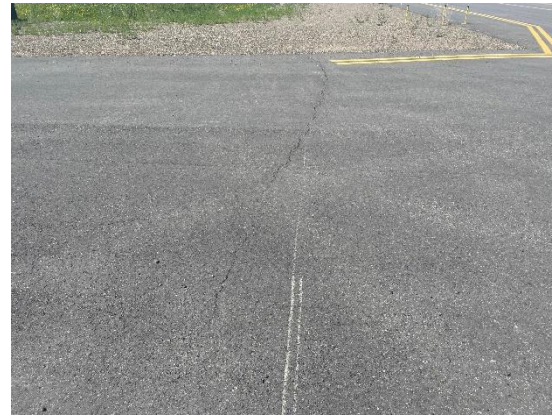
Branch ID	Branch Name	Branch Use	No. of Sections	Area (sf)	Weighted Average PCI
0300	Taxiway C	Taxiway	1	5,526	90

The paved areas of Taxiway C were constructed in 2004 and reconstructed in 2018. Crack seal operations have not been performed on the branch. The most common distresses are low severity depression and low severity longitudinal and transverse cracking. A minimal number of distresses exist on the taxiway due to it primarily being used to access the gravel-surfaced Runway 6/24 by crossing Taxiway F from the gravel-surfaced General Aviation Apron.

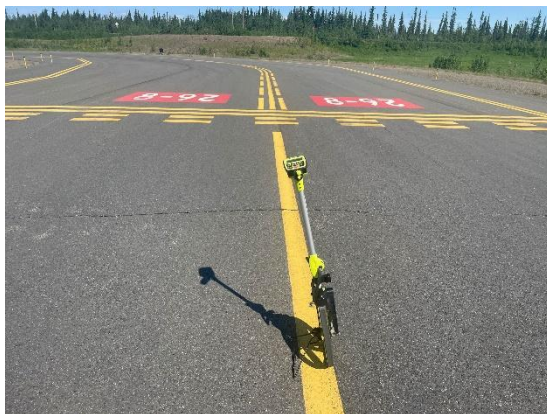
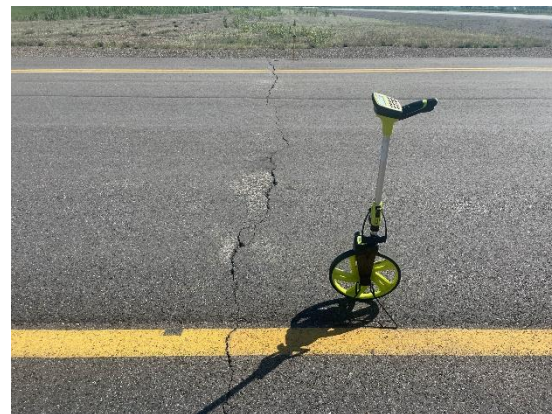
Branch ID	Branch Name	Branch Use	No. of Sections	Area (sf)	Weighted Average PCI
0400	Taxiway D	Taxiway	1	28,559	83

Taxiway D was constructed in 2004 and reconstructed in 2018. Crack seal operations have not been performed on the branch. The most common distresses are low to medium severity longitudinal and transverse cracking, low severity raveling, and low severity weathering. Pavement inspectors noted an increase in the quantity and severity of cracks developing across the taxiway. Crack sealing is recommended to slow the rate of deterioration.

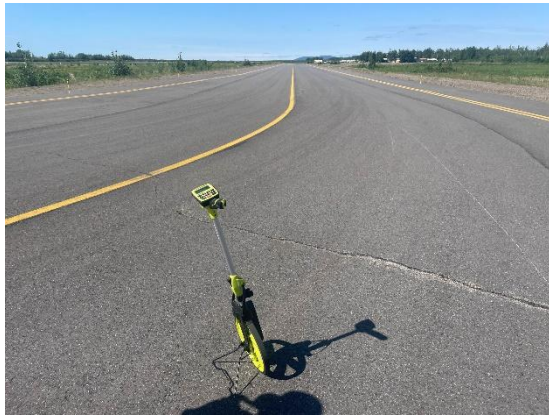
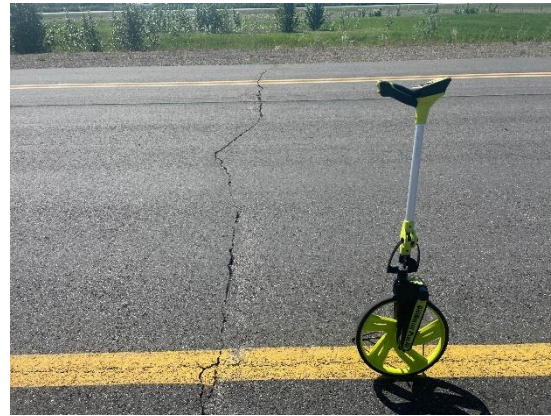
Branch ID	Branch Name	Branch Use	No. of Sections	Area (sf)	Weighted Average PCI
0600	Taxiway F	Taxiway	1	171,428	79

Taxiway F was constructed in 2004 and reconstructed in 2018. Crack seal operations have not been performed on the branch. The most common distresses are low to medium severity longitudinal and transverse cracking, low severity raveling, and low severity weathering. Pavement inspectors noted an increase in the quantity and severity of cracks developing across the taxiway. Crack sealing is recommended to slow the rate of deterioration.

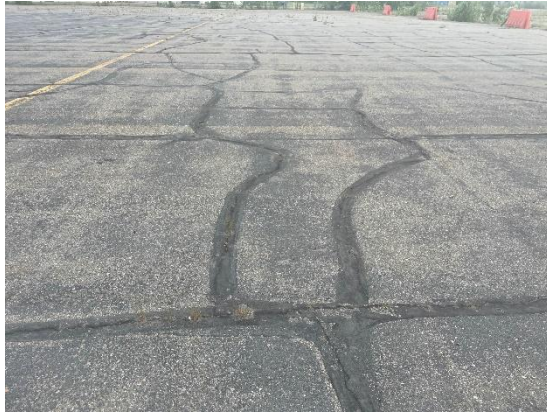
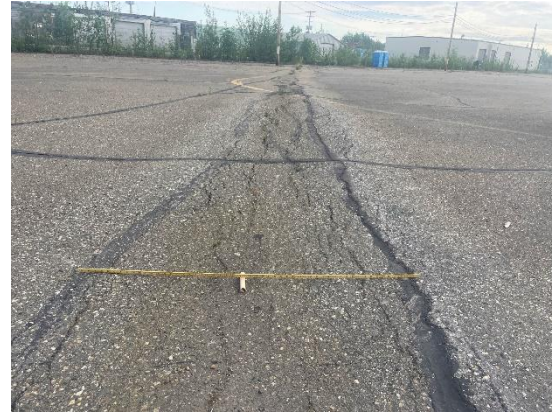
AC Section 4100-01 (41 PCI)

The North Apron consists of four sections, two AC sections (Sections 4100-01 and 4100-02) and two PCC sections (Section 4100-03 and 4100-04). AC Section 4100-01 was constructed in 1987 and has not received any major work since. Occasional crack seal operations have been performed on the branch. The most common distresses are low to medium severity block cracking, low to high severity longitudinal and transverse cracking, low to high severity raveling, medium to high severity swelling, and low severity weathering. With the shortening of the RW 8-26, Section 4100-01 is the more distant apron from access to RW 8-26 and therefore has not been used often since 2018. Pavement inspectors note that the large number and increasing severity of distresses is consistent with its age.

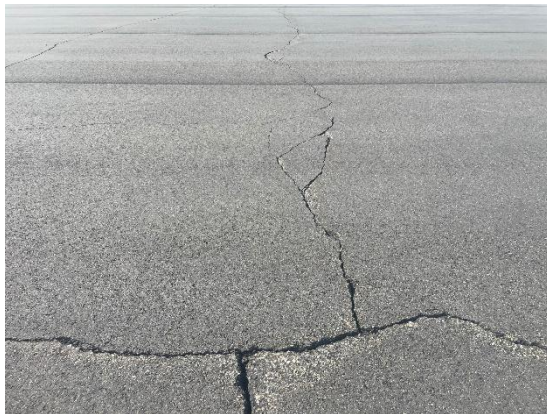
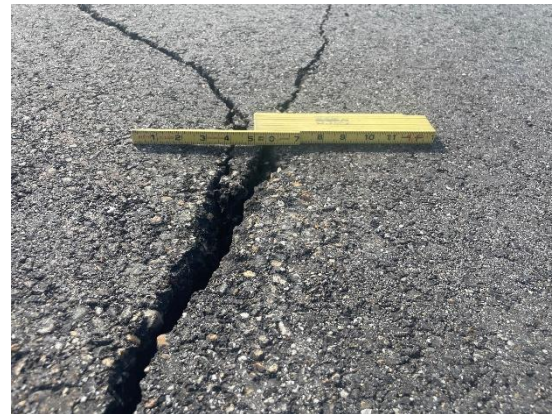
AC Section 4100-02 (80 PCI)

AC Section 4100-02 was constructed in 1987 and reconstructed in 2018. Crack seal operations have not been performed on the branch. The most common distresses are low to medium severity longitudinal and transverse cracking, oil spillage, low severity raveling, and low severity weathering. The quantity and severity of cracks is increasing across the parking apron. Crack sealing is recommended to slow the rate of deterioration.

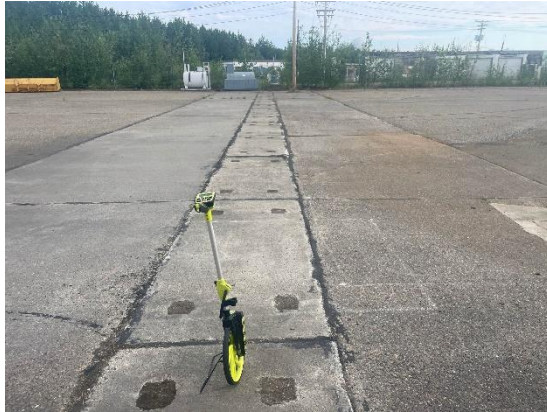
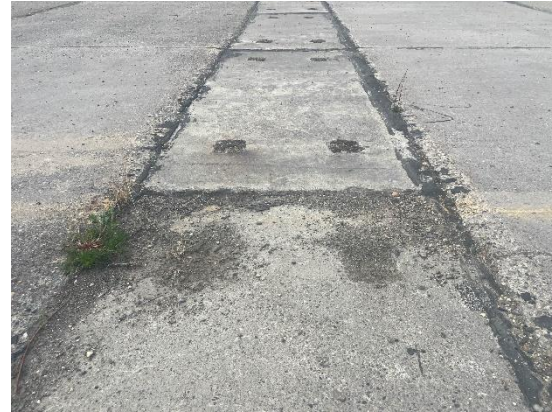
PCC Section 4100-03 (33 PCI)

PCC Section 4100-03 was constructed in 1987 and has not received any major work since. The most common distresses are low severity linear cracking, medium severity joint seal damage, low to medium severity scaling, and low to medium severity faulting. This section of the North Apron is behind the Alert Hangar and is not often used due to its location. The large quantity of distresses at increasing severities is consistent with the nearly 40-year age of the pavement.

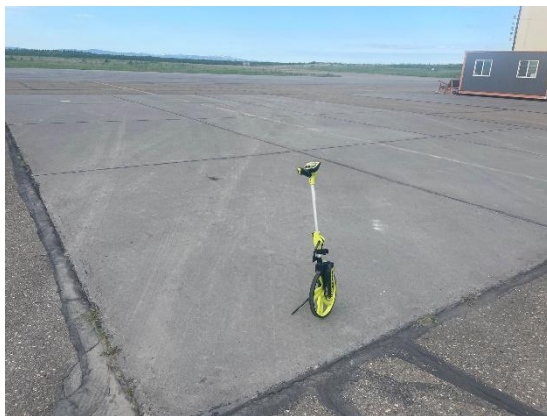
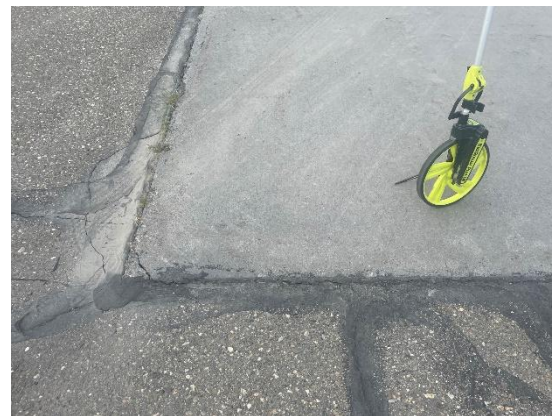
PCC Section 4100-HS (83 PCI)

PCC section 4100-HS consists of four individual hardstands that were constructed in 1987 and have not received any major work since. The most common distresses are low severity joint seal damage, low to medium joint spalling, and low to medium corner spalling. The edges of the concrete hardstands are spalled, which is evident on each of the four hardstands.

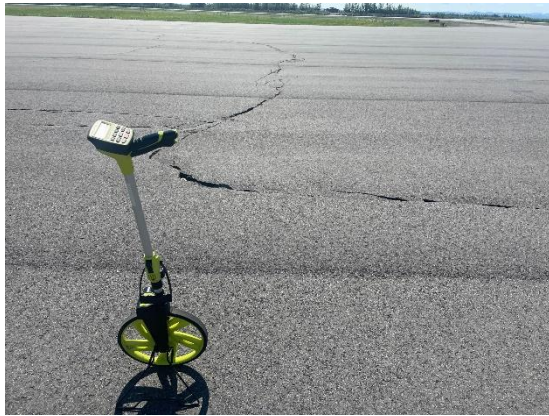
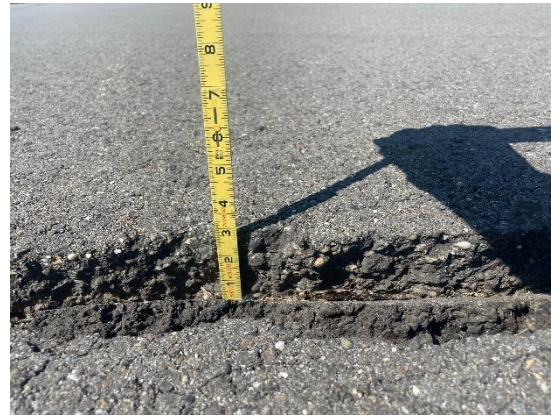
Branch ID	Branch Name	Branch Use	No. of Sections	Area (sf)	Weighted Average PCI
4200	GA Apron	Apron	1	457,389	82

The General Aviation (GA) Apron was constructed in 1983, reconstructed in 2004 and reconstructed again in 2018. Crack seal operations have not been performed on the branch. The most common distresses include low to high severity longitudinal and transverse cracking, oil spillage, low severity raveling, and low severity weathering. Pavement inspectors identified a high severity crack extending across the entire width of the apron. This crack is significant, measuring more than an inch wide in areas, has led to the formation of a vertical fault exceeding two inches. Localized repair may be required to correct the wide cracking and faulting. In addition, crack sealing is recommended to slow the rate of pavement deterioration.

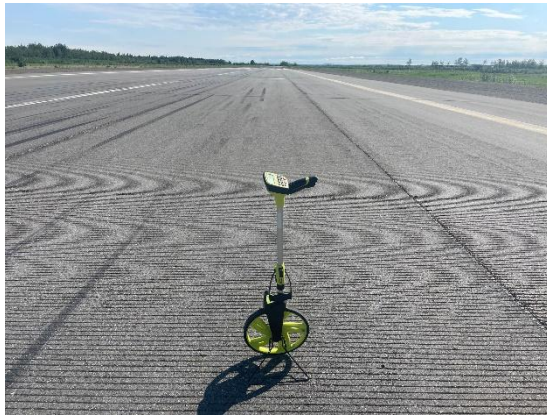
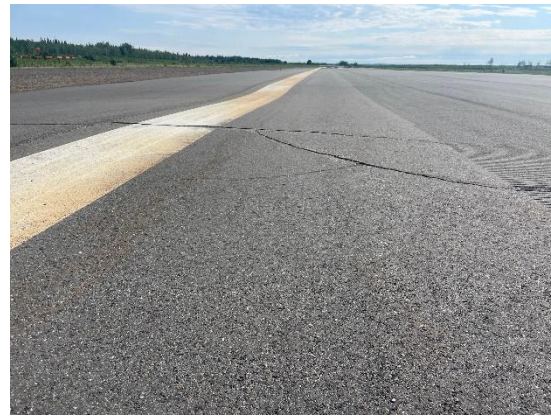
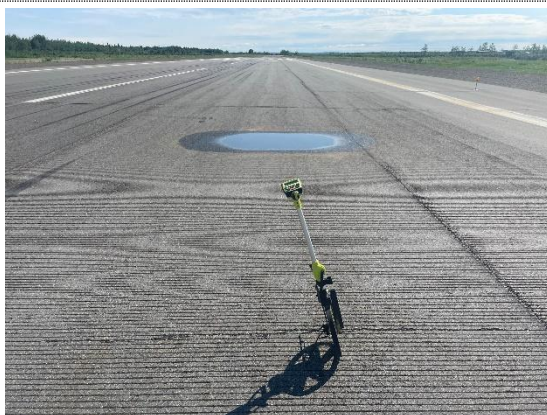
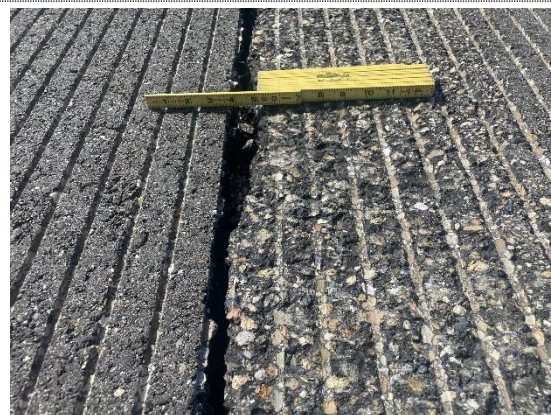
Branch ID	Branch Name	Branch Use	No. of Sections	Area (sf)	Weighted Average PCI
6100	Runway 08/26	Runway	5	656,000	73

Runway 08/26 was constructed in 1987 and reconstructed in 2018. The 2018 project also reduced the width of RW 08/26 from 150 feet to 100 feet and reduced its length from 7,250 feet to 6,000 feet. Crack seal operations have not been performed on this runway. The most common distresses include medium to high severity depressions, low to medium severity longitudinal and transverse cracking, low severity raveling, and low severity weathering. Significant depressions are present on the runway surface at a point approximately 500 feet east of its intersection with TW D. There are also a substantial number of large depressions off the runway edge on either side of the runway in the same area. Water accumulation was observed in these depressions, as documented in the accompanying photographs.
