Alaska DOT&PF

Pavement Inspection Report Gambell Airport

Airport Name	IATA	ICAO	Latitude	Longitude	Elevation (ft)
Gambell Airport	GAM	PAGM	63° 45' 59.82" N	171° 43' 58.02" W	29.5

Point of Contact	Phone	Email	Date Inspected	Date Published
Mr. Andrew Pavey, Pavement Management Engineer	(907) 269 6213	andrew.pavey@alaska.gov	July 2024	November 2024

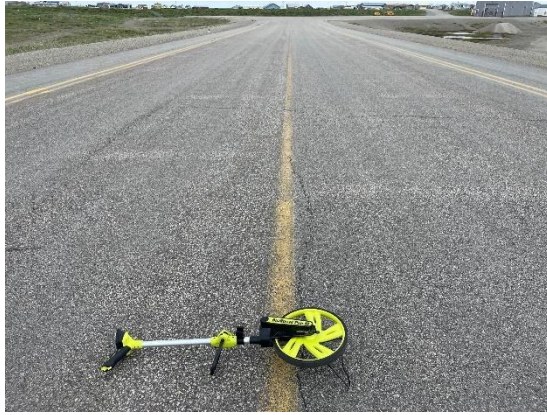
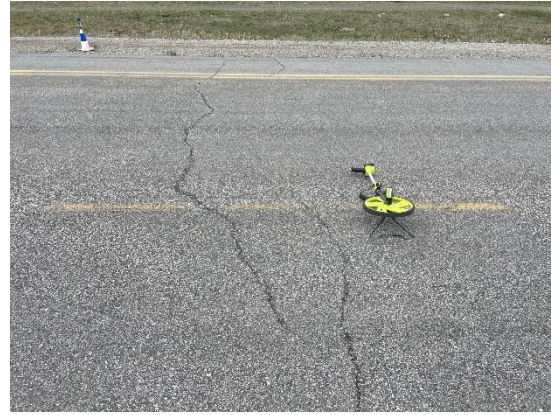
Branch ID	Branch Name	Branch Use	No. of Sections	Area (sf)	Weighted Average PCI
0100	Taxiway A	Taxiway	2	54,150	84

Taxiway A was initially constructed in 1999 and then underwent surface reconstruction in 2018. The surface reconstruction consisted of milling 2" of existing HMA and 2" of existing CABC which in turn was replaced with 4" of P-209 CABC and 4" of P-401 HMA. Crack seal operations have not been performed on the taxiway. The most common distresses observed are low to medium severity longitudinal and transverse cracking, low severity raveling, and low severity weathering. Field observations include initial deterioration of the top layer of asphalt which is contributing to higher quantities of raveling and weathering across the taxiway as well as the development of new unfilled cracks.

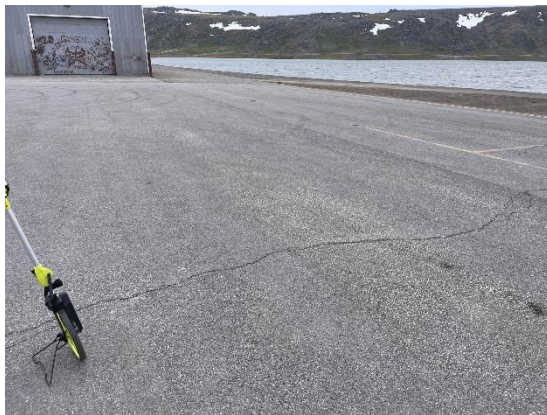
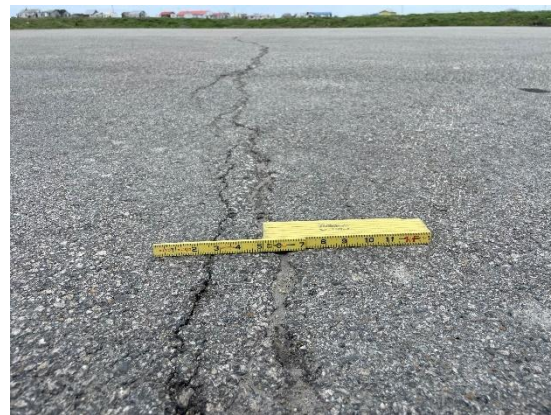
Branch ID	Branch Name	Branch Use	No. of Sections	Area (sf)	Weighted Average PCI
4100	Apron	Apron	1	60,000	86

Like Taxiway A, the Apron was initially constructed in 1999 and then underwent surface reconstruction in 2018. The surface reconstruction consisted of milling 2" of existing HMA and 2" of existing CABC which in turn was replaced with 4" of P-209 CABC and 4" of P-401 HMA. Crack seal operations have not been performed on the apron. The most common distresses observed are low to medium severity longitudinal and transverse cracking, low quantities of oil spillage, low severity raveling, and low severity weathering. Field observations include the development of new unfilled cracks, some of which are widening to the level of medium severity.

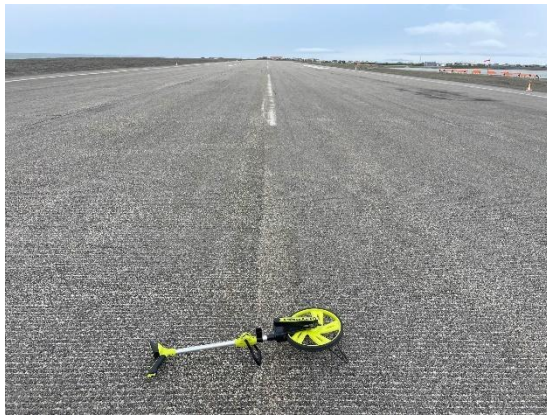
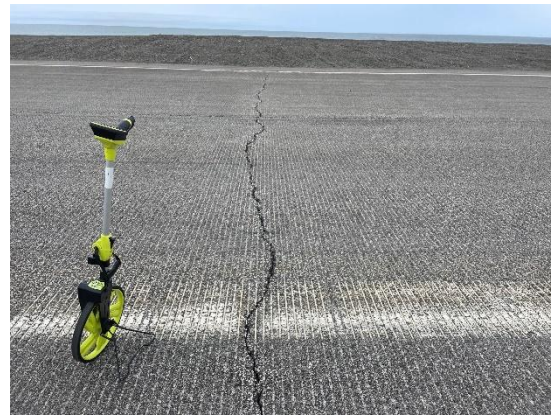
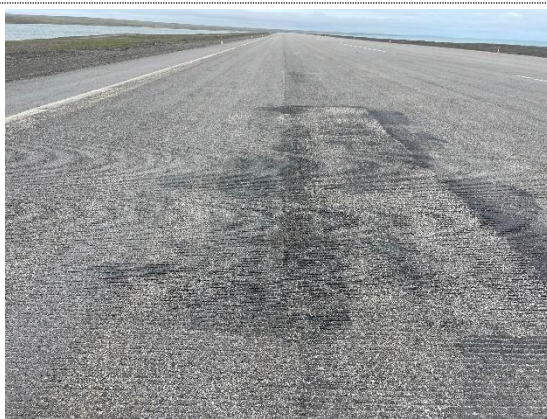
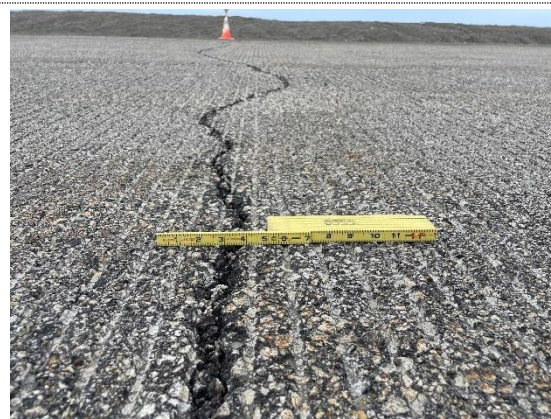
Branch ID	Branch Name	Branch Use	No. of Sections	Area (sf)	Weighted Average PCI
6100	Runway 16/34	Runway	2	450,000	77

Runway 16/34 was constructed in 1999 and then underwent surface reconstruction in 2018. The surface reconstruction consisted of milling 4" of existing HMA and 2" of existing CABC which in turn was replaced with 6" of P-209 CABC and 4" of P-401 HMA. Crack seal operations have not been performed on the runway. The most common distresses observed are low to medium severity longitudinal and transverse cracking, low severity raveling, and low severity weathering. Field observations include initial deterioration of the top layer of asphalt which is contributing to higher quantities of raveling and weathering across the runway as well as the development of new unfilled cracks, some of which are widening to the level of medium severity.
